September 2022

## Mundaring Weir Rd - Road Safety Investigation

Prepared For: City of Kalamunda

## Final Report

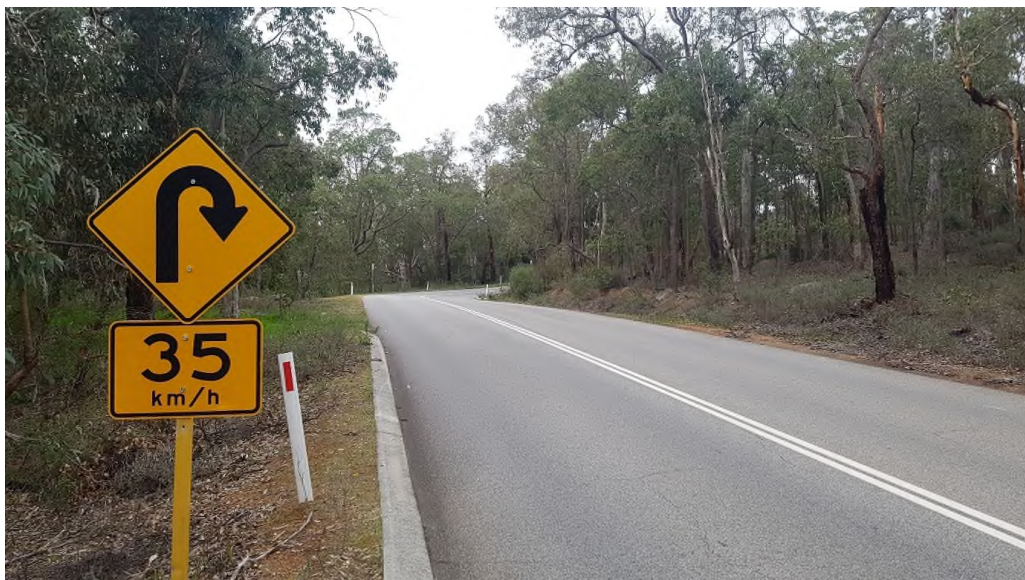
It is noted from the crash history that there have been four (4) head on crashes on the bend in **Photo 20**. Two of these crashes involved a motorcyclist and one a cyclist. With the exception of the crash involving a bicycle, the other three resulted from a westbound vehicle (2 x motorcycles, 1 x unknown) losing control and running wide into an oncoming vehicle.

All four crashes occurred during the day, in dry conditions. It is not known when the advisory speed limit signs were installed, but they appear new.

**Photo 20: Both curves currently have advisory speed limit signs.**

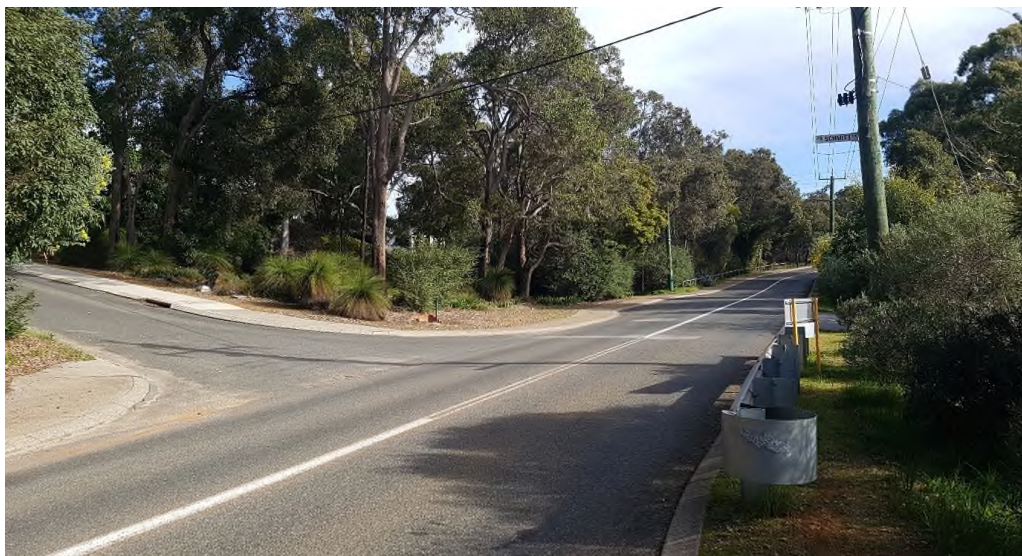
The side road at this intersection approaches from the south on a significant downhill gradient. There is an existing hazard board opposite the approach, but no Give Way (or Stop) signs or line marking. See **Photo 21.**

**Photo 21: T-intersection of Schmitt Road with Mundaring Weir Road.**

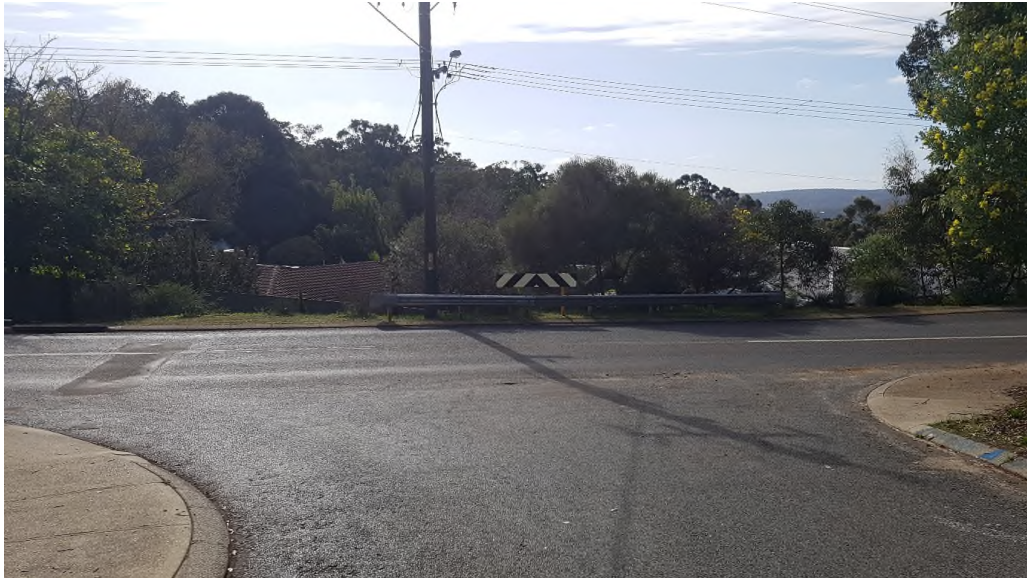
There is a short section of W-beam opposite the side road, ostensibly to prevent overshoots from the side road dropping down the embankment. Typically, W-beam is not designed to withstand such impacts. It should also be noted that the barrier as installed does not cover the length of need regarding either the embankment or the power pole, does not meet the minimum effective length requirement of 28m and has non-crashworthy end terminations. See **Photo 22**.

**Photo 22: Hazard board, but no Give Way lines or signs. Note unsuitable safety fence.**

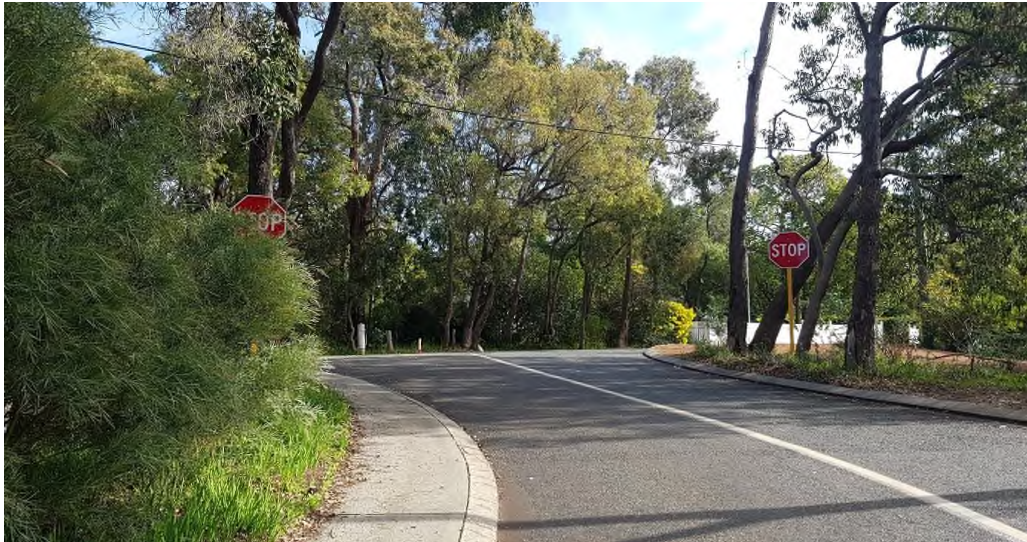
Approaching Mundaring Weir Road on an uphill gradient, Hummerston Road has Stop signs and lines, but no hazard board. See **Photo 27**.

**Photo 27: Hummerston Road approach to Mundaring Weir Road.**

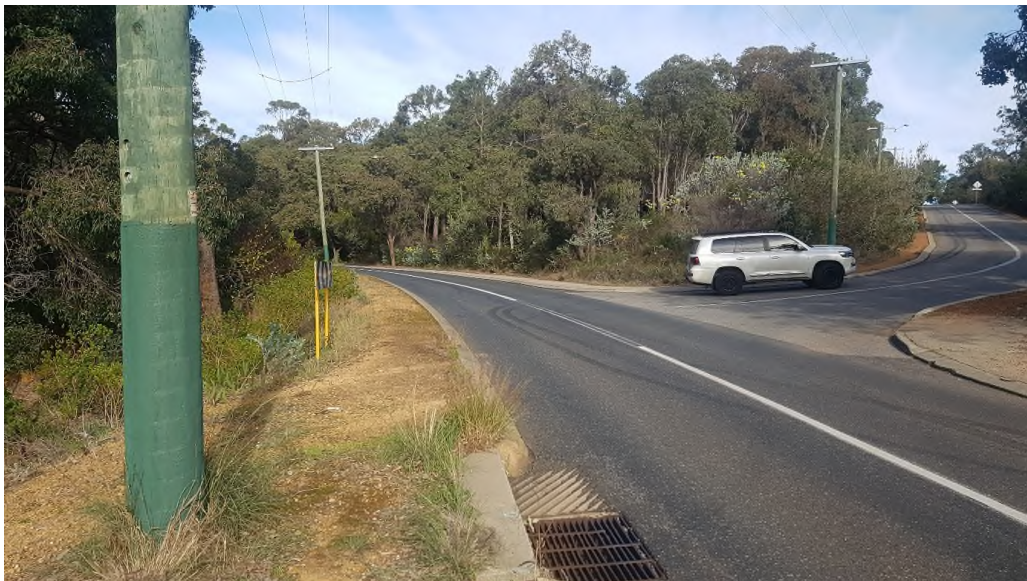
The geometry of the intersection with King Road is not ideal. The side road approaches at an acute angle, before swinging down and right to meet the through road at 90°. However, overgrown verge vegetation limits visibility. The intersection has a hazard board opposite the side road, as well as for the change in alignment on approach, but no Give Way or Stop signs or lines. See **Photos 29 & 30**.

**Photo 29: T-intersection of King Road with Mundaring Weir Road.**

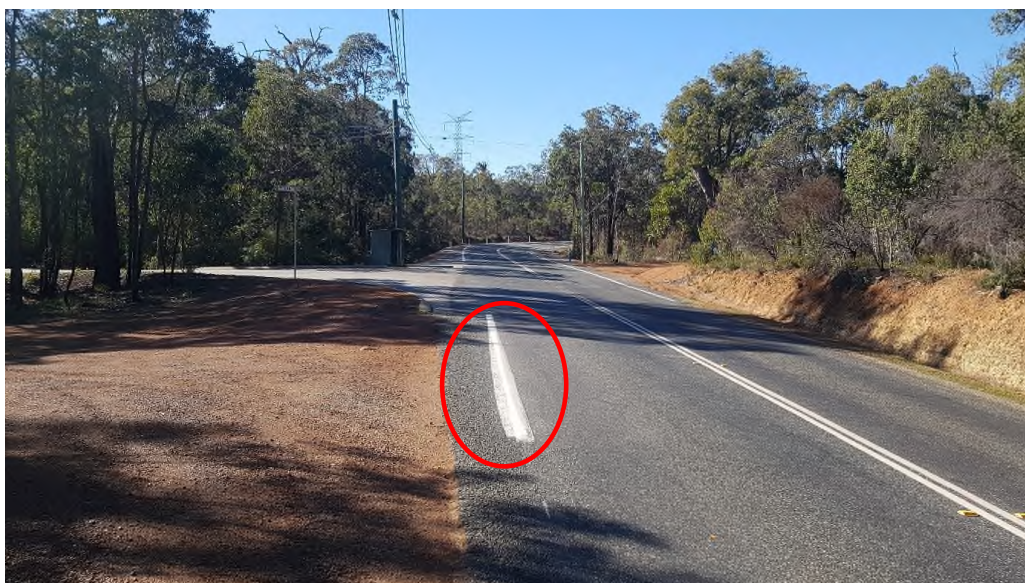
Fern Road forms a T-intersection with Mundaring Weir Road, located on a short straight between two sweeping bends. Visibility is limited to some extent to the left by the presence of a disused bus shelter, and to the right by a horizontal curve. The intersection has no Give Way lines or signs, no hazard board and a non-standard section of edge line. See **Photos 40 to 41a**.

**Photo 40: Fern Road intersection, with non-standard edge line marking.**

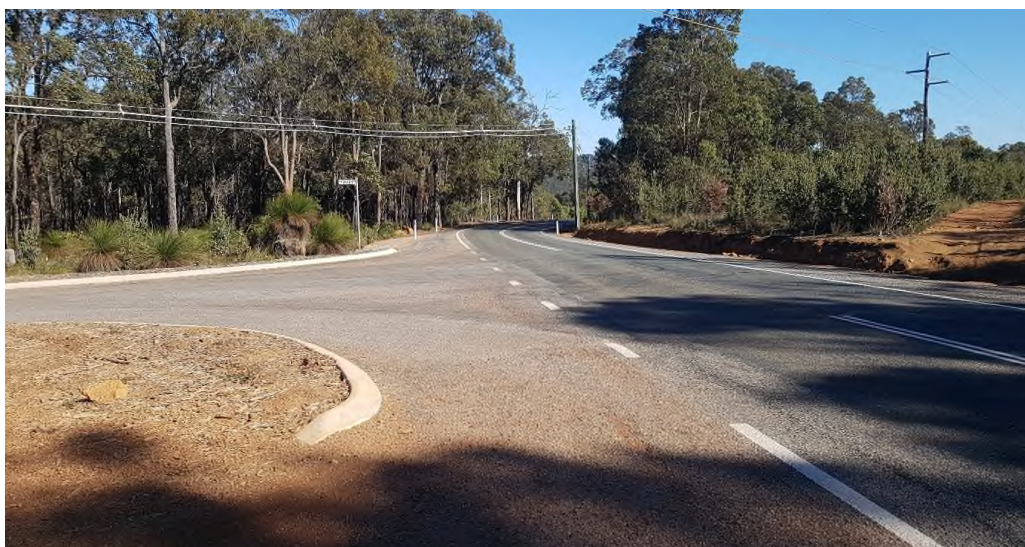
The intersection of Mundaring Weir Road with Bahen Road is a T-intersection. It has no Give Way signs or lines and no hazard board opposite. Visibility is limited in both directions by horizontal and vertical alignment issues. See **Photos 42 to 43a**.

**Photo 42: The intersection of Mundaring Weir Road with Bahen Road is a T-intersection.**

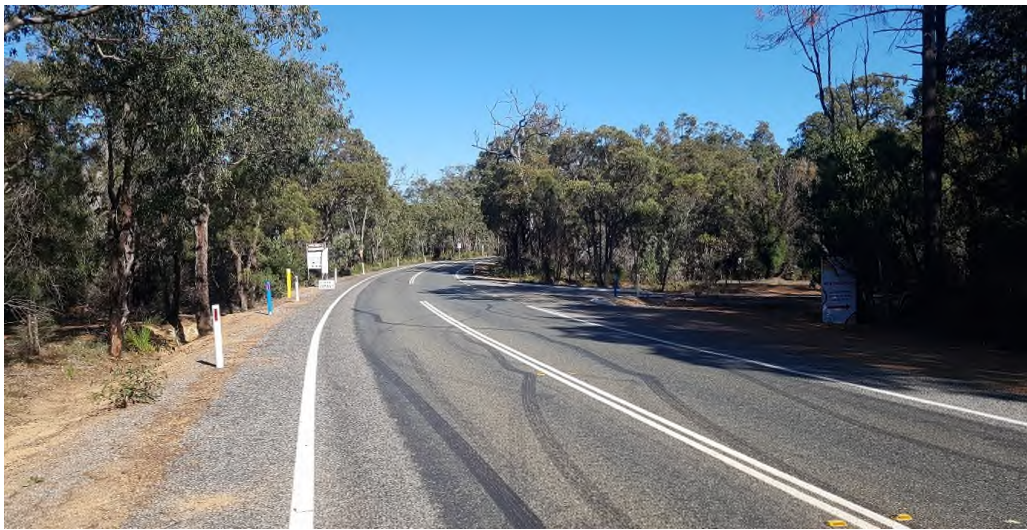
The intersection of Mundaring Weir Road with Paulls Valley Road is a T-intersection. It has no Give Way signs or lines and no hazard board opposite. However, it appears from markings and other evidence on site that upgrades to this intersection have yet to be completed. Visibility is limited in both directions by horizontal and vertical alignment issues. See **Photos 44 to 45a**.

**Photo 44:** Visibility to the right from the Paulls Valley Road intersection is limited by a horizontal curve.

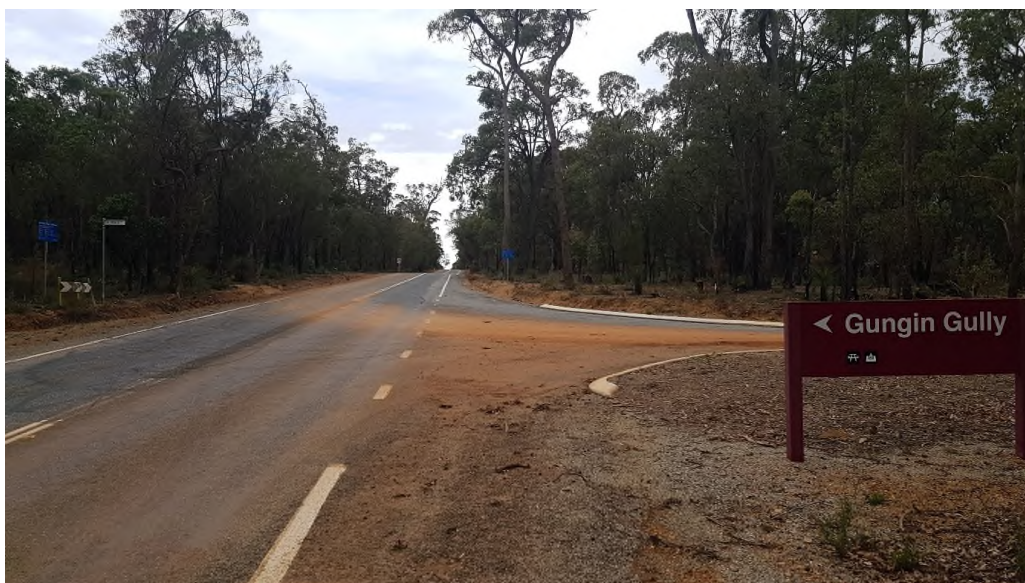
The Lockwood Road intersection has no Give Way signs or lines, but does have a damaged Hazard board which is, in any case, incorrect for its location. There is also a significant amount of loose material being dragged onto the through road at the intersection. This may present a hazard to road users, especially bicycles and motor cycles. See **Photos 48 to 49a**.

**Photo 48: Lockwood Road intersection.**

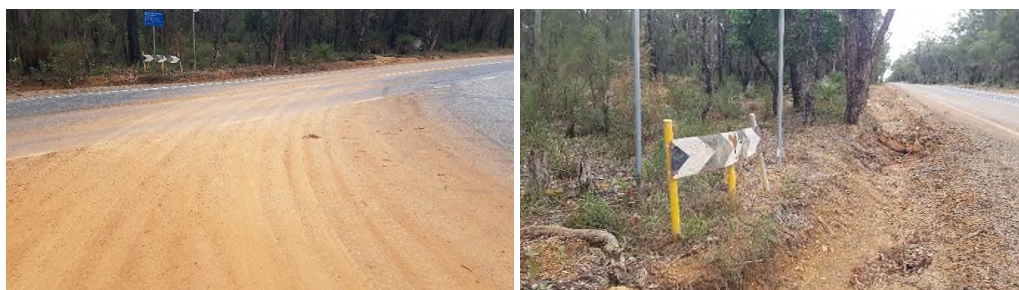
**Photos 49 & 49a: Loose material being dragged onto the carriageway and a damaged (incorrect) hazard board.**

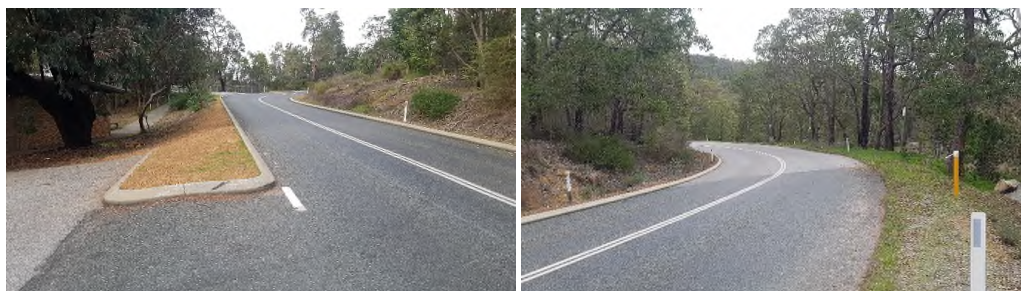
However, visibility at the western car park access is limited by the bends. See **Photos 57 & 57a**.

**Photos 57 & 57a:** Visibility from the western Mundaring Weir car parking access.

It is noted that from the Crash History data, there have been four (4) head on crashes on the bend just west of the western car park access.

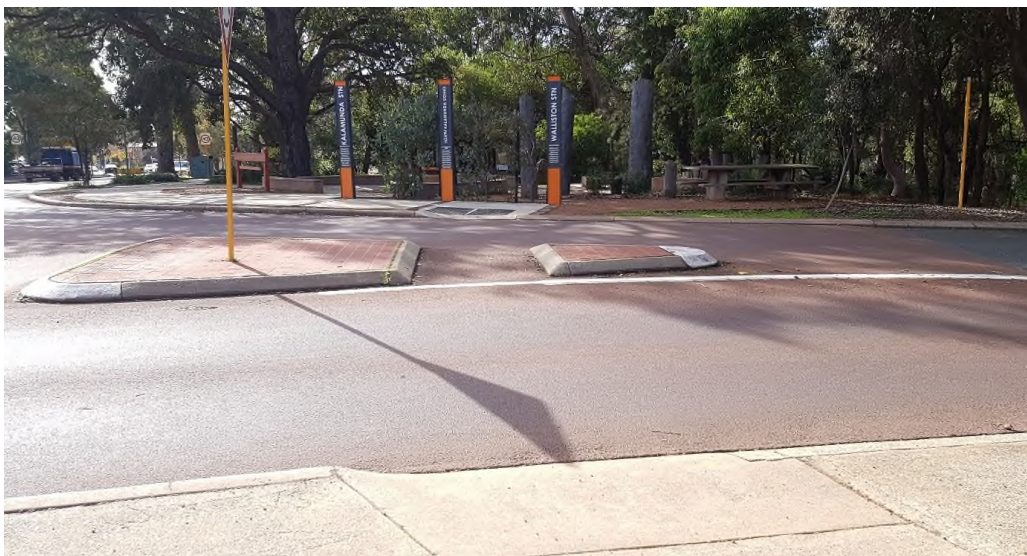
The standard of pedestrian crossings is generally poor. Even at the Railway Road roundabout, TGSIs are either missing or poorly aligned. See **Photo 67**.

**Photo 67:** Tactile Ground Surface Indicators (TGSIs) are poorly aligned or missing.

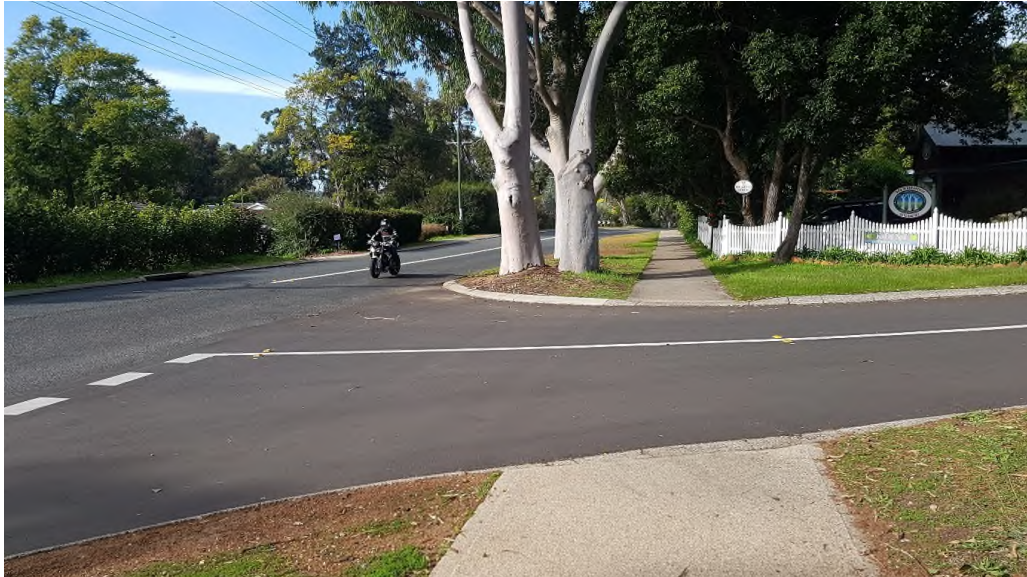
**Photo 68:** Typical pedestrian crossing, with ramps being well below current design standards.

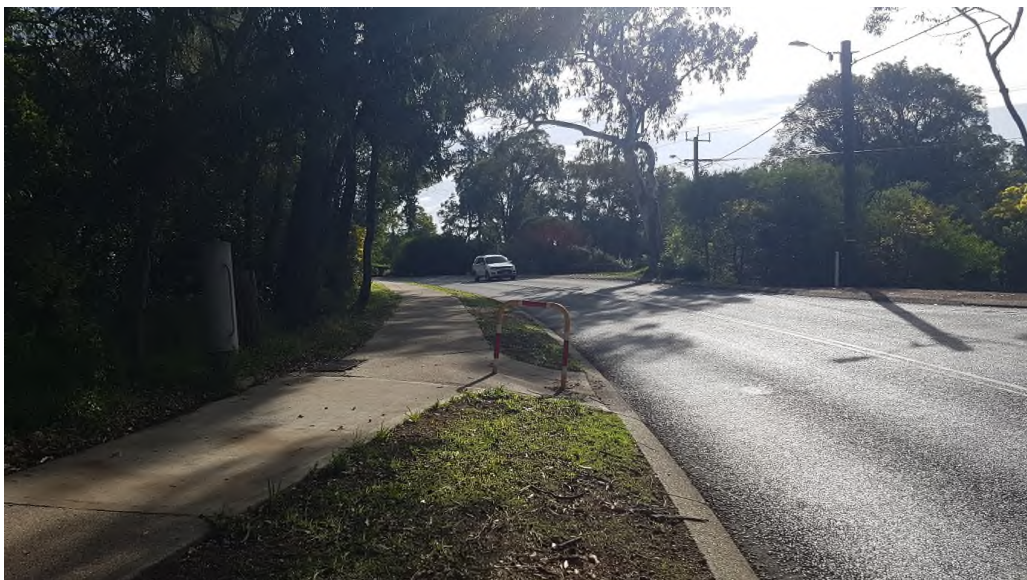
The crossing opposite Hummerston Road is unsafe and should be removed / relocated.

The crossing is badly located, with poor visibility, the ramp is far too steep and there are no TGSIs. The ramps on the opposite side – one on each side of the Hummerston Road intersection – are well below standard, and would be impossible to identify for anyone who is visually impaired. See **Photos 69 & 70**.

**Photo 69:** This crossing opposite the Hummerston Road intersection is poorly designed and should be removed.

As discussed in **section 3.4.1**, this crossing is unsafe, and should be removed and relocated.

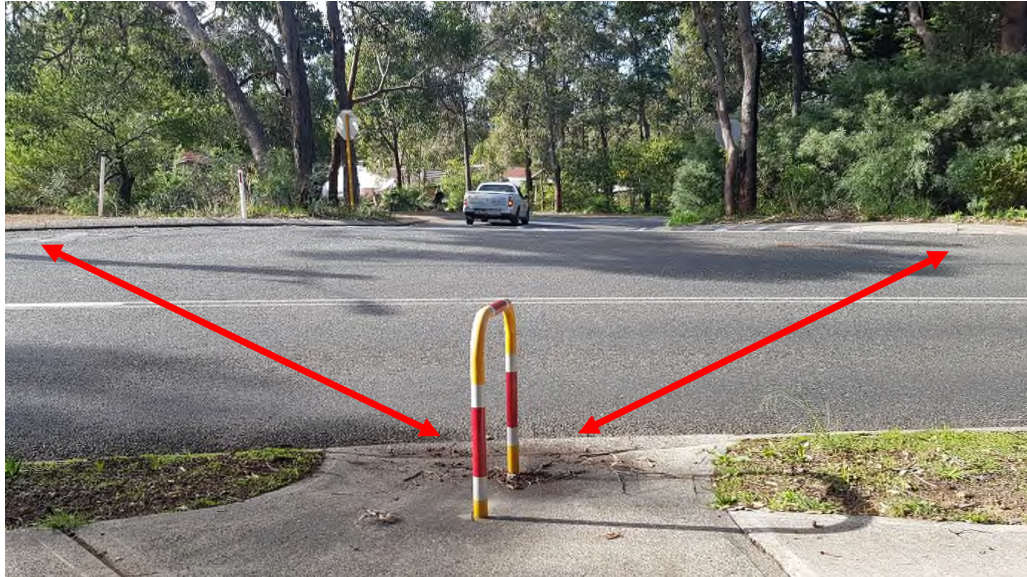
**Photo 70:** The crossing is badly aligned, with ramps well below current standards, no TGSIs and limited visibility.

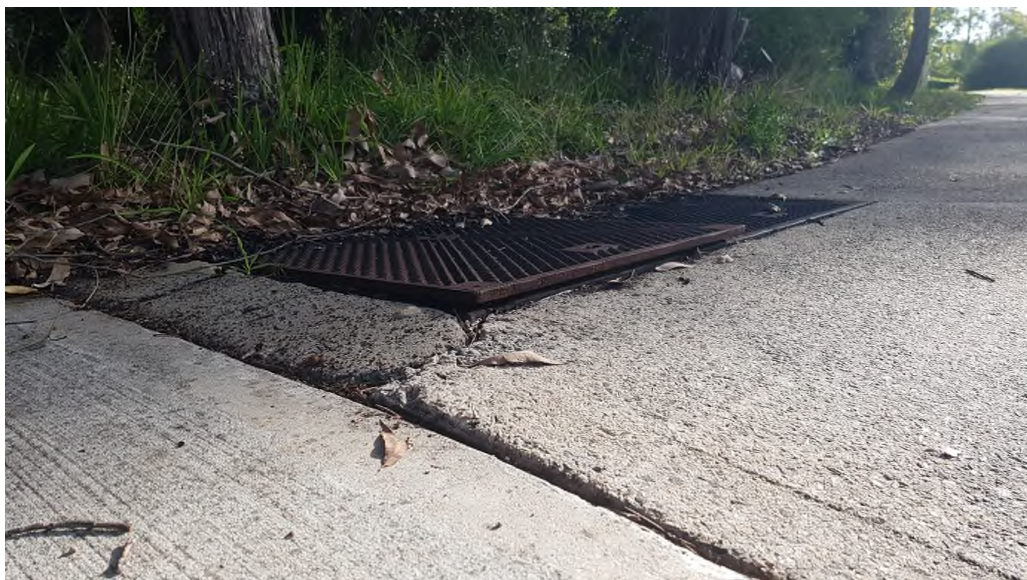
There are numerous trip hazards along this section of footpath. These range from badly fitted service lids to cracks caused by tree roots. Other obstacles observed on site included trees in close proximity to the path, overgrown verge vegetation, loose material and debris, and a trailer parked on the footpath.

**Photo 71:** Trip hazard in footpath.

It is therefore recommended that the existing footpath through this section be upgraded to a 3m shared path, with suitable crossing points as required. The cost estimate has allowed for 1m widening of the path for the majority of its length (80% or 1,600m), with 20% (400m) assumed to be required to be new path.

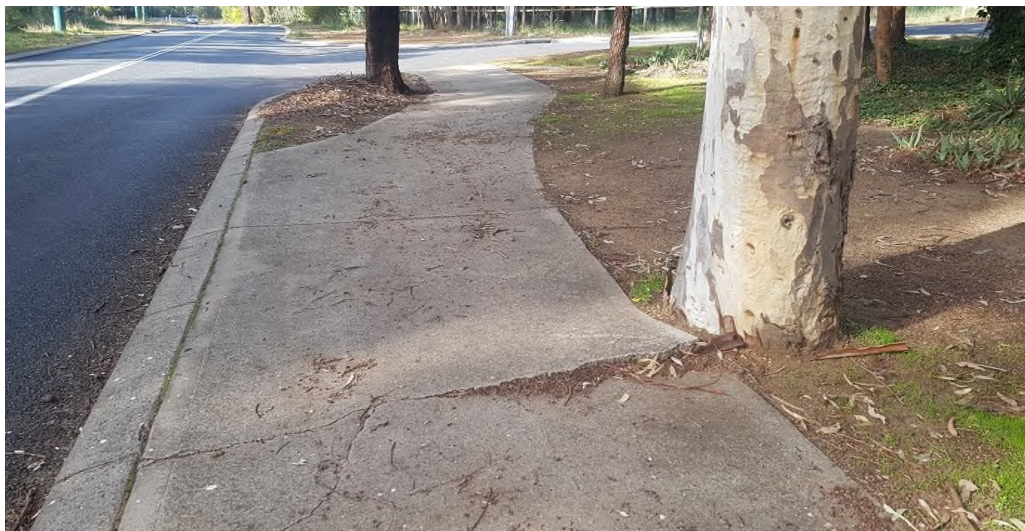
**Photo 72: Significant trip hazard due to root damage.**

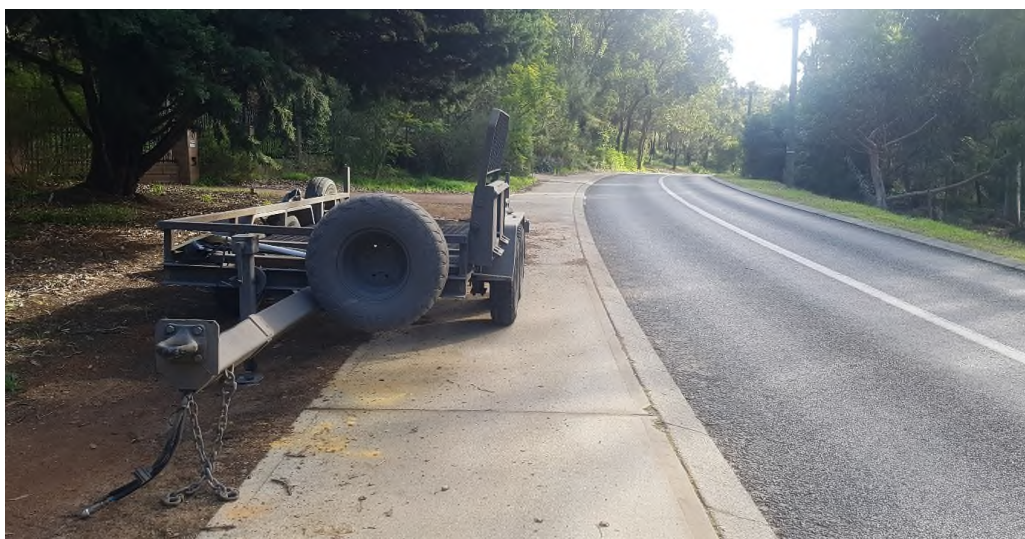
**Photo 73: This trailer appears to be parked on the footpath regularly.**

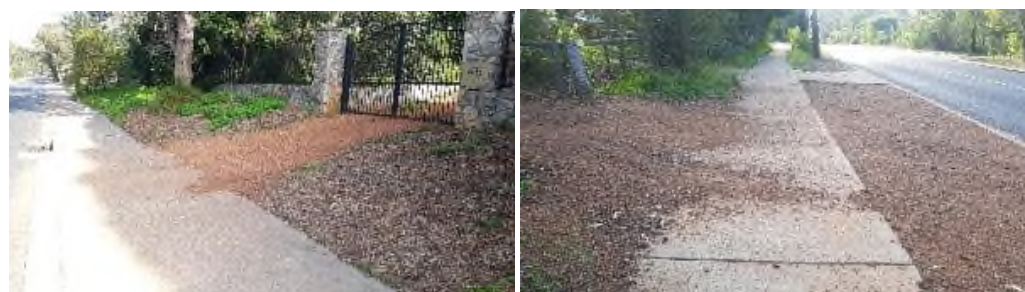
**Photos 74 & 74a: Loose material dragged onto footpath and road surface from unsealed driveways.**

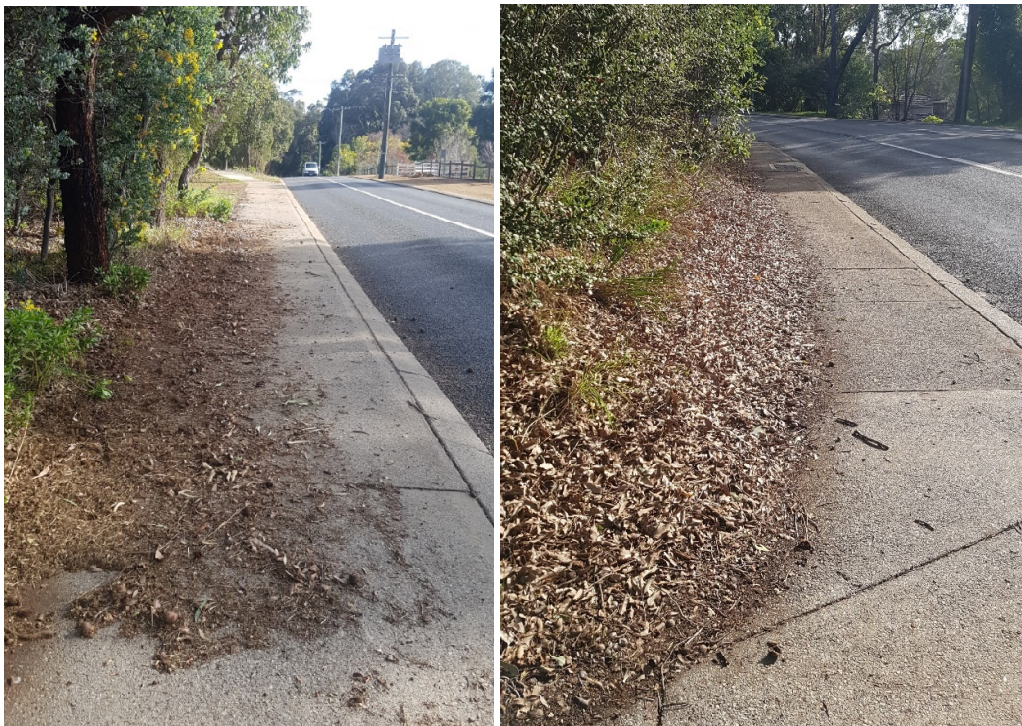
**Photos 75 & 75a: Footpaths obstructed by debris.**

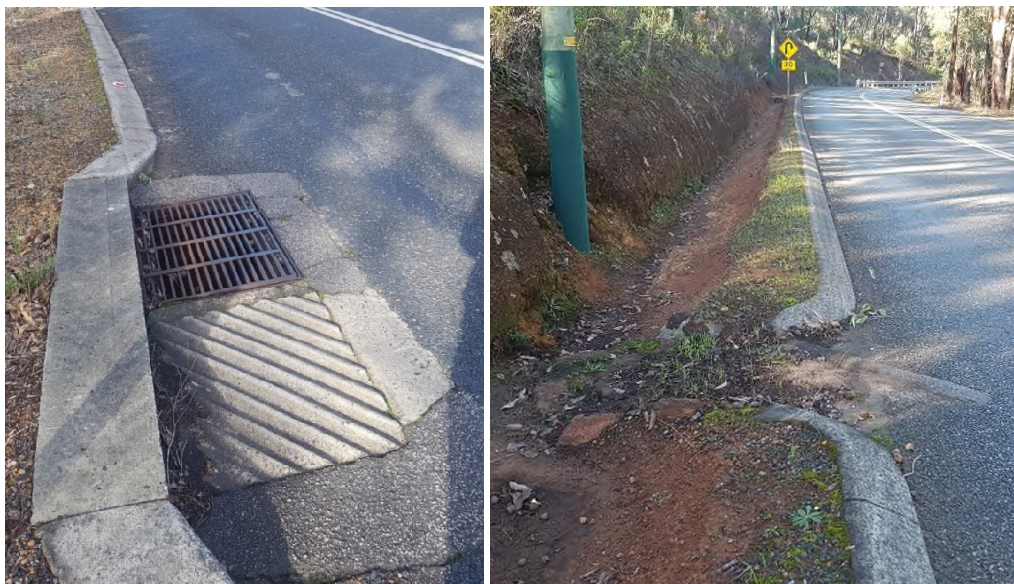
Again there are a number of drainage features that are unsafe for cyclists. See **Photos 79 & 79a**.

**Photos 79 & 79a:** These drainage designs present a hazard to cyclists.

A number of unsuitable drainage features were identified, at various locations, which, although designed to channel water flow into the kerbside gulleys, also present a significant hazard to cyclists and possibly motorcyclists. These should be replaced with gratings designed to meet current standards.

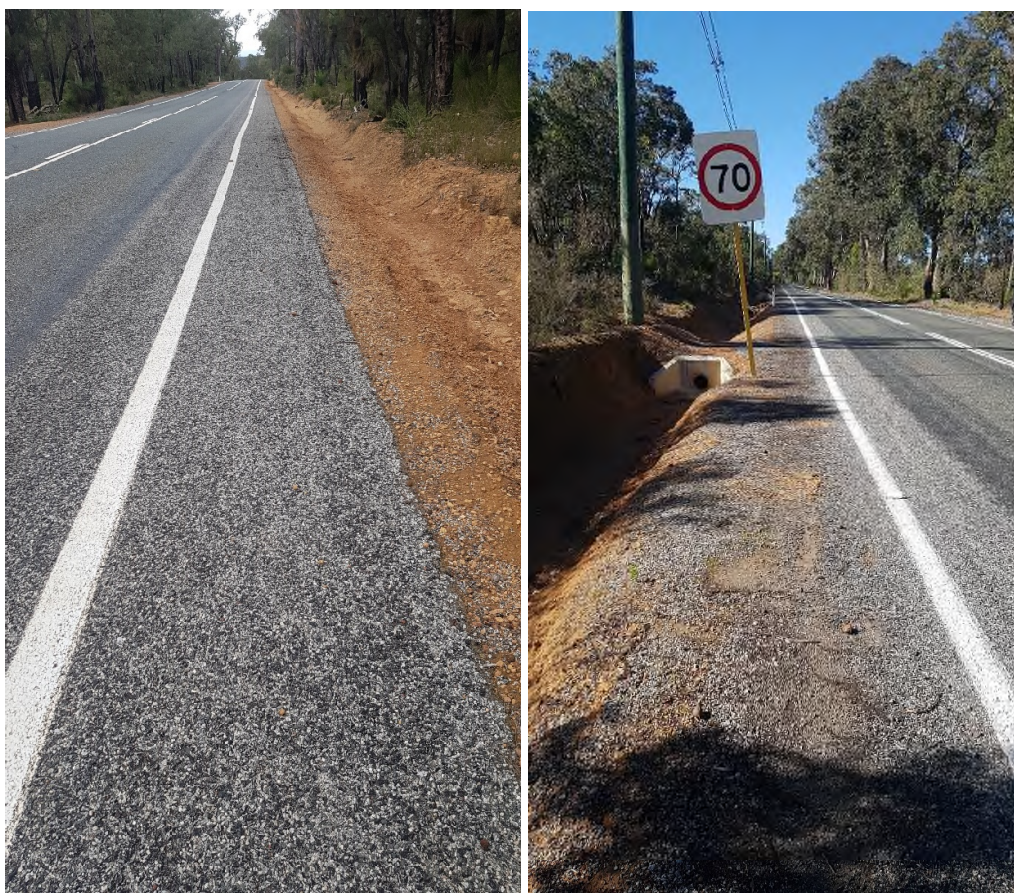
There are no specific cycling or pedestrian facilities along this section of Mundaring Weir Road. The road has recently been widened along the majority of this section, with edge lines, guideposts and sealed hard shoulders. However, the width of the hard shoulder varies, and whilst in some areas it provides a reasonably safe place for cyclists to ride, in others it is either too narrow, or the surfacing of the shoulder is not conducive to safe cycling. See **Photos 81 and 81a**.

**Photos 81 & 81a: Hard shoulders vary in width and rideability. Note temporary reflector tabs on white lining.**

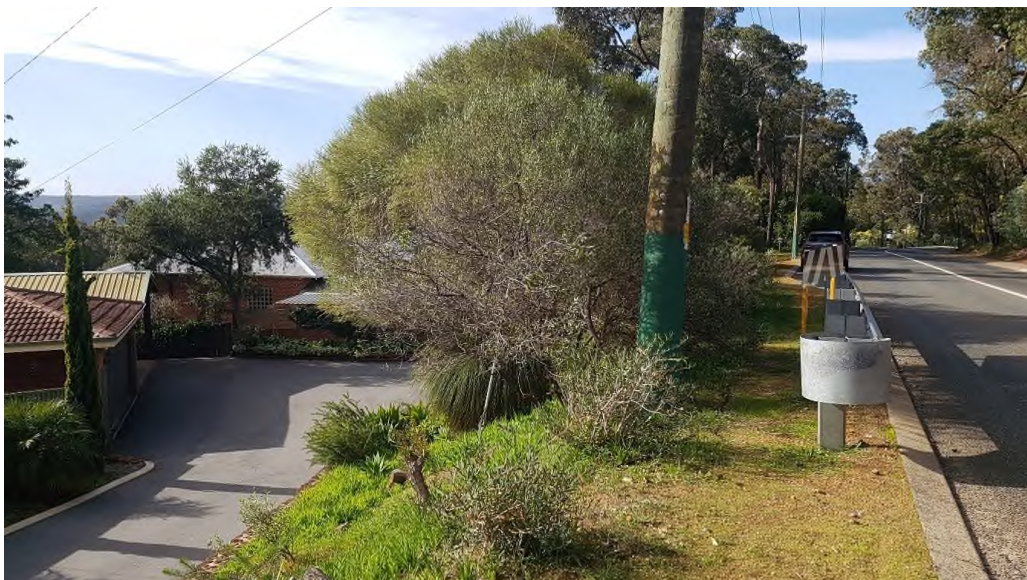
Typically, W-beam is not intended to be used to withstand 90° impacts. The section as installed is also too short to provide effective protection from acute angle collisions, and has non-crashworthy end treatments.

**Photo 83: Barrier is too short, does not fully protect the power pole and has non-crashworthy end treatments.**

A number of non-crashworthy end treatments were seen during the site visits. These should be replaced by treatments that comply with the latest standards.

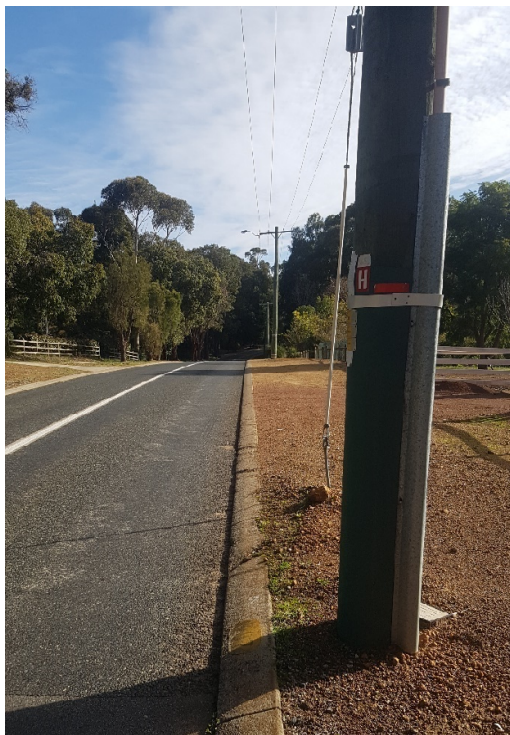
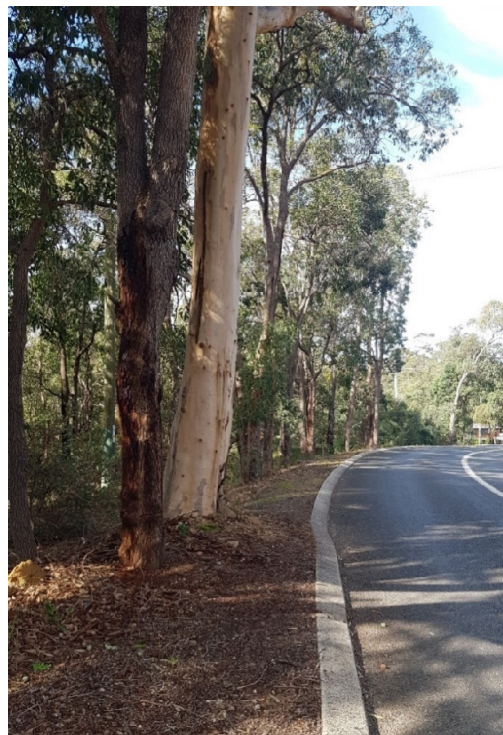
There are also a significant number of roadside hazards along this section of the road. These include power poles and trees located too close to the traffic lanes. See **Photos 84 & 84a**.

**Photos 84 & 84a:** Roadside hazards for errant vehicles include non frangible power poles and trees.

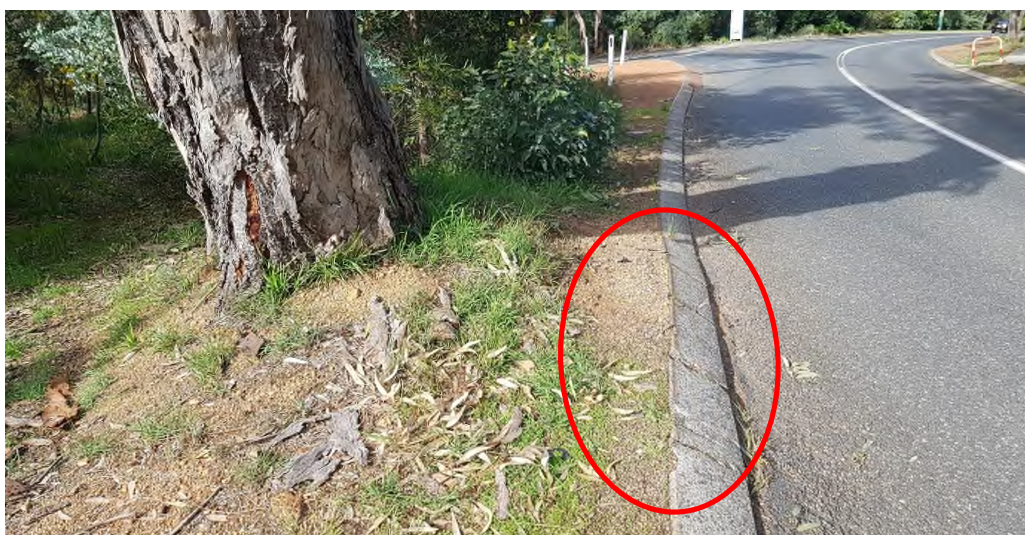
There are a number of other hazards adjacent the carriageway on this stretch of Mundaring Weir Road, including root damaged kerbing and narrow parking bays. See **Photos 85 to 86a**.

**Photo 85:** Tree roots are beginning to lift and crack the kerbs.

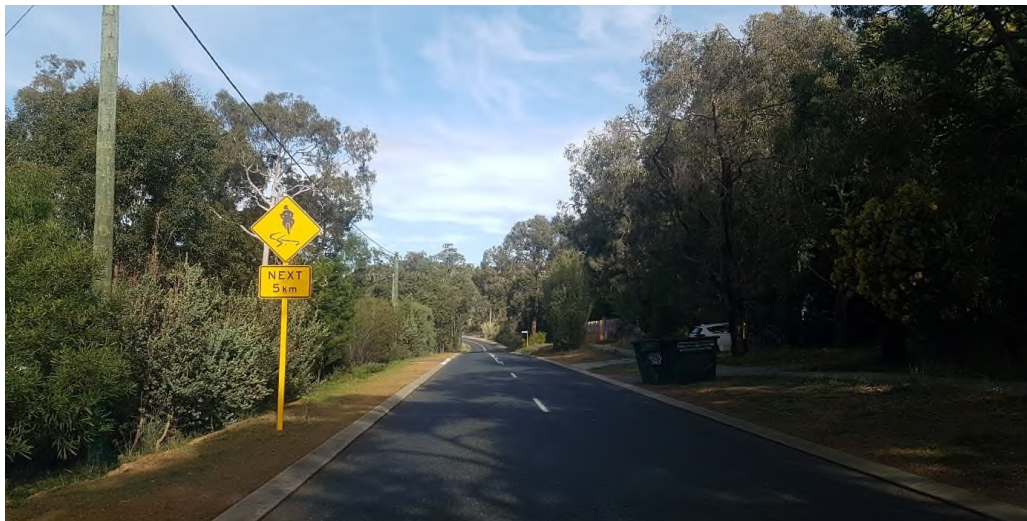
The night audit revealed that not all of the signs are retro-reflective. See **Photo 87**.

**Photo 87:** One example of a number of sign faces that are worn and consequently no longer retro-reflective.

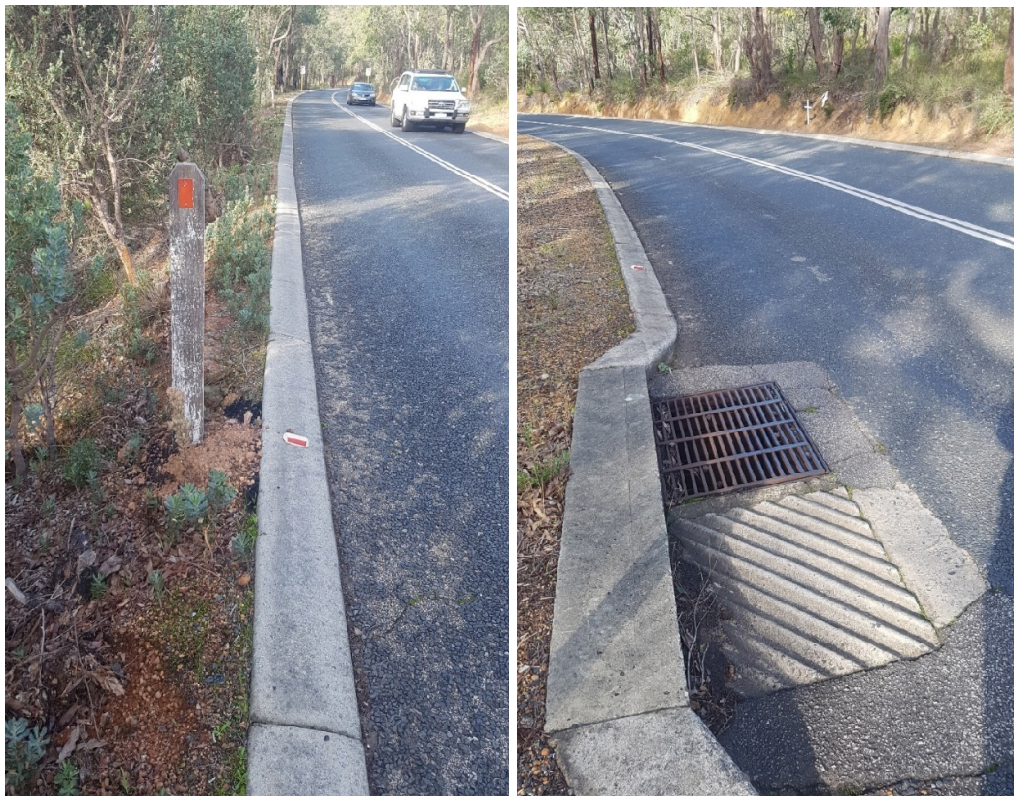
Photo 90: Very old guide post. Note reflectors mounted on kerbs. Photo 91: Non-cycle friendly drainage grid.

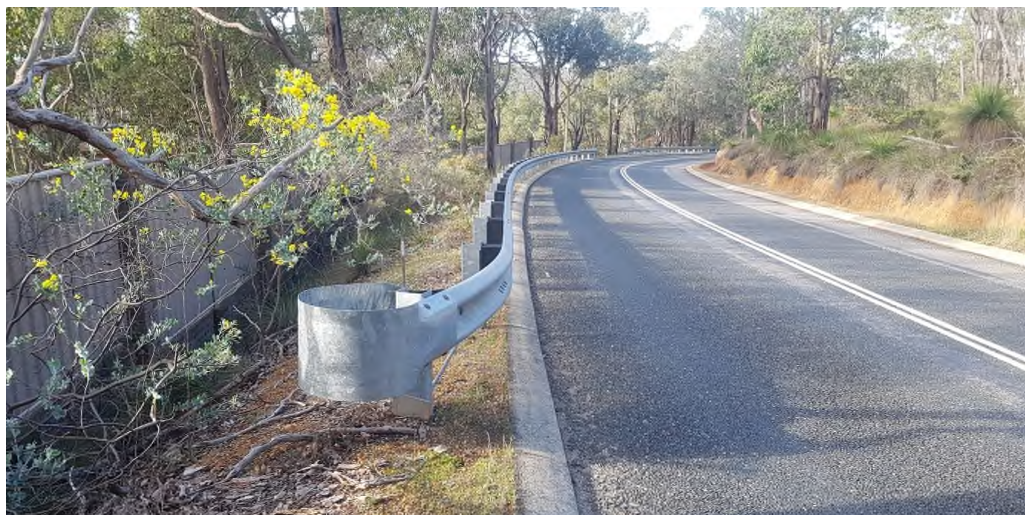
Photo 92: W-beam with a non-crashworthy termination treatment.

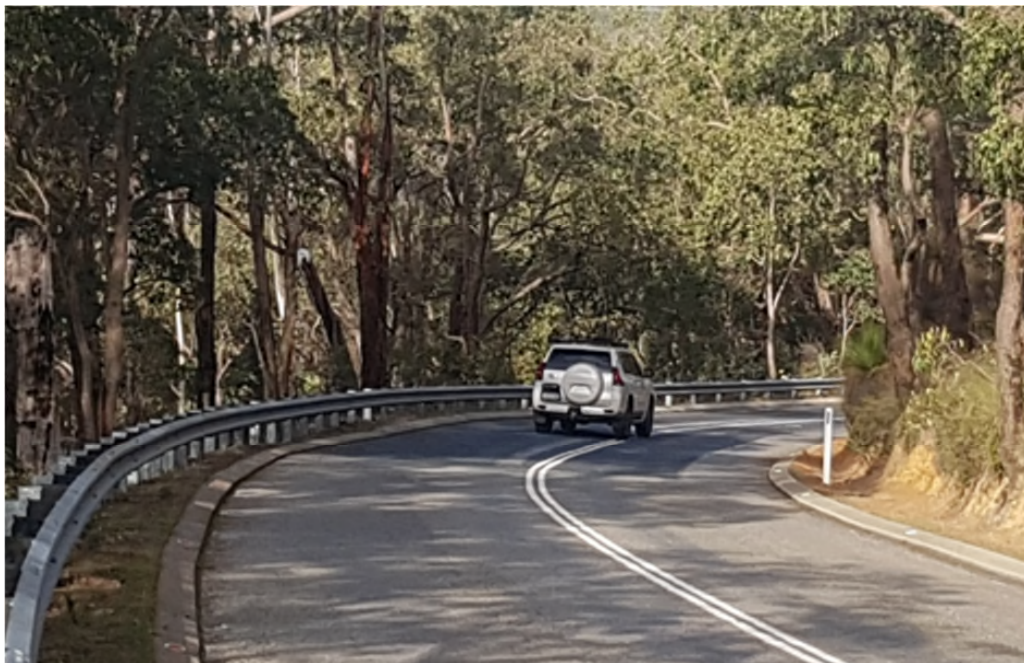
It was noted on site that a number of drivers tend to drive over the centreline of the road, especially when accelerating up hills. The introduction of audible lines may help to prevent this. See **Photo 93**.

**Photo 93:** Numerous vehicles were observed cutting the curves and straddling the centreline.

Audible edge lines can be very effective in encouraging drivers to remain within the traffic lanes, and should, as a priority, be installed where there are no kerbs or safety barriers. It appears from the damage to newly installed guideposts, and from observation on site, that some drivers do use the hard shoulders to 'straighten out' some of the curves, as well as crossing the centrelines, to enable them to travel at higher speeds. This is particularly noticeable with bends located on gradients.

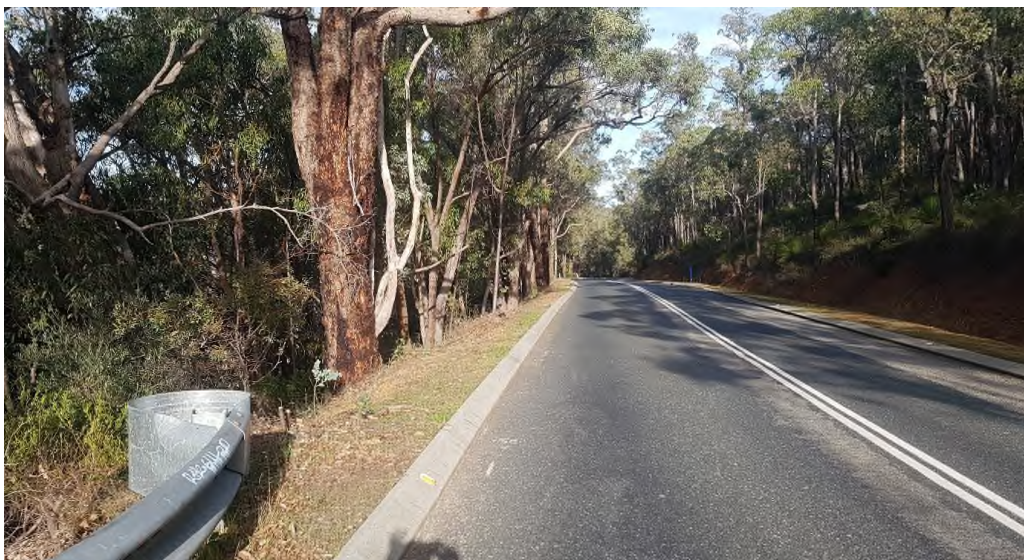
Although the safety barriers do protect errant vehicles from some of the roadside hazards along this section of road, it can be seen in **Photos 94 & 95** that there are many more that remain exposed.

**Photo 94:** Although the safety barrier ends here, the roadside hazards do not.

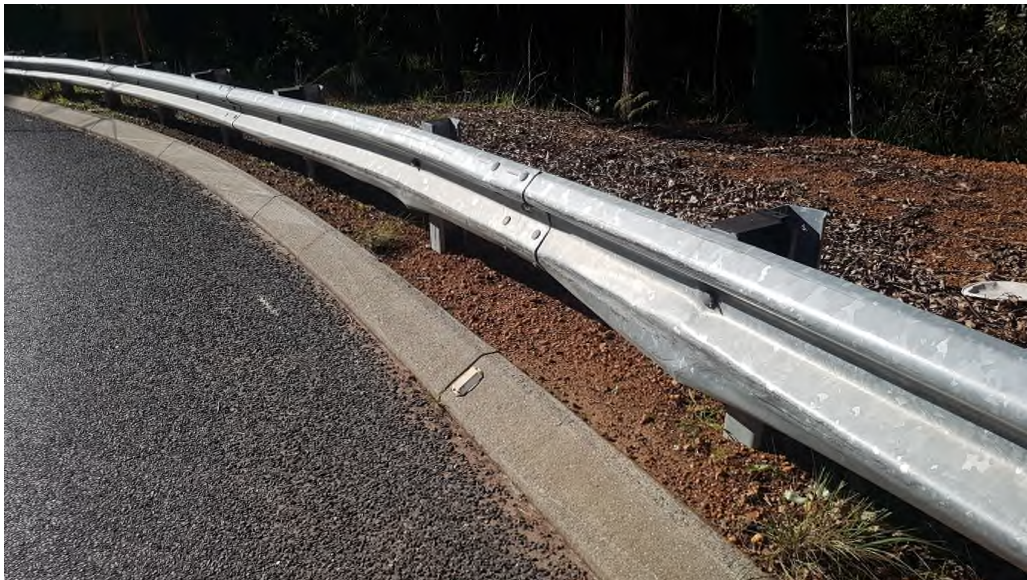
The W-beam safety barriers lining the road through the curves near the southern Aldersyde Road intersection are mounted very close to the kerbs, and have been struck numerous times on both the outside and the inside of the bend. See **Photo 96**.

**Photo 96:** Damage to the safety fence near Aldersyde Road.

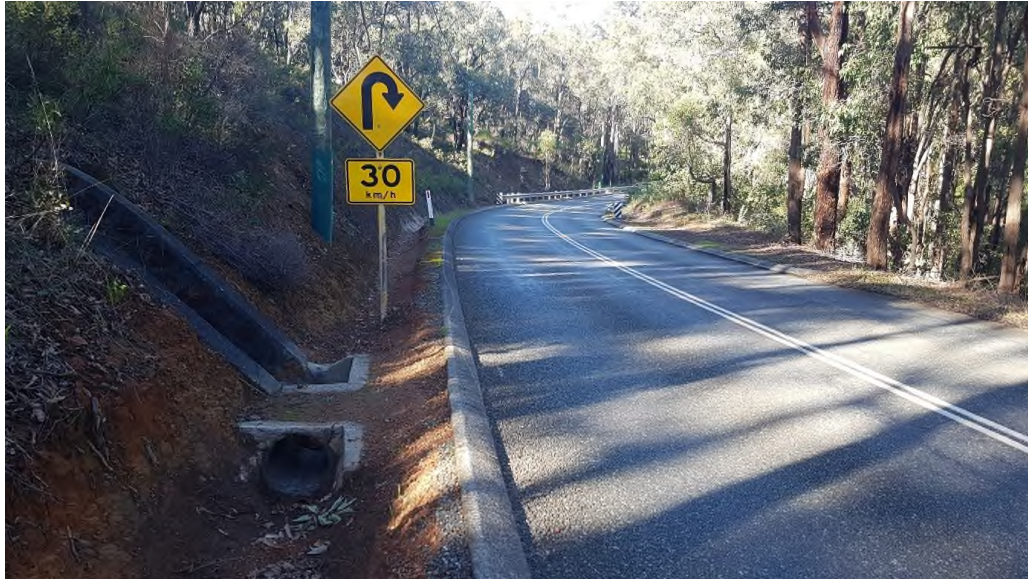
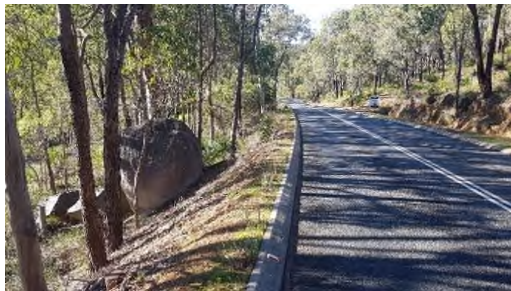
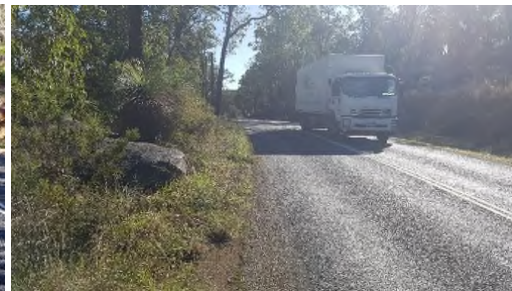
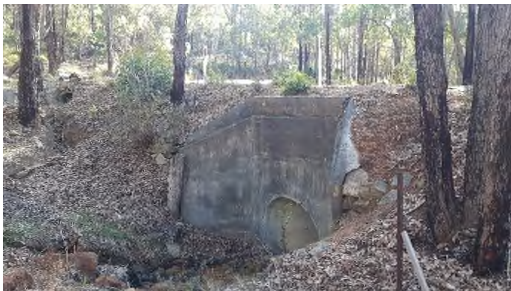
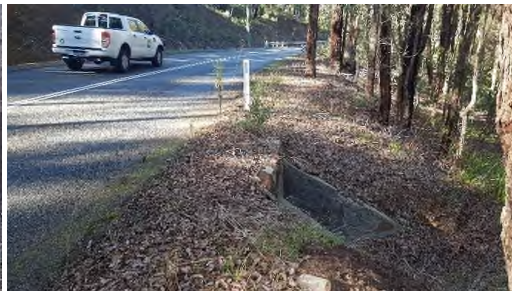
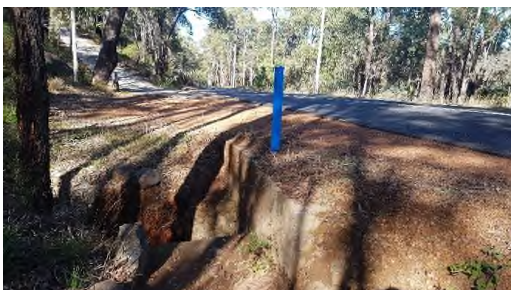
As well as trees, steep embankments and safety barriers, there are a number of other roadside hazards awaiting errant vehicles along this stretch. See **Photos 97 to 97f**.

Photo 97 to 97f: Other roadside hazards include head walls, culverts and large rocks.

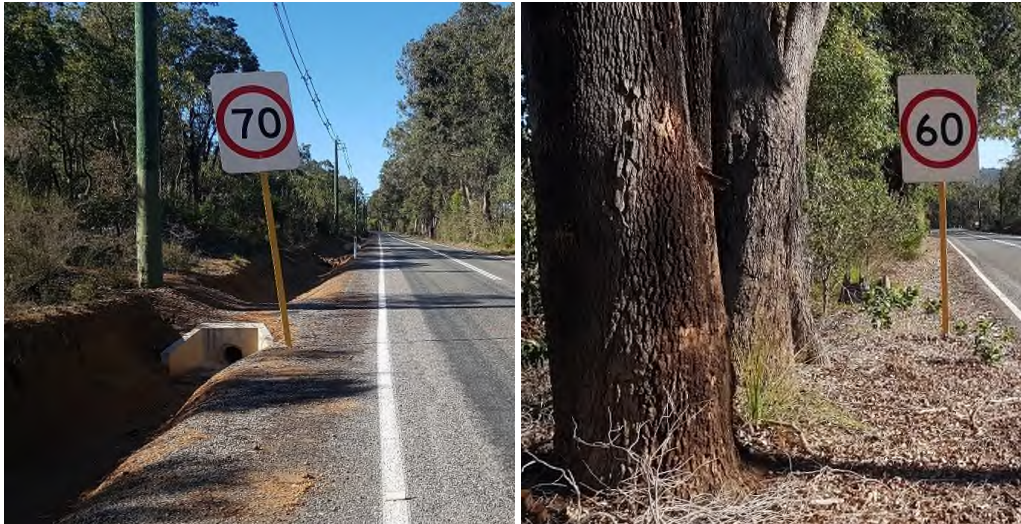
Although this section of road has largely been widened, with edge lines and sealed shoulders installed, there still remain a number of roadside hazards. These include large trees and concrete drainage culverts, especially along the section west of Bahen Road. See **Photos 98 & 98a**.

**Photos 98 & 98a: Roadside hazards**
