September 2022

## Mundaring Weir Rd - Road Safety Investigation

Prepared For: City of Kalamunda

## Final Report

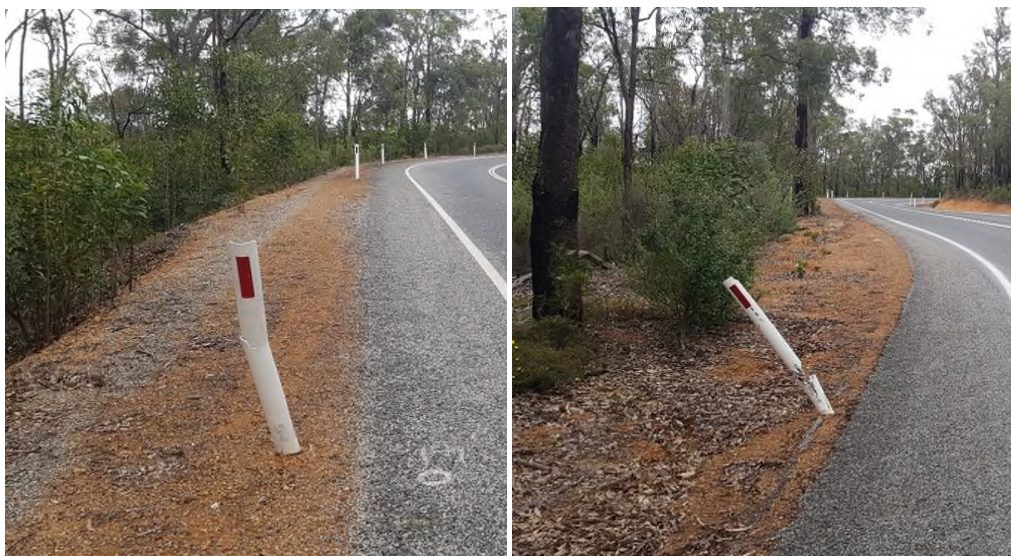
As can be seen in **Photos 99 to 100**, a number of the new guideposts installed along this section are being struck by vehicles. It is not immediately clear why this would occur, but it may be reduced by the installation of audible edge lines.

**Photos 99 & 99a: Broken guide posts.**

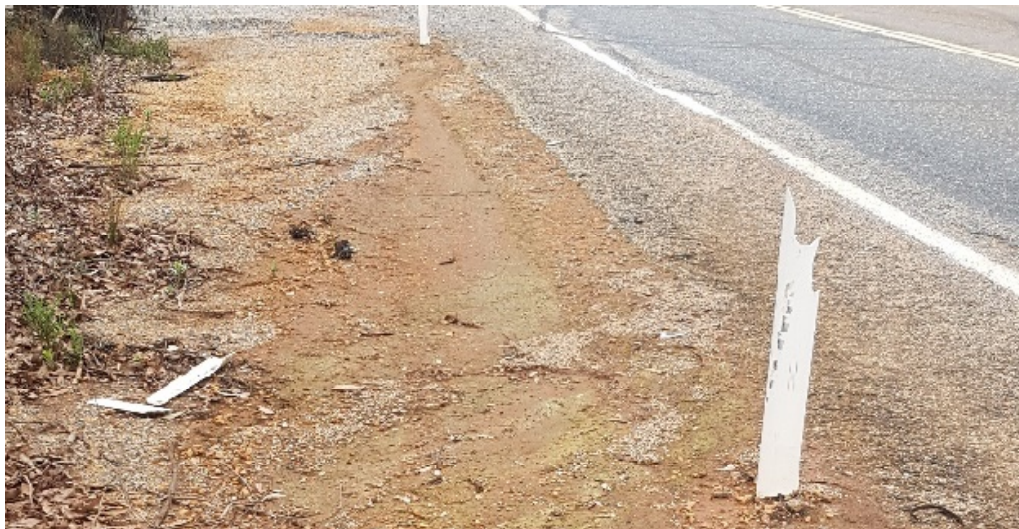
**Photo 100: Damaged Guidepost.**

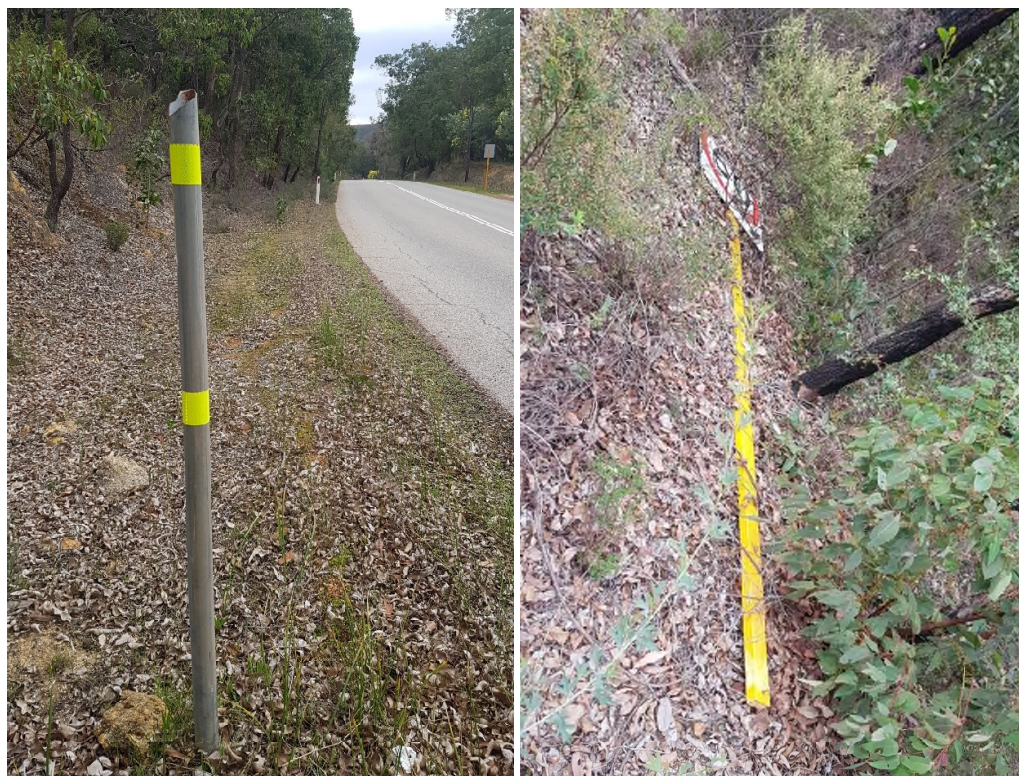
One of the 60 km/h speed signs was seen lying down in the verge. This should be replaced. Another post had been sheared off. See **Photos 101 & 101a.**

**Photos 101 & 101a: Broken sign posts.**

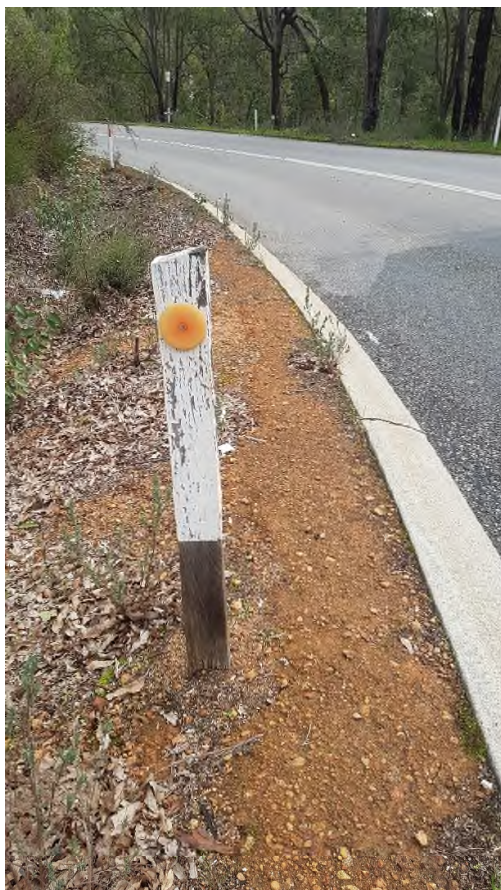
Outside the area recently widened, there are still a number of very old guideposts. See **Photo 103**.

**Photo 102: Old guidepost**

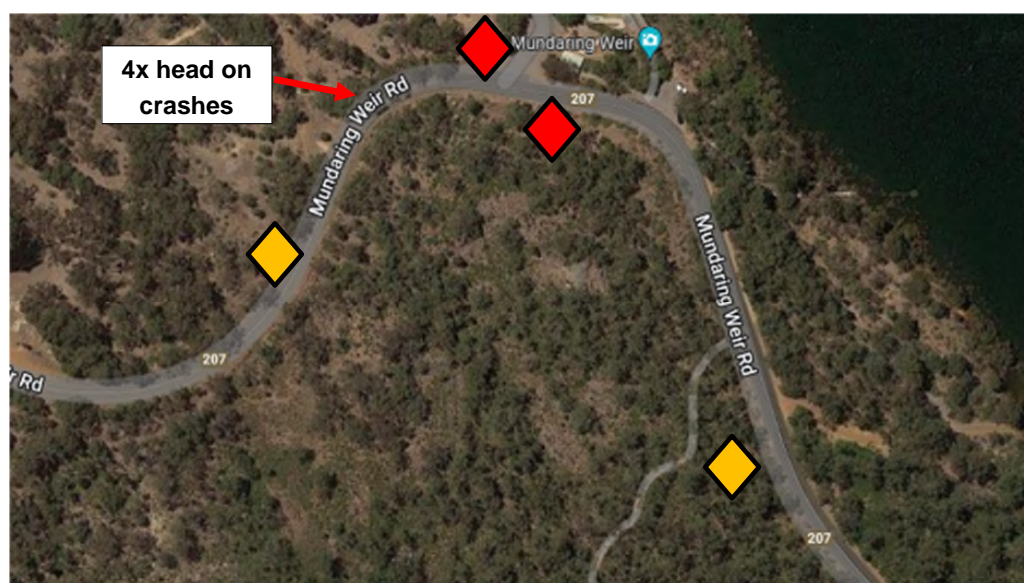
It is noted that advisory speed signs have been installed on the approaches to the outer bends in each direction, but not to the second bends being encountered. See **Figure 4.1** below.

**Figure 4.1:** Curve warning sign locations, existing (yellow) and recommended (Red).
