Lot 192 Hale Road

Wattle Grove

Preliminary Arborist Report

September 2023

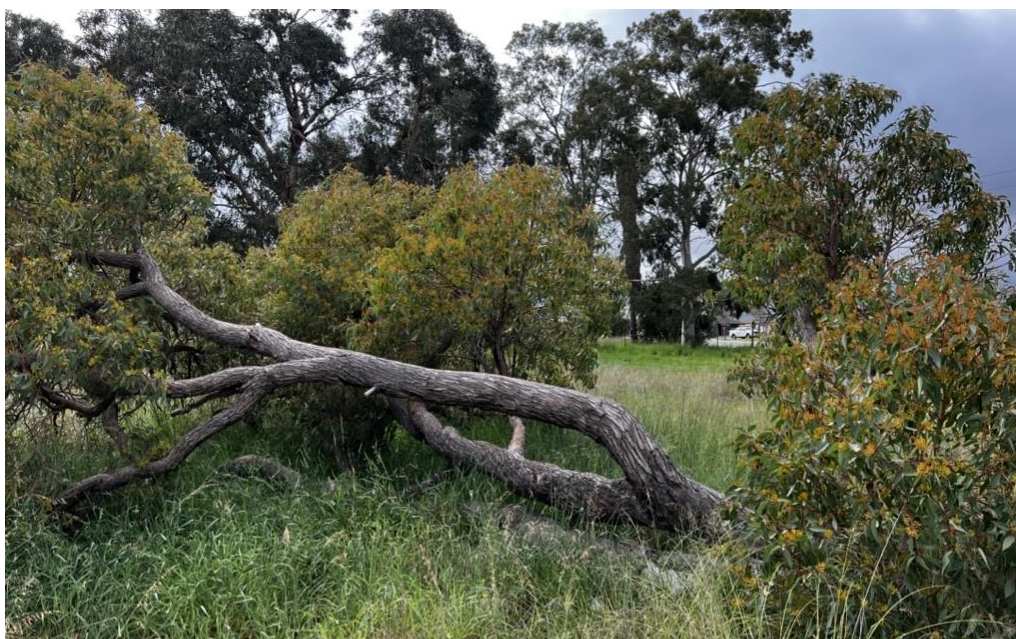
Tree 29 is a jarrah (*Eucalyptus marginata*) that is in good health with great vigour but has poor structure having failed whole and is now prostrate. It would make an interesting feature if it were able to be incorporated into the soft landscape but doesn't appear to be compatible with the current design.

Figure 4 Tree 29 - Vigorous but failed jarrah

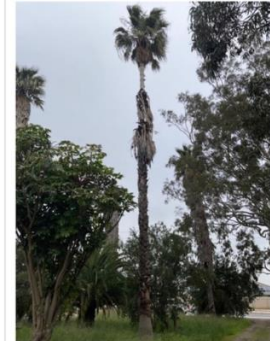
Cotton Palm Tree ID 08**Tree Details**

Botanical Name:	Washingtonia filifera
Common Name:	Cotton Palm
Height (m):	17
Spread (m):	2
Health:	Good
Structure:	Good
Age:	Mature
SULE:	40+ yrs
Retention Value:	Low
Comments (assessment):	Non-native species
DBH (mm):	490
Tree Protection Zone (TPZ)(m):	5.88
Structural Root Zone (SRZ)(m):	2.45

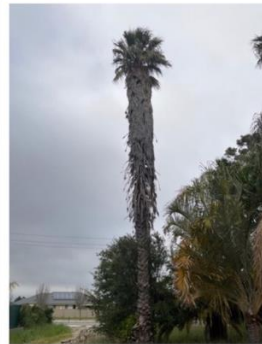
Cotton Palm Tree ID 09**Tree Details**

Botanical Name:	Washingtonia filifera
Common Name:	Cotton Palm
Height (m):	17
Spread (m):	2
Health:	Good
Structure:	Good
Age:	Mature
SULE:	40+ yrs
Retention Value:	Low
Comments (assessment):	Non-native species
DBH (mm):	510
Tree Protection Zone (TPZ)(m):	6.12
Structural Root Zone (SRZ)(m):	2.49

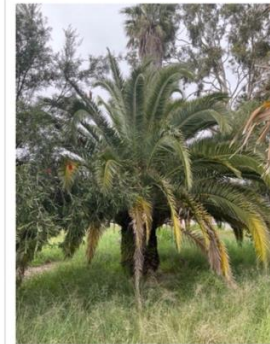
Canary Island Date Palm Tree ID 10**Tree Details**

Botanical Name:	Phoenix canariensis
Common Name:	Canary Island Date Palm
Height (m):	5
Spread (m):	7
Health:	Good
Structure:	Good
Age:	Mature
SULE:	40+ yrs
Retention Value:	Low
Comments (assessment):	Non-native species
DBH (mm):	900
Tree Protection Zone (TPZ)(m):	19.8
Structural Root Zone (SRZ)(m):	3.17

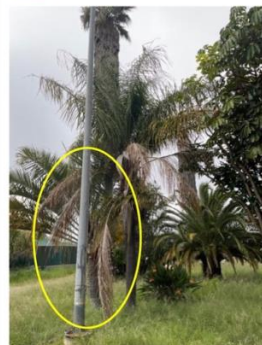
Triangle Palm Tree ID 11**Tree Details**

Botanical Name:	Dypsis decaryi
Common Name:	Triangle Palm
Height (m):	5
Spread (m):	4
Health:	Good
Structure:	Good
Age:	Mature
SULE:	40+ yrs
Retention Value:	Low
Comments (assessment):	Non-native species
DBH (mm):	350
Tree Protection Zone (TPZ)(m):	4.2
Structural Root Zone (SRZ)(m):	2.13

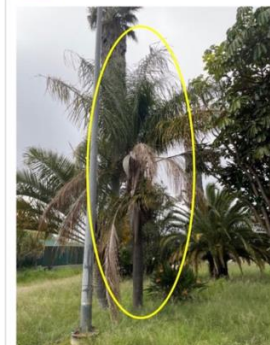
Cocos Palm Tree ID 12**Tree Details**

Botanical Name:	Syagrus romanzoffiana
Common Name:	Cocos Palm
Height (m):	8
Spread (m):	5
Health:	Good
Structure:	Good
Age:	Mature
SULE:	21-40 yrs
Retention Value:	Low
Comments (assessment):	Non-native palm species
DBH (mm):	270
Tree Protection Zone (TPZ)(m):	3.24
Structural Root Zone (SRZ)(m):	1.91

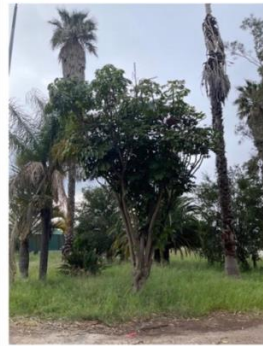
Umbrella Tree Tree ID 13**Tree Details**

Botanical Name:	<i>Schefflera actinophylla</i>
Common Name:	Umbrella Tree
Height (m):	7
Spread (m):	6
Health:	Fair
Structure:	Fair
Age:	Mature
SULE:	21-40 yrs
Retention Value:	Low
Comments (assessment):	Non-native species. Bifurcated with tight forks at 1 m.
DBH (mm):	357
Tree Protection Zone (TPZ)(m):	4.29
Structural Root Zone (SRZ)(m):	2.13

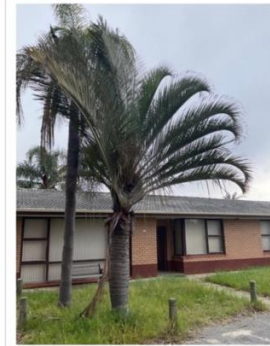
Triangle Palm Tree ID 14**Tree Details**

Botanical Name:	<i>Ocypsis decaryi</i>
Common Name:	Triangle Palm
Height (m):	5
Spread (m):	4
Health:	Good
Structure:	Good
Age:	Mature
SULE:	40+ yrs
Retention Value:	Low
Comments (assessment):	Non-native species
DBH (mm):	350
Tree Protection Zone (TPZ)(m):	4.2
Structural Root Zone (SRZ)(m):	2.13

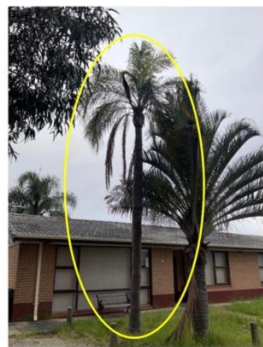
Cocos Palm Tree ID 15**Tree Details**

Botanical Name:	<i>Syagrus romanzoffiana</i>
Common Name:	Cocos Palm
Height (m):	8
Spread (m):	4
Health:	Good
Structure:	Poor
Age:	Mature
SULE:	21-40 yrs
Retention Value:	Low
Comments (assessment):	Non-native palm species
DBH (mm):	270
Tree Protection Zone (TPZ)(m):	3.24
Structural Root Zone (SRZ)(m):	1.91

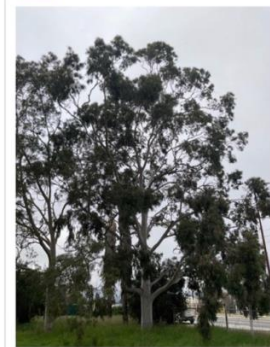
Lemon-scented Gum Tree ID 16**Tree Details**

With one exception all trees with a high or very high retention values have been incorporated into the current design. Trees 16 and 17 are a pair of large lemon scented gums (*Corymbia citriodora*) closest to the road. The current design has a tree 16 on the landscaped verge with tree 17 in a traffic island with driveway on both sides. Both have a minimum deep soil area which is lower than the recommended 64m² recommended in LPP33 Table 1.2 for large trees, but both do meet the recommended 40m² as contained in Table 2.1 Minimum planting area requirements for car parks. There are also rootable soil volumes surrounding these areas and in conjunction with careful use of materials for the driveway this will minimise the impact on these trees and allow them to continue to be a prominent feature in the landscape.

Botanical Name:	<i>Corymbia citriodora</i>
Common Name:	Lemon-scented Gum
Height (m):	17
Spread (m):	22
Health:	Good
Structure:	Good
Age:	Mature
SULE:	40+ yrs
Retention Value:	Very High
Comments (assessment):	Excellent specimen. Typical open canopy. Good weight distribution. Minimal deadwood. 5.9 m from adjacent tree.
DBH (mm):	825
Tree Protection Zone (TPZ)(m):	9.9
Structural Root Zone (SRZ)(m):	3.2

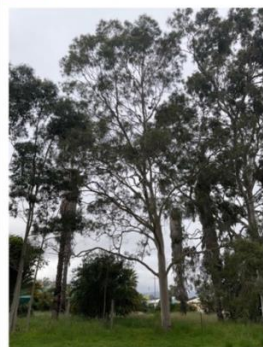
Lemon-scented Gum Tree ID 17**Tree Details**

Botanical Name:	<i>Corymbia citriodora</i>
Common Name:	Lemon-scented Gum
Height (m):	13
Spread (m):	17
Health:	Good
Structure:	Fair
Age:	Mature
SULE:	40+ yrs
Retention Value:	High
Comments (assessment):	Slightly sparse canopy. Minimal deadwood. Slightly suppressed by adjacent larger tree.
DBH (mm):	540
Tree Protection Zone (TPZ)(m):	6.48
Structural Root Zone (SRZ)(m):	2.55

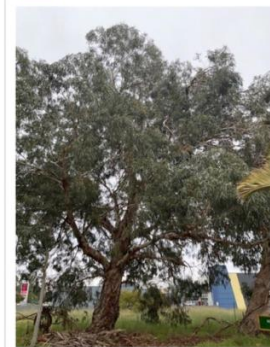
Tasmanian Blue Gum Tree ID 18**Tree Details**

Tree 18 is a large mature Tasmanian blue gum (*Eucalyptus globulus*) which is not compatible with the current design. While the retention of a mature tree such as this is to be preferred there appears to be no practical way to incorporate this tree into the design. This tree is currently in good condition but its longevity is uncertain. It is tree endemic to Tasmania, and like most Tasmanians it prefers a cooler wetter climate than is typical of Perth area. It is likely in good condition currently due to high water availability, which may change with the site development.

Botanical Name:	<i>Eucalyptus globulus</i>
Common Name:	Tasmanian Blue Gum
Height (m):	16
Spread (m):	16
Health:	Good
Structure:	Fair
Age:	Mature
SULE:	21-40 yrs
Retention Value:	High
Comments (assessment):	Slight canopy loss, hollows in trunk, some evidence of failure.
DBH (mm):	1190
Tree Protection Zone (TPZ)(m):	14.28
Structural Root Zone (SRZ)(m):	3.56

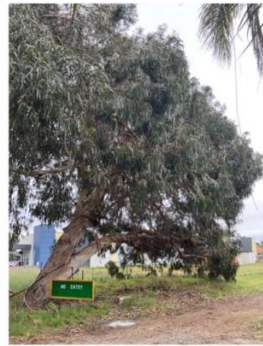
Tasmanian Blue Gum Tree ID 19**Tree Details**

Tree 19 is another Tasmanian bluegum (*E. globulus*), also in good health similar to tree 19 but in worse structural condition. It has a heavy lean, although it appears stable, and has a very large, long, low main scaffold limb making it difficult to prune to achieve useable space around the trees. Again, the retention of this tree would be preferable but does not appear compatible with full effective use of the site.

Botanical Name:	Eucalyptus globulus
Common Name:	Tasmanian Blue Gum
Height (m):	12
Spread (m):	13
Health:	Good
Structure:	Poor
Age:	Mature
SULE:	21-40 yrs
Retention Value:	High
Comments (assessment):	Extended low westerly stem, sound union. Codominant stems. Good branch architecture, no signs root heave.
DBH (mm):	1050
Tree Protection Zone (TPZ)(m):	12.6
Structural Root Zone (SRZ)(m):	3.38

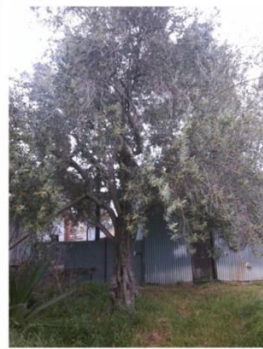
Olive Tree ID 21**Tree Details**

Trees 21 and 22 are olive (*Olea europaea*) trees and are currently incorporated into the current design. Their location is compatible with the design, although they will require careful protection during construction. However, their profuse fruiting nature means that they may not be suitable in such close proximity to the carpark surface.

Botanical Name:	Olea europaea
Common Name:	Olive
Height (m):	9
Spread (m):	12
Health:	Good
Structure:	Good
Age:	Mature
SULE:	40+ yrs
Retention Value:	Medium
Comments (assessment):	Even canopy, minor deadwood
DBH (mm):	410
Tree Protection Zone (TPZ)(m):	4.92
Structural Root Zone (SRZ)(m):	2.28

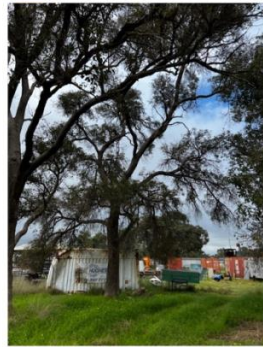
Marri Tree ID 23**Tree Details**

Botanical Name:	Corymbia calophylla
Common Name:	Marri
Height (m):	13
Spread (m):	15
Health:	Fair
Structure:	Good
Age:	Mature
SULE:	40+ yrs
Retention Value:	High
Comments (assessment):	Slight lean south. Closest to high water table, more stress responsive growth. Typical amount of deadwood
DBH (mm):	650
Tree Protection Zone (TPZ)(m):	7.8
Structural Root Zone (SRZ)(m):	2.76

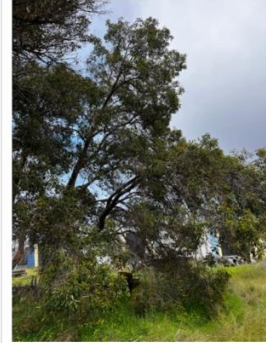
Marri Tree ID 25**Tree Details**

Botanical Name:	Corymbia calophylla
Common Name:	Marri
Height (m):	14
Spread (m):	13.5
Health:	Fair
Structure:	Fair
Age:	Mature
SULE:	40+ yrs
Retention Value:	High
Comments (assessment):	Slight lean south and suppressed by neighbour. Stressed, slightly sparse canopy potentially from excess water.
DBH (mm):	573
Tree Protection Zone (TPZ)(m):	6.88
Structural Root Zone (SRZ)(m):	2.61
