***ARBORICULTURAL ASSESSMENT AT THE KALAMUNDA HISTORY VILLAGE***

Please find enclosed the results of the arboricultural assessment undertaken recently for the tree adjacent to the grader shed at the Kalamunda History Village, Kalamunda.

- 1.2 The purpose of this report is to summarise the results of the arboricultural assessment and provide recommendations for the mature northern river red gum tree (*Eucalyptus camaldulensis* var. *obtusa*) located adjacent to the grader shed within the Kalamunda History Village, at Williams Street, Kalamunda. The site visit and visual tree assessment was undertaken from ground level on the 20<sup>th</sup> January 2021 at 1530hrs and was accurate at the time of inspection. No soil excavation or below ground level inspection was undertaken unless specified. Viewing conditions were fine.

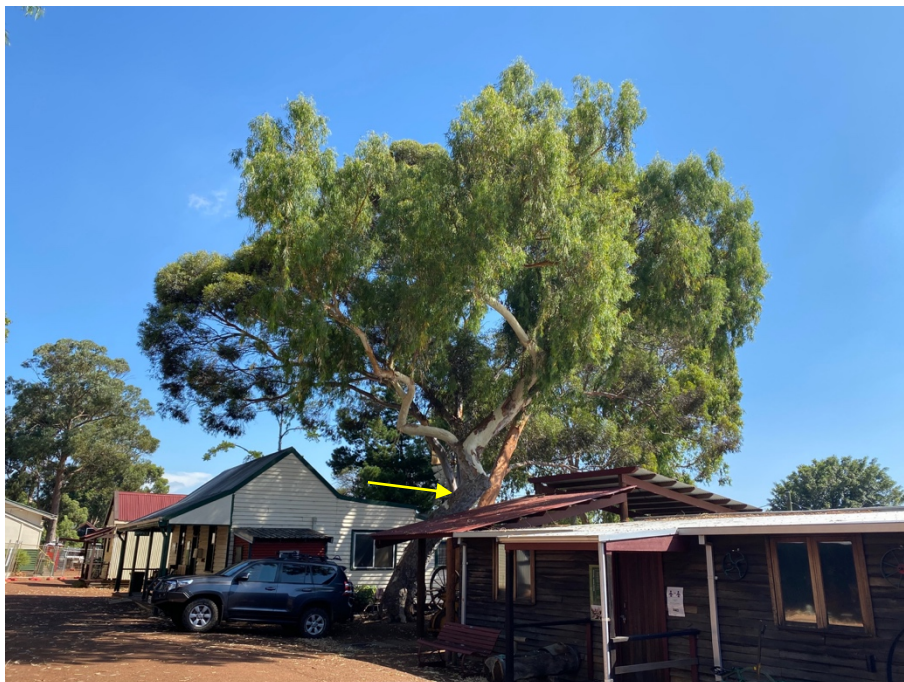
**Figure 2.** Assessed tree (see arrow); looking towards the southwest.

<b>Assessed Tree:</b>	<b>Botanical Name:</b> <i>Eucalyptus camaldulensis</i> var. <i>obtusa</i>
<b>Common Name:</b>	northern river red gum
<b>Location:</b>	Adjacent grader shed - south side
<b>Height:</b>	18m
<b>DBH:</b>	86cm
<b>Crown Spread (NS/ EW):</b>	11/15m
<b>Structure:</b>	Fair
<b>Health:</b>	High
<b>Comments:</b>

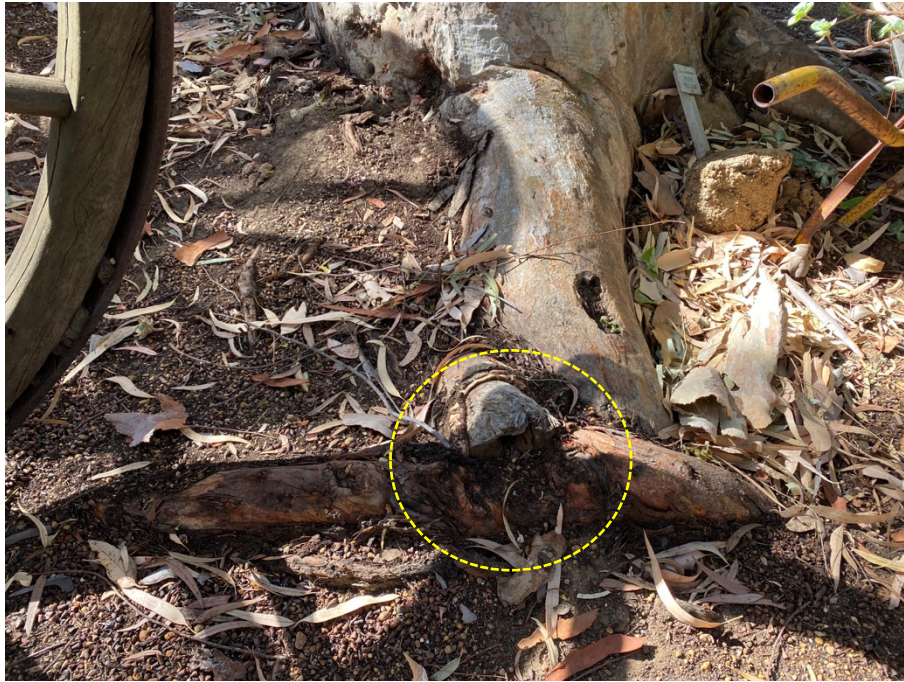
- Adequate trunk basal flare was evident with buttressing visible and satisfactory rootplate stability deduced
- The previous severance of a woody root of 100mm diameter (approx.) was observed on the south side of the tree, with subsequent adventitious growth evident at the cut section to maintain water/ nutrient uptake and stability

**Figure 3.** The previous severance of a woody root was observed (see dashed line) on the south side of the tree, with subsequent adventitious root growth evident at the cut section to maintain water/ nutrient uptake and stability; looking towards the north.

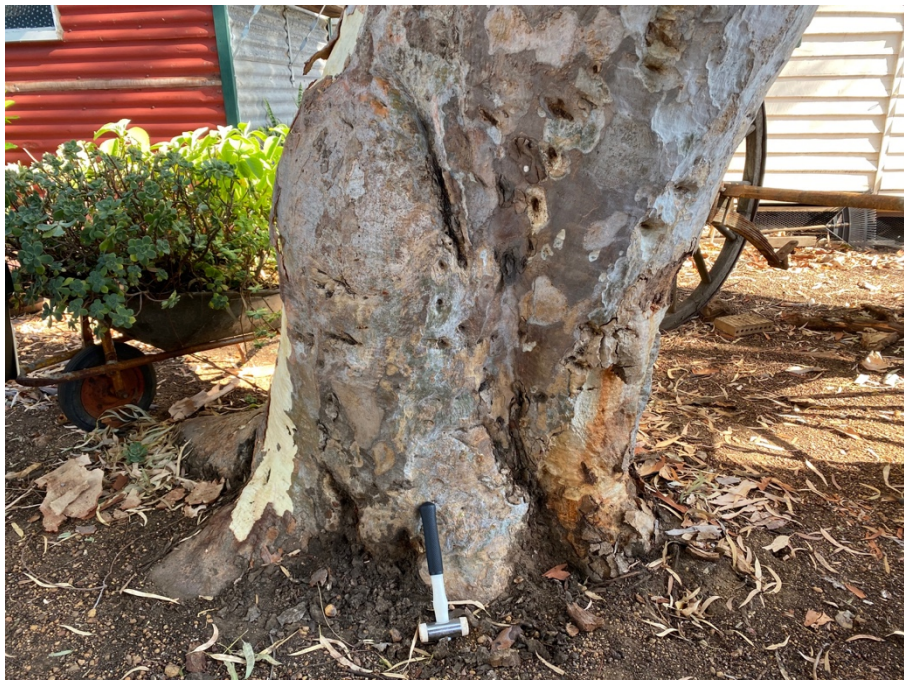
- Cracking within the bark was observed at the trunk basal area, typical for the species and age-class of tree, however is likely to be superficial only and not extend into the structural wood of the tree

**Figure 4.** Cracking within the bark was observed at the trunk basal area, typical for the species and age-class of tree, however is likely to be superficial only and not extend into the structural wood of the tree; looking towards the south.

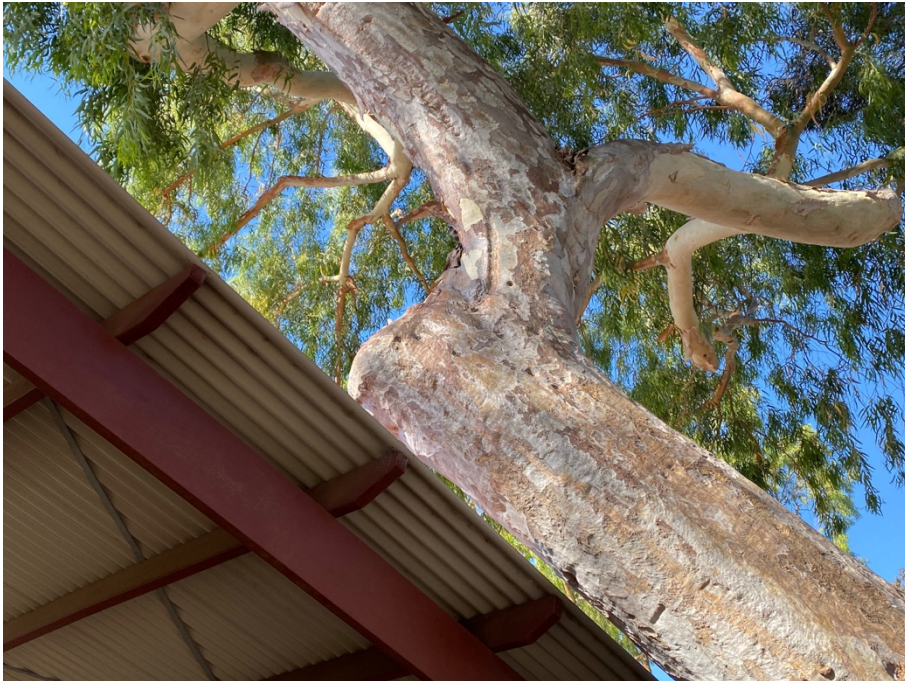
- Trunk lean was natural, towards the north and attributable to the close proximity of the adjacent mature brown mallet tree (*Eucalyptus astringens*) and subsequent competition for sunlight and growing space

- Subsequently, the trunk section was in very-near contact with the grader shed roof on the north side and is likely to make contact during periods of high wind energy

**Figure 5.** Trunk lean was natural towards the north and attributable to the close proximity of the adjacent tree, with the trunk section in very-near contact with the grader shed roof on the north side, and is likely to make contact during periods of high wind energy; looking towards the northeast.

**3.6** Consideration could also be given to modification of the adjacent roof to increase the distance between the trunk section and the grader shed.

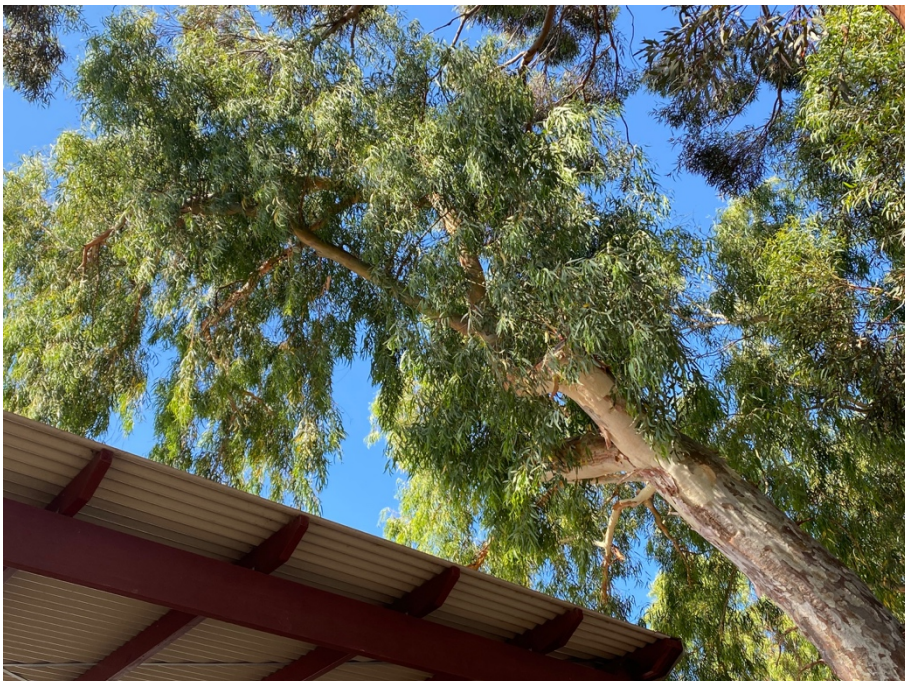
- No structurally compromised v-shaped unions or cluster branch attachments were visible throughout the lower crown of the tree
- Previous and recent reduction pruning works were observed on the north side and northwest side of the tree and is likely to have been undertaken to clear the roof and alleviate crown extension, with minor epicormic regrowth branches evident present

- Lateral stem/ branch extension on the north side was assessed as excessive, and due to the adjacent large tree and competition for growing space
- Foliage size, colour and density was normal, and no significant foliar insect infestation and/ or disease infection symptoms were visible on sample foliage within the lower crown

**Figure 6.** Previous and recent reduction pruning works were observed on the north side and northwest side of the tree and is likely to have been undertaken to clear the roof and alleviate crown extension, with minor epicormic regrowth branches evident present.

**3.5** Where tree retention is desired, it is recommended to undertake reduction pruning by 2-3m to reduce/ shorten the length of the first order branches on the north side of the tree to reduce crown spread, to alleviate branch elongation, end weight and loading and to mitigate the potential for branch/ rootplate failure. N.B. Reduction pruning should occur back to lateral branches that are at least one-third the diameter of the branch being reduced and should leave the tree/ branches looking as natural as possible. Internal growth including minor epicormic regrowth branches should also be retained, as the excessive removal of foliage (photosynthetic material) has the potential to increase tree stress and may initiate a decline spiral.
