PiCUS Sonic Tomograph Test and Summary Report

Prepared for: Jerry Hutter at the City of Kalamunda

Date of Test: 20 January 2021

Site Details: Kalamunda History Village (adj. grader shed)

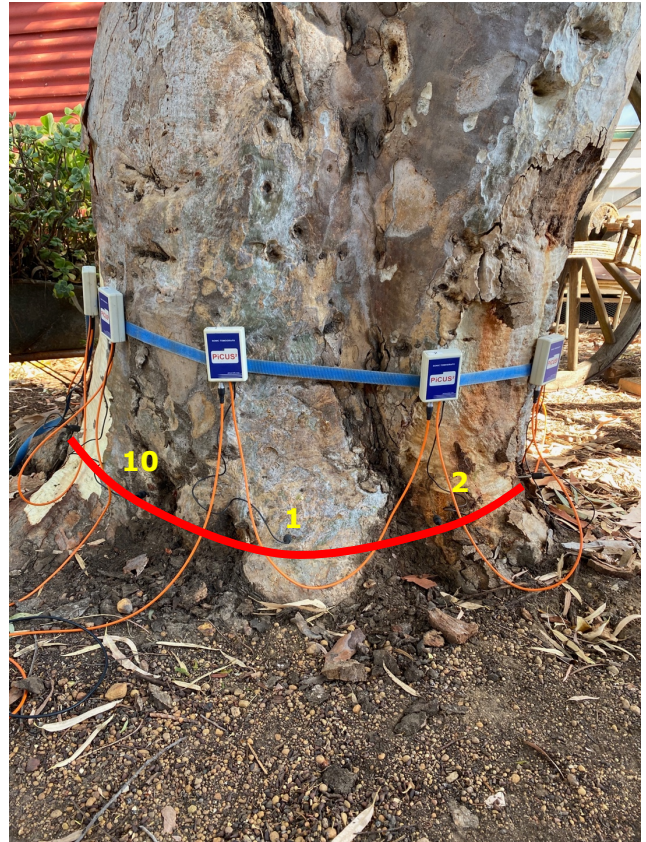
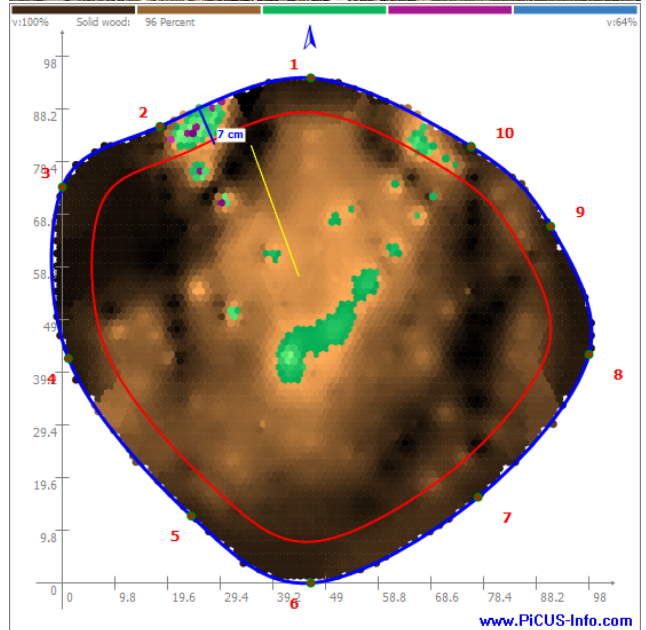
Eucalyptus camaldulensis* var. *obtusa
northern river red gum
120mm above ground level
3050mm at test height

The PiCUS® Sonic Tomograph test result indicates 96% of the test area is solid (high density) wood. There is 3% incipient wood (wood being altered). The remaining <1% is active degradation (low density) wood, cracking or cavity.

The pest and/ or pathogen is likely to have entered the tree through the rootplate.

The radial extent of incipient/ degraded wood adjacent to sensor number 2 was measured at 7cm.

It is observed that new wood growth increments are evident at all sensor numbers.

The test result provides evidence that the tree is still structurally sound at the test point and in excellent condition. Response growth (new wood) is evident as part of self-optimisation and is maintaining an adequately-loaded structure at present. No remedial pruning to alleviate loading on the test point is recommended at present.
