Jerry Hutter  
Supervisor Horticulture  
City of Kalamunda  
PO Box 42  
KALAMUNDA WA 6926

***ARBORICULTURAL ASSESSMENT AT THE KALAMUNDA HISTORY VILLAGE***

Please find enclosed the results of the arboricultural assessment undertaken recently for the tree adjacent to the toilet block at the Kalamunda History Village, Kalamunda.

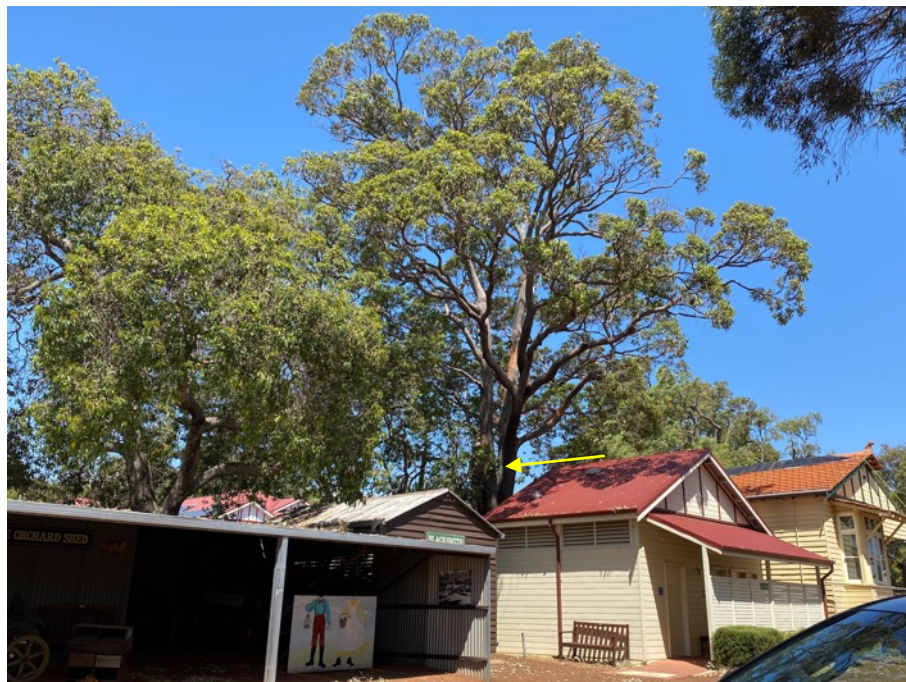
**Figure 2.** Assessed tree (see arrow); looking towards the southeast.

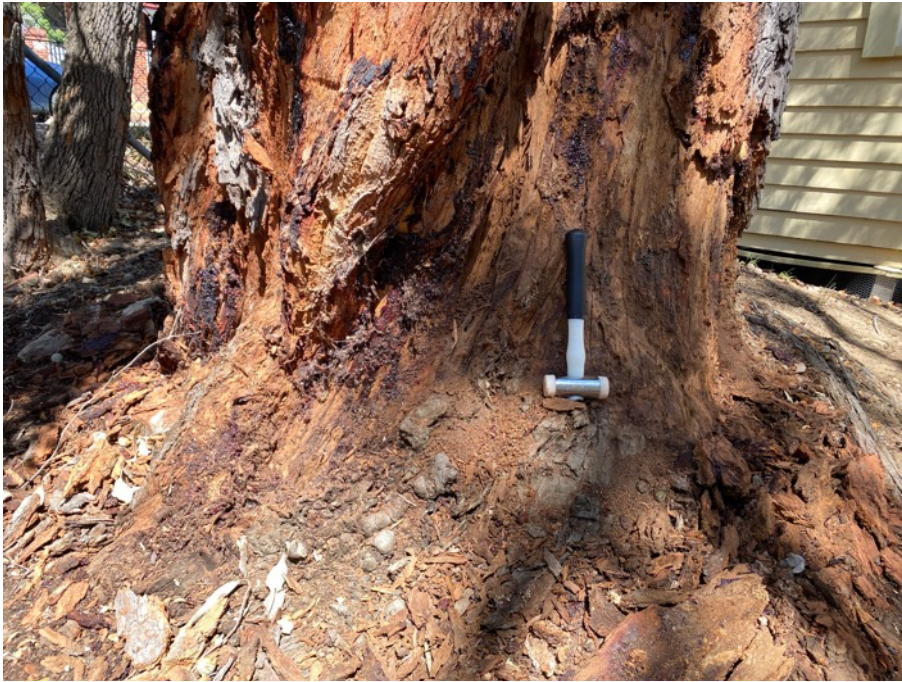
- Adequate trunk basal flare was evident with buttressing visible and several minor surface roots were observed on the west side of the tree
- Extensive (primary) infection by the marri canker fungal pathogen (*Quambalaria coyrecup*) was evidenced by a large wound at the root collar and trunk basal area on the west side, resulting in necrosis of the vascular tissue and exposure of the sapwood, and subsequently providing an entry opportunity for infection by wood decay fungi and/ or infestation by wood-destroying insects/ termites

- Further investigation using PiCUS sonic tomography revealed the trunk section to have 94% solid wood and 1% damaged wood, with degradation revealed predominantly within the central part of the test cross section

**Figure 3.** Extensive infection by the marri canker fungal pathogen was evidenced by a large wound at the root collar and trunk basal area, resulting in necrosis of the vascular tissue and exposure of the sapwood, and subsequently providing an entry opportunity for infection by wood decay fungi and/ or infestation by termites; looking towards the southeast.

- 3.11 Undertake a non-invasive, no drill treatment for control of the active termite infestation. Such treatment may include dusting and/ or the installation of bait stations, and should be undertaken by a licensed pest controller.

- 3.12 Consider further investigation in 12 months using PiCUS sonic tomography at the trunk basal area to evaluate the rate of degradation and/ or production of response growth (new wood).

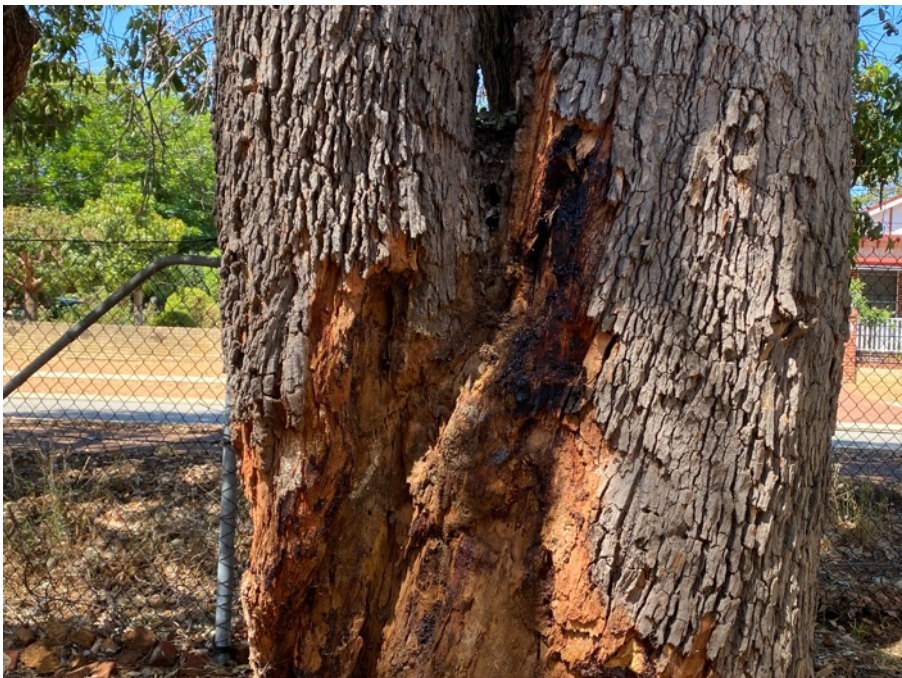
- Closer inspection within the large wound revealed wood decay, active termite infestation and additional infection by a resupinate fungus likely to be *Macrohyporia* sp. (further investigation required to confirm)

**Figure 4.** Closer inspection within the large wound revealed wood decay, active termite infestation and additional infection by a resupinate fungus likely to be *Macrohyporia* sp.; looking towards the east.

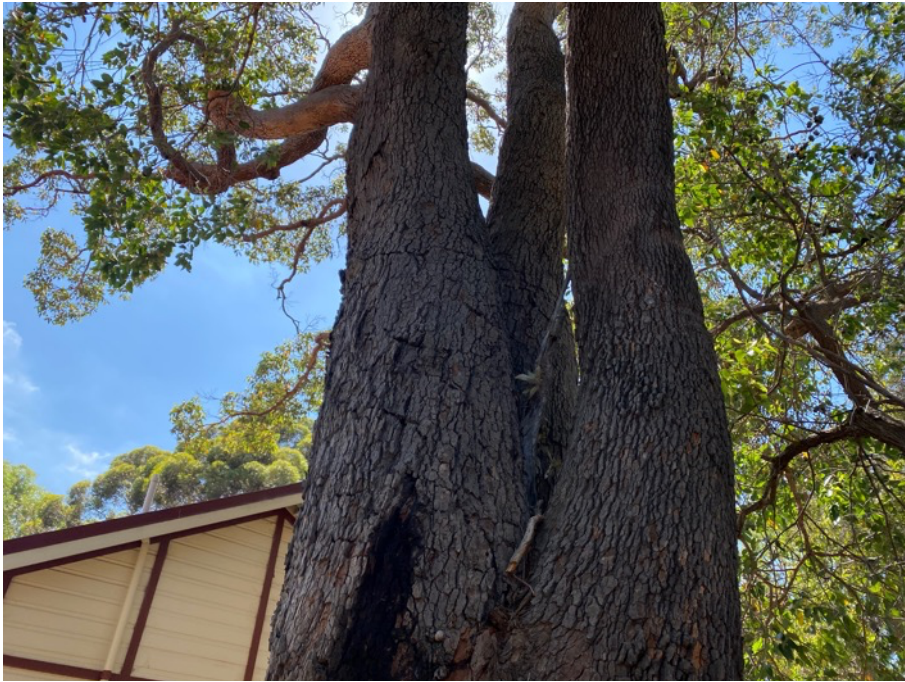
- The trunk forked at approximately 2m above ground level and whilst no structurally compromised v-shaped unions were observed, the stem attachments were acutely-angled i.e. limited space for normal secondary thickening of the stem attachments

**Figure 5.** The trunk forked at approximately 2m above ground level and whilst no structurally compromised v-shaped unions were observed, the stem attachments were acutely-angled with limited space for normal secondary thickening; looking towards the northwest.

- 3.8 Undertake the installation of a non-invasive 4-tonne cable brace such as Yale brace in a triangular configuration at a height of approximately 16m above ground level, to provide supplementary support to the three codominant stems.

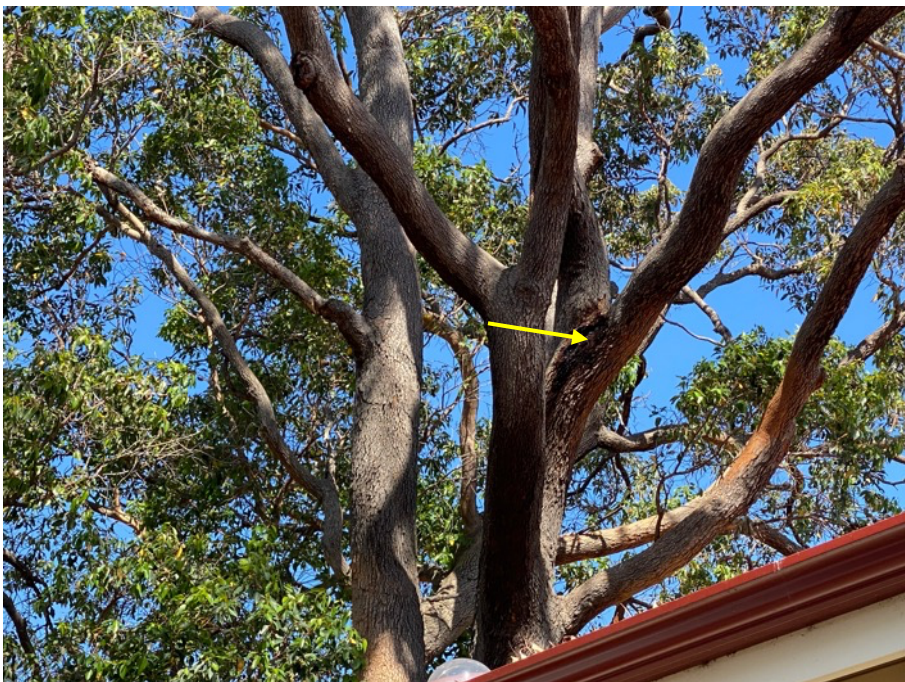
- Previous crown lifting pruning works were evident predominantly on the west side to improve clearance above the buildings
- Marri canker infection was also evident within the middle crown on the west side of the tree, and located within a branch union - potentially compromising the structural integrity of the branch attachment

**Figure 6.** Marri canker infection was evident (see arrow) within the middle crown on the west side within a branch union - potentially compromising the structural integrity of the branch attachment; looking towards the southeast.

- 3.10 Undertake reduction pruning by 1-2m within the middle crown on the west side to reduce branch length (see figure 6 for branch with canker infection within union) and alleviate end weight and loading on the branch attachment - to mitigate the potential for branch failure.
