27th January 2021

ARBORICULTURAL ASSESSMENT AT THE KALAMUNDA HISTORY VILLAGE

Please find enclosed the results of the arboricultural assessment undertaken recently for the tree adjacent to the train platform at the Kalamunda History Village, Kalamunda.

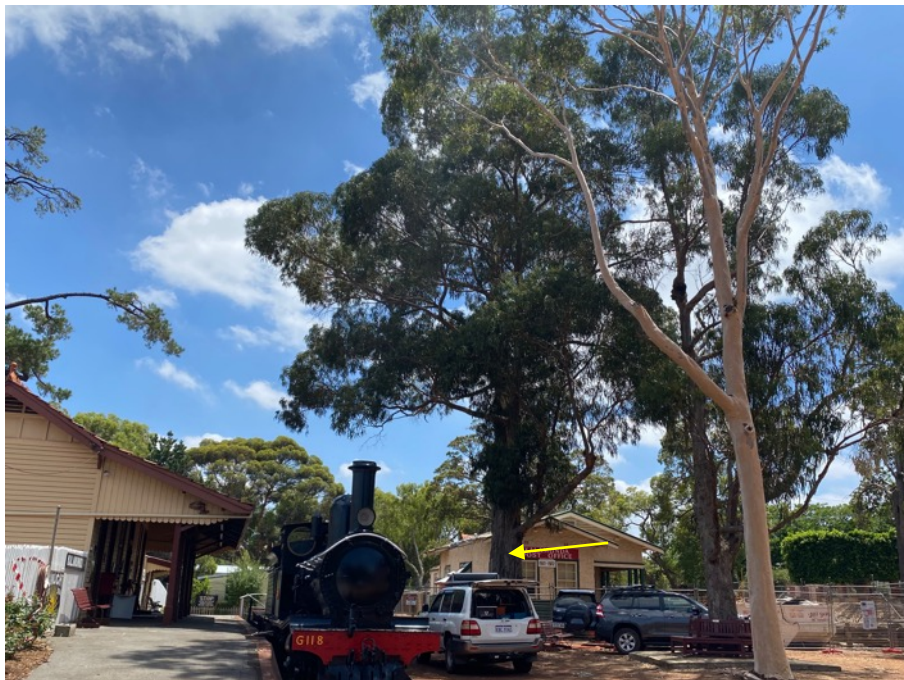
Figure 2. Assessed tree (see arrow); looking towards the north.

Assessed Tree:	Botanical Name: <i>Eucalyptus globulus</i>
Common Name:	Tasmanian blue gum
Location:	Train platform - east side
Height:	24.3m
DBH:	136cm
Crown Spread (NS/ EW):	20/16m
Structure:	Fair
Health:	High
Comments:

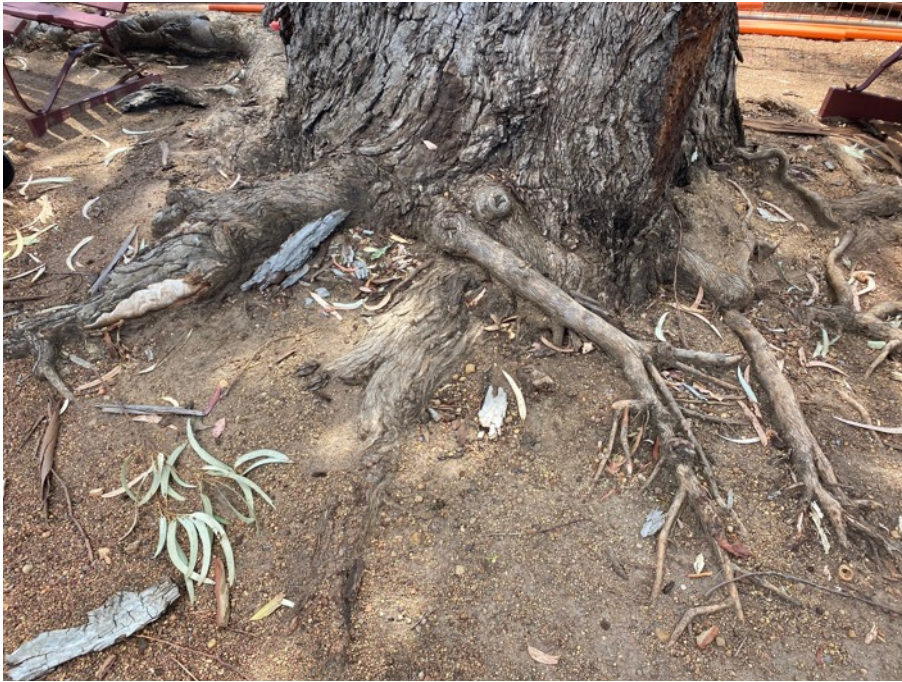
- Adequate trunk basal flare was evident with buttressing visible however a number of surface woody roots were observed extending from the root collar – likely to have resulted from excessive pedestrian traffic within close proximity of the trunk basal area compacting/ shifting soil

- Several exposed surface roots were evident within 1-2m of the basal area with missing bark and exposed sapwood visible predominantly on the north side (roots not severed), however sufficient rootplate stability is deduced

Figure 3. Adequate trunk basal flare was evident with buttressing visible and a number of woody roots were observed extending from the root collar - likely resulting from excessive pedestrian traffic within close proximity of the trunk basal area; looking towards the northeast.

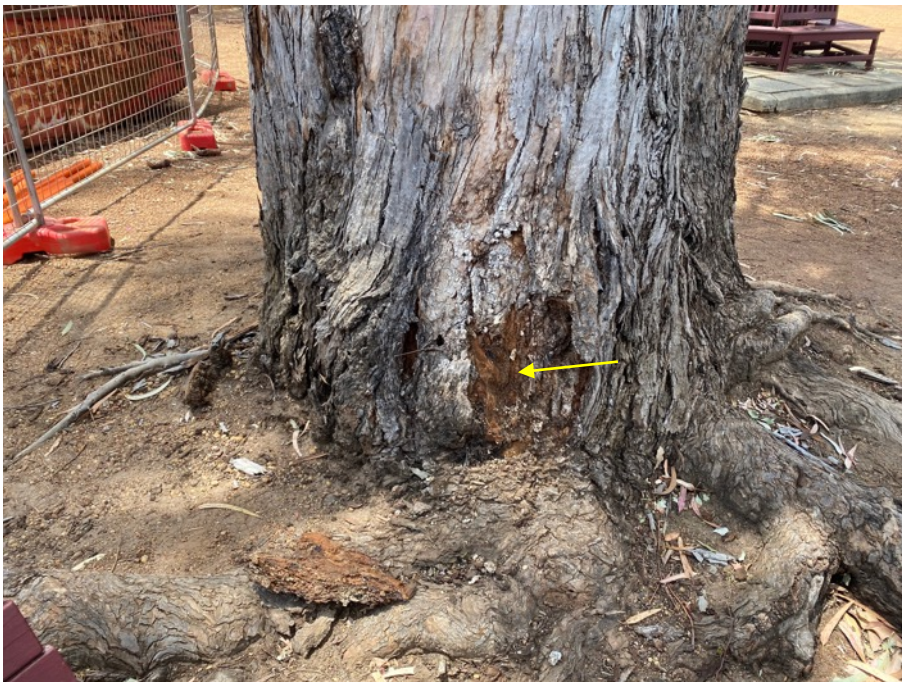
- No fungal conks were observed however canker infection (species unknown) and subsequent woundwood production was evident on the northwest side however internal degradation if any is likely to be superficial and the infection minor in proportion to the entire trunk basal area circumference

Figure 4. Fungal canker infection was evident on the northwest side (see arrow) however internal degradation if any is likely to be superficial and the infection minor in proportion to the entire trunk basal area circumference; looking towards the southeast.

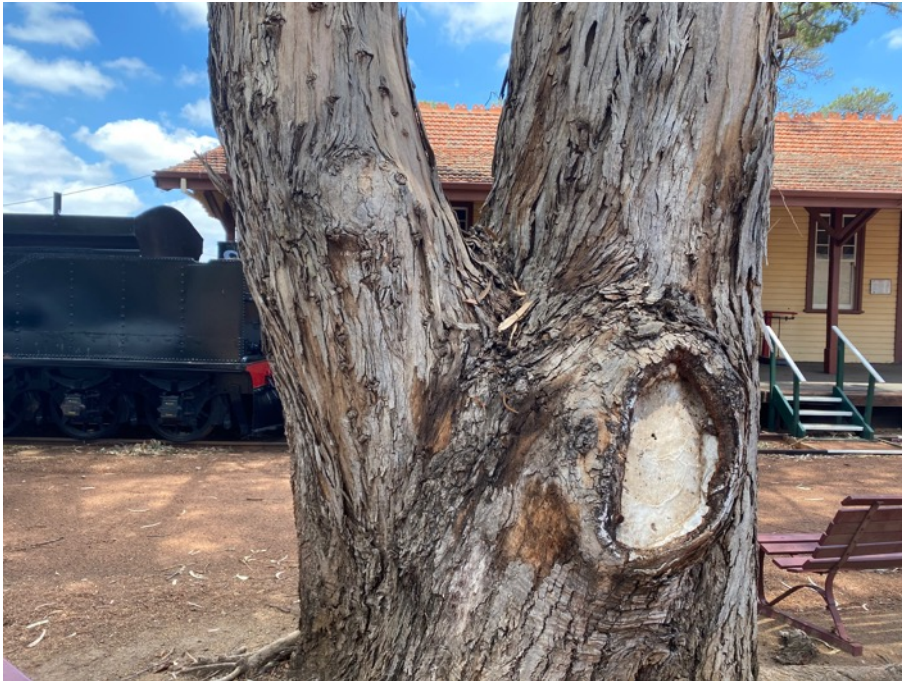
- A (concealed) pruning wound cavity opening was visible at 1m above ground level on the northeast side and was adjacent to the union of the two codominant stems, however no structurally compromised stem attachments were observed

- Further investigation using PiCUS sonic tomography revealed the trunk section to have 55% solid wood and 29% damaged wood, with the degradation predominantly centrally located

Figure 5. A large pruning wound was visible on the northeast side and was adjacent to the union of the two codominant stems however no structurally compromised stem attachments were observed; looking towards the west.

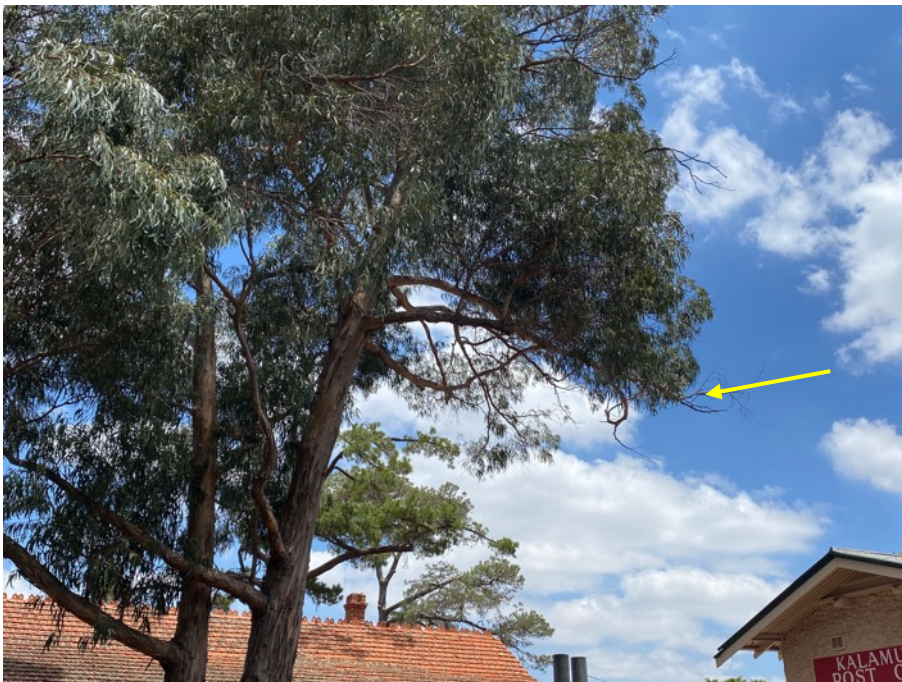
- Naturally occurring dead branches to approximately 120mm diameter were observed including such branches overhanging the phone booth area on the north side of the tree

Figure 6. Naturally occurring dead branches to approximately 120mm diameter were observed including such branches overhanging the phone booth area on the north side of the tree; looking towards the northwest.

- 3.7 Undertake the installation of a non-invasive 4-tonne cable brace such as Yale brace at a height of approximately 16m between the two codominant stems, to provide supplementary support to codominant stem union.
- 3.8 Undertake deadwooding to remove the dead branches greater than 50mm in diameter from the crown of the tree. N.B. Broken branch stubs of nominal length in native tree species have the potential to provide food source, roost sites and habitat and can be retained to assist a range of local native fauna.

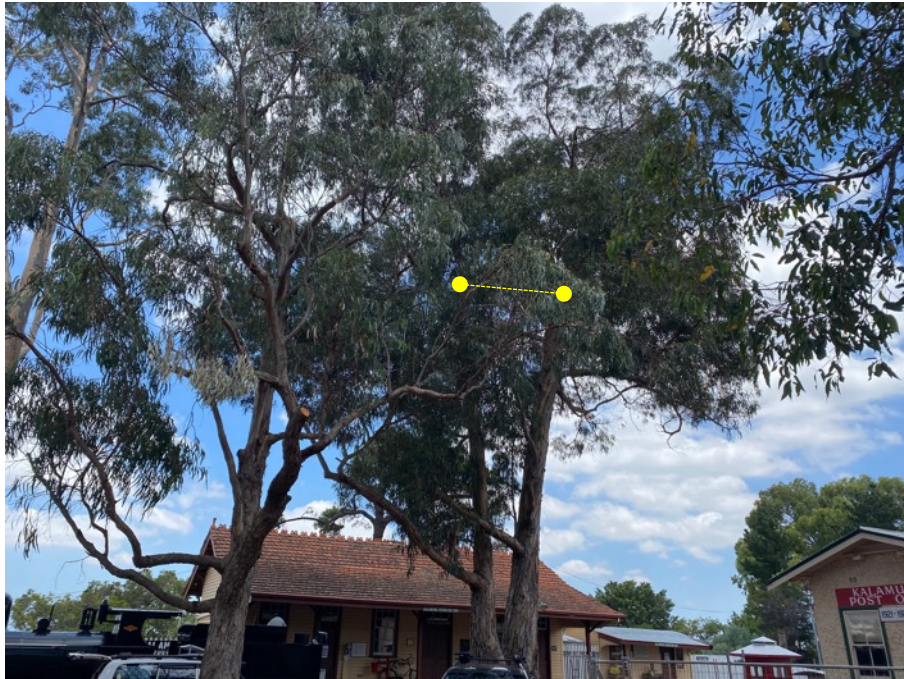
Figure 7. The installation of a cable brace at a height of approximately 16m (see dashed line) is recommended between the two codominant stems to provide supplementary support to codominant stem union; looking towards the northwest.
