PiCUS Sonic Tomograph Test and Summary Report

Prepared for: Jerry Hutter at the City of Kalamunda

Date of Test: 20 January 2021

Site Details: Kalamunda History Village (adj. train station)

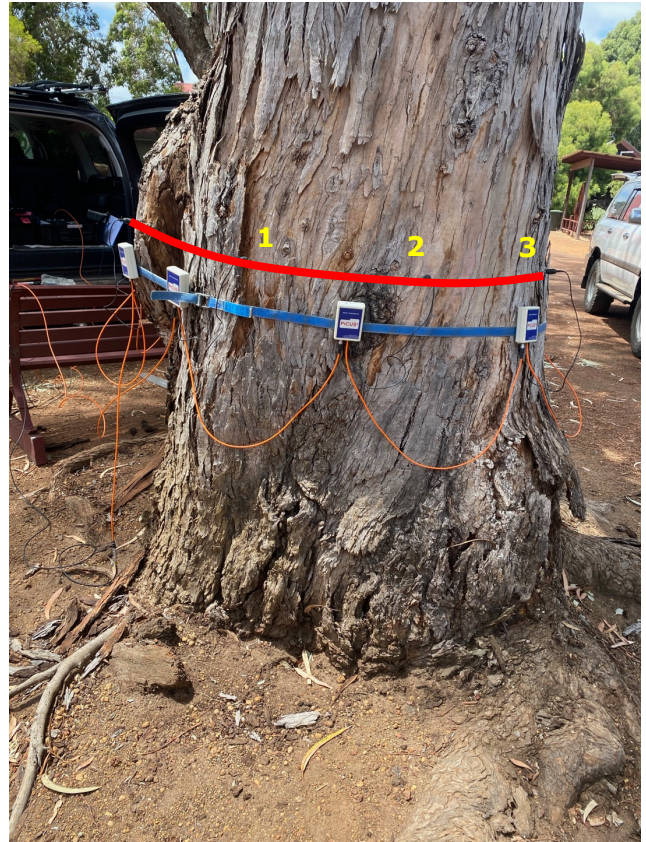
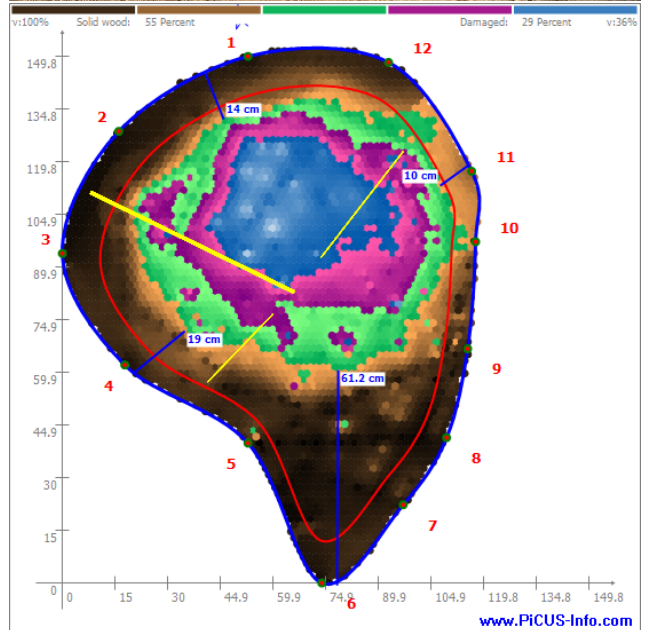
The PiCUS® Sonic Tomograph test result indicates 55% of the test area is solid (high density) wood. There is 16% incipient wood (wood being altered). The remaining 29% is active degradation (low density) wood, cracking or cavity.

The pest and/ or pathogen is likely to have entered the tree through the trunk basal area wounds and/ or rootplate.

The radial amount of solid wood adjacent to sensor number 1 was measured at 14cm, adjacent to sensor 4 was measured at 19cm, adjacent to sensor 6 was measured at 61cm, and adjacent to sensor 11 was measured at 10cm.

It is observed that new wood growth increments are evident at all sensor numbers.

The test result provides evidence that the tree is still structurally sound at the test point and in good condition. Response growth (new wood) is evident as part of self-optimisation and is maintaining an adequately-loaded structure at present.
