September 2022 Final

Mundaring Weir Rd - Road Safety Investigation

Prepared For: City of Kalamunda

Final Report

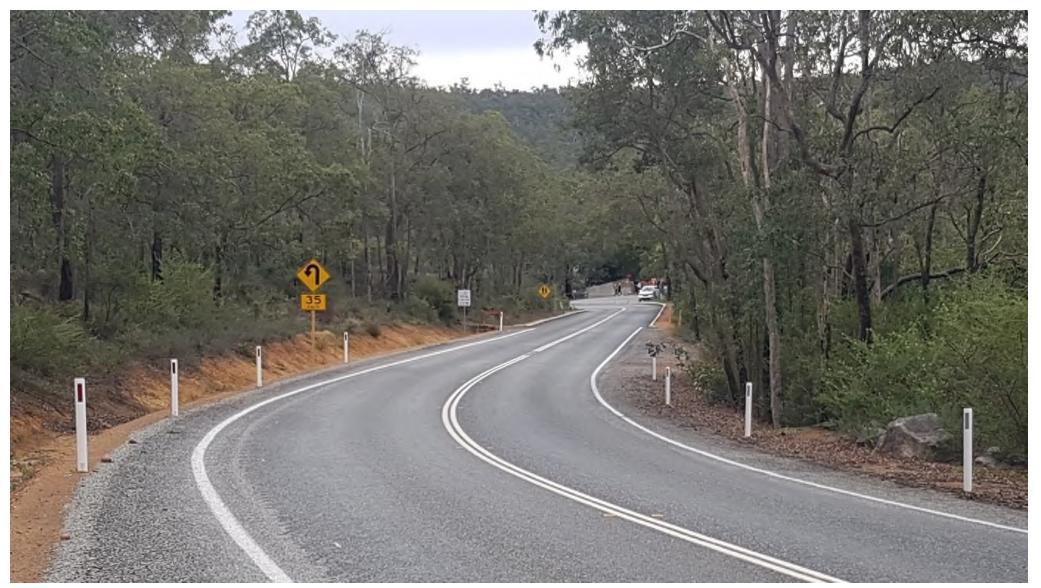
Photo 19: Sharp left hand bend adjacent Mundaring Weir car park.

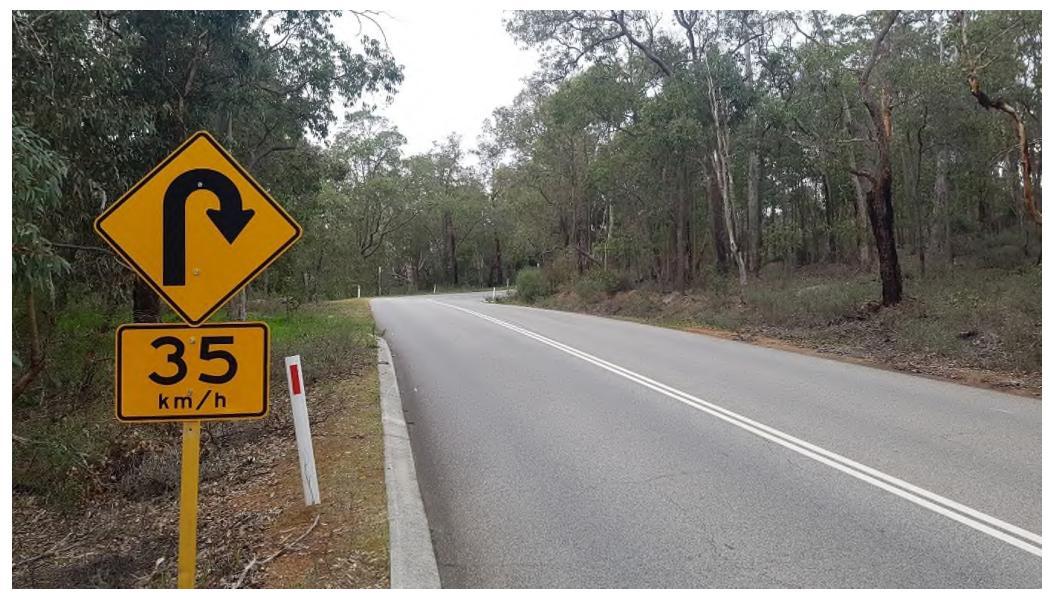
It is noted from the crash history that there have been four (4) head on crashes on the bend in **Photo 20**. Two of these crashes involved a motorcyclist and one a cyclist. With the exception of the crash involving a bicycle, the other three resulted from a westbound vehicle (2 x motorcycles, 1 x unknown) losing control and running wide into an oncoming vehicle.

All four crashes occurred during the day, in dry conditions. It is not known when the advisory speed signs were installed, but they appear new.

Photo 20: Both curves currently have advisory speed limit signs.

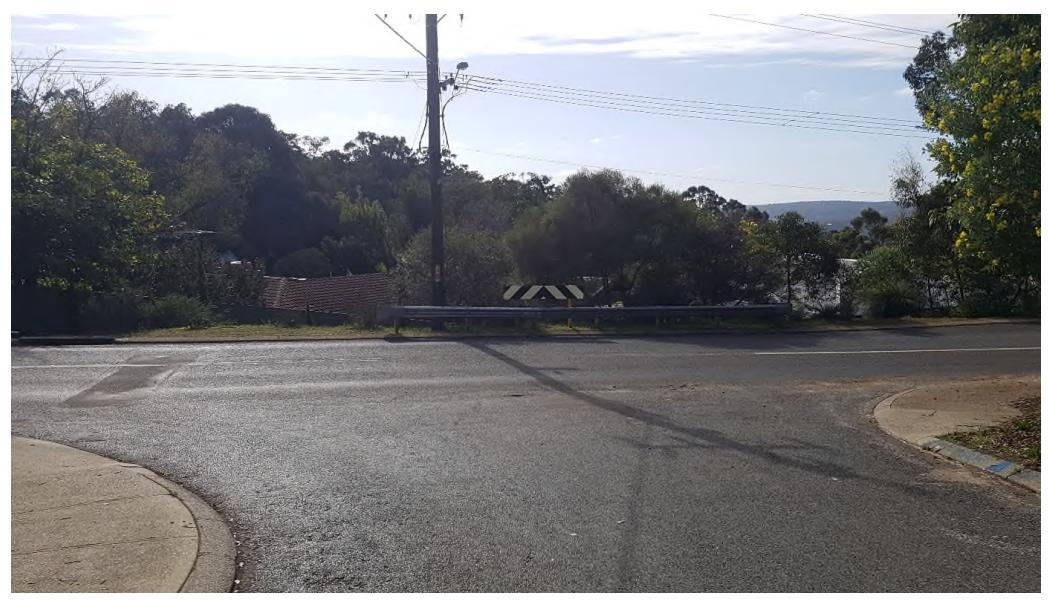
There is a short section of W-beam opposite the side road, ostensibly to prevent overshoots from the side road dropping down the embankment. Typically, W-beam is not designed to withstand such impacts. It should also be noted that the barrier as installed does not cover the length of need regarding either the embankment or the power pole, does not meet the minimum effective length requirement of 28m and has non-crashworthy end terminations. See **Photo 22**.

Photo 22: Hazard board, but no Give Way lines or signs. Note unsuitable safety fence.

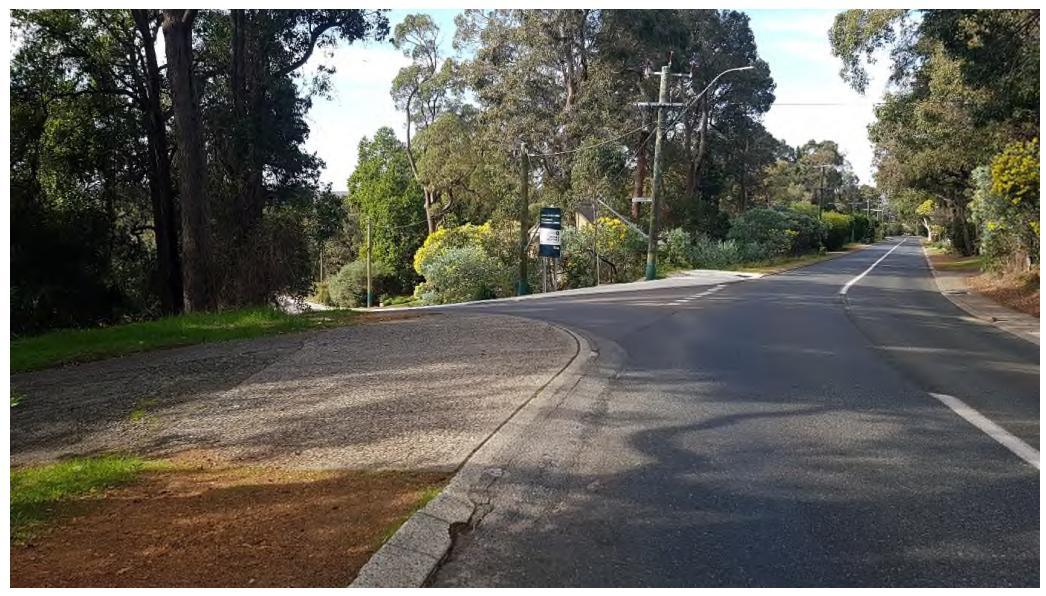
Photo 23: T-intersection of Crescent Road with Mundaring Weir Road.

The side road has Give Way and centre line markings, but no Give Way sign or hazard board. However, due to the acute angle of approach to Mundaring Weir Road, an advance warning sign on Crescent Road for the junction ahead would be more suitable and recommended.

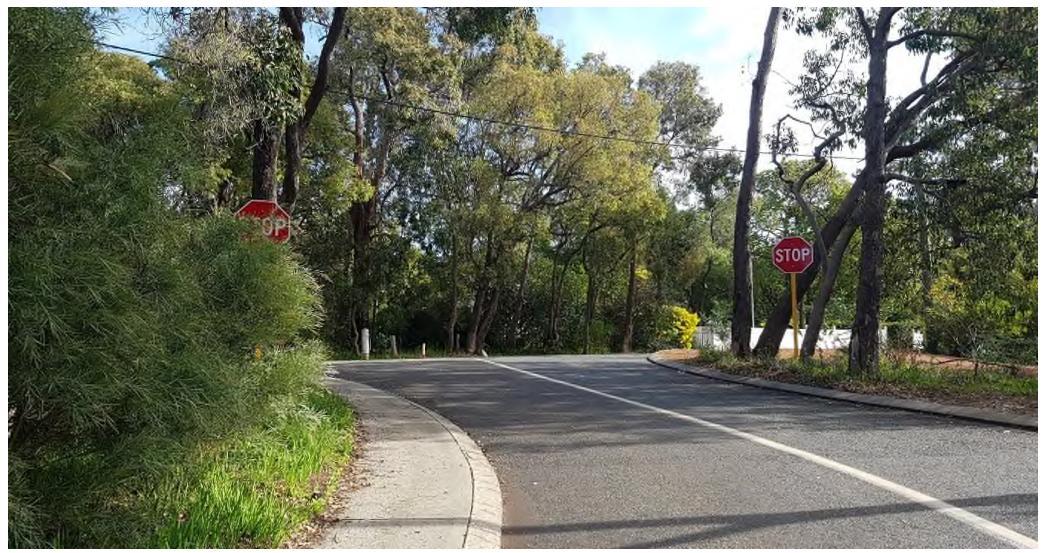
Approaching Mundaring Weir Road on an uphill gradient, Hummerston Road has Stop signs and lines, but no hazard board. See **Photo 27**.

Photo 27: Hummerston Road approach to Mundaring Weir Road.

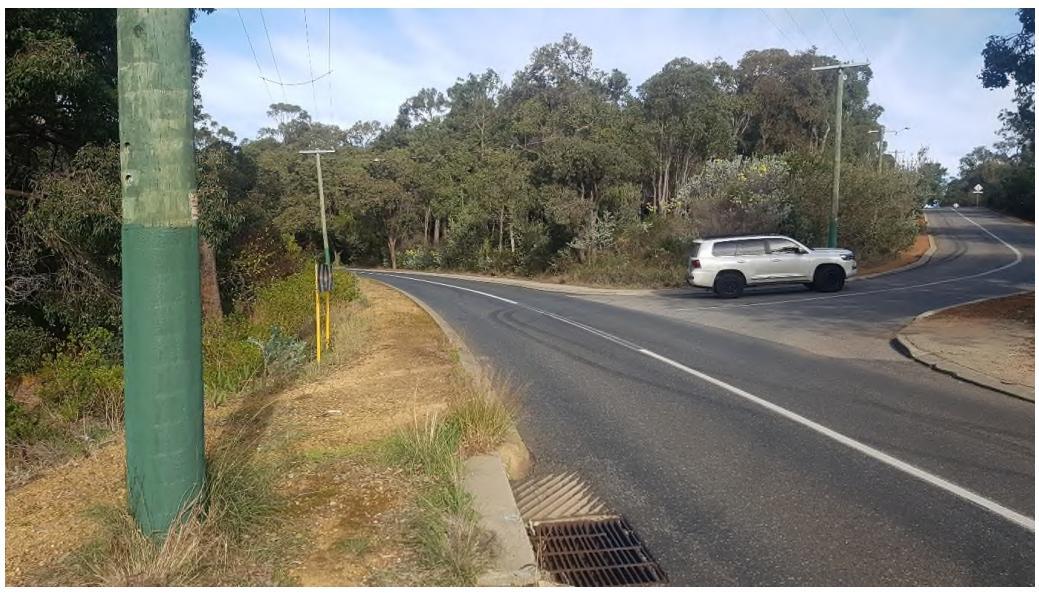
The geometry of the intersection with King Road is not ideal. The side road approaches at an acute angle, before swinging down and right to meet the through road at 90°. However, overgrown verge vegetation limits visibility. The intersection has a hazard board opposite the side road, as well as for the change in alignment on approach, but no Give Way or Stop signs or lines. See **Photos 29 & 30**.

Photo 29: T-intersection of King Road with Mundaring Weir Road.

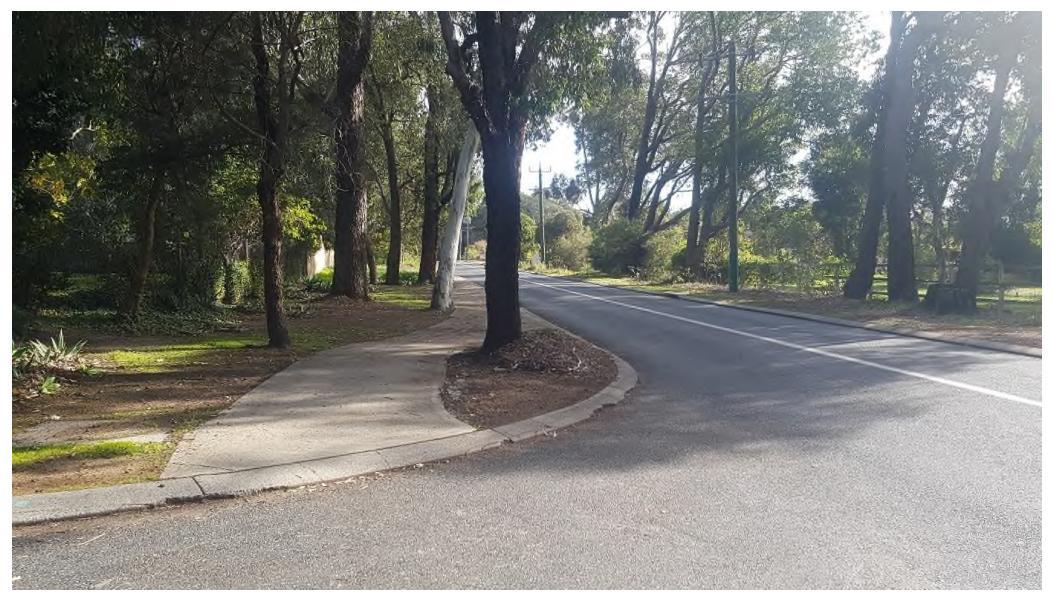
Photo 32: Visibility to the left is compromised by verge trees.

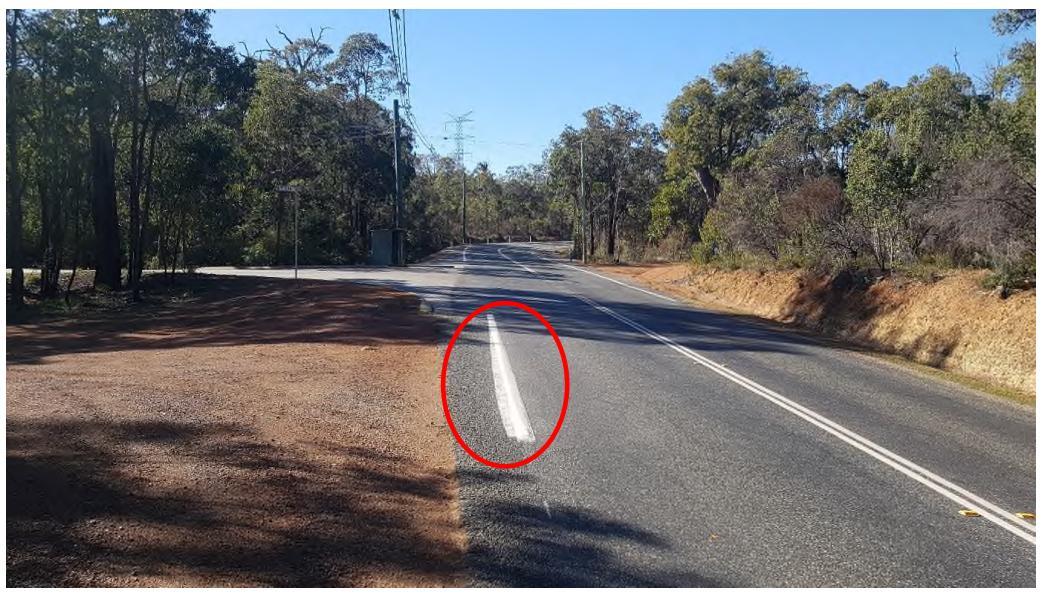
Fern Road forms a T-intersection with Mundaring Weir Road, located on a short straight between two sweeping bends. Visibility is limited to some extent to the left by the presence of a disused bus shelter, and to the right by a horizontal curve. The intersection has no Give Way lines or signs, no hazard board and a non-standard section of edge line. See **Photos 40 to 41a**.

Photo 40: Fern Road intersection, with non-standard edge line marking.

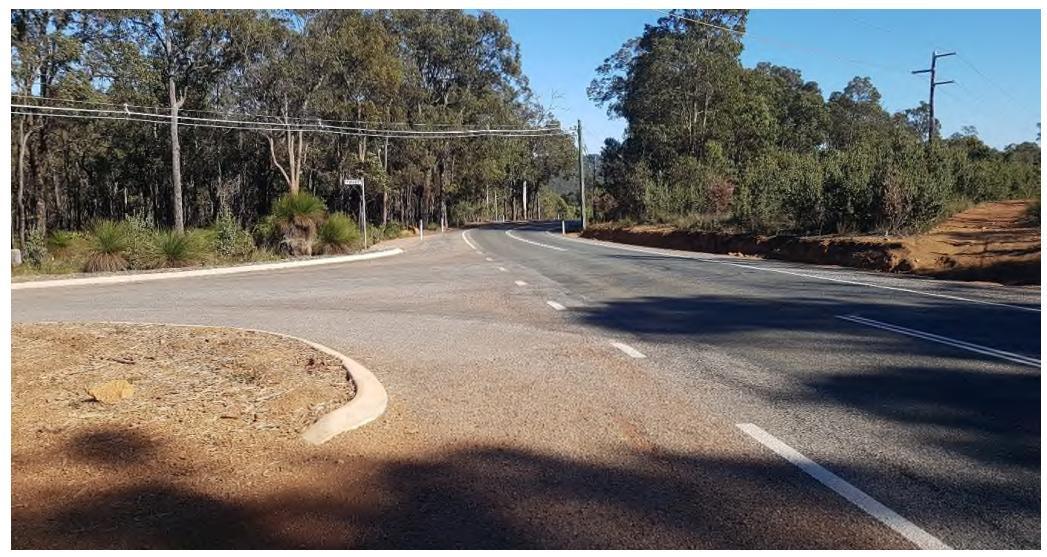
The intersection of Mundaring Weir Road with Bahen Road is a T-intersection. It has no Give Way signs or lines and no hazard board opposite. Visibility is limited in both directions by horizontal and vertical alignment issues. See **Photos 42 to 43a**.

Photo 42: The intersection of Mundaring Weir Road with Bahen Road is a T-intersection.

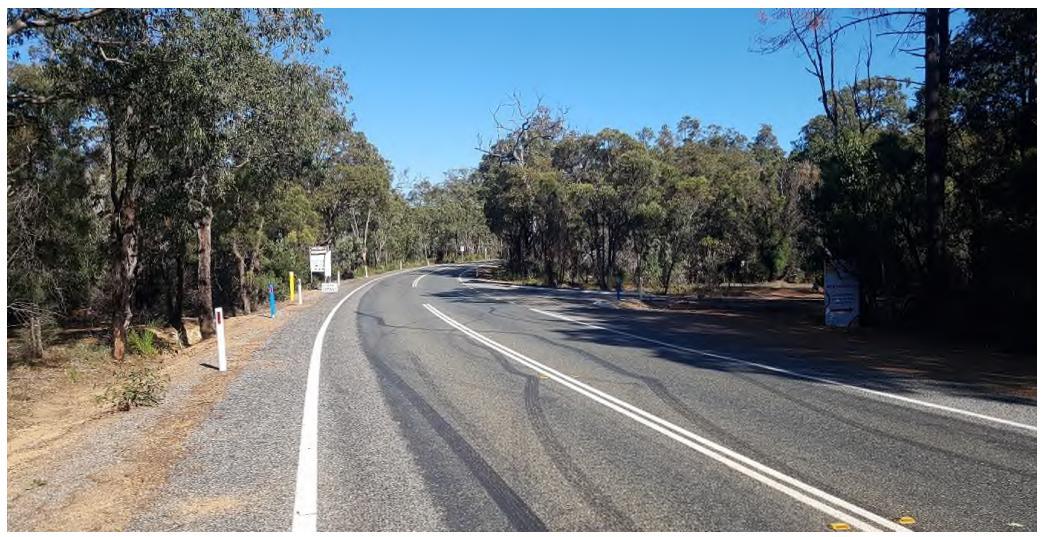
The intersection of Mundaring Weir Road with Paulls Valley Road is a T-intersection. It has no Give Way signs or lines and no hazard board opposite. However, it appears from markings and other evidence on site that upgrades to this intersection have yet to be completed. Visibility is limited in both directions by horizontal and vertical alignment issues. See **Photos 44 to 45a**.

Photo 44: Visibility to the right from the Paulls Valley Road intersection is limited by a horizontal curve.

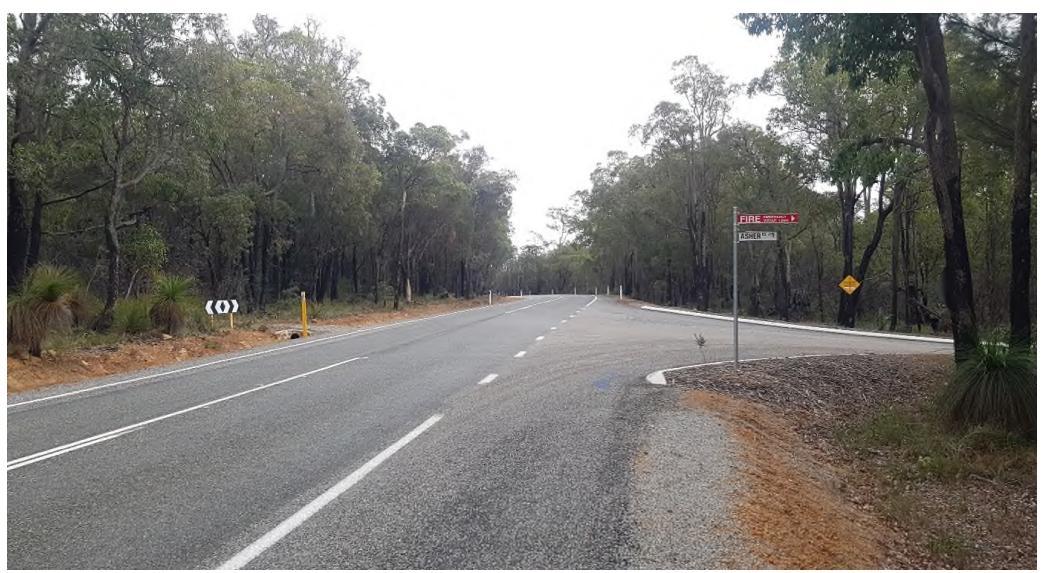
The intersection of Asher Road has a hazard board, but no Give Way signs or lines. The radii have been kerbed. Visibility is reasonable. See **Photo 46**.

Photo 46: Intersection with Asher Road.

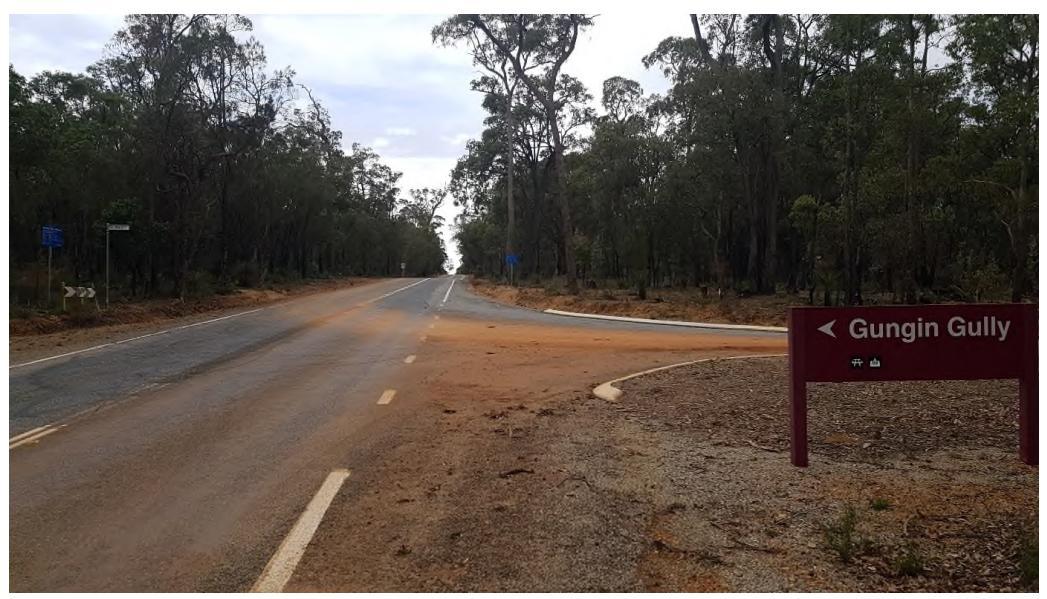
The Lockwood Road intersection has no Give Way signs or lines, but does have a damaged Hazard board which is, in any case, incorrect for its location. There is also a significant amount of loose material being dragged onto the through road at the intersection. This may present a hazard to road users, especially bicycles and motor cycles. See **Photos 48 to 49a**.

Photo 48:Lockwood Road intersection.

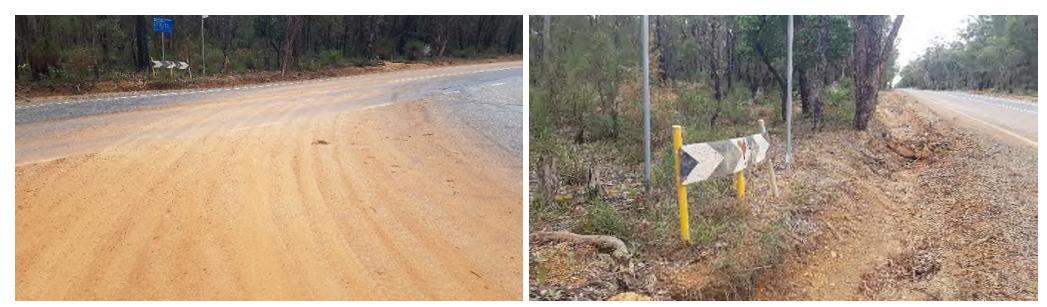
Photos 49 & 49a: Loose material being dragged onto the carriageway and a damaged (incorrect) hazard board.

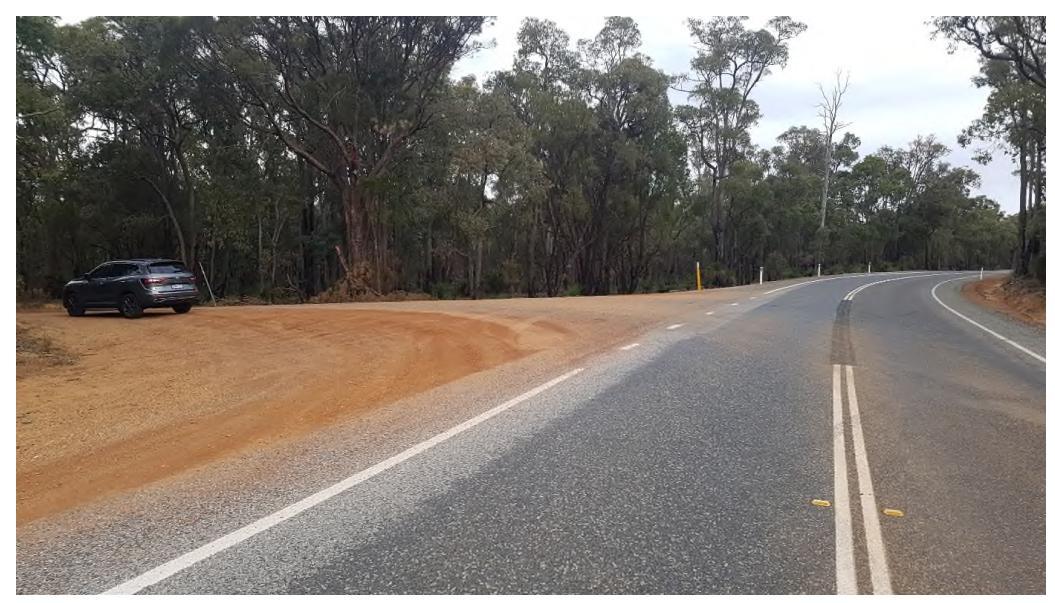
Ashendon Road is a very minor, unsealed road. As can be seen in **Photo 51**, the side road approach has not been sealed. There are no signs or line markings.

Photo 51: Ashendon Road approach is unsealed.

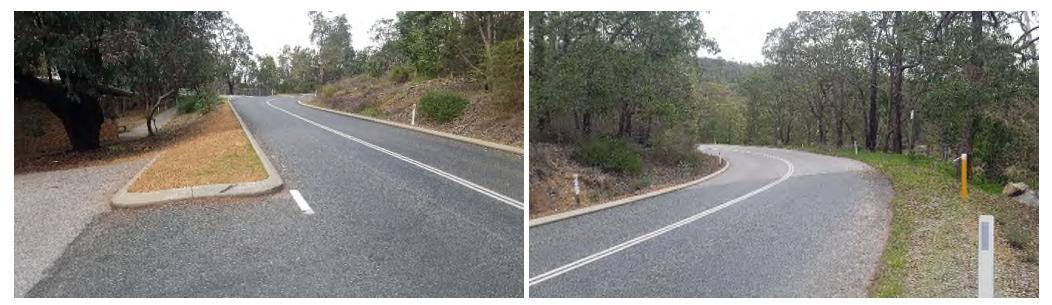
However, visibility at the western car park access is limited by the bends. See Photos 57 & 57a.

Photos 57& 57a: Visibility from the western Mundaring Weir car parking access.

It is noted that from the Crash History data, there have been four (4) head on crashes on the bend just west of the western car park access.

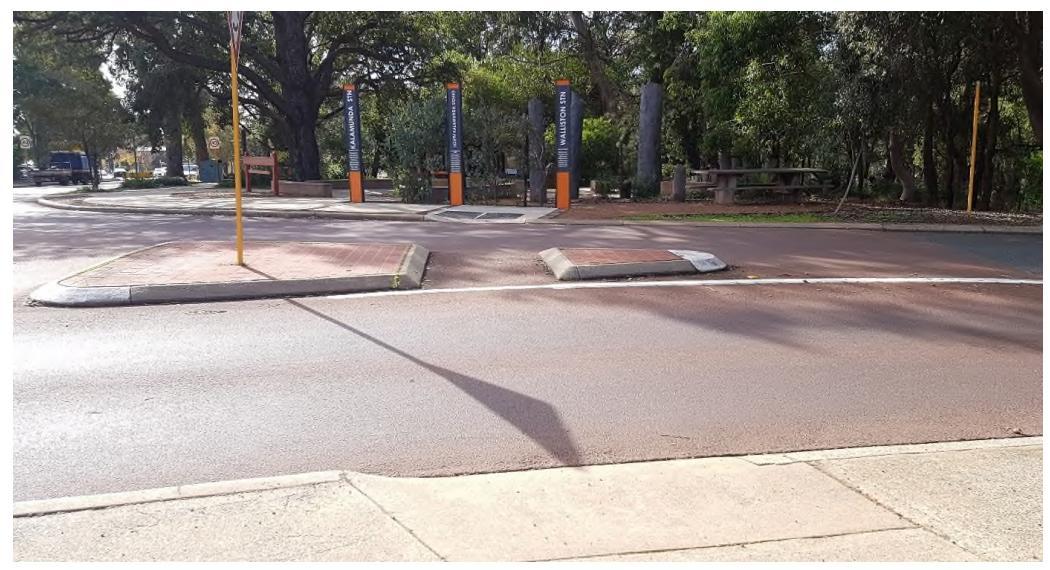
The standard of pedestrian crossings is generally poor. Even at the Railway Road roundabout, TGSIs are either missing or poorly aligned. See **Photo 67**.

Photo 67: Tactile Ground Surface Indicators (TGSIs) are poorly aligned or missing.

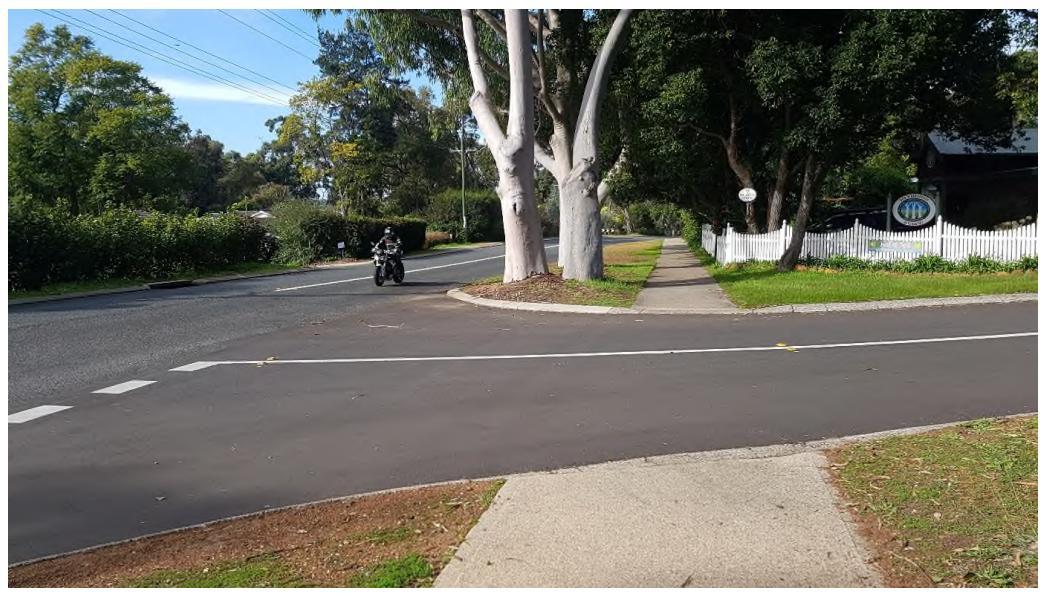
Photo 68: Typical pedestrian crossing, with ramps being well below current design standards.

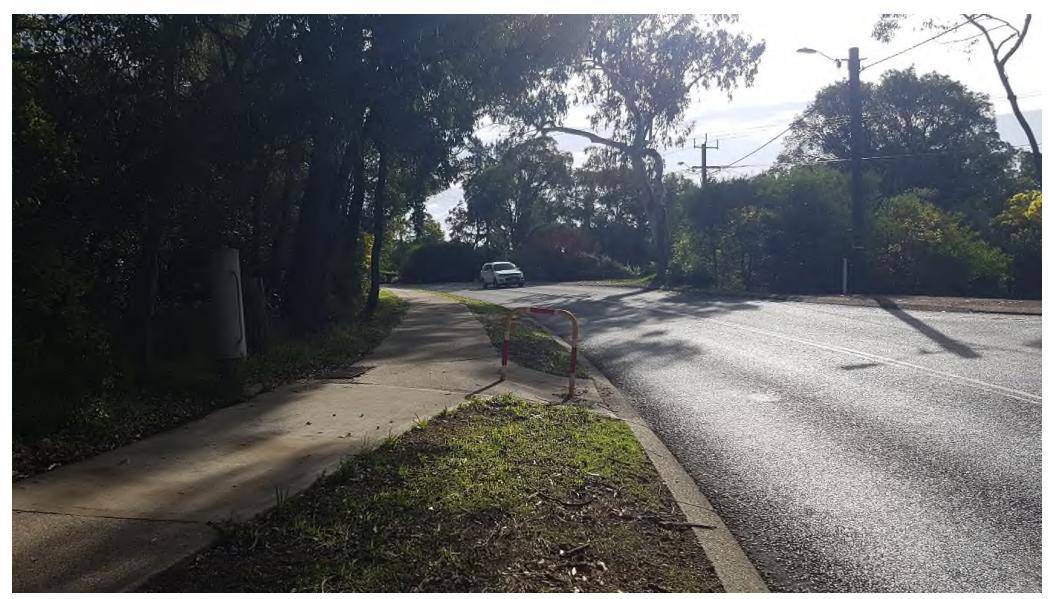
The crossing opposite Hummerston Road is unsafe and should be removed / relocated.

The crossing is badly located, with poor visibility, the ramp is far too steep and there are no TGSIs. The ramps on the opposite side – one on each side of the Hummerston Road intersection – are well below standard, and would be impossible to identify for anyone who is visually impaired. See **Photos 69 & 70.**

Photo 69: This crossing opposite the Hummerston Road intersection is poorly designed and should be removed.

As discussed in **section 3.4.1**, this crossing is unsafe, and should be removed and relocated.

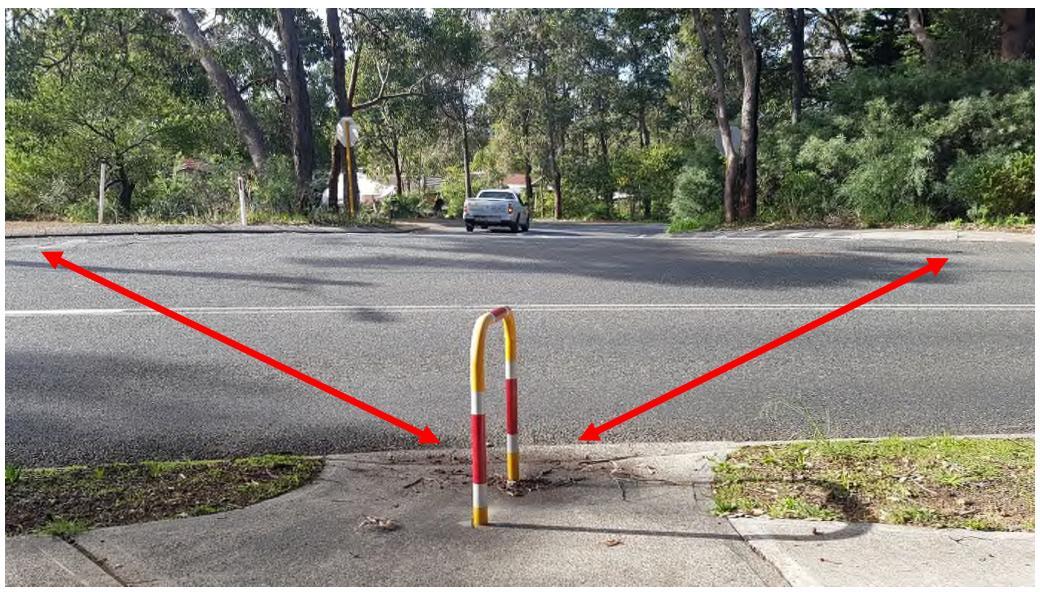
Photo 70: The crossing is badly aligned, with ramps well below current standards, no TGSIs and limited visibility.

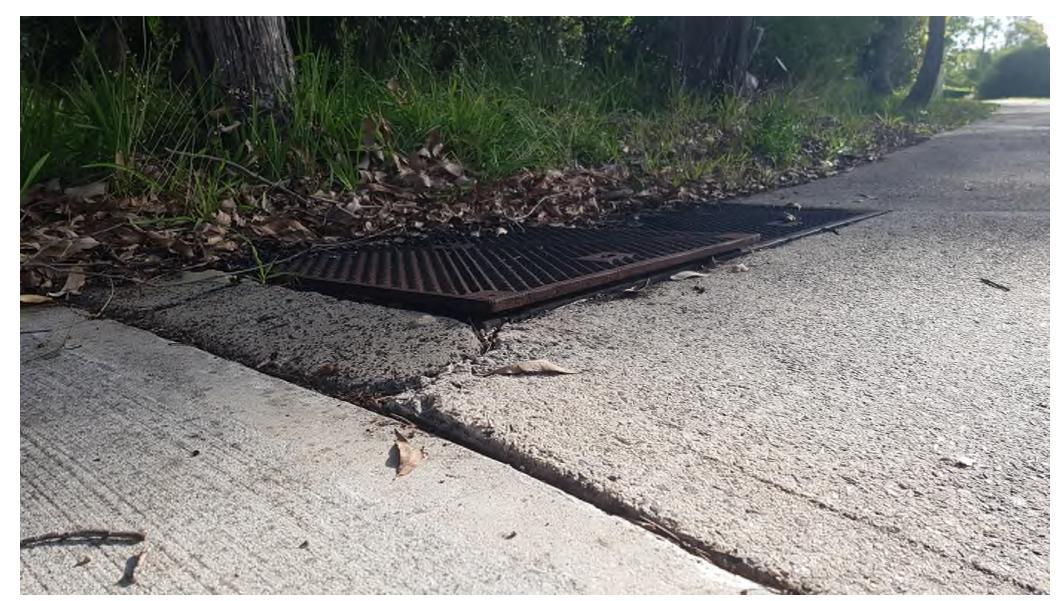
There are numerous trip hazards along this section of footpath. These range from badly fitted service lids to cracks caused by tree roots. Other obstacles observed on site included trees in close proximity to the path, overgrown verge vegetation, loose material and debris, and a trailer parked on the footpath.

Photo 71: Trip hazard in footpath.

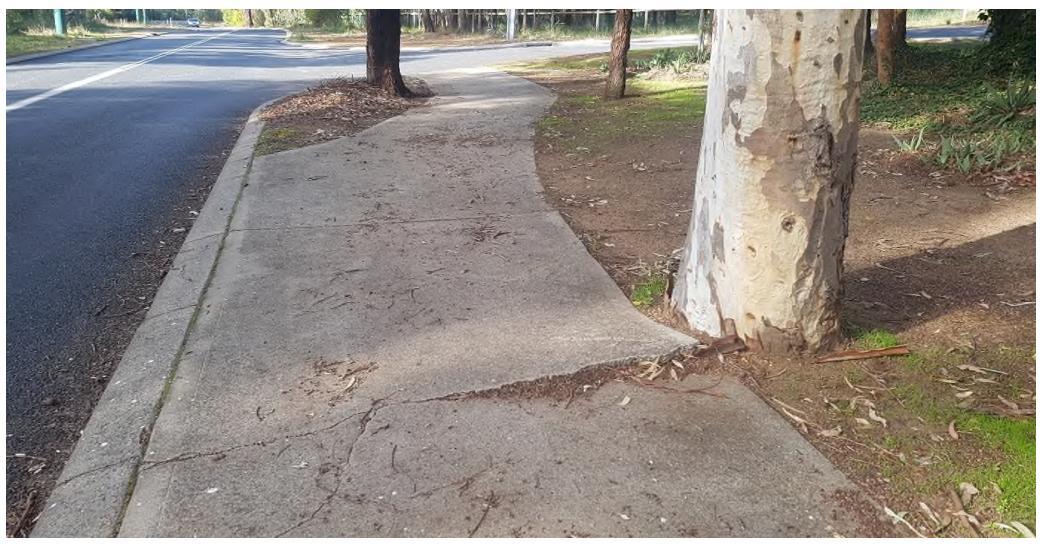
Photo 72: Significant trip hazard due to root damage.

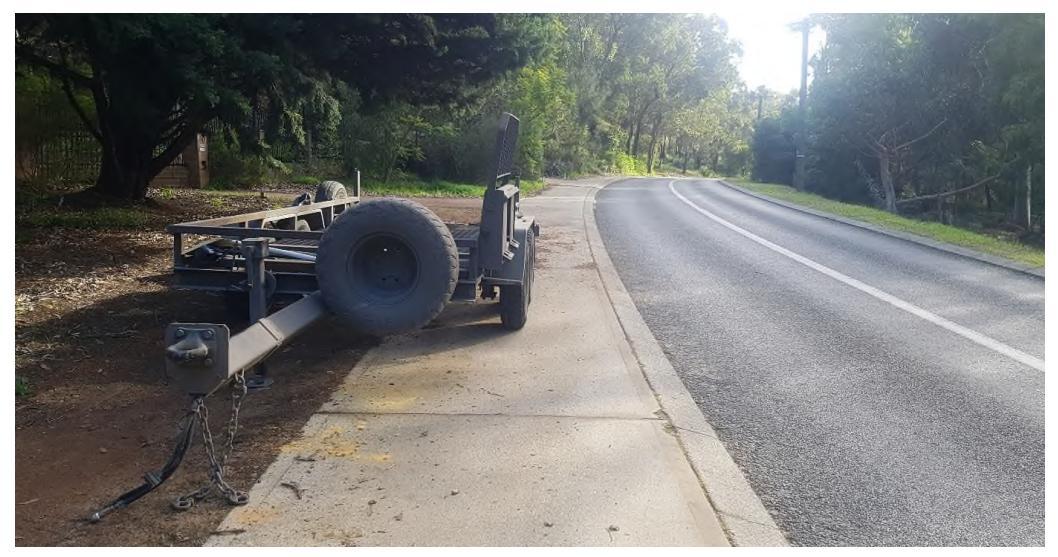
Photo 73: This trailer appears to be parked on the footpath regularly.

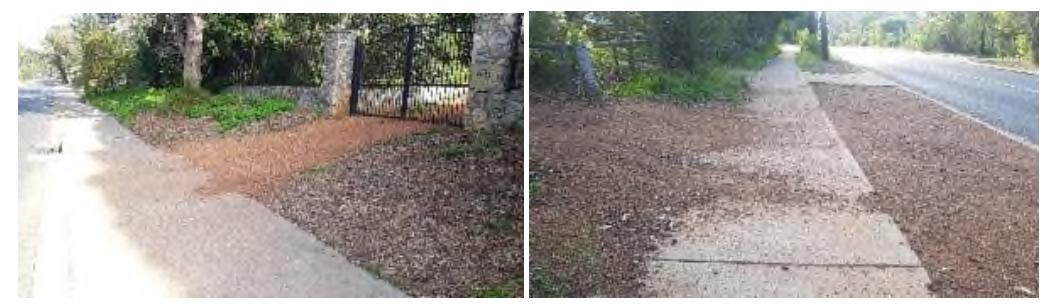
Photos 74 & 74a: Loose material dragged onto footpath and road surface from unsealed driveways.

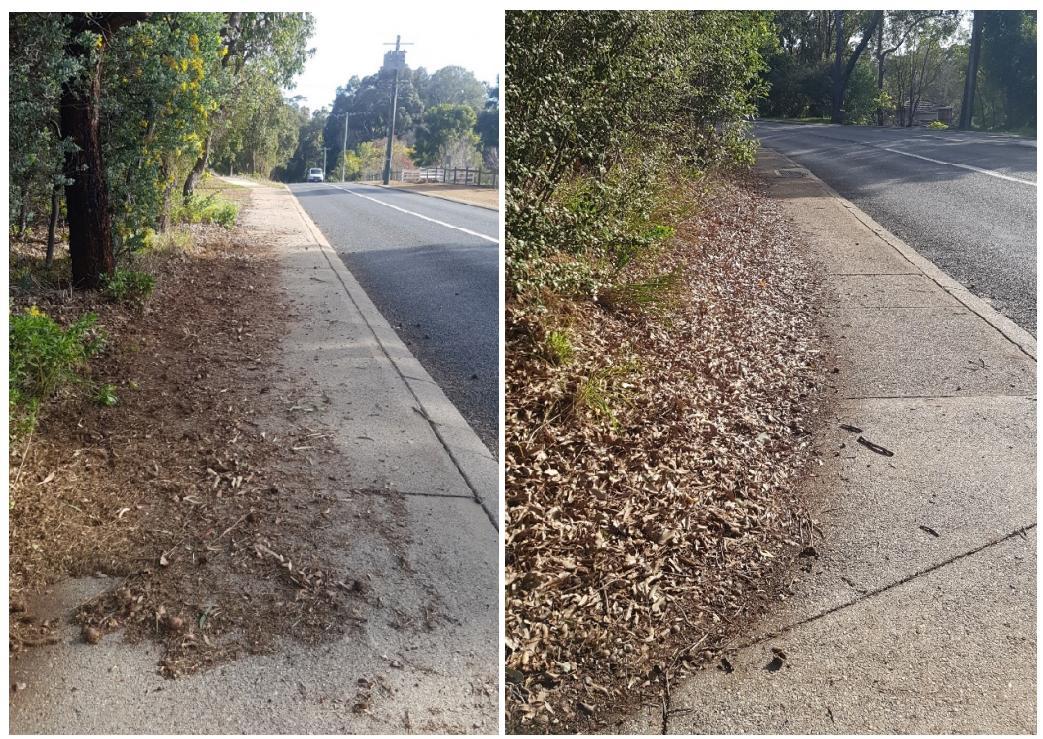
Photos 75 & 75a: Footpaths obstructed by debris.

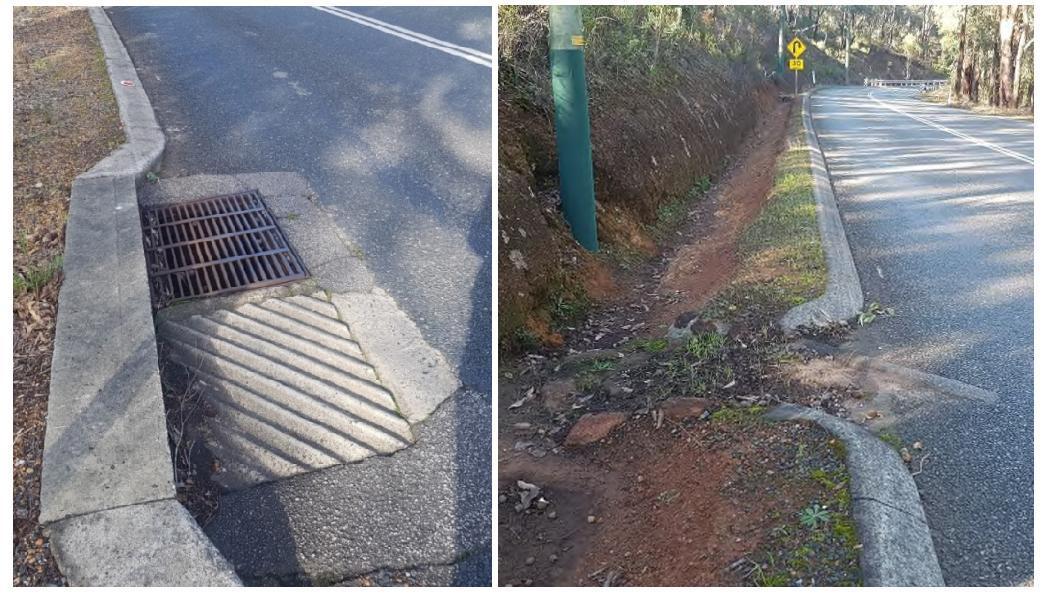
Again there are a number of drainage features that are unsafe for cyclists. See Photos 79 & 79a.

Photos 79 & 79a: These drainage designs present a hazard to cyclists.

A number of unsuitable drainage features were identified, at various locations, which, although designed to channel water flow into the kerbside gulleys, also present a significant hazard to cyclists and possibly motorcyclists. These should be replaced with gratings designed to meet current standards.

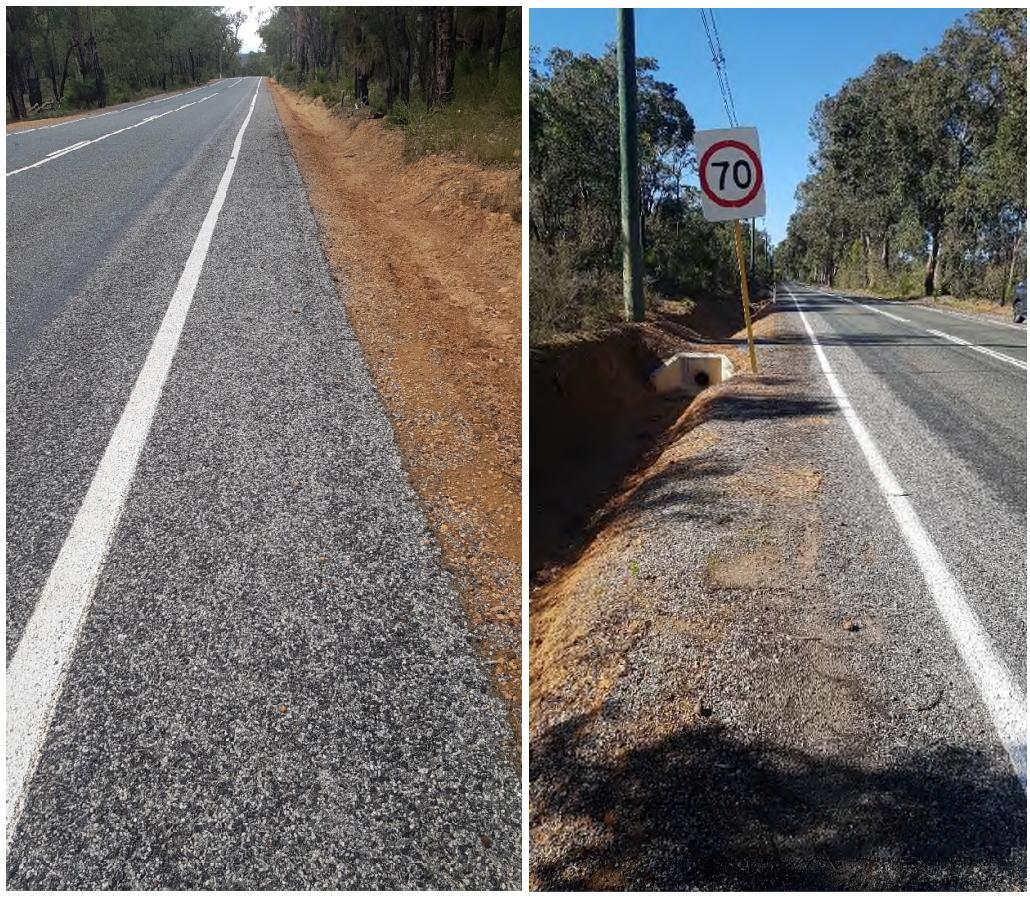
There are no specific cycling or pedestrian facilities along this section of Mundaring Weir Road. The road has recently been widened along the majority of this section, with edge lines, guideposts and sealed hard shoulders. However, the width of the hard shoulder varies, and whilst in some areas it provides a reasonably safe place for cyclists to ride, in others it is either too narrow, or the surfacing of the shoulder is not conducive to safe cycling. See **Photos 81 and 81a**.

Photos 81 & 81a: Hard shoulders vary in width and rideability. Note temporary reflector tabs on white lining.

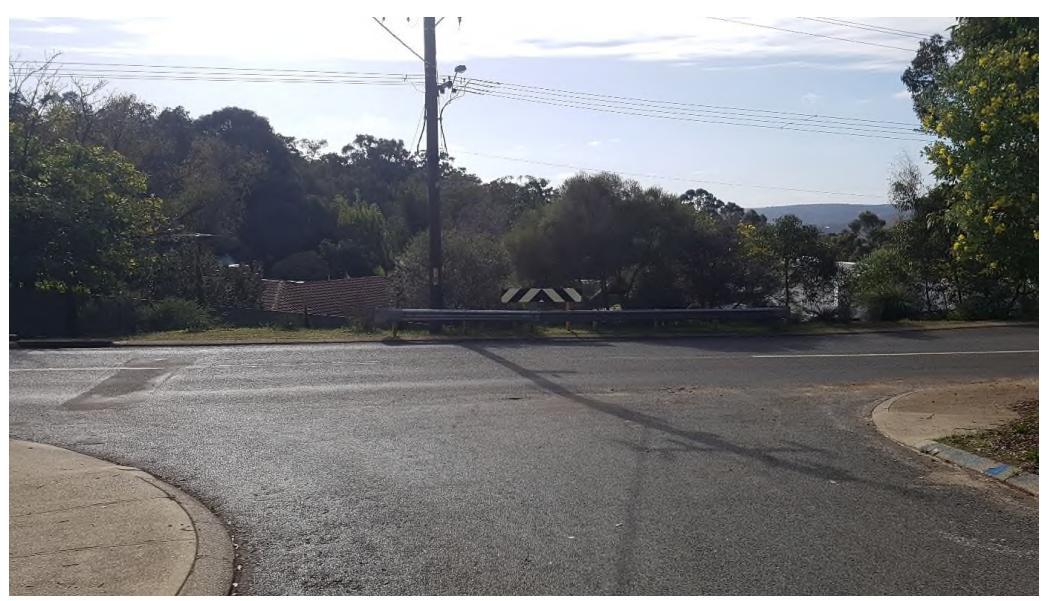
Photo 82: Schmitt Road: No Give way signs or lines. Note unsuitable use of not-to-standard W-beam.

Typically, W-beam is not intended to be used to withstand 90° impacts. The section as installed is also too short to provide effective protection from acute angle collisions, and has non-crashworthy end treatments.

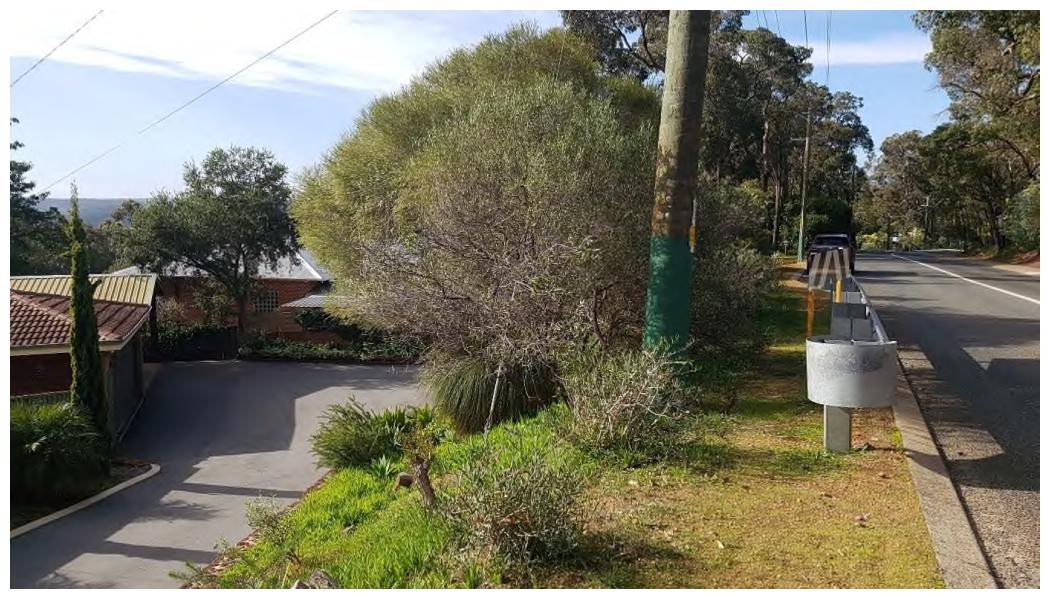
Photo 83: Barrier is too short, does not fully protect the power pole and has non-crashworthy end treatments.

A number of non-crashworthy end treatments were seen during the site visits. These should be replaced by treatments that comply with the latest standards.

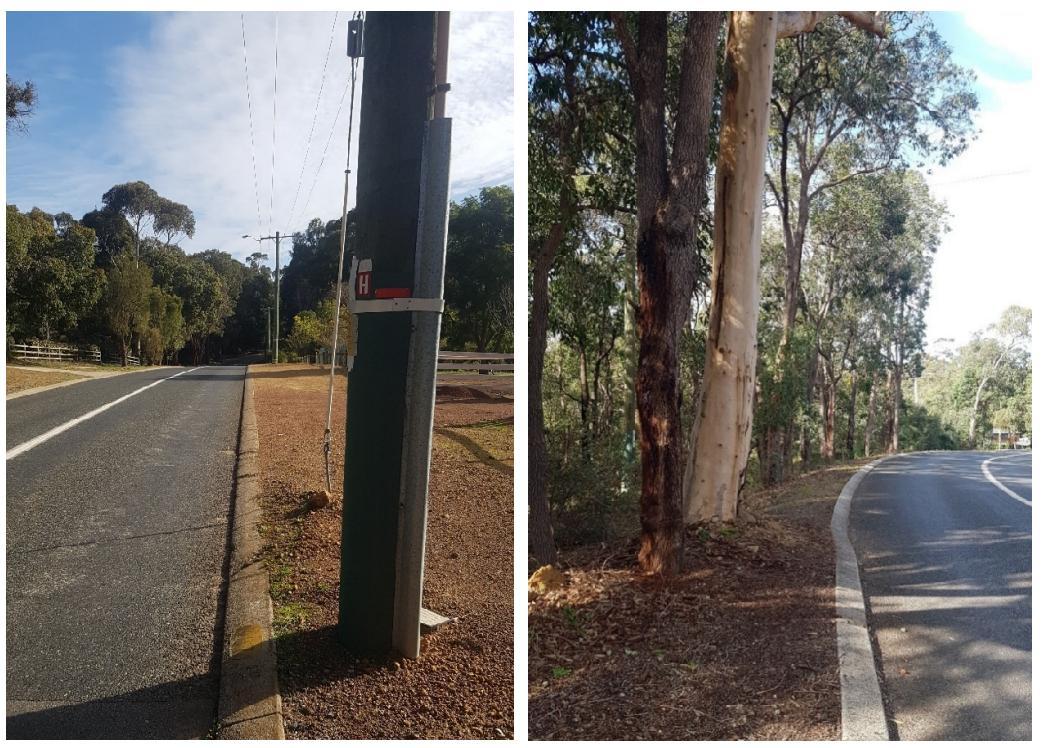
There are also a significant number of roadside hazards along this section of the road. These include power poles and trees located too close to the traffic lanes. See **Photos 84 & 84a**.

Photos 84 & 84a: Roadside hazards for errant vehicles include non frangible power poles and trees.

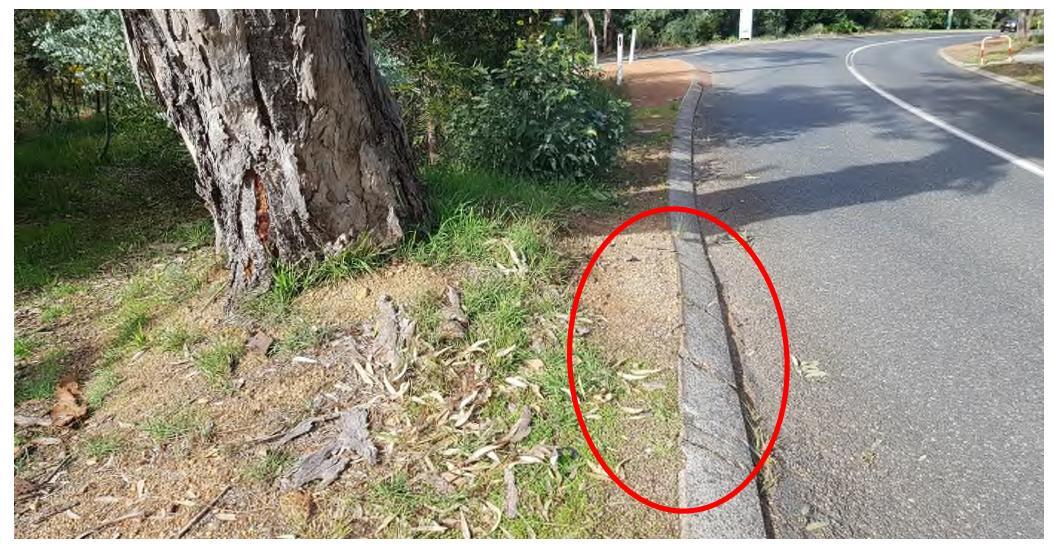
Photo 85: Tree roots are beginning to lift and crack the kerbs.

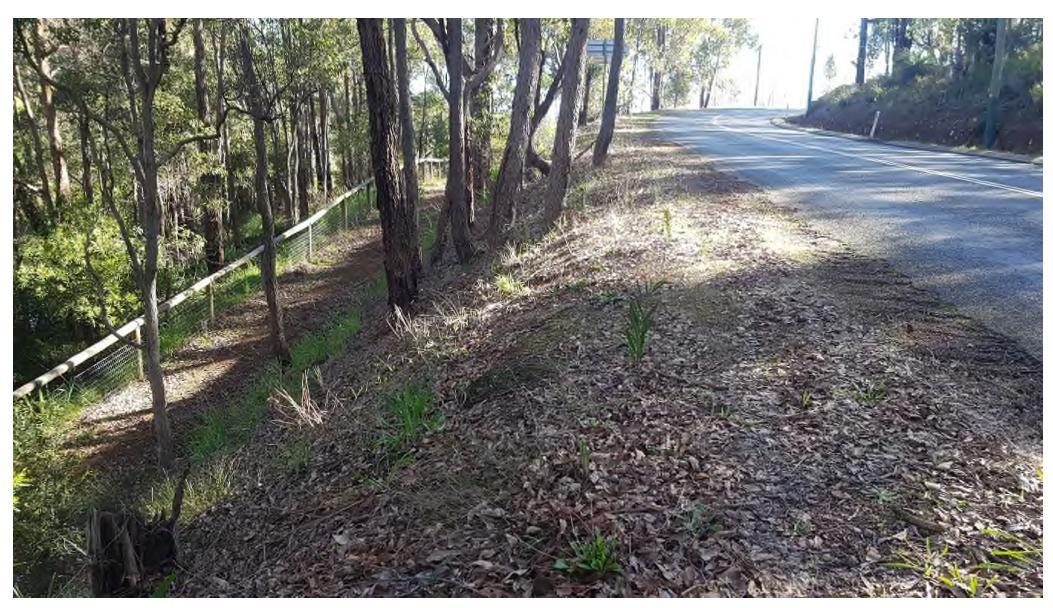
Photo 89: Another typical drop off along this section.

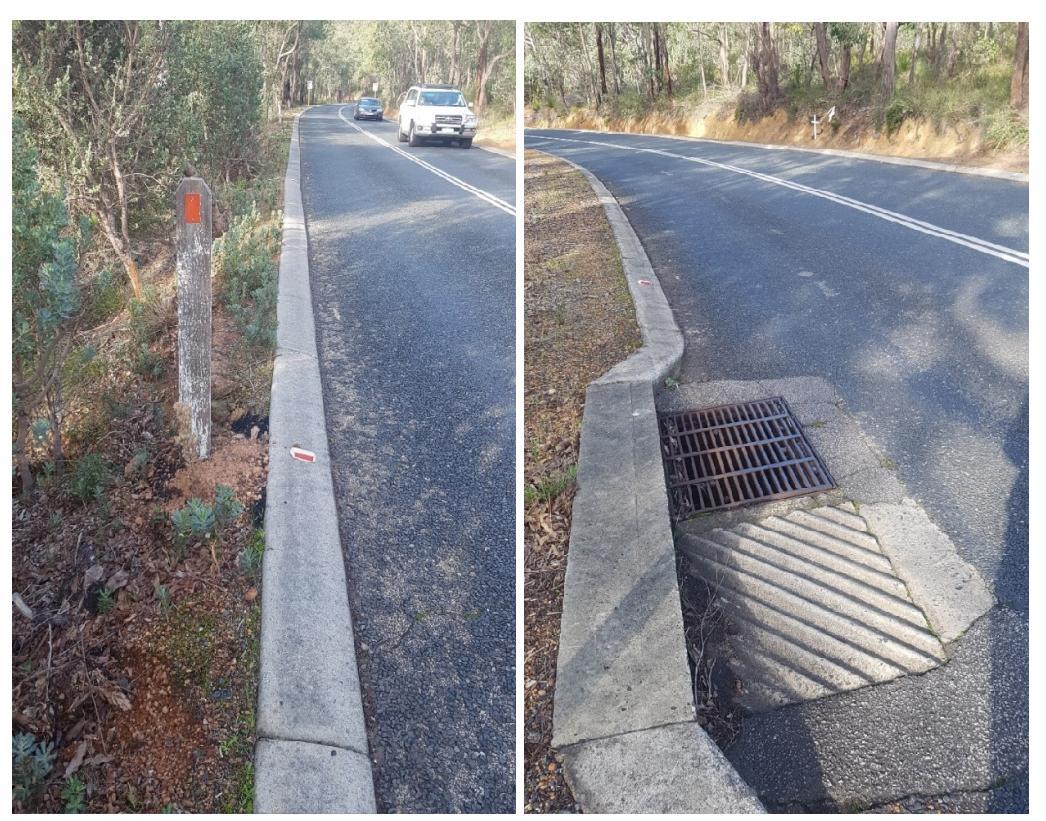
Photo 90: Very old guide post. Note reflectors mounted on kerbs. Photo 91: Non-cycle friendly drainage grid.

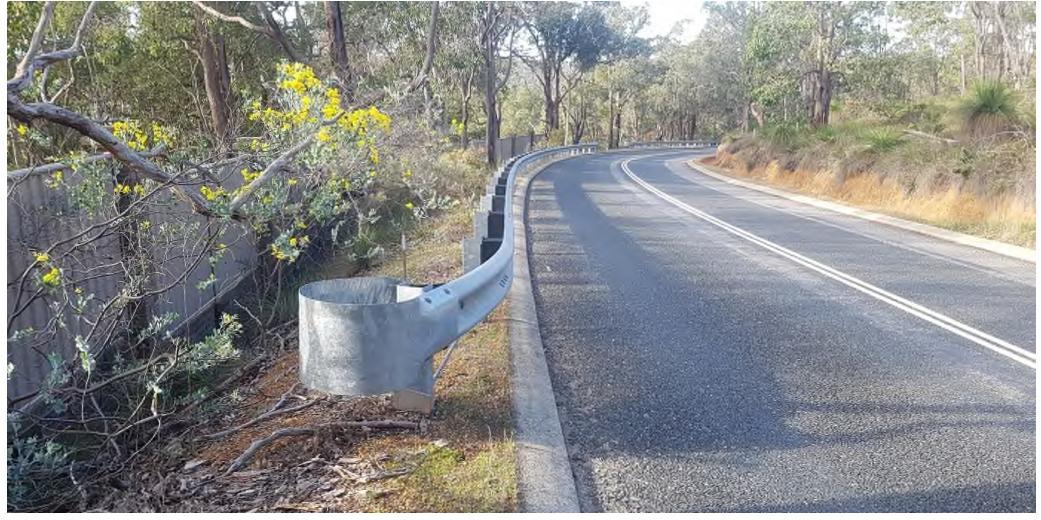
Photo 92: W-beam with a non-crashworthy termination treatment.
