September 2022 Final

Mundaring Weir Rd - Road Safety Investigation

Prepared For: City of Kalamunda

Final Report

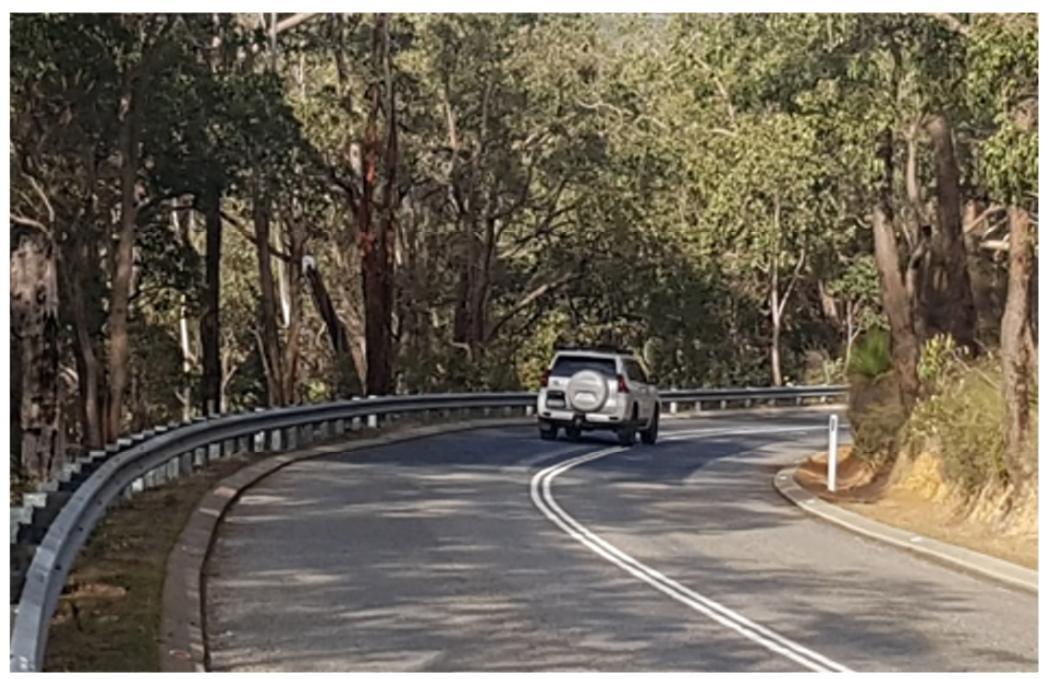
It was noted on site that a number of drivers tend to drive over the centreline of the road, especially when accelerating up hills. The introduction of audible lines may help to prevent this. See **Photo 93**.

Photo 93: Numerous vehicles were observed cutting the curves and straddling the centreline.

Audible edge lines can be very effective in encouraging drivers to remain within the traffic lanes, and should, as a priority, be installed where there are no kerbs or safety barriers. It appears from the damage to newly installed guideposts, and from observation on site, that some drivers do use the hard shoulders to 'straighten out' some of the curves, as well as crossing the centrelines, to enable them to travel at higher speeds. This is particularly noticeable with bends located on gradients.

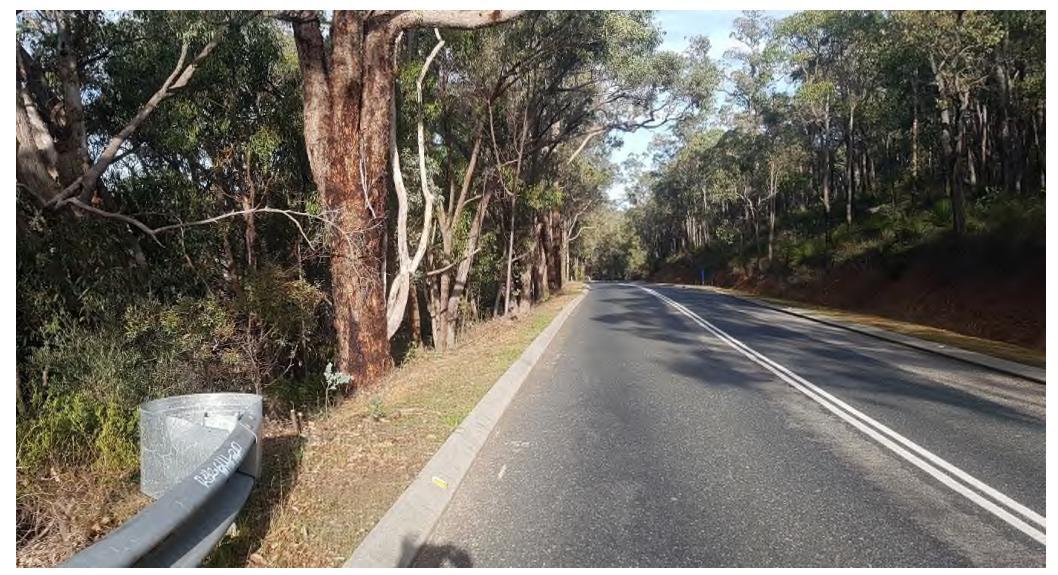
Although the safety barriers do protect errant vehicles from some of the roadside hazards along this section of road, it can be seen in **Photos 94 & 95** that there are many more that remain exposed.

Photo 94: Although the safety barrier ends here, the roadside hazards do not.

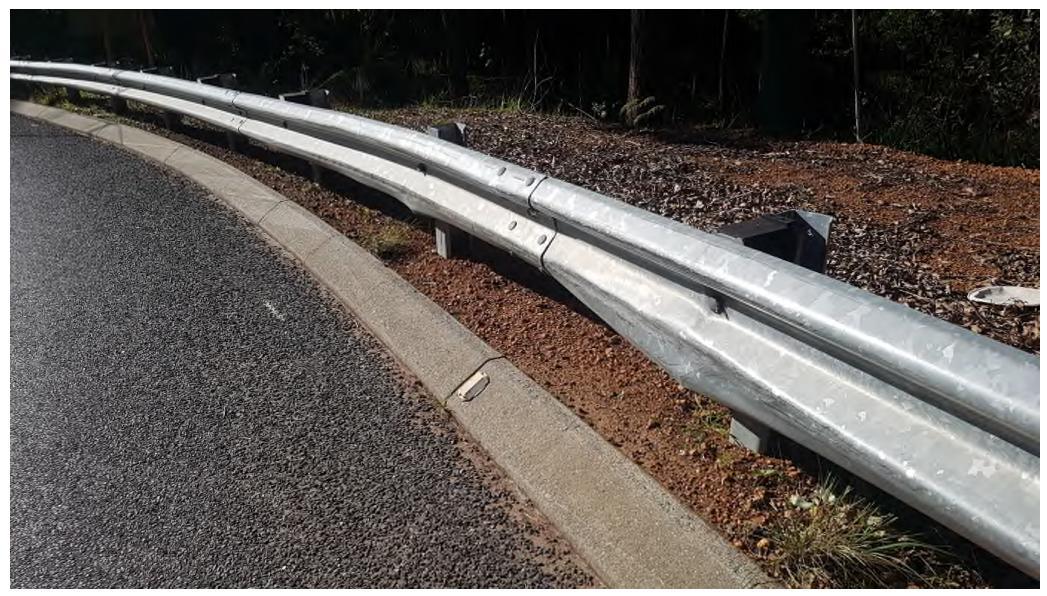
The W-beam safety barriers lining the road through the curves near the southern Aldersyde Road intersection are mounted very close to the kerbs, and have been struck numerous times on both the outside and the inside of the bend. See **Photo 96**.

Photo 96: Damage to the safety fence near Aldersyde Road.

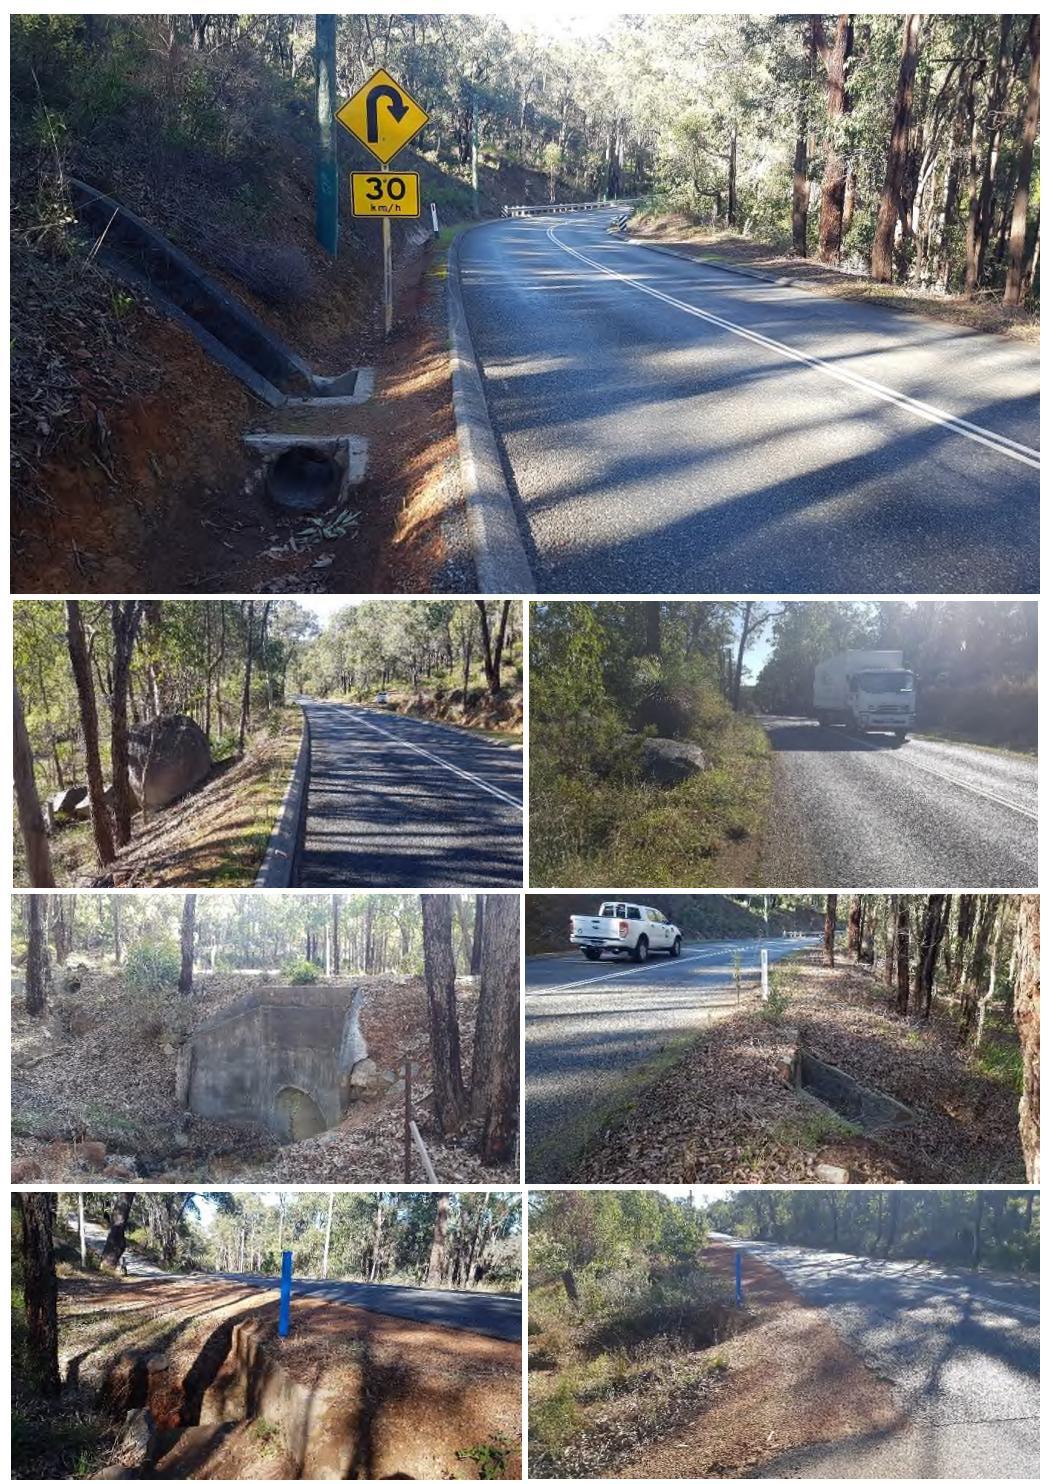
Photo 97 to 97f: Other roadside hazards include head walls, culverts and large rocks.

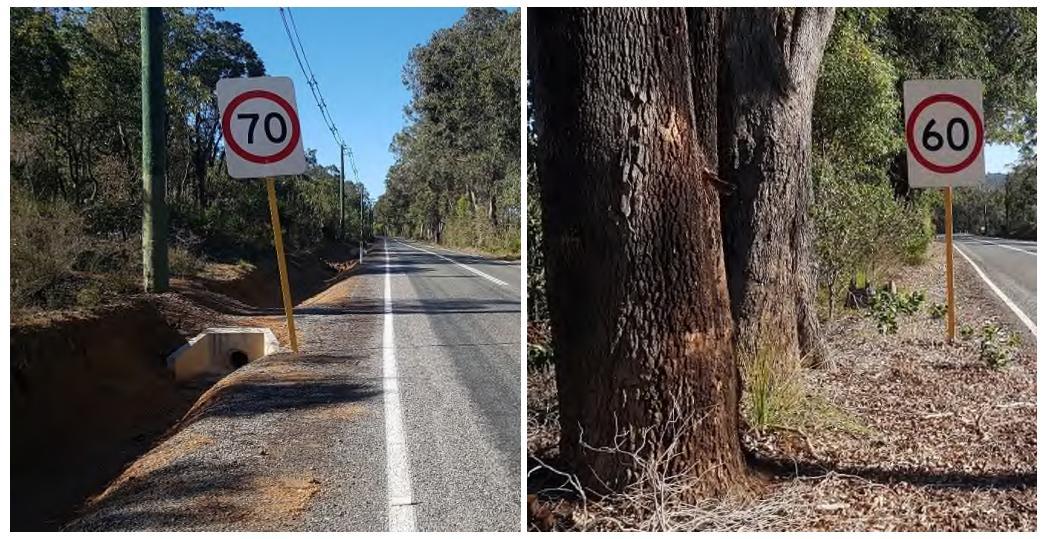
Although this section of road has largely been widened, with edge lines and sealed shoulders installed, there still remain a number of roadside hazards. These include large trees and concrete drainage culverts, especially along the section west of Bahen Road. See **Photos 98 & 98a.**

Photos 98 & 98a: Roadside hazards

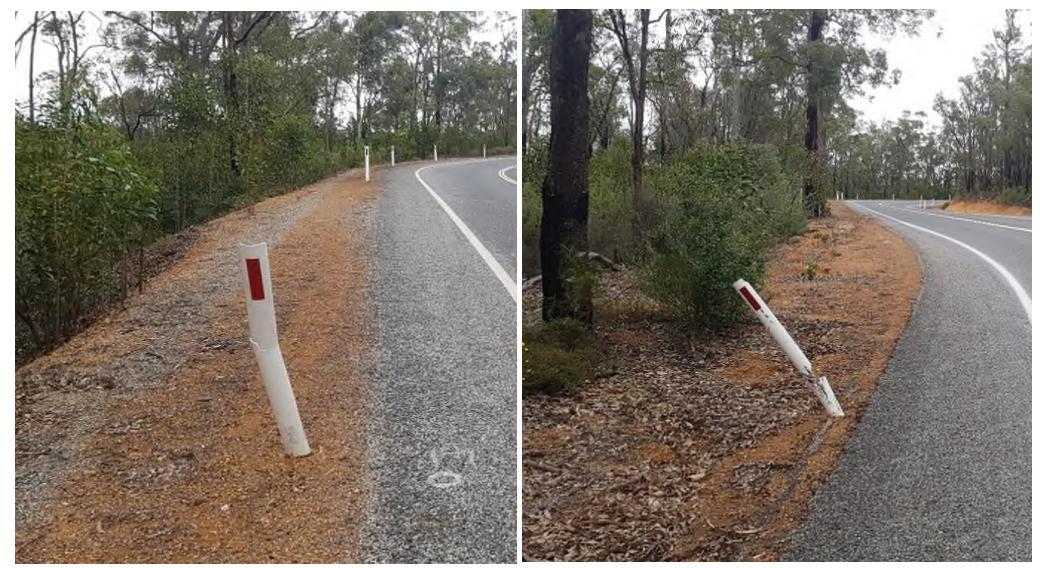
As can be seen in **Photos 99 to 100**, a number of the new guideposts installed along this section are being struck by vehicles. It is not immediately clear why this would occur, but it may be reduced by the installation of audible edge lines.

Photos 99 & 99a: Broken guide posts.

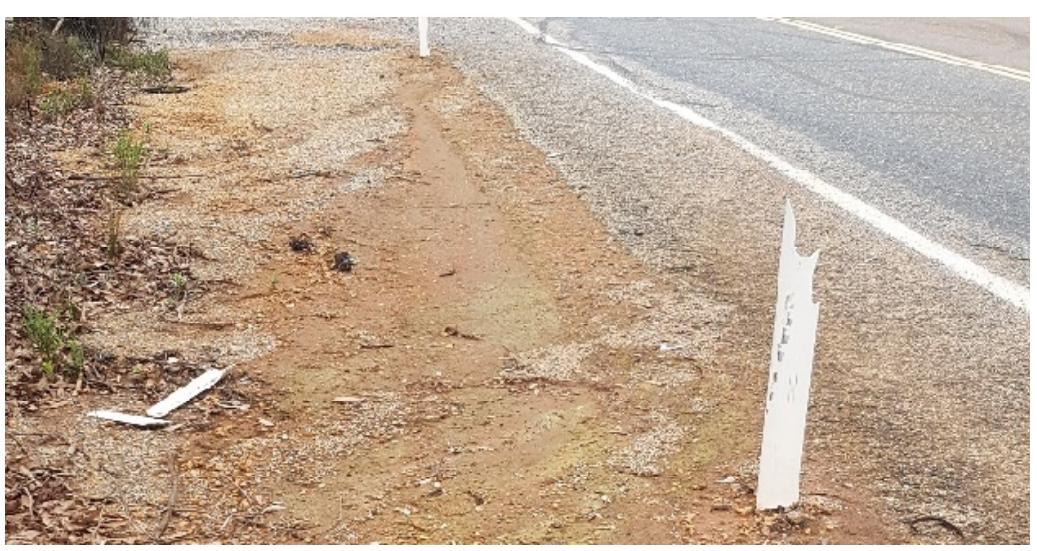
Photo 100: Damaged Guidepost.

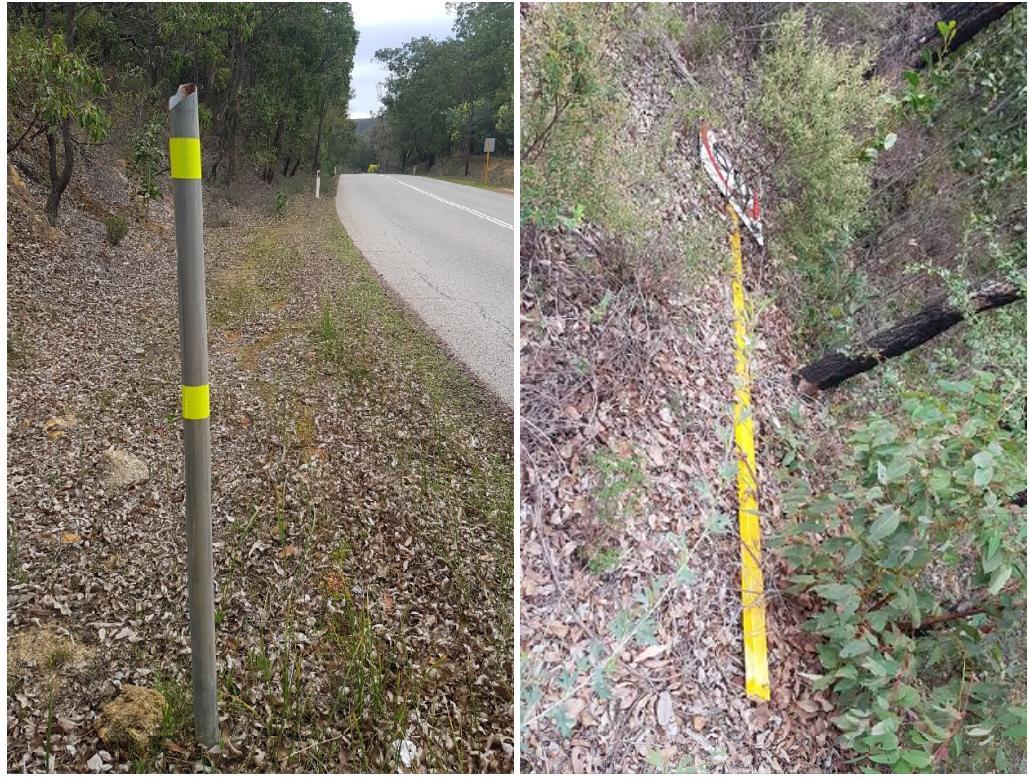
One of the 60 km/h speed signs was seen lying down in the verge. This should be replaced. Another post had been sheared off. See **Photos 101 & 101a**.

Photos 101 & 101a: Broken sign posts.

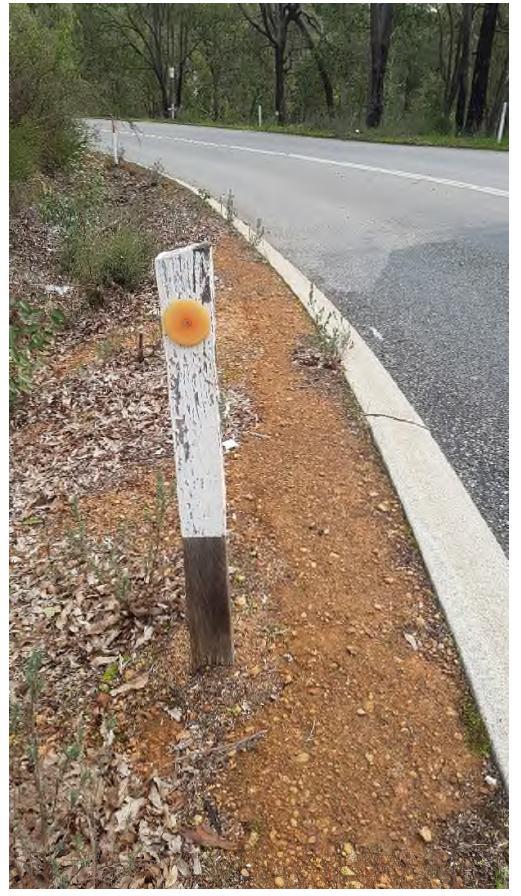
Outside the area recently widened, there are still a number of very old guideposts. See Photo 103.

Photo 102: Old guidepost

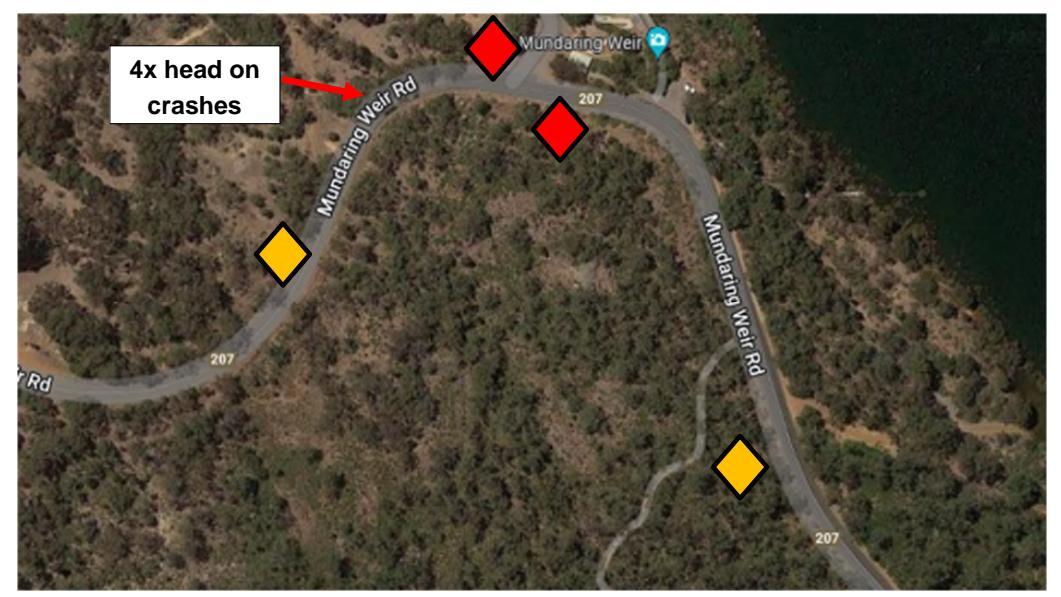
It is noted that advisory speed signs have been installed on the approaches to the outer bends in each direction, but not to the second bends being encountered. See **Figure 4.1** below.

Figure 4.1: Curve warning sign locations, existing (yellow) and recommended (Red).
