## Cambridge Reserve Community Enhancement Project

# Cambridge Reserve Introduction Report

This report outlines the history and key features of the Cambridge Reserve Community Enhancement Project located in the City of Kalamunda (City). This report, prepared by the City addresses the lengthy history, strategic priority, delivery process and preliminary feasibility of transferring a portion of Cambridge Reserve from Local Open Space Reserve to Urban Development and to supplement the findings of the technical appendices.

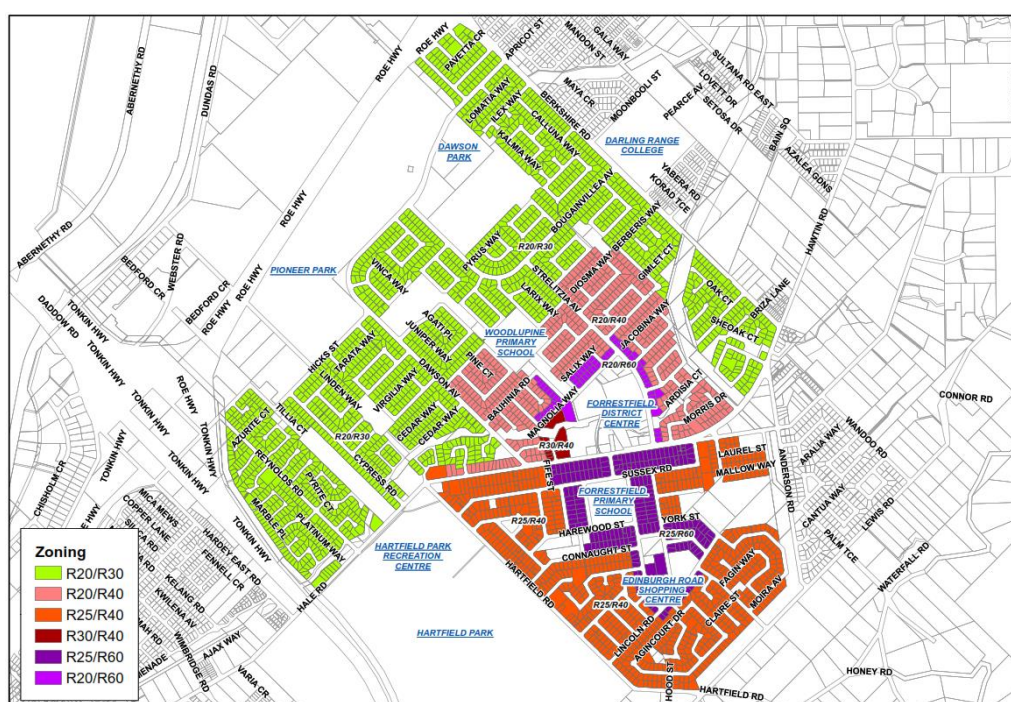
Figure 3. Map showing location of Dual Density zoning

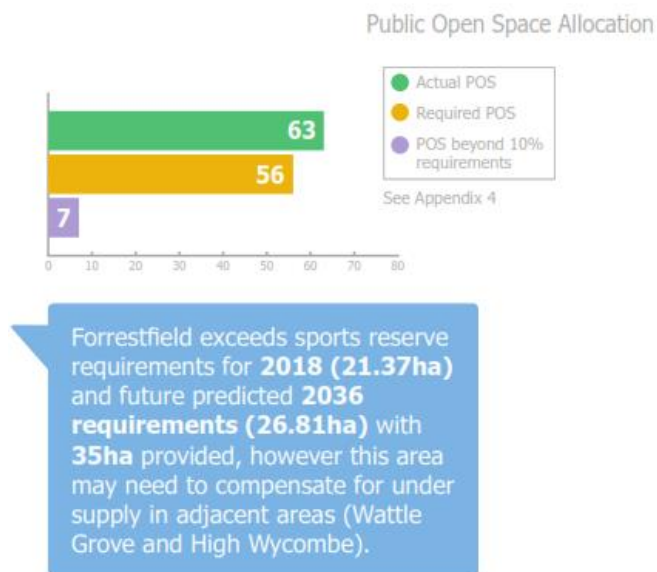
Figure 7: Extract of POS Strategy 2018 showing proportion of POS in Forrestfield.

This was followed by the Public Open Space Strategy in 2018 which noted Forrestfield contains approximately 7ha of POS above the usual 10% benchmark and that most of Forrestfield was located within 400m of POS (refer Fig 7). This indicates that if a portion of Cambridge Reserve was developed then it would not reduce the overall POS allocation to less than 10% in the locality.

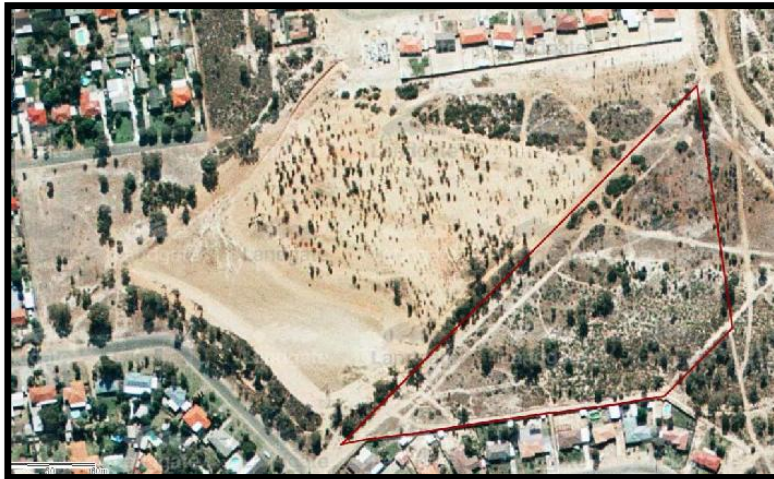
**Plate 3: Aerial Photography from 1983 (Landgate, 2019)**

The 1983 aerial photograph shows planted vegetation on a part of the area previously cleared for the drainage basin. The south-eastern area remains vegetated although in variable condition (Plate 3).

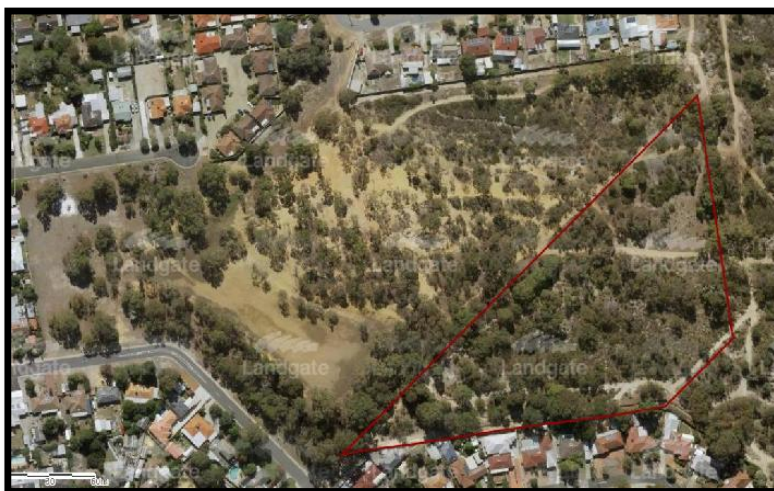
**Plate 4: Aerial Photography from 2019 (Landgate, 2019)**

The 2019 aerial photo shows the current condition of the site. Vegetation, both the remnant and planted areas have regrown substantially since the 1983 photograph (Plate 4).

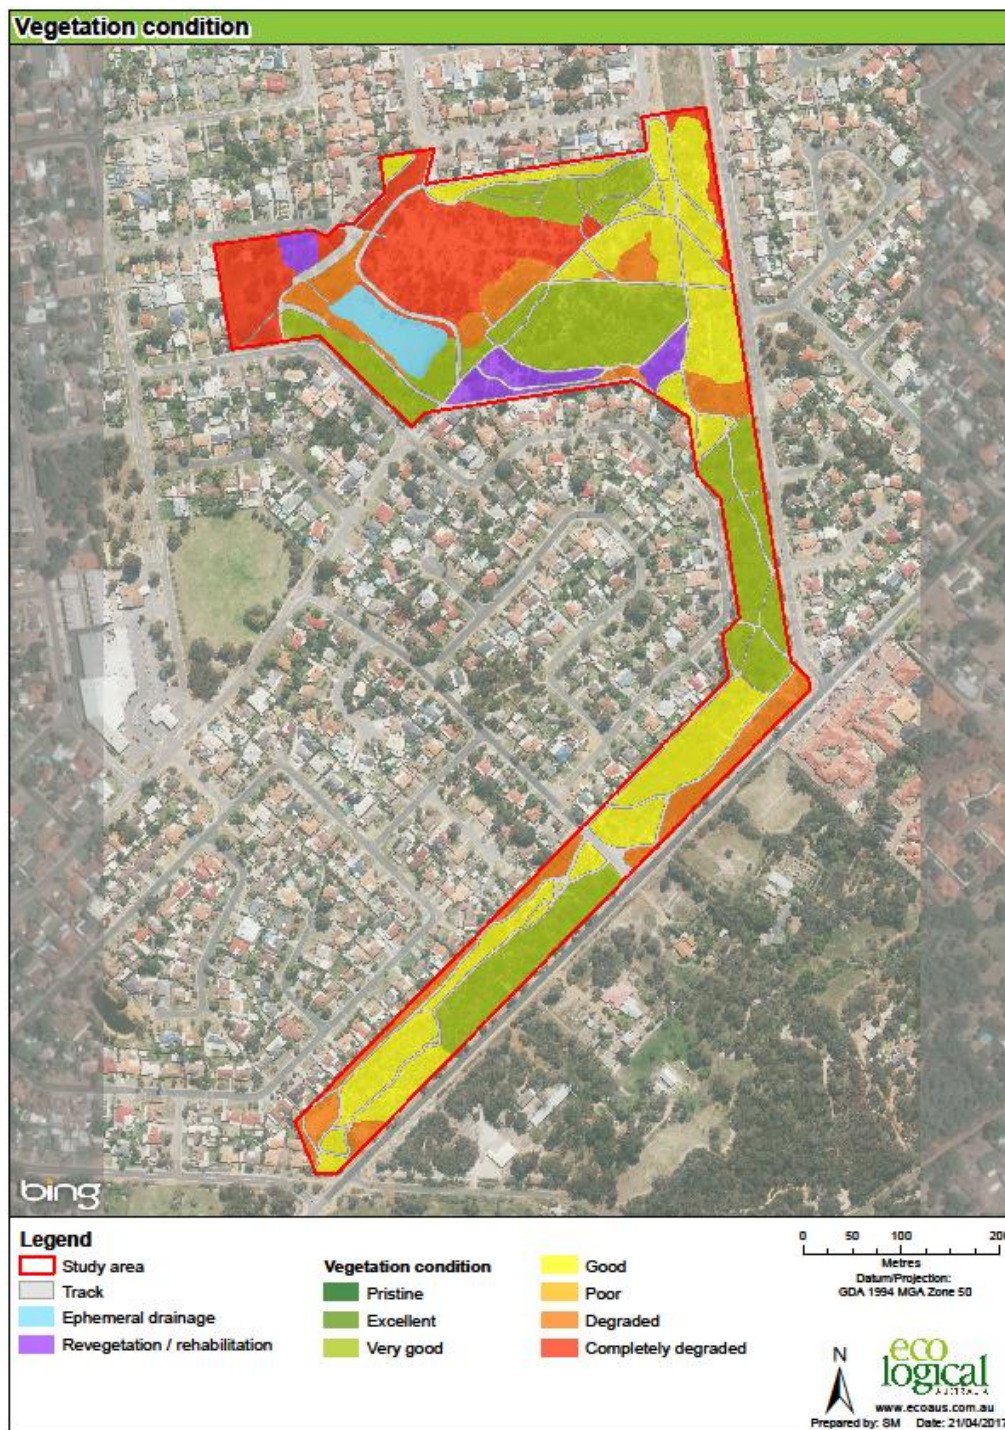
Figure 9: Vegetation condition within the study area

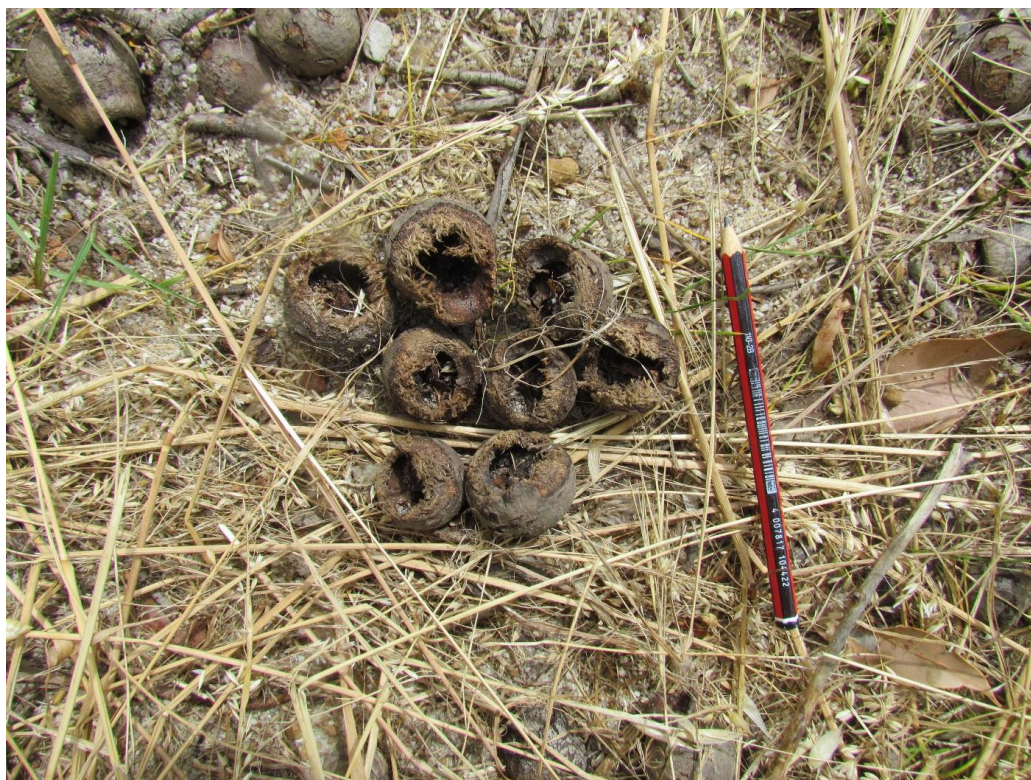
**Figure 10: Marri nuts chewed by Forest Red-tailed Black Cockatoos in the study area**

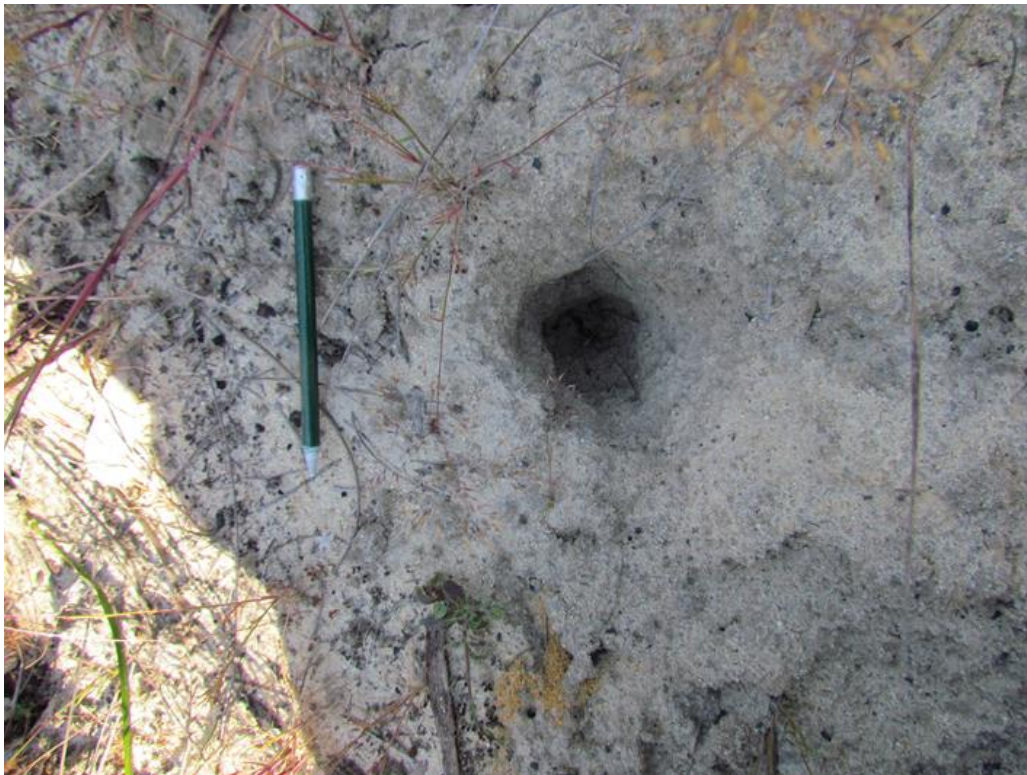
**Figure 11: Example of Quenda digging observed in the study area**

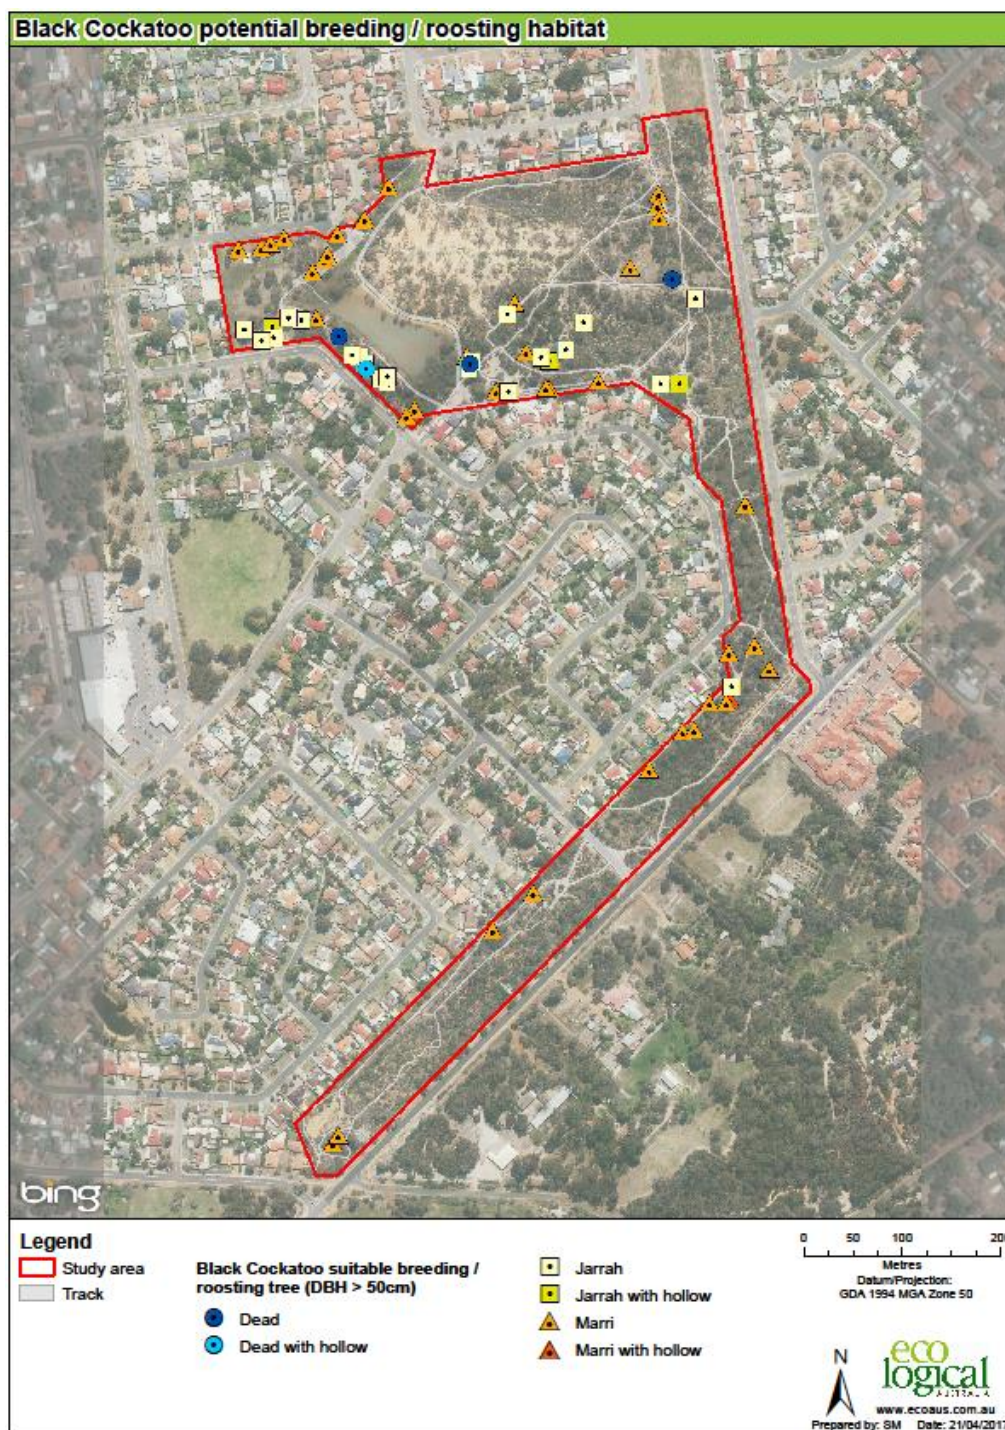
Figure 12: Black cockatoo potential breeding / night roosting habitat

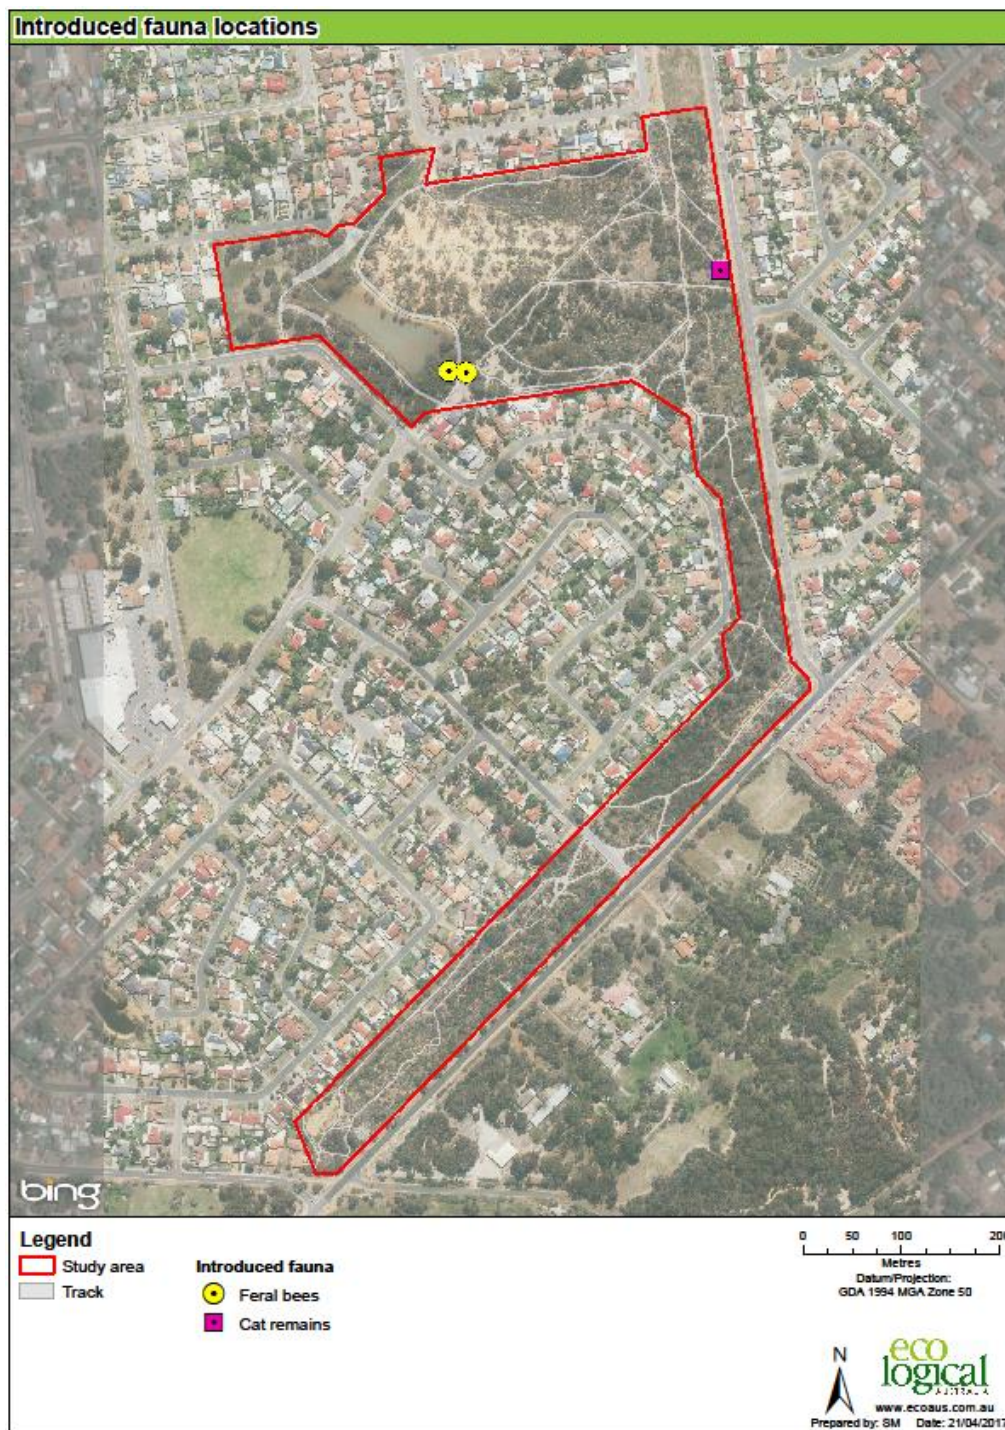
Figure 14: Introduced fauna recorded during the survey

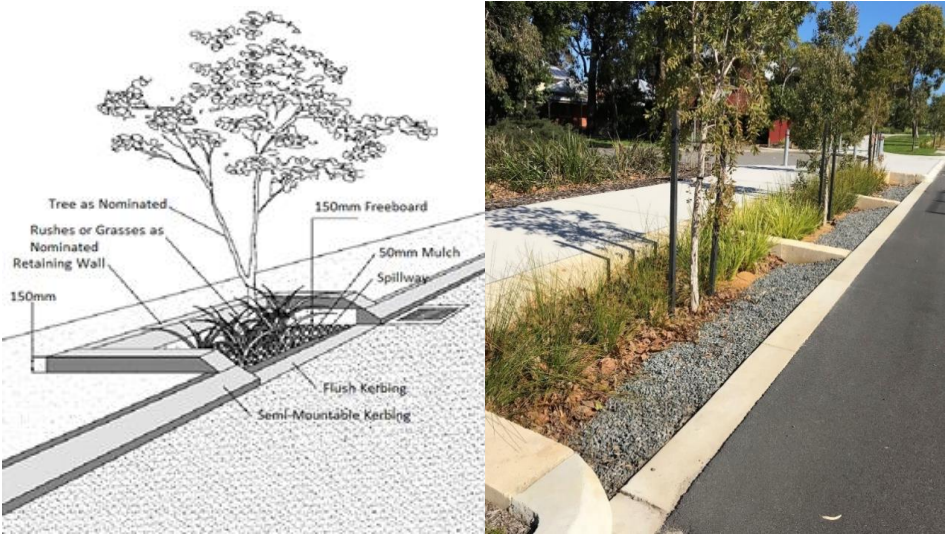
Figure 12: Typical roadside tree pit or raingarden

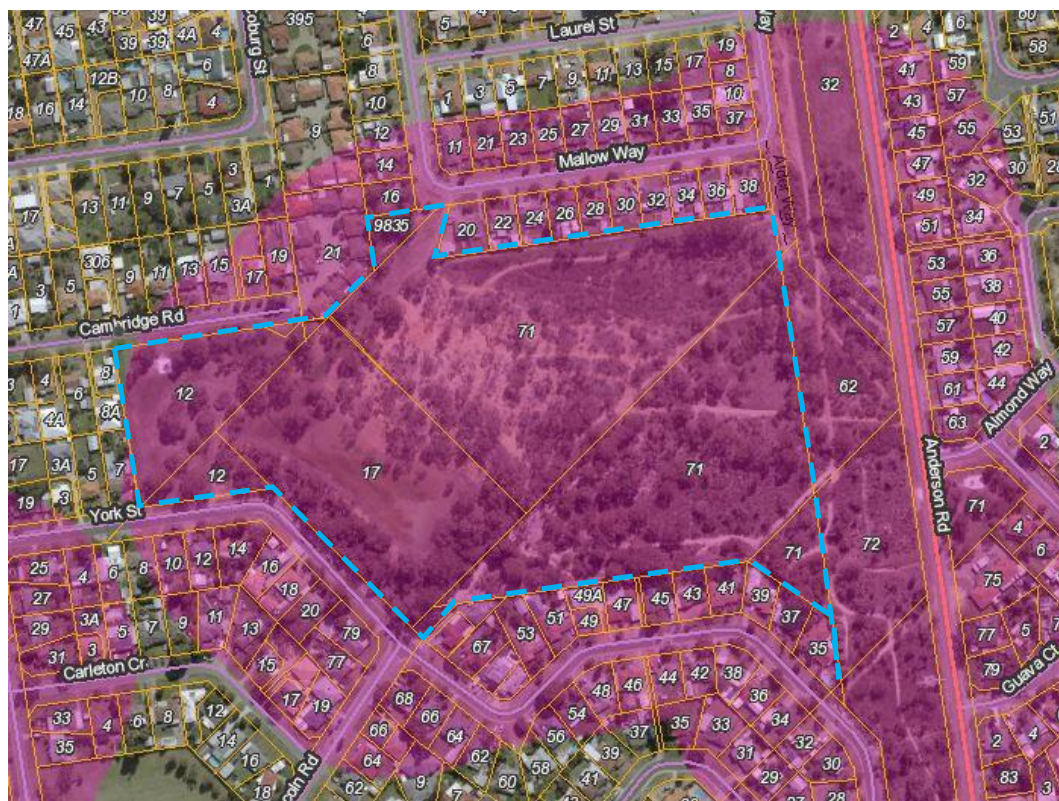
**Figure 3.** Aerial photo of the bushfire prone area for the subject site.

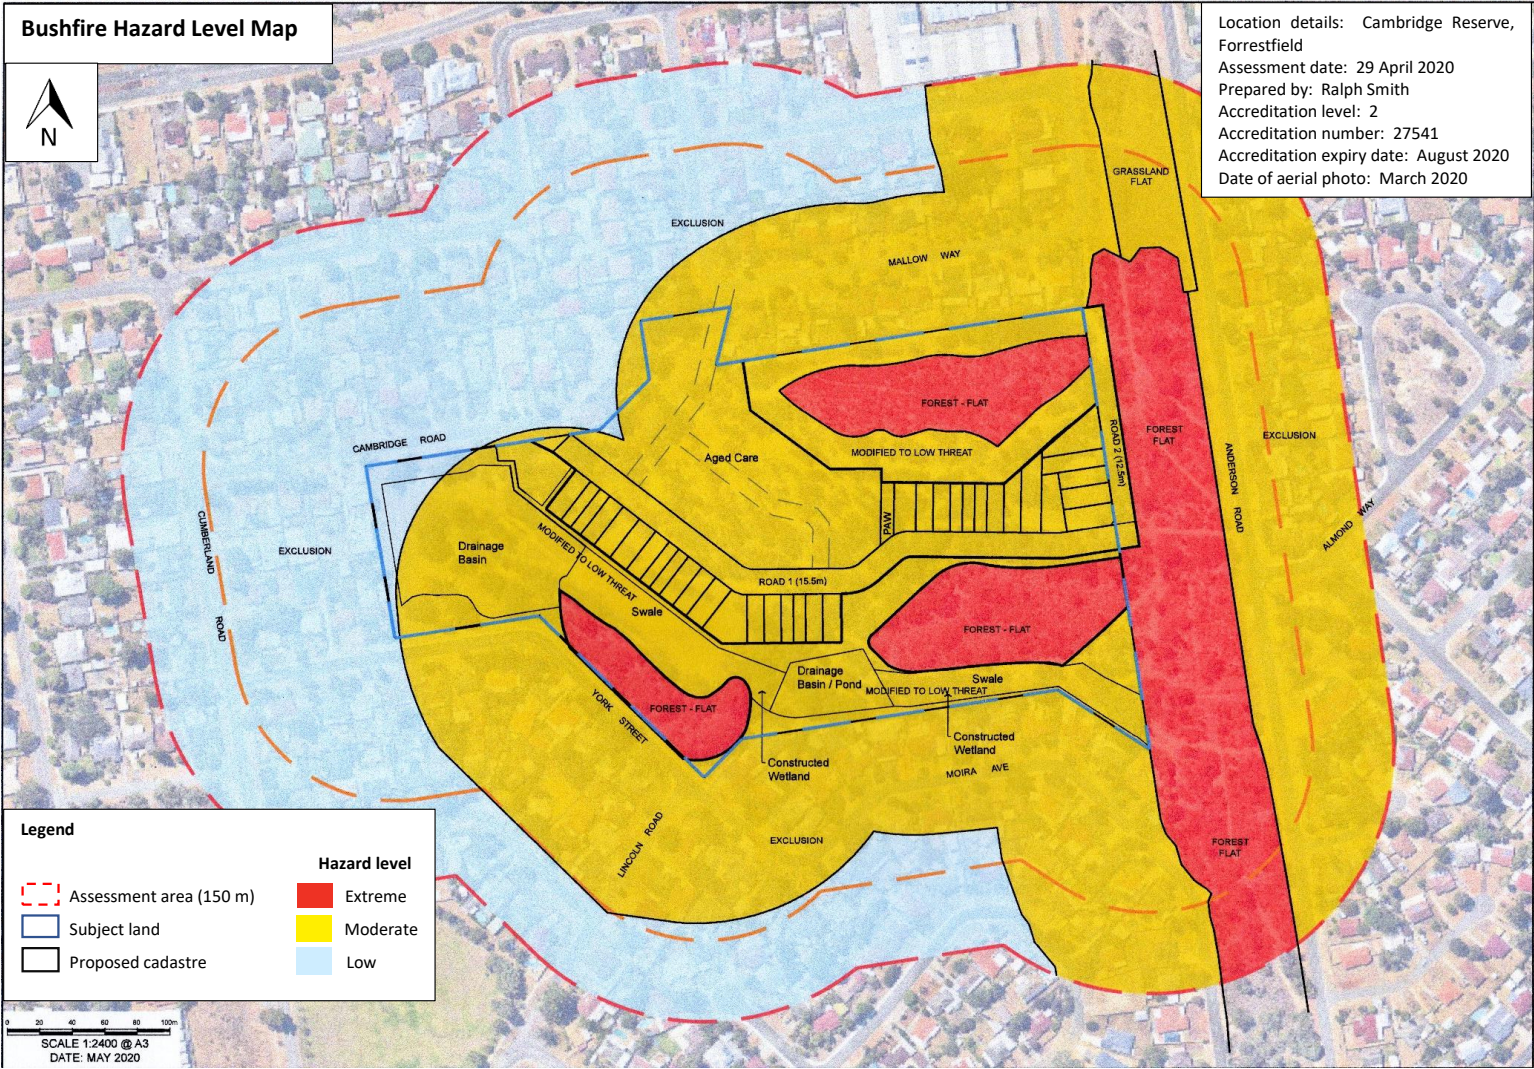
Figure 6. Bushfire hazard level map for Option 1.

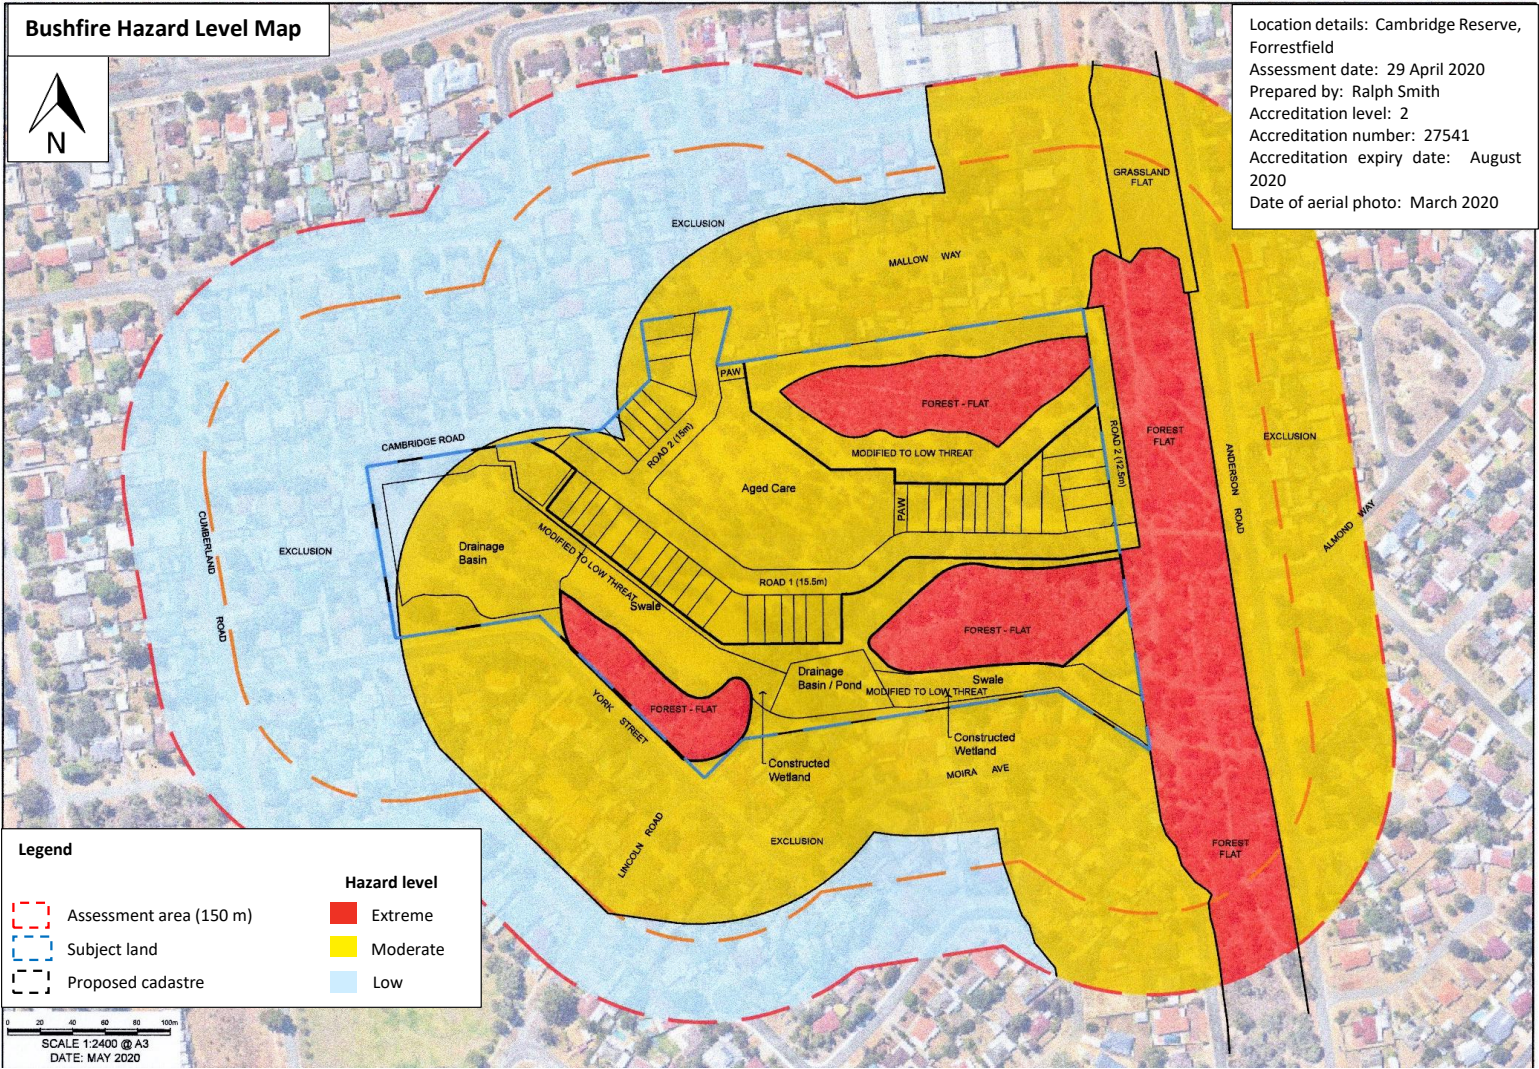
Figure 7. Bushfire hazard level map for Option 2.

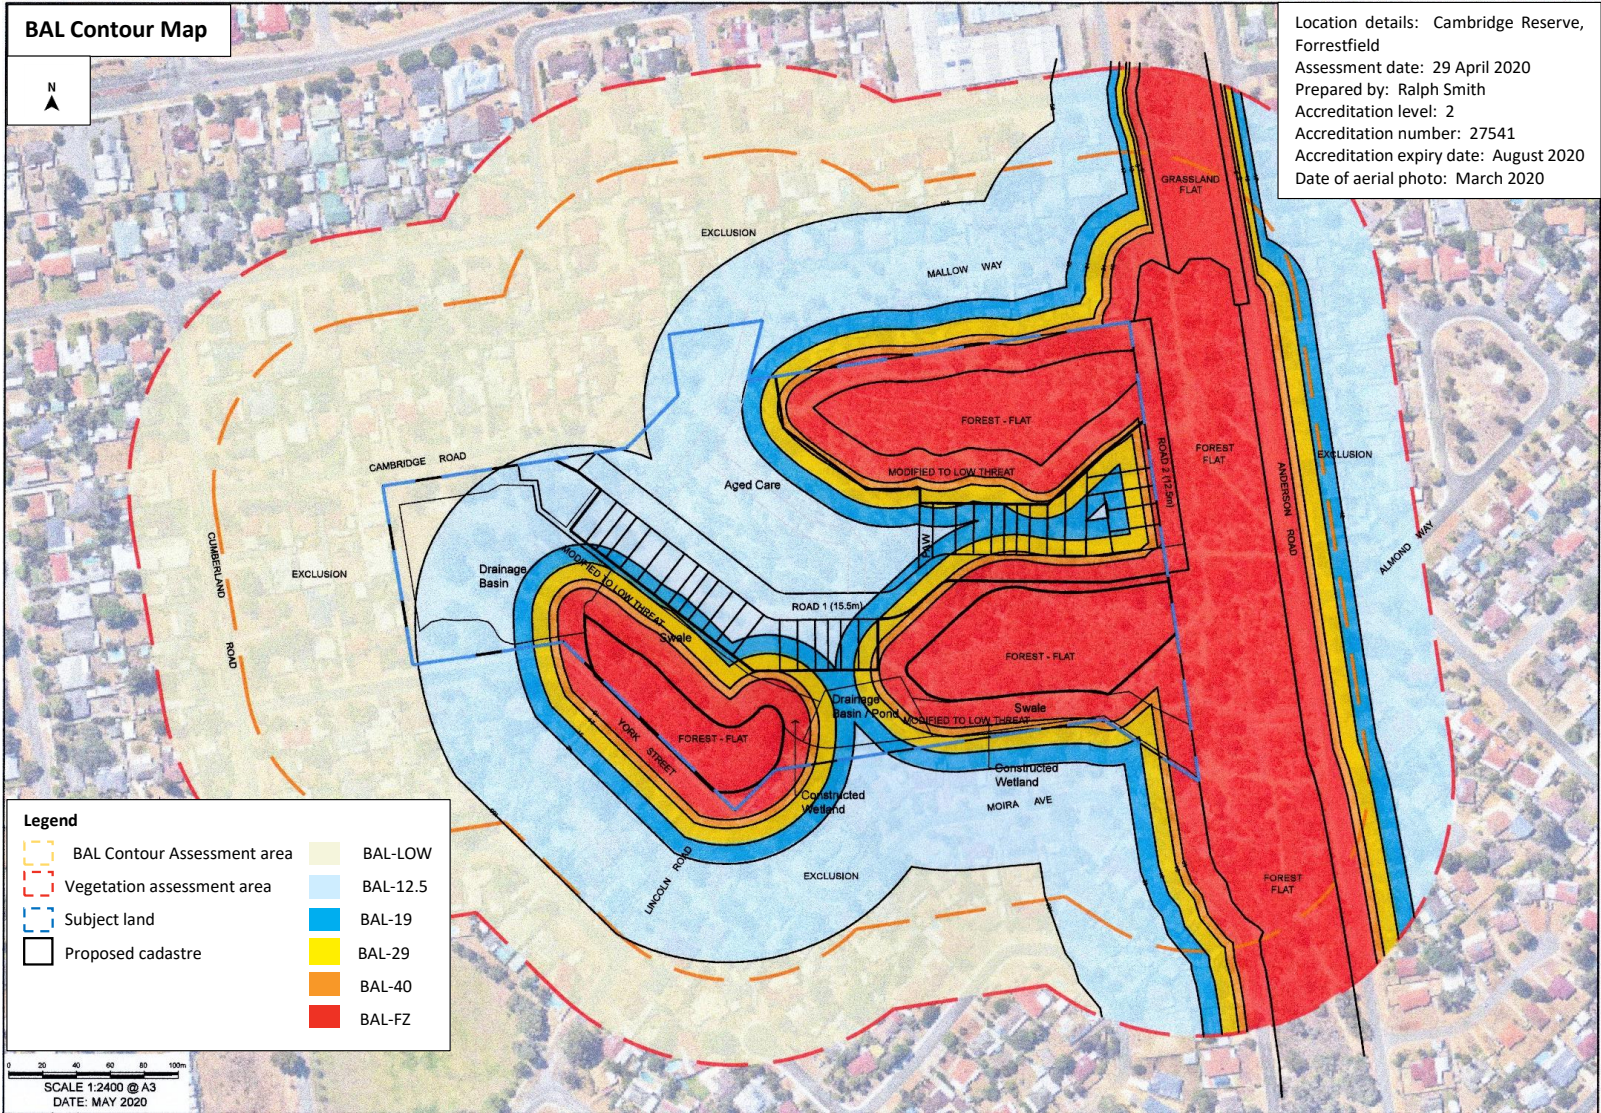
Figure 8. BAL contour map (Option 1).
