September 2020

Canning Road Safety Investigation

Prepared For: City of Kalamunda

Final Report

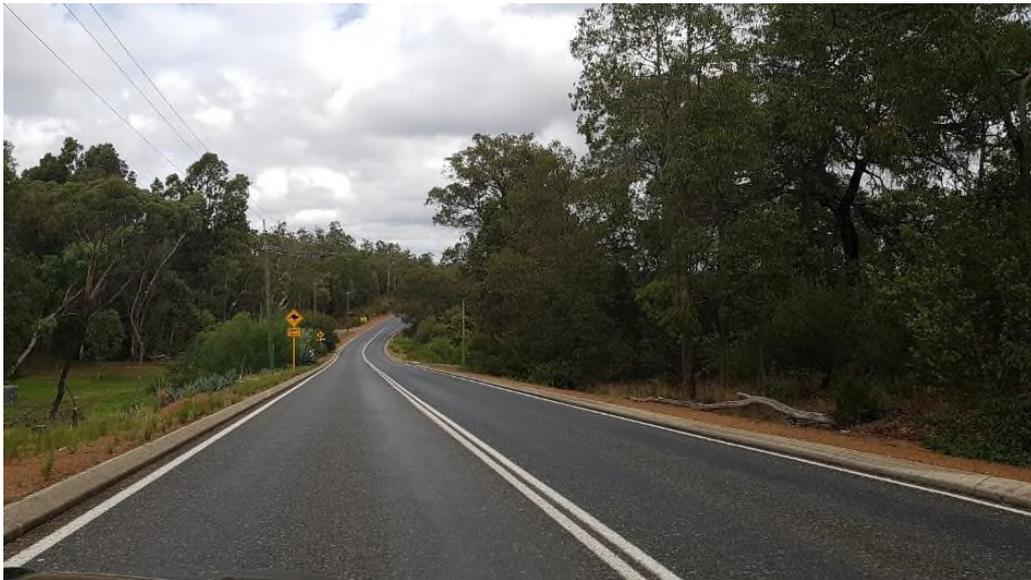
Whilst there are a number of significant horizontal curves along this section, these have been assessed as being acceptable in terms of their maximum desirable operating speeds being higher than the relevant posted speed limit. Thus, drivers should be able to negotiate the curves safely if complying with the speed limit.

Photo 2: Typical combined horizontal and vertical curves within this section of Canning Road.

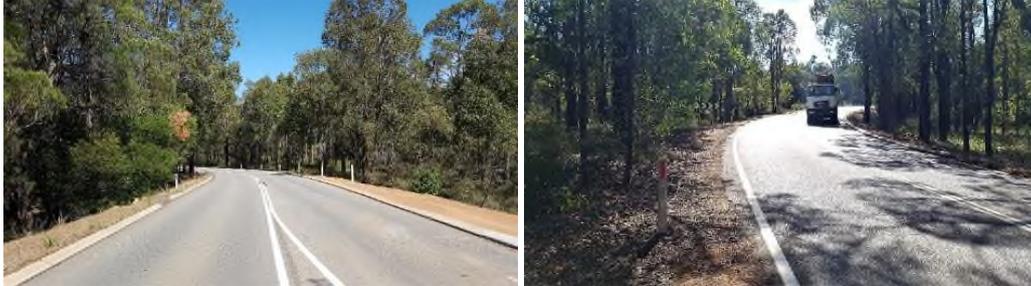
Photos 3 & 3a: The bend south of Pickering Brook Road is too sharp for the posted 70 km/h speed limit

Photo 3a shows that there is a hazard board only on the south approach of the bend. As the curve appears to be substandard, the curve should be delineated by (yellow) chevron alignment markers at regular intervals along the length of the curve as per AS1742.2. These should be installed on both approaches to the curve.

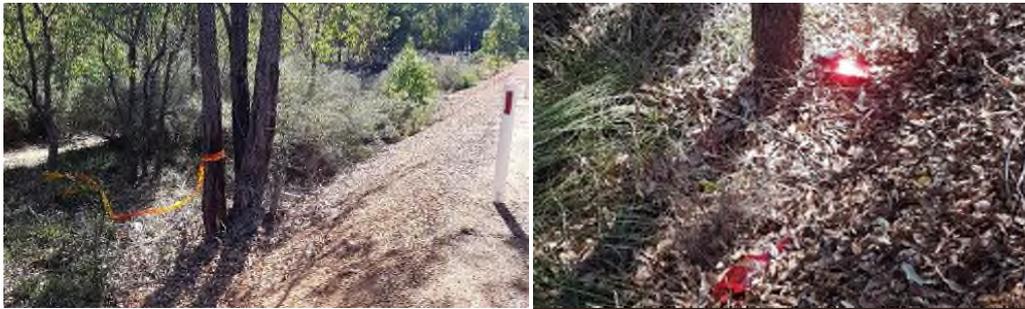
This may have been a contributing factor in a number of crashes as evidenced by roadside debris. See **Photos 4 & 4a**.

Photos 4 & 4a: Evidence of a recent run-off road crash.

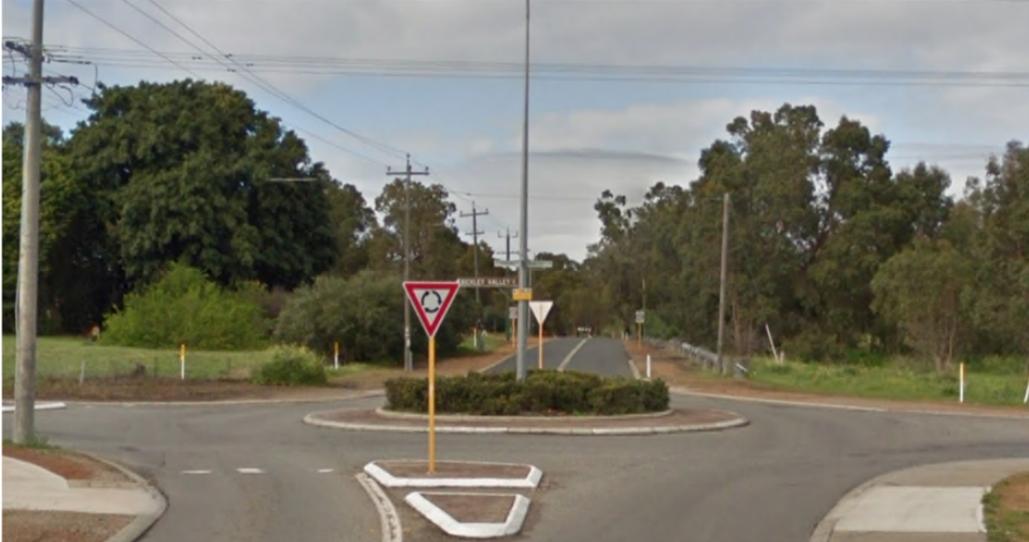
Photo 5: Roundabout at the intersection of Pomeroy Road and Canning Road. Source: Google Streetview.

The intersection with Pomeroy Road takes the form of a single lane roundabout. Whilst quite tight for larger vehicles, it has good visibility. See **Photo 5**.

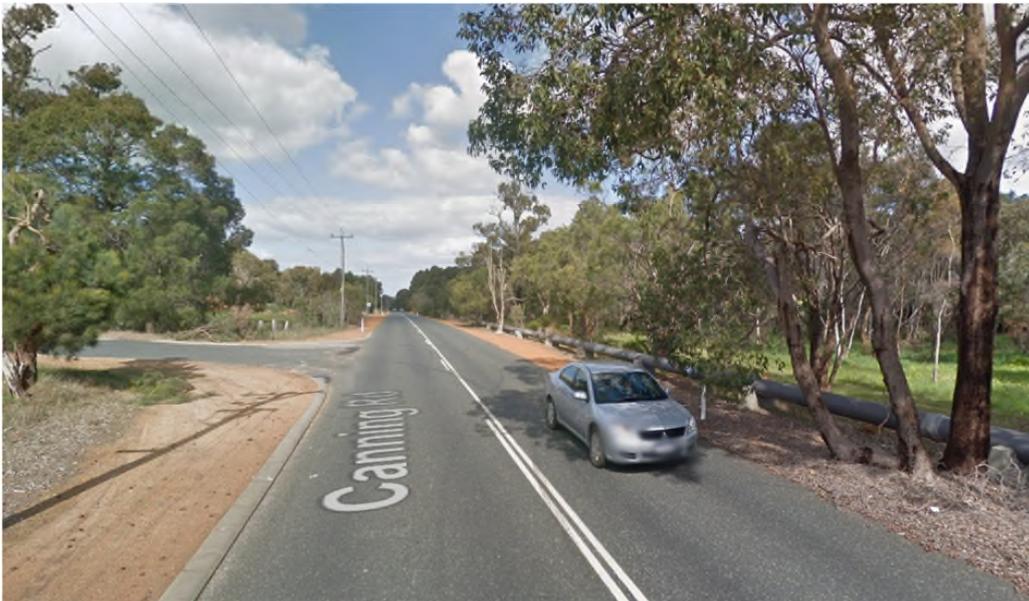
The T- intersection with Annetts Road is Give Way controlled and has good visibility in both directions along Canning Road. See **Photo 6**.

Photo 6: T-intersection of Annetts Road with Canning Road. Source: Google Streetview.

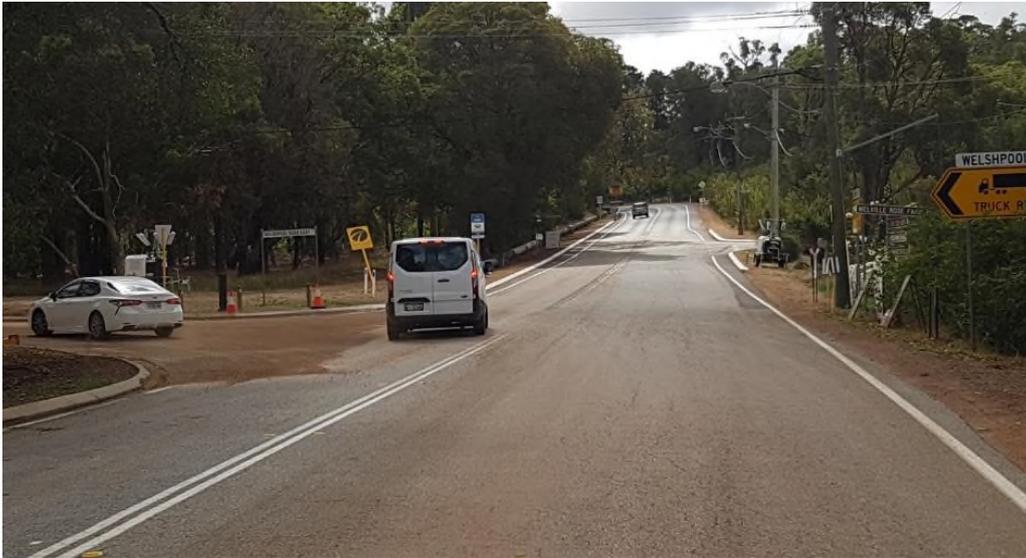
Photo 7: Staggered T-intersection with Carmel Road and Welshpool Road East.

The stagger is technically incorrectly arranged, as movements between the two side road requires a left turn followed by a right turn, which is more likely to result in rear end crashes. A right turn followed by a left is considered to be the safer option. However, the two T-intersections are over 65m apart, giving following drivers some time to react. See **Photo 7**.

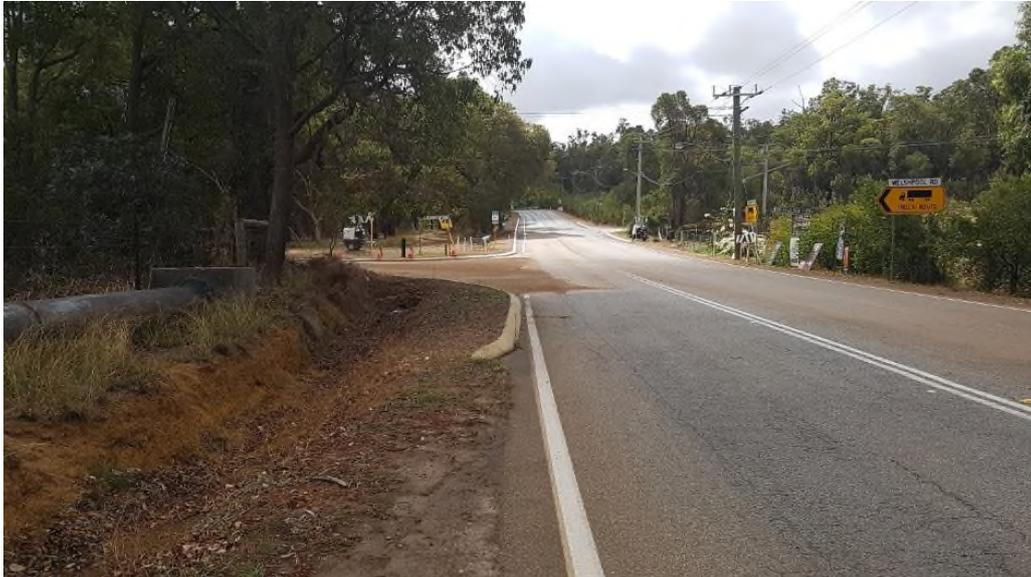
Improvements and/or resurfacing are currently under way at the Welshpool Road East intersection, which forms part of MRWA's RAV4 network. RAV vehicles are permitted to turn left into and right out of the side road. Visibility appears to be adequate. See **Photo 8**.

Photo 8: Ongoing works at the Welshpool Road East intersection.

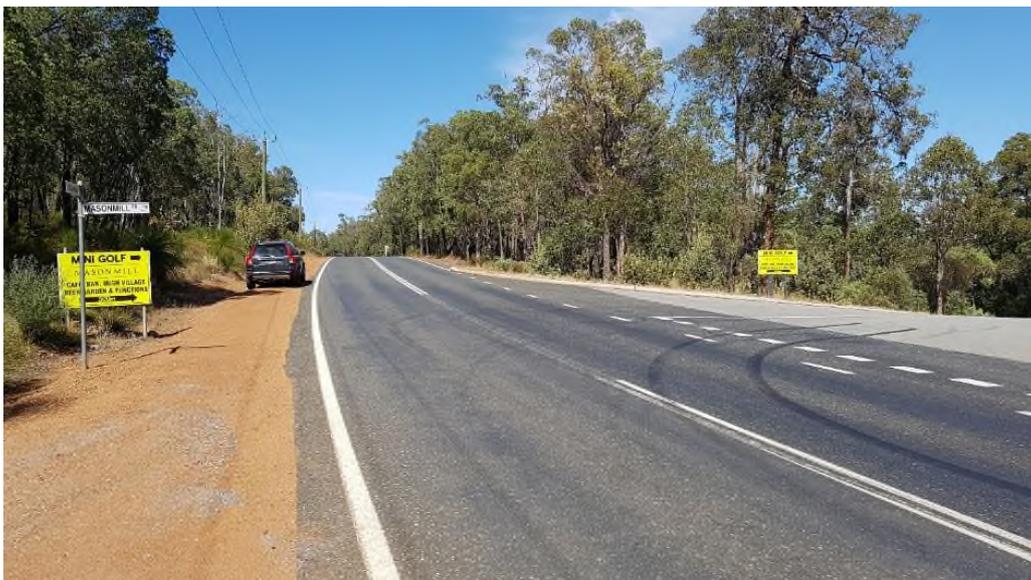
Each of these two connections has poor visibility in either direction from the side road, due to the horizontal and vertical alignments of Canning Road. This is exacerbated by the extensive roadside vegetation.

Photo 9: Northern of the two Masonmill Road intersections.

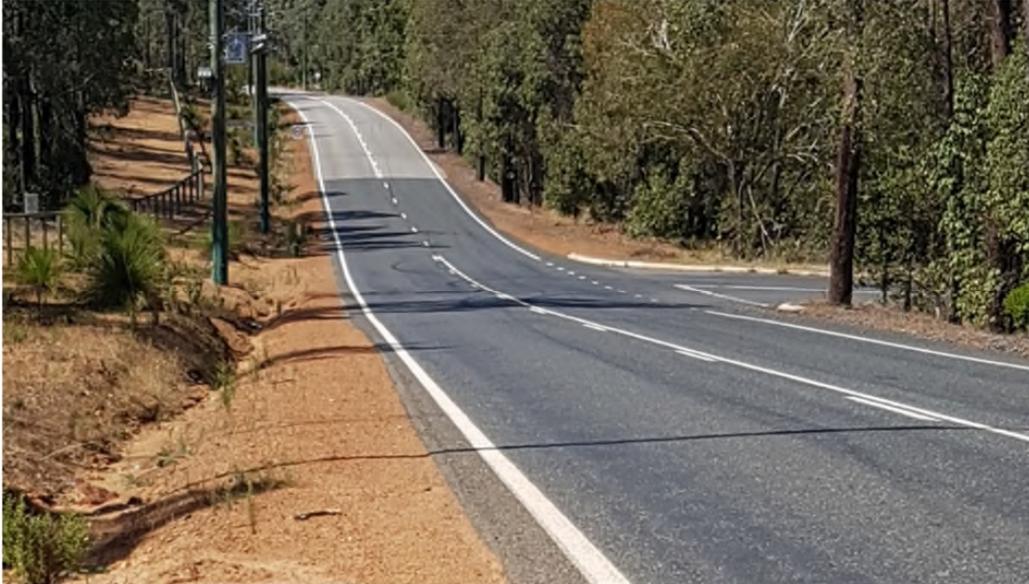
Photo 10: Southern of the two Masonmill Road intersections.

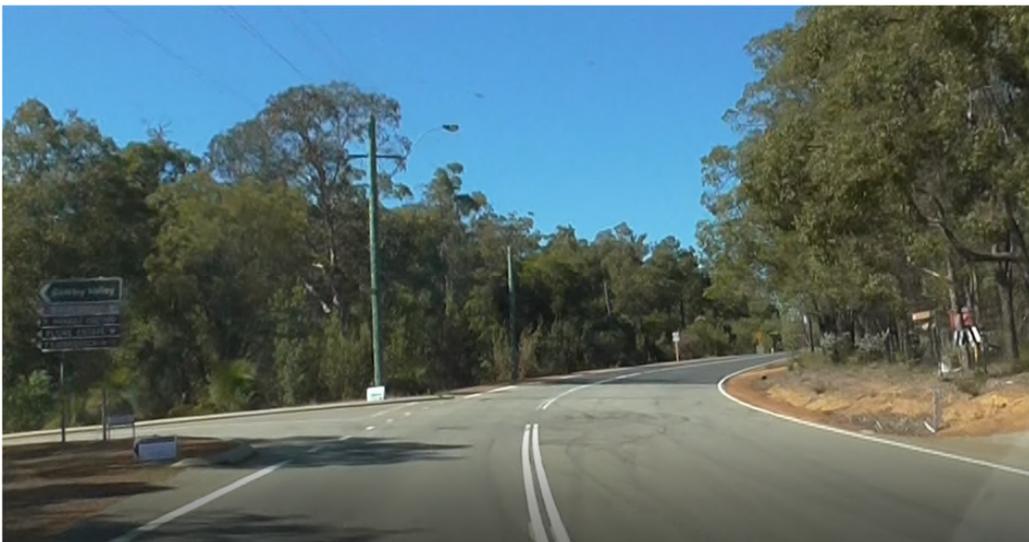
Glen Isla Road forms a T-intersection with Canning Road, located on the outside of a sweeping bend. This gives drivers on the side road approach good visibility. However, visibility for drivers on Canning Road turning right into the side road is limited.

Widening has been provided to allow through vehicles to pass to the left of these turning vehicles. There is evidence of significant hoon behaviour at this intersection. See **Photos 11 & 12**.

Photo 11: Glen Isla Road intersection.

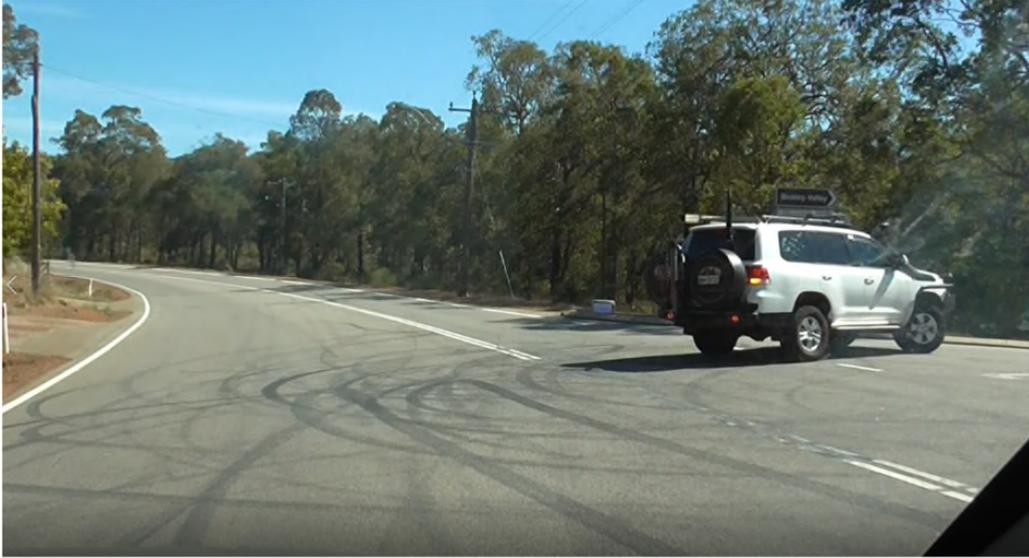
Photo 12: Sight distance is limited for right turning vehicles.

A desktop analysis reveals sightlines of 120m to the west for those undertaking the right turn, which corresponds to a SISD design speed of 60km/h (123m).

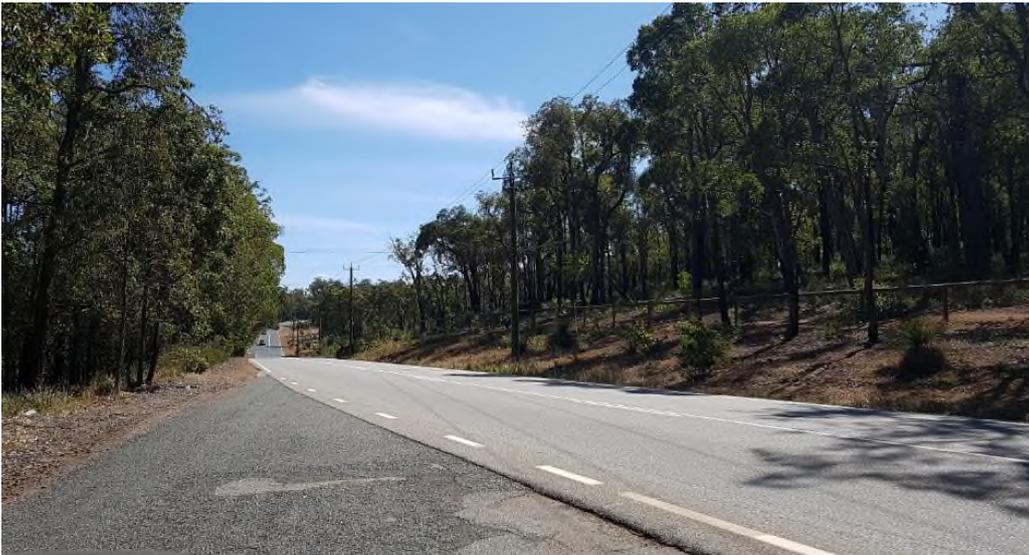
There are however two existing connections to an unnamed service road. This gives access to businesses and properties to the south of Canning Road, including A. Giumelli & Sons. There are a number of safety issues associated with these connections. See **Photos 13 & 14**. See also paragraph 3.4.2.

Photo 13: Northern end of unnamed service road.

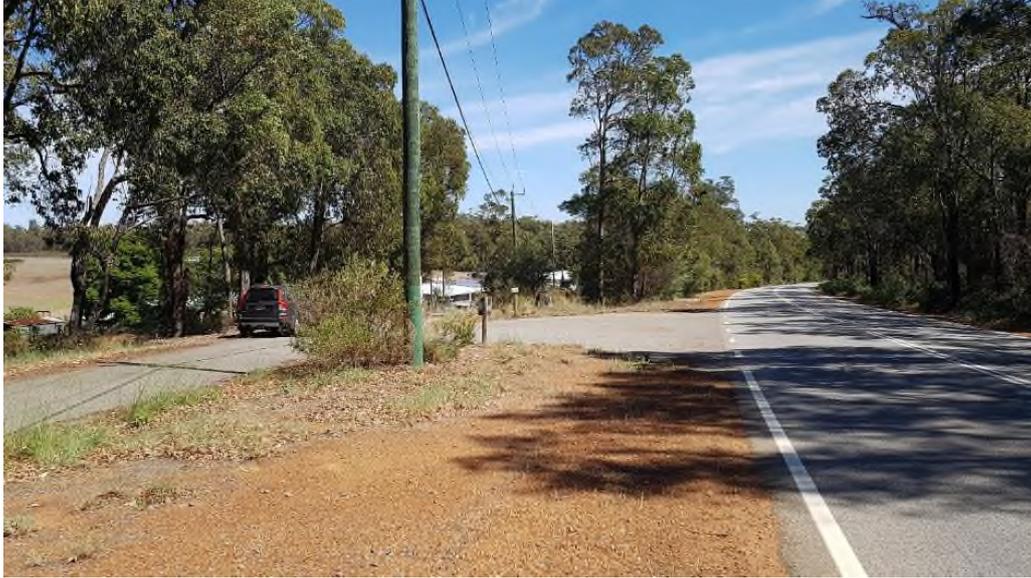
Photo 14: Southern end of unnamed service road.

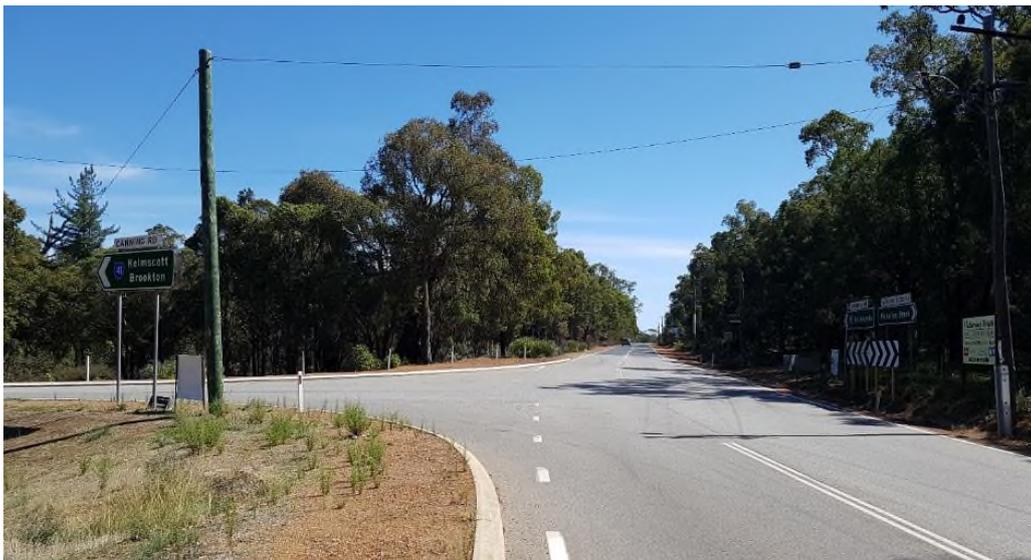
Photo 15: The intersection of Canning Road with Pickering Brook Road is a T-intersection.

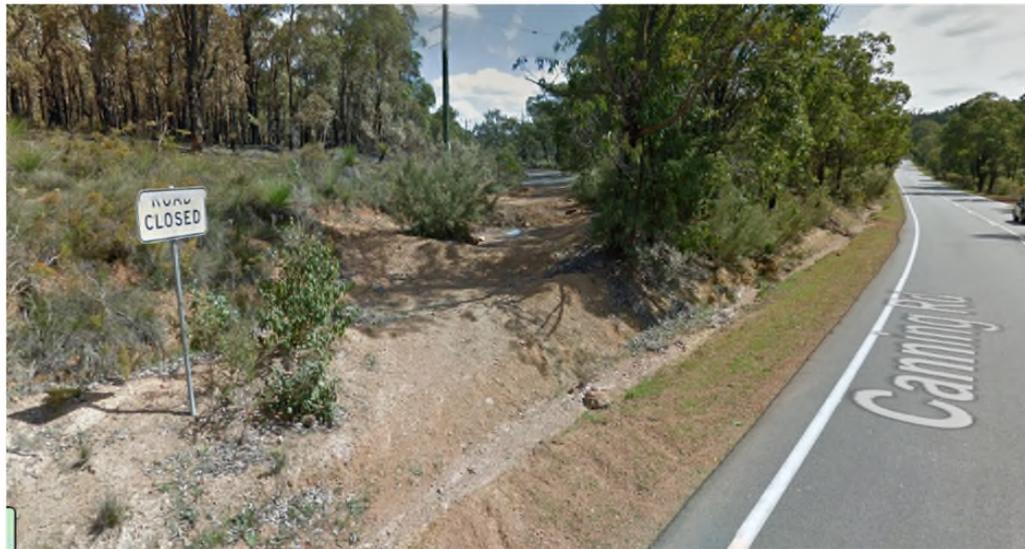
Photo 17: No connection to Douglas Road at its southern end. Source: Google Streetview.

Google Maps shows additional connections to Douglas Road, but this link is blocked off with a bund and a 'Road Closed' sign at the southern end, and is restricted by a locked barrier at the other end (refer **Photo 17 and 18**).

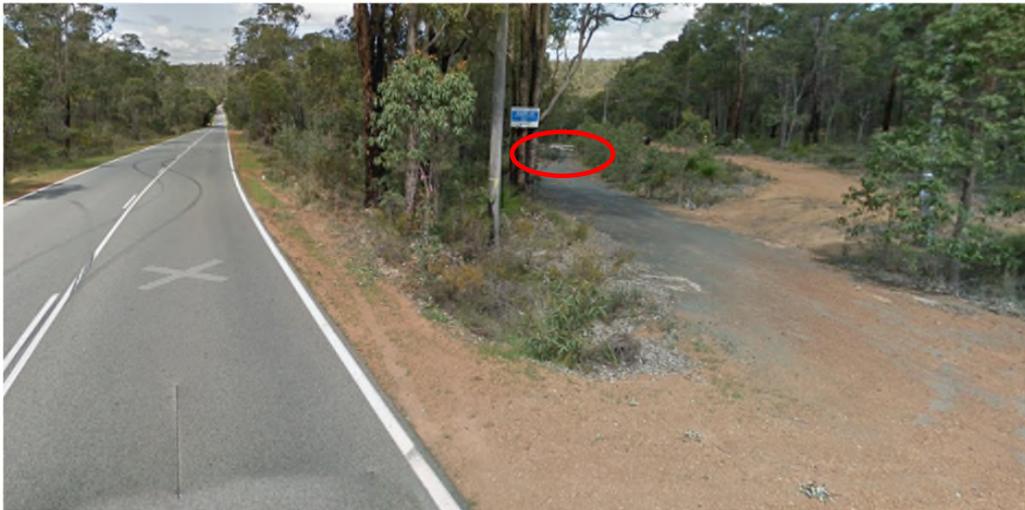
Photo 18: Douglas Road access at its northern end, but a barrier obstructs passage. *Source: Google Streetview*

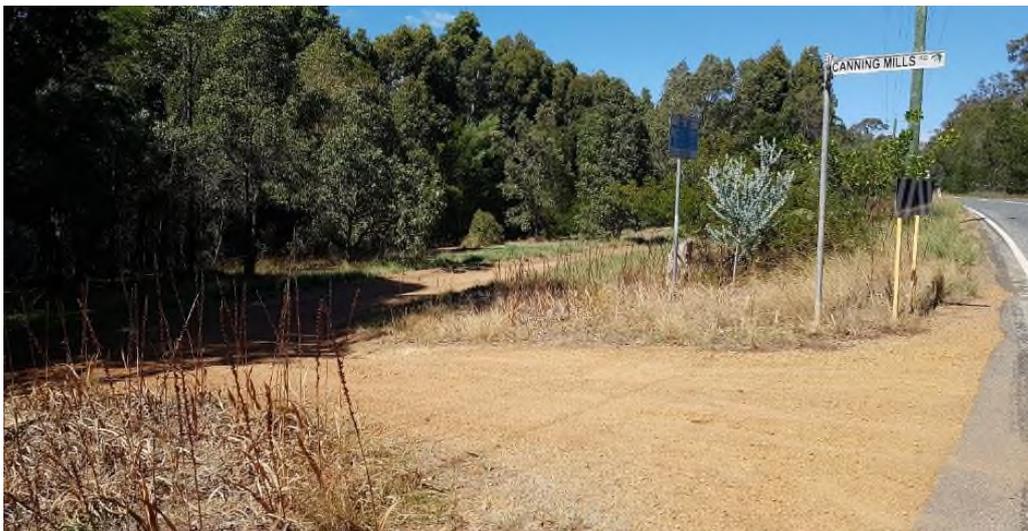
The Canning Mills Road intersection is signed as a T-intersection, but has an additional, unsealed fourth leg. Visibility from this fourth leg is very poor. There is also a short, non-standard road safety barrier on the Canning Mills Road side, with non-crashworthy end treatments. This appears to have been struck more than once. See **Photos 19 - 21**.

Photo 19: The Canning Mills Road intersection has an unsealed fourth leg.

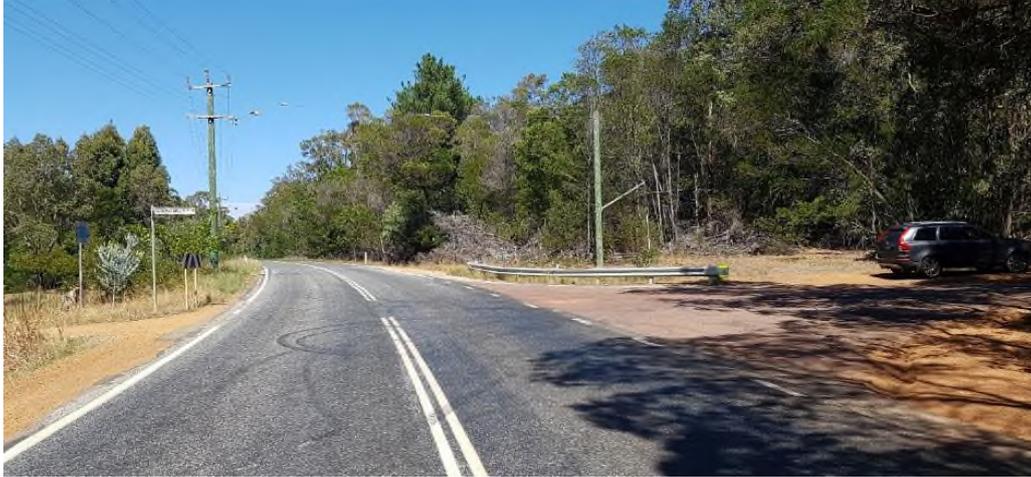
Photo 20: Visibility to the south is restricted.

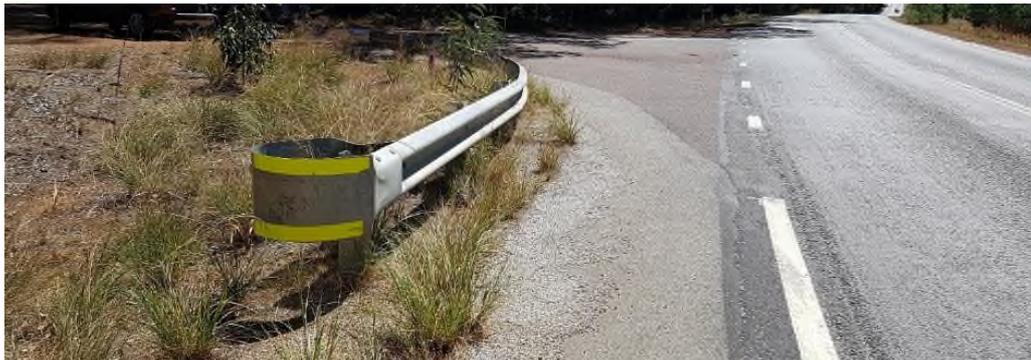
Photo 21: Non-crashworthy end treatment.

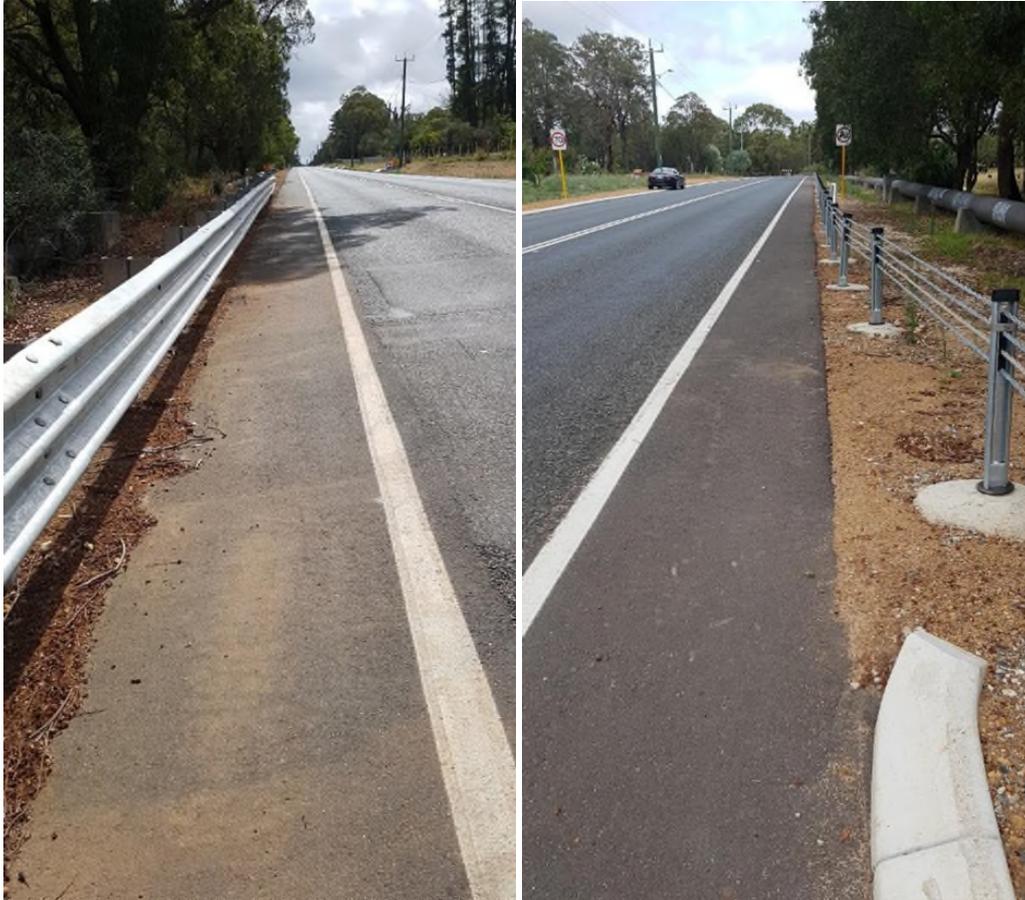
Photos 22 & 22a: Sealed shoulders are of sufficient width for cyclists to use, but are not to cycle lane standard.

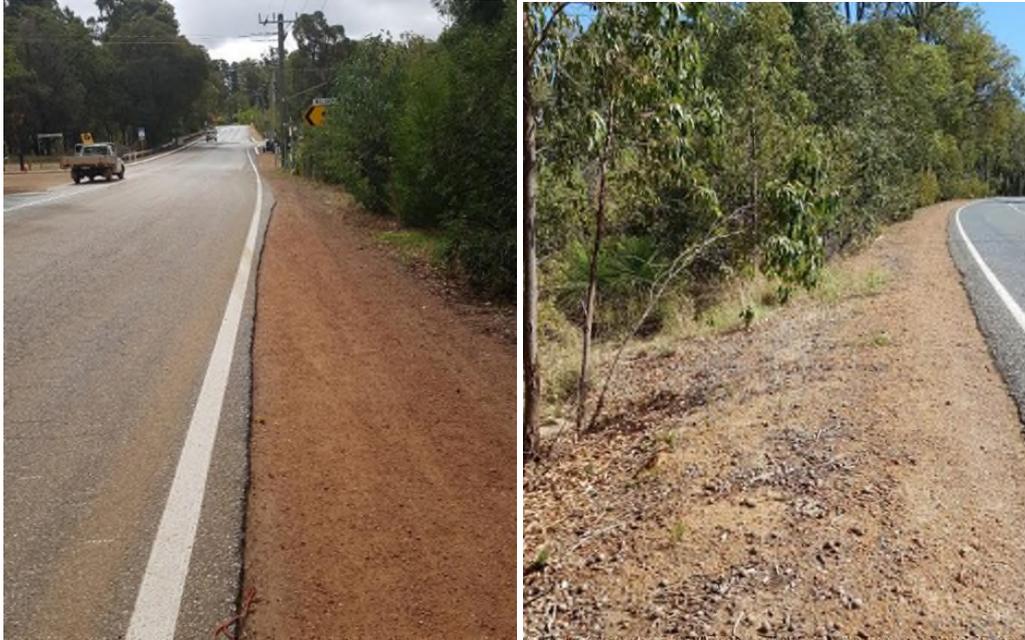
Photo 23 & 23a: The sealed shoulders along this section of Canning Road are almost negligible.

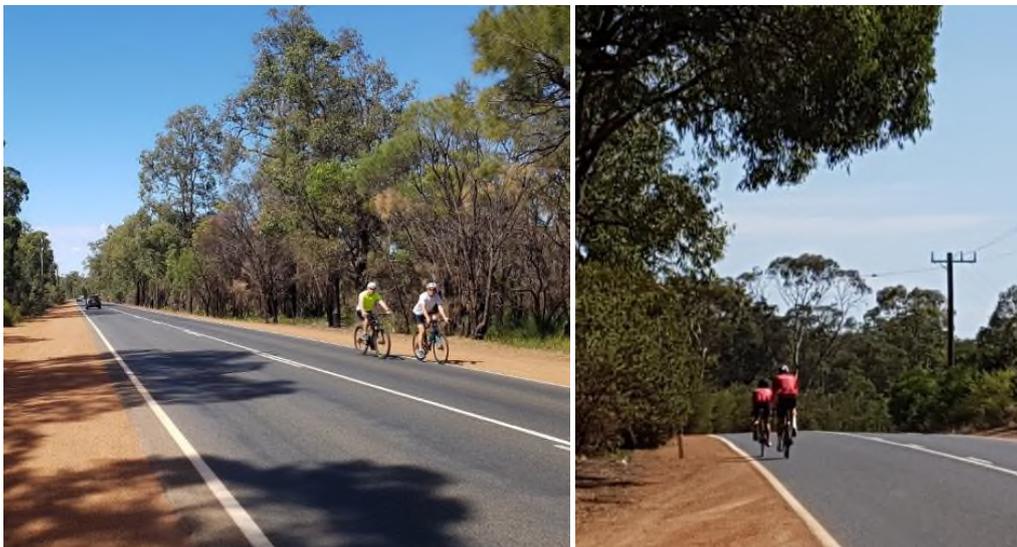
Photo 24 & 24a: Even during coronavirus restrictions, numerous cyclists were seen using this road.

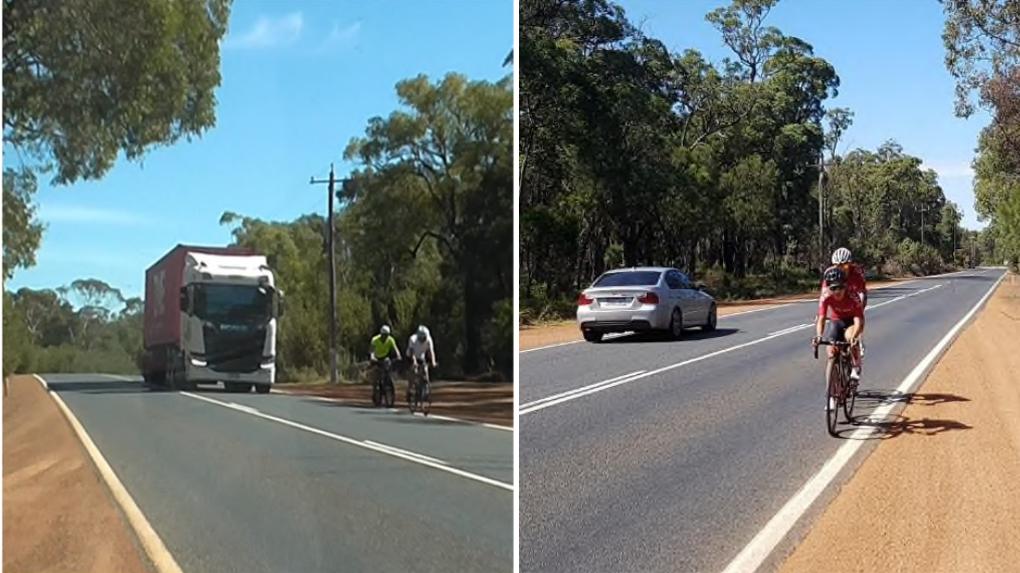
A number of cyclists were observed being tracked by both cars and trucks until they were able to safely overtake them.

Photo 25 & 25a: The lack of sealed shoulders force cyclists to share the road space with other vehicles.

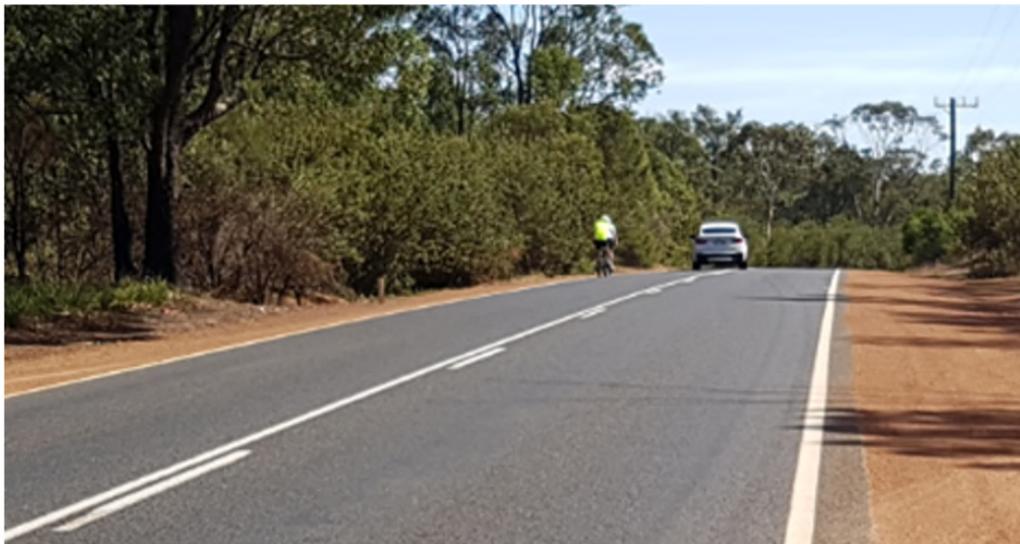
Photo 26: Car overtaking bicycles against the road markings

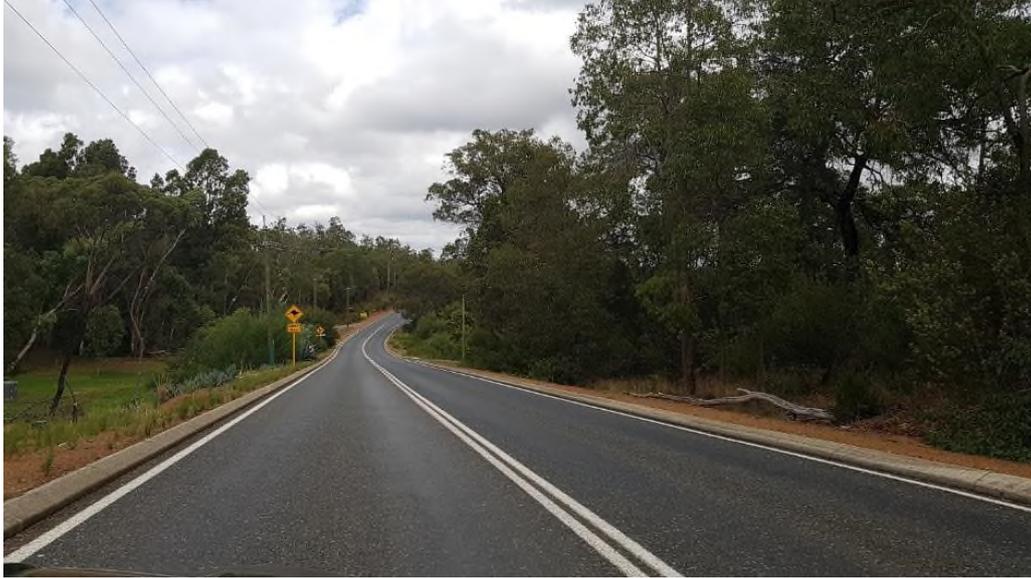
Photo 27: Kerbed sections offer no opportunity for cyclists to take evasive action.

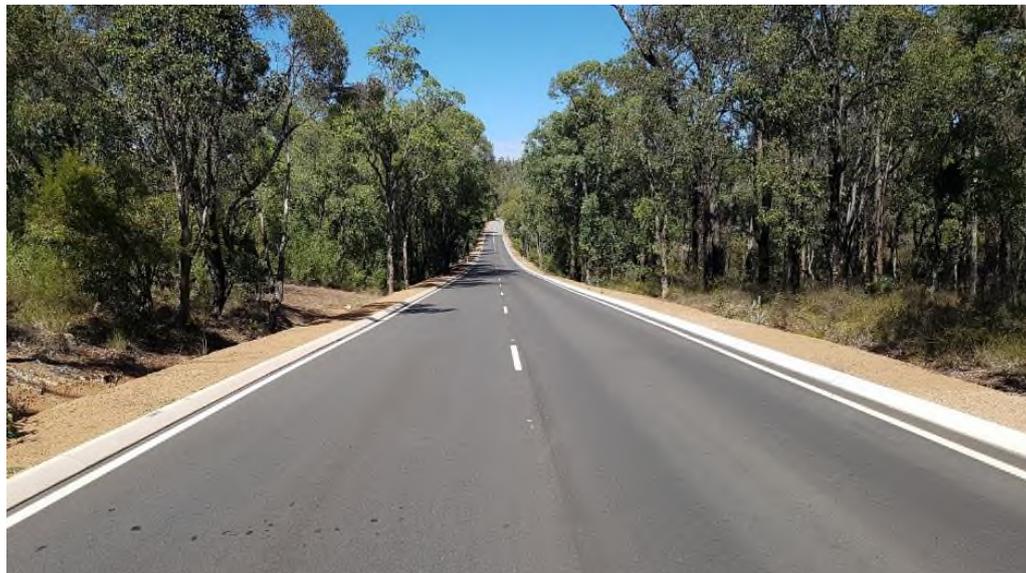
There are no specific cycling (or pedestrian) facilities along this section of Canning Road. Generally, the sealed shoulders are too narrow to afford any refuge for cyclists, who are therefore forced to cycle on-road and in traffic, despite the presence of a significant number of large trucks using this route. Even the kerbed sections offer nowhere for cyclists to escape the following traffic. See **Photos 28 and 29**.

Photo 28: No hard shoulder between edge lines and kerbs.

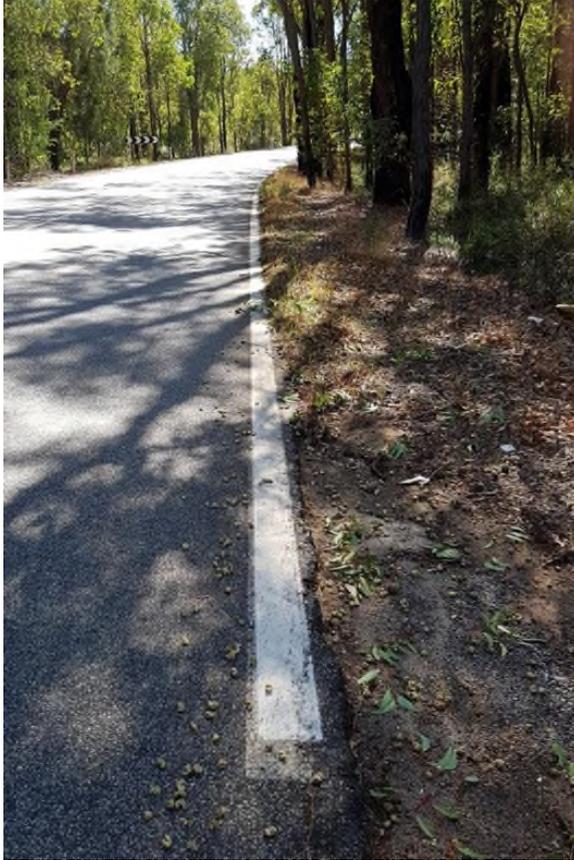
Photo 29: Cyclists would have no option here but to ride on-road.

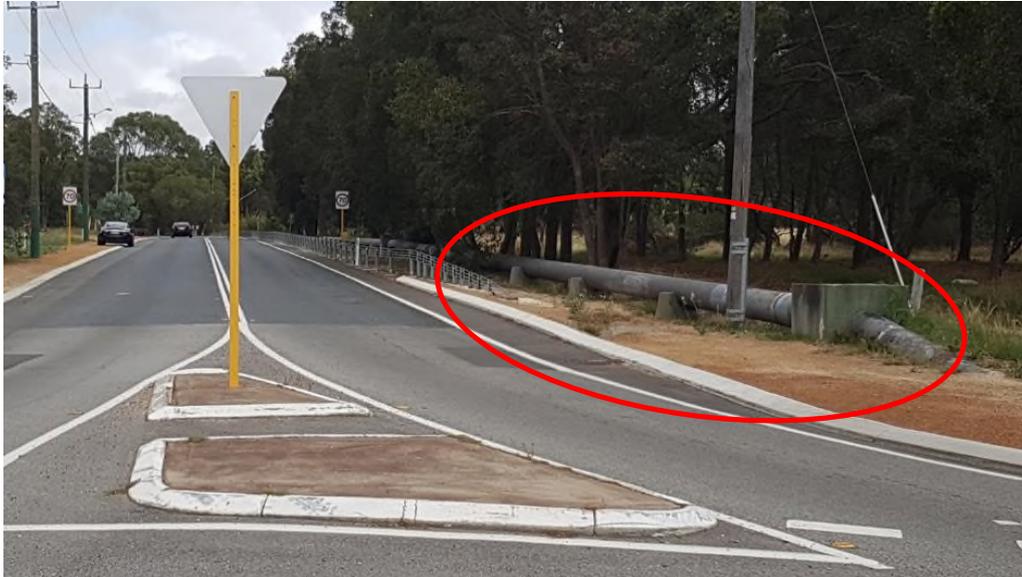
Photo 30: Wire rope safety fence does not cover these items.

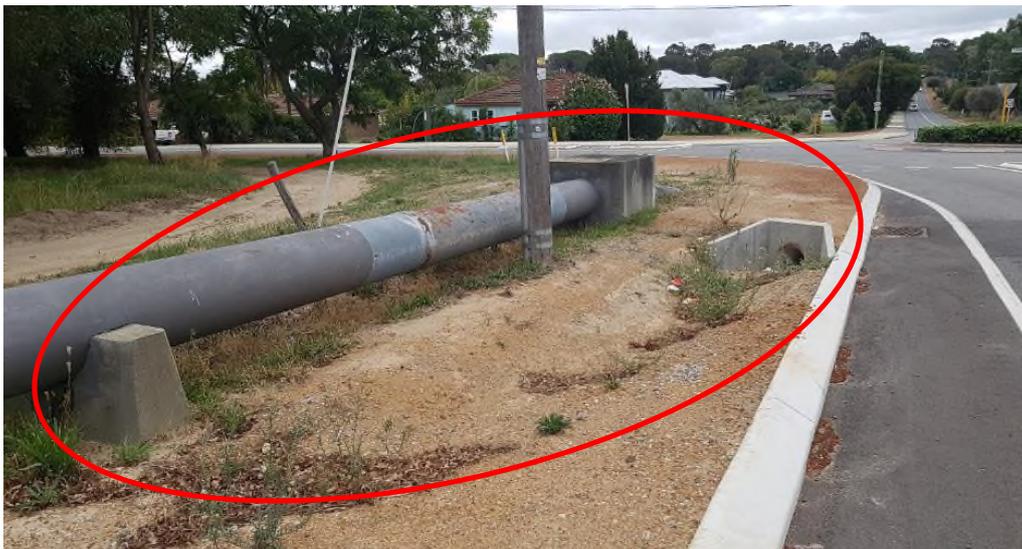
Photo 31: Pipe, concrete blocks, post and headwall – all remain exposed.

There are a number of other hazards adjacent the carriageway on this stretch of Canning Road, including numerous concrete headwalls on the eastern side. These are mainly provided to culverts passing under property driveways. In addition, the above ground pipe continues along the western side of the road with no protection.

Extend the safety fence to protect drivers from roadside hazards such as the above-ground pipe and concrete block. See **Figure 4.1** below.

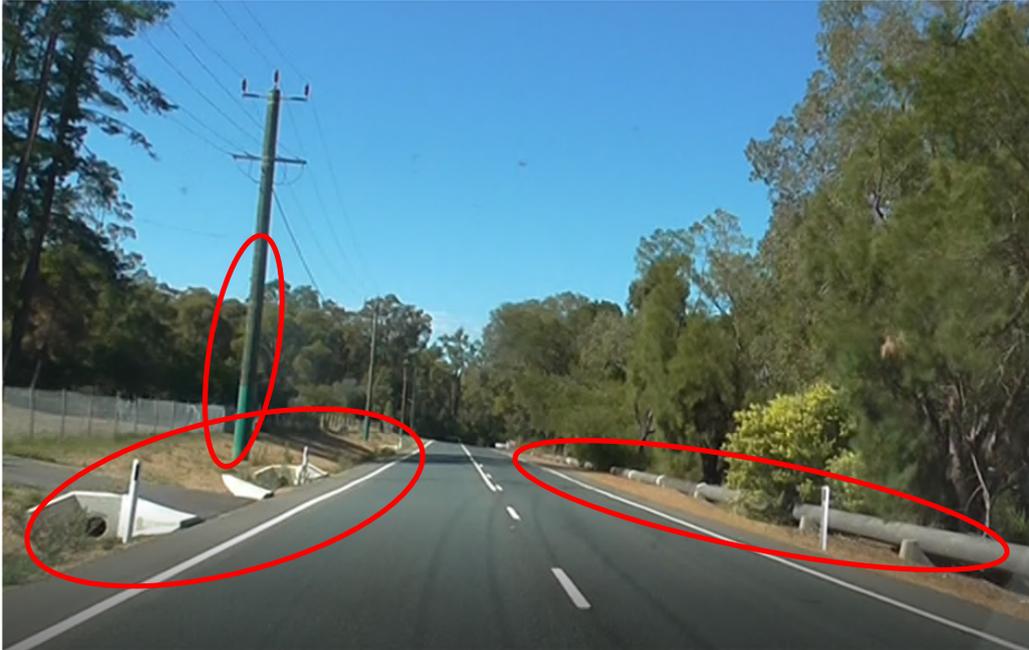
Photo 32: Concrete headwalls, piping and concrete blocks all provide hazards to errant vehicles.

Other roadside hazards such as driveway headwalls should be removed, relocated or redesigned.

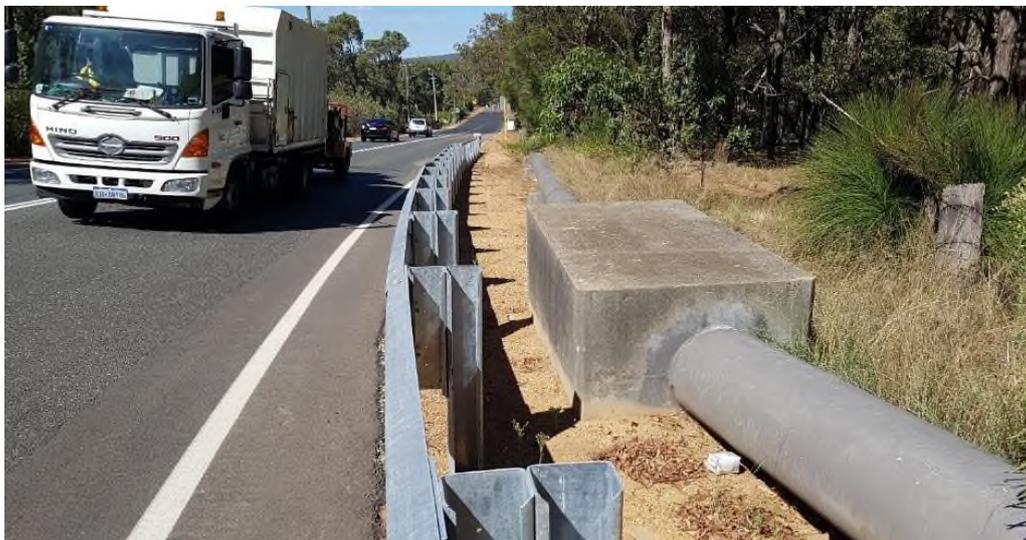
Where protection is afforded to the pipe it has limited clearance, and may not be fully effective. See **Photo 33**.

Photo 33: If struck by a vehicle, this safety fence may deflect further than the concrete block.

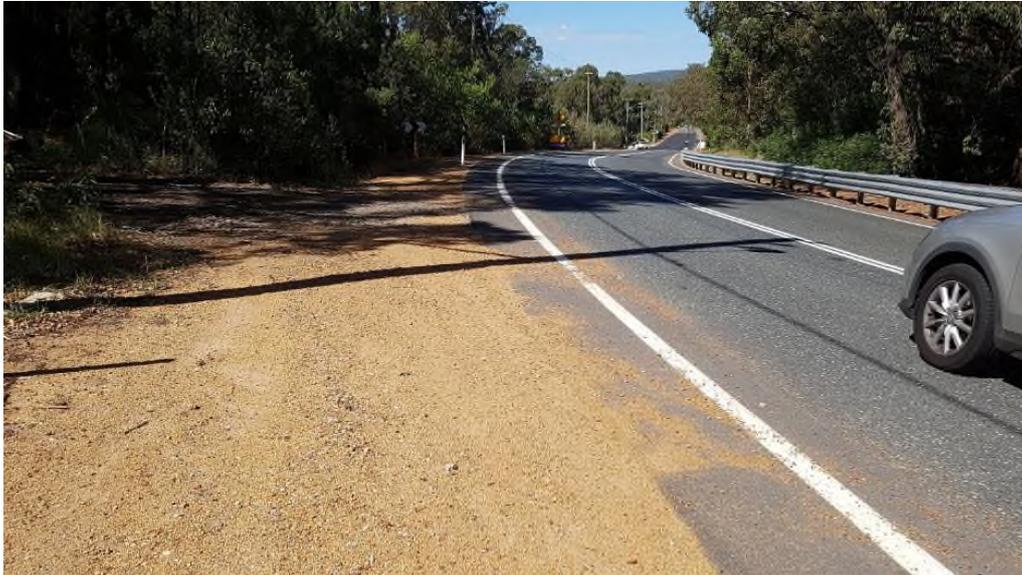
With minimal sealed shoulders, and numerous unsealed driveways, there are also various locations where loose material is being dragged not only onto the sealed shoulder, but also onto the carriageway itself. This may present a hazard for drivers, but more specifically for cyclists. See **Photo 34**.

Photo 34: Loose material on hard shoulder and road surface.

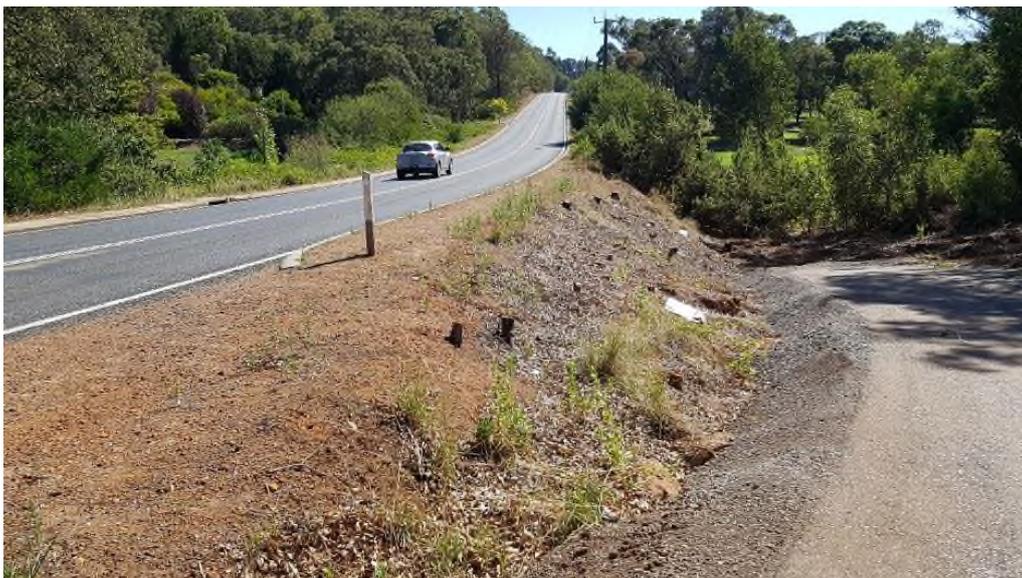
There are some areas within this section that have significant drop offs adjacent the road, some with open, unrecoverable batter slopes, whilst others are hidden by trees and bushes. See **Photo 35**.

Photo 35: Unrecoverable batter with a significant drop off.

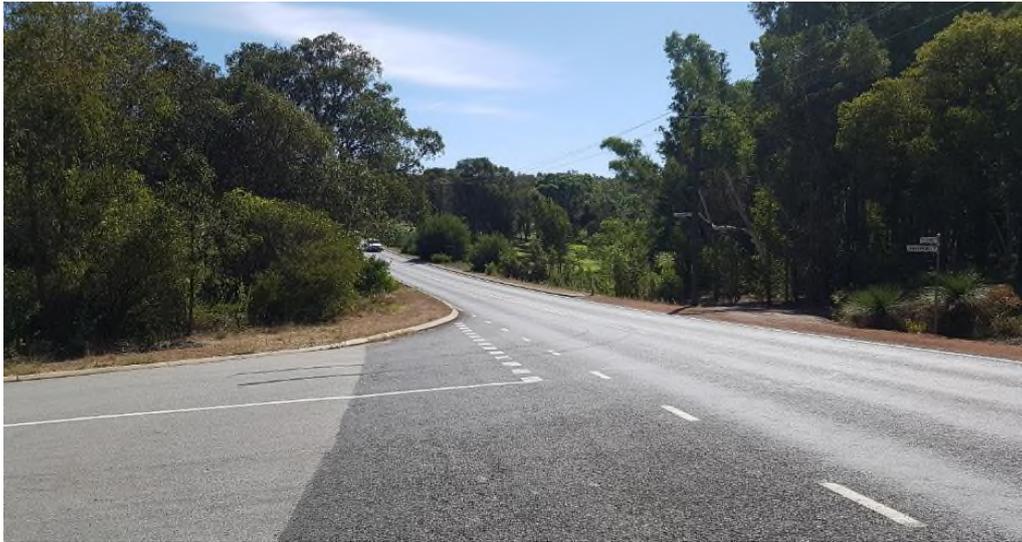
As identified in paragraph 3.2.2, visibility is an issue at some of the intersections and accesses along this part of Canning Road. As can be seen in **Photos 36 & 37**, this is of particular concern at the northern Masonmill Road intersection.

Photo 36: Visibility to the north is limited by both geometry and roadside vegetation.

At Masonmill Road (north), a desktop analysis indicates approximately 100m of sight line to the north. Austroads Guide to Road Design Part 4A Unsignalised and Signalised Intersections indicates that this would correspond roughly to the required SISD for a design speed of 50km/h (97m).

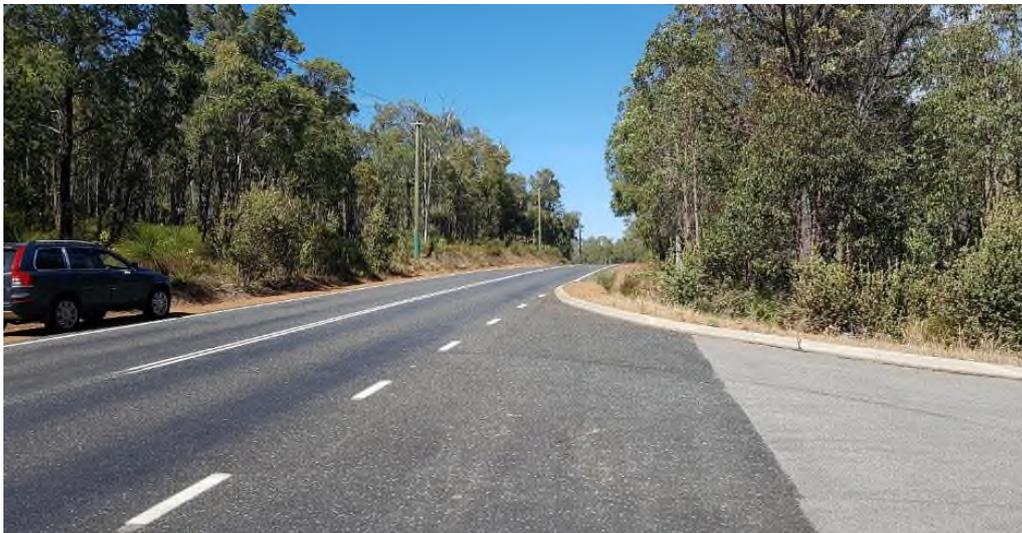
Photo 37: Visibility to the south is limited by a crest.

To the south, however, the presence of a crest reduces sight lines significantly. On-site measurement would be required to determine the corresponding SISD. See **Photo 37**.

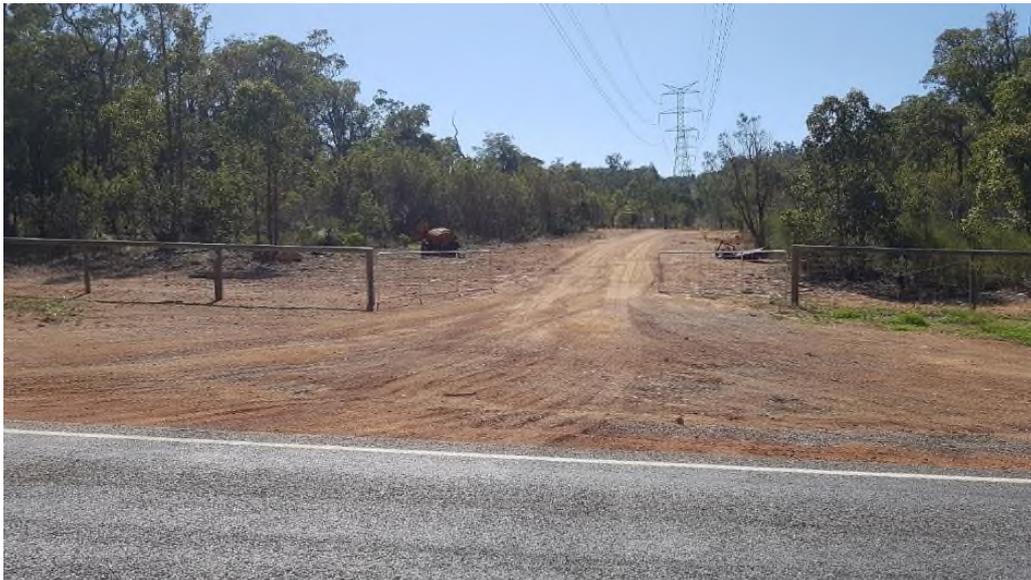
Between the two Masonmill Road intersections, there is an unsealed property access with evidence of significant truck movements. Visibility to the north of the access is limited by the road geometry. A desktop analysis reveals sightlines to the north are restricted by the curve in the road to approximately 130m. This corresponds to a SISD design speed of 60km/h (123m). See **Photos 38 & 39**.

Photo 38: Unsealed property access to the east of Canning Road.
