September 2020

Canning Road Safety Investigation

Prepared For: City of Kalamunda

Final Report

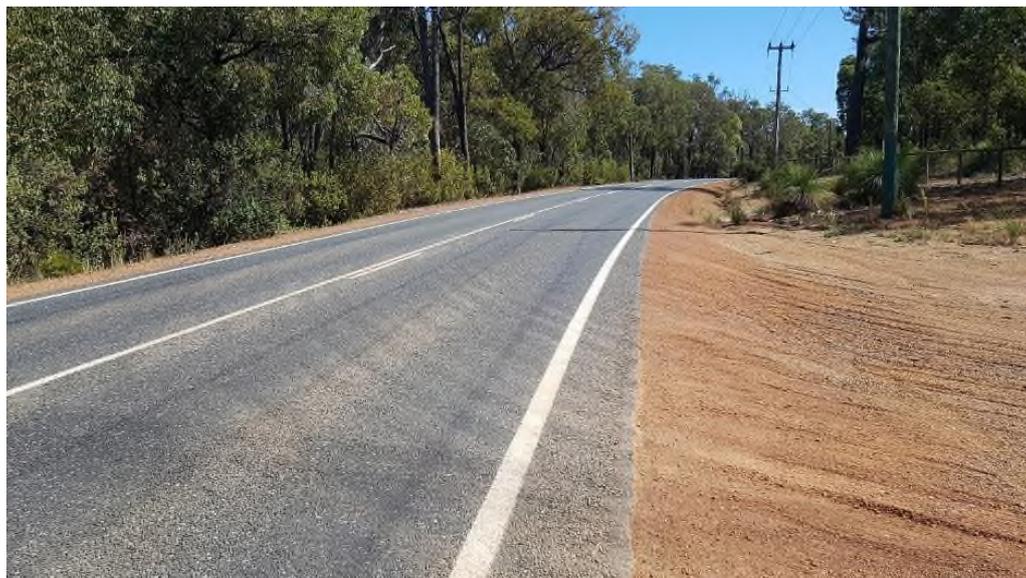
Between the two Masonmill Road intersections, there is an unsealed property access with evidence of significant truck movements. Visibility to the north of the access is limited by the road geometry. A desktop analysis reveals sightlines to the north are restricted by the curve in the road to approximately 130m. This corresponds to a SISD design speed of 60km/h (123m). See **Photos 38 & 39**.

Photo 39: Evidence of trucks turning in and out of the access. Visibility to the north is limited.

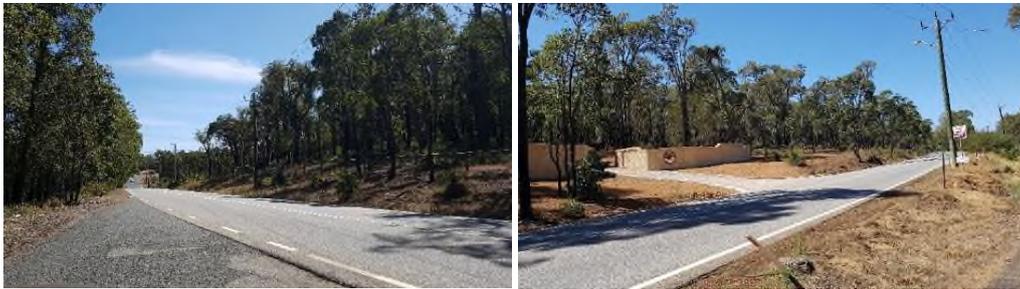
The northern intersection is simple, but has a poor angle of incidence. Although there is an advertising sign on the side of the road, there do not appear to be any intersection warning signs heading south. There is also a power pole close to the road in this vicinity. See **Photos 40 & 40a**.

Photos 40 & 40a: Northern service road intersection joins Canning Road at an acute angle of around 20°.

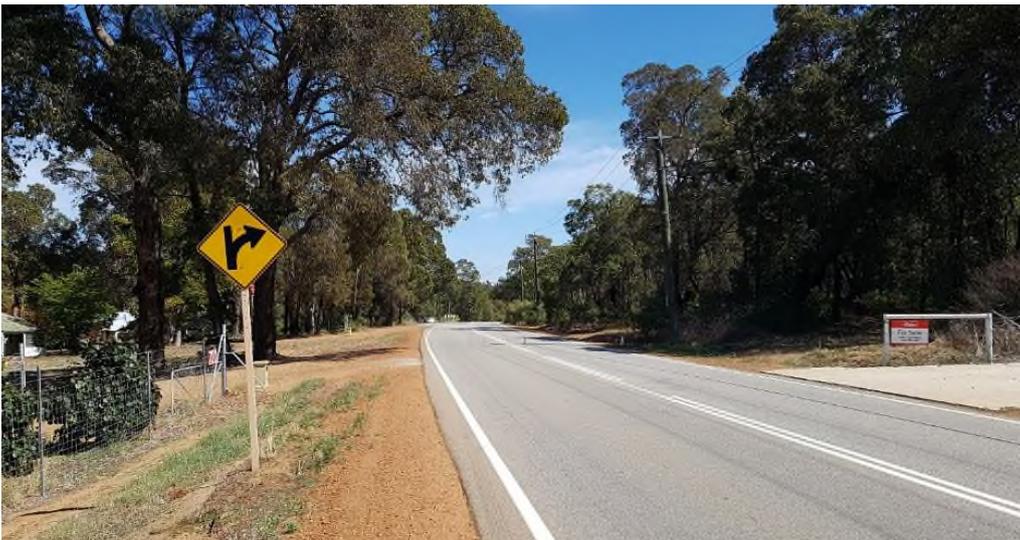
The southern intersection has a non-standard configuration, which may cause confusion for those unfamiliar with the layout. Although an intersection warning sign has been provided on the northbound approach, it does not fully identify the potential vehicle movements. (See **Photos 41 to 43**).

Photo 41: The warning sign does not fully identify the connections or potential movements.

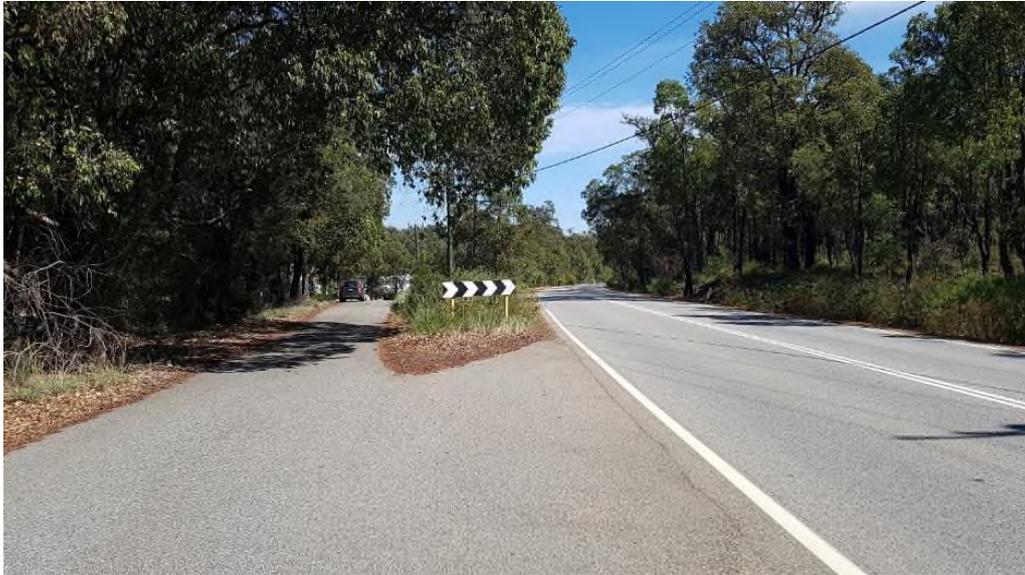
Photo 42: Southern intersection, looking north.

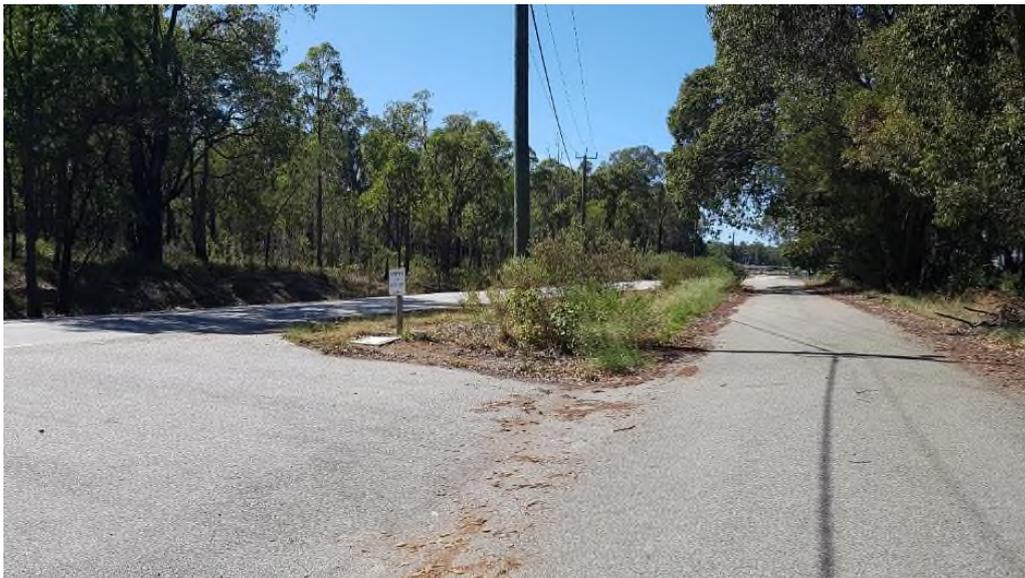
Photo 43: Southern intersection, looking south. There appears to be potential for head on crashes here.

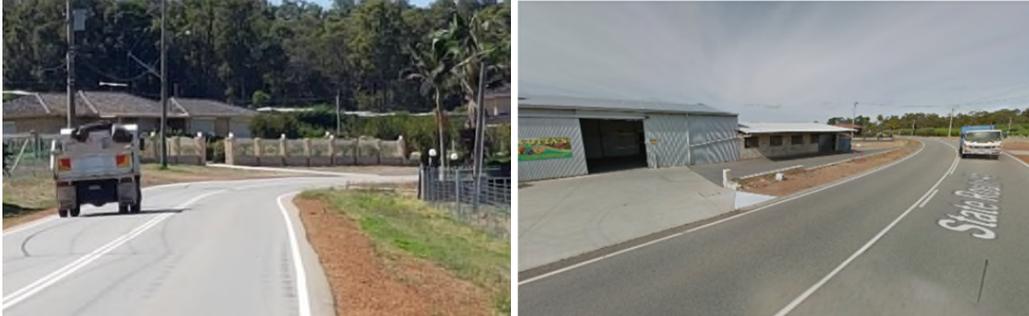
Photos 44 & 44a: There are a number of property accesses around blind bends. Leotta's access provides one example.

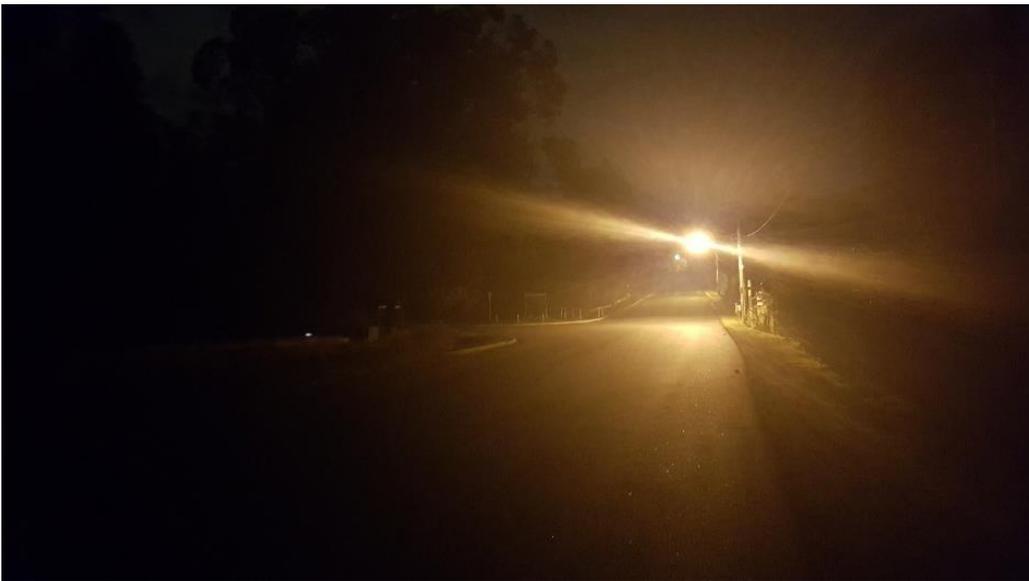
Despite recent upgrades at the Welshpool Road East intersection, the street lighting remains below par. A single lighting column gives an isolated pool of light, as seen in **Photo 45**.

Photo 45: A single lighting column at the Welshpool Road East intersection.

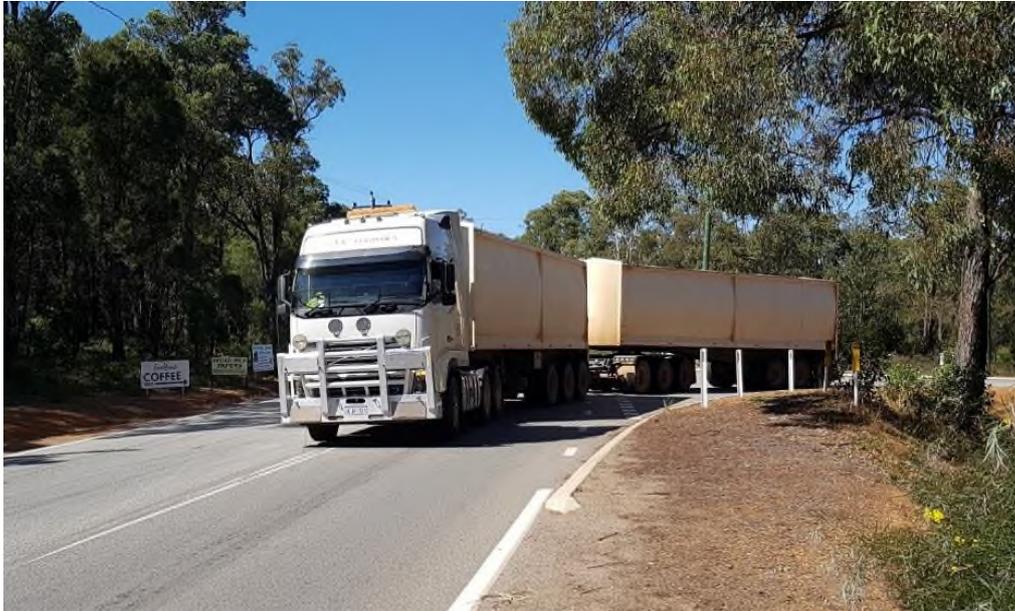
At the Canning Road / Pickering Brook Road intersection, the radius of the left turn out of the side road does not appear to be sufficient to cater for RAV vehicles, with most of those observed crossing the centre line of the through road.

Photo 46: Turning truck crossing centre line

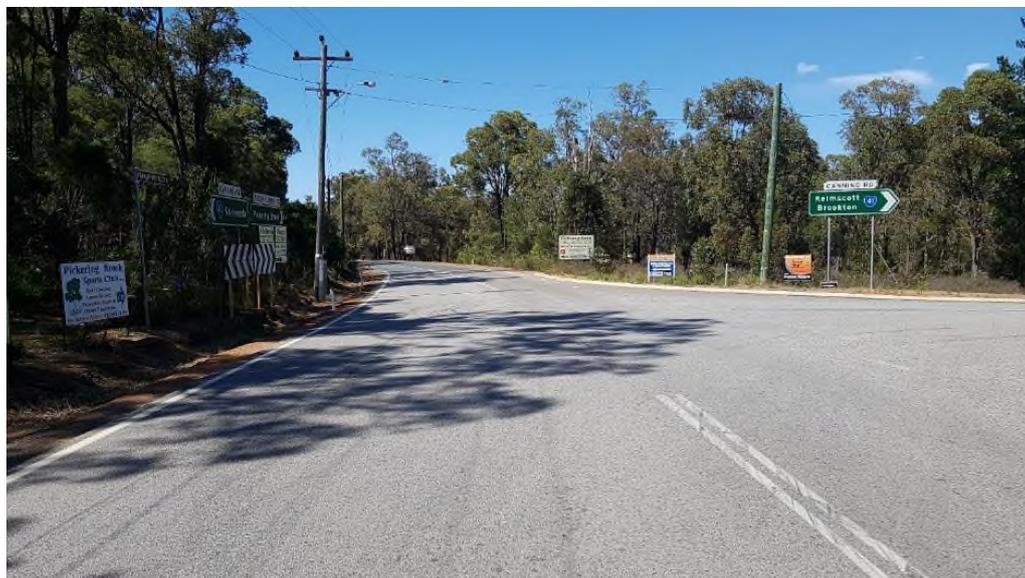
The geometry of Pickering Brook Road is such that visibility to through vehicles is limited for drivers turning right into the side road. See **Photo 47**.

Photo 47: Limited visibility for vehicles turning right.

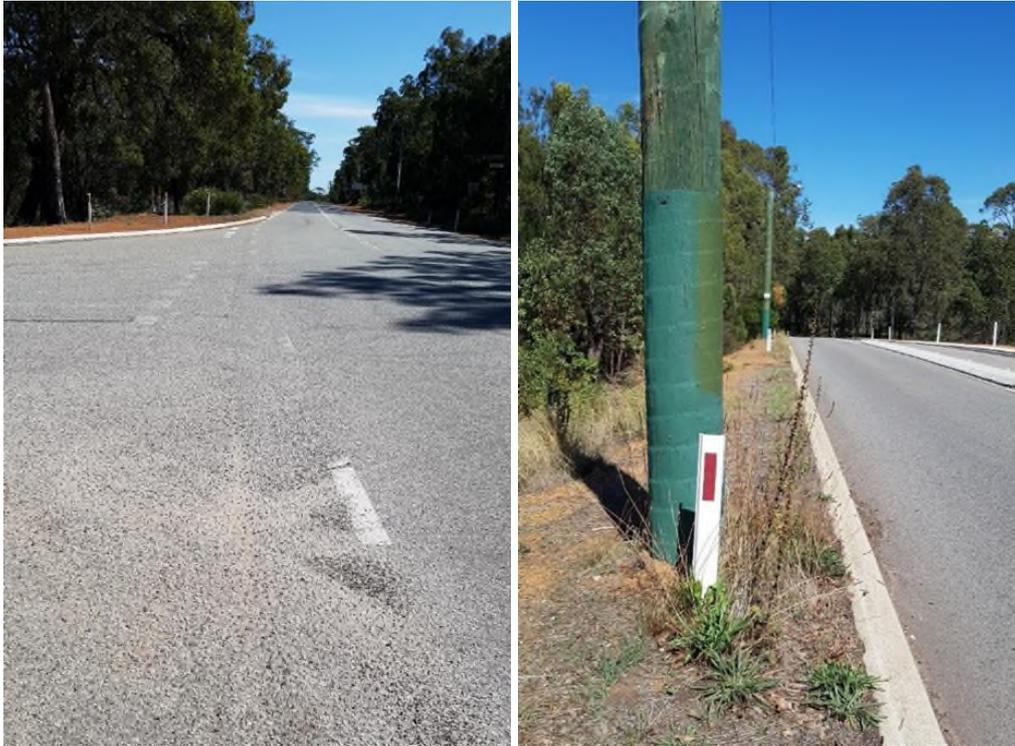
safety problems, including badly faded line marking and non-frangible items in the clear zones. See **Photos 48 & 48a**.

Photos 48 & 48a: Worn line marking and Power pole in verge.

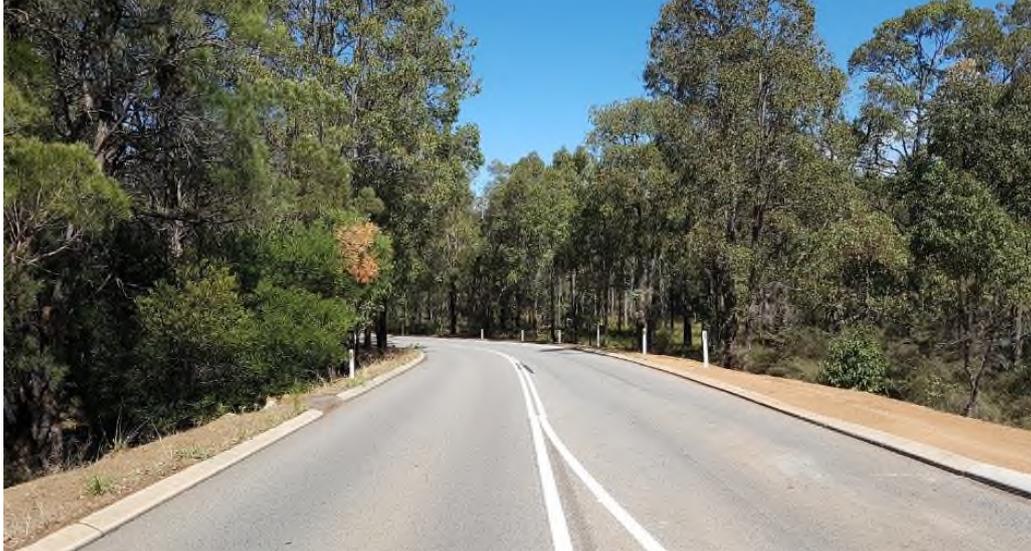
As identified in paragraph **3.1.3**, the bend to the south of the Pickering Brook Road intersection is too sharp for the 70 km/h speed limit, has poor visibility and an unrecoverable batter slope. This has already led to a number of crashes, and there is a significant risk of further incidents. See **Photos 49 & 50**.

Photo 49: Sharp bend south of Pickering Brook Road intersection.

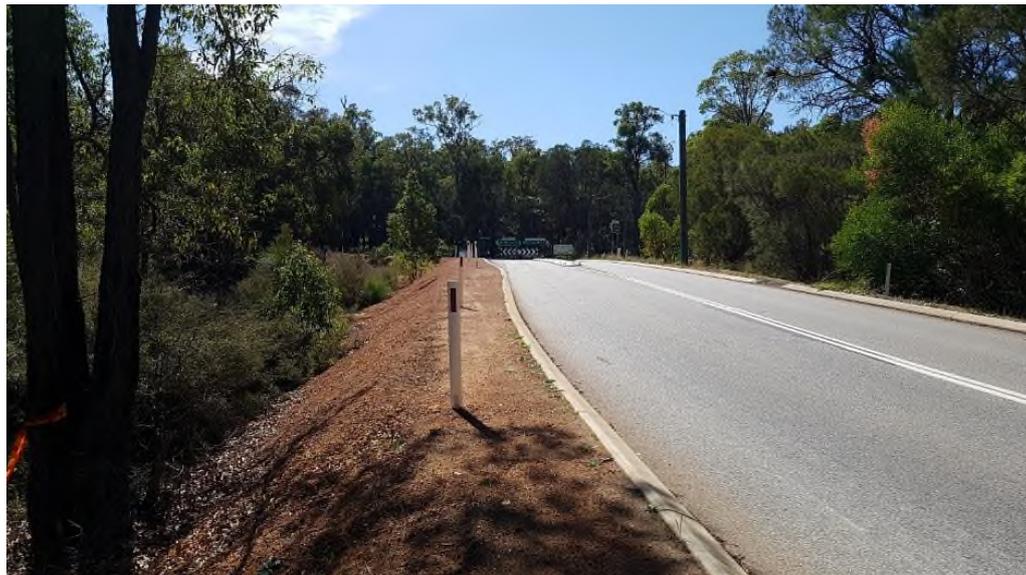
Photo 50: Unrecoverable batter and signs of a previous crash. One fatality has occurred here in recent years.

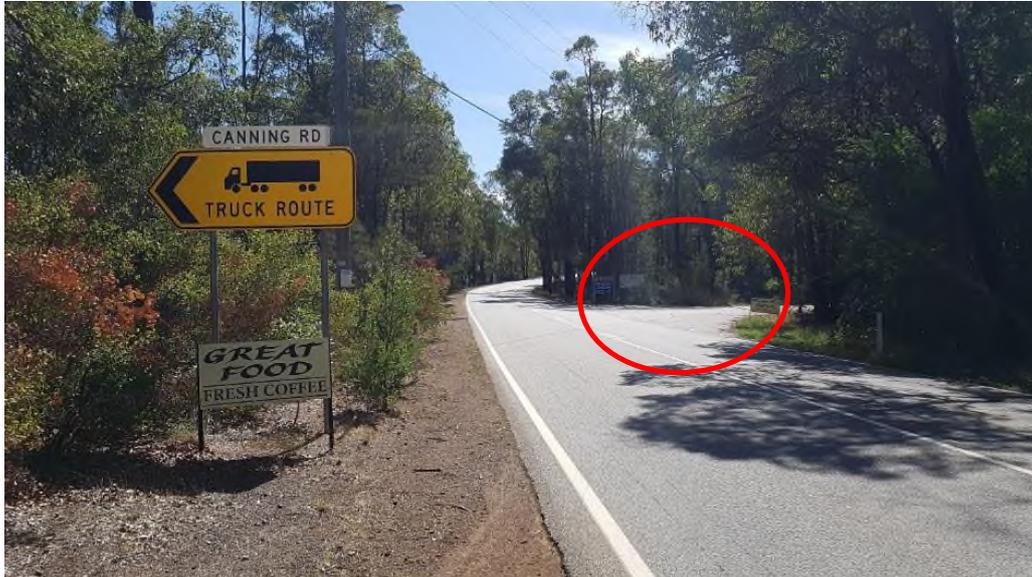
In the same vicinity, there is an intersection with what may be 'Old Canning Road'. This is immediately south of the sharp bend, has no warning signs and is almost hidden by vegetation. Indeed it is preceded by warning signs for the Canning Road / Pickering Brook Road intersection. See **Photo 51**.

Photo 51: This intersection has no warning signs and very poor visibility.

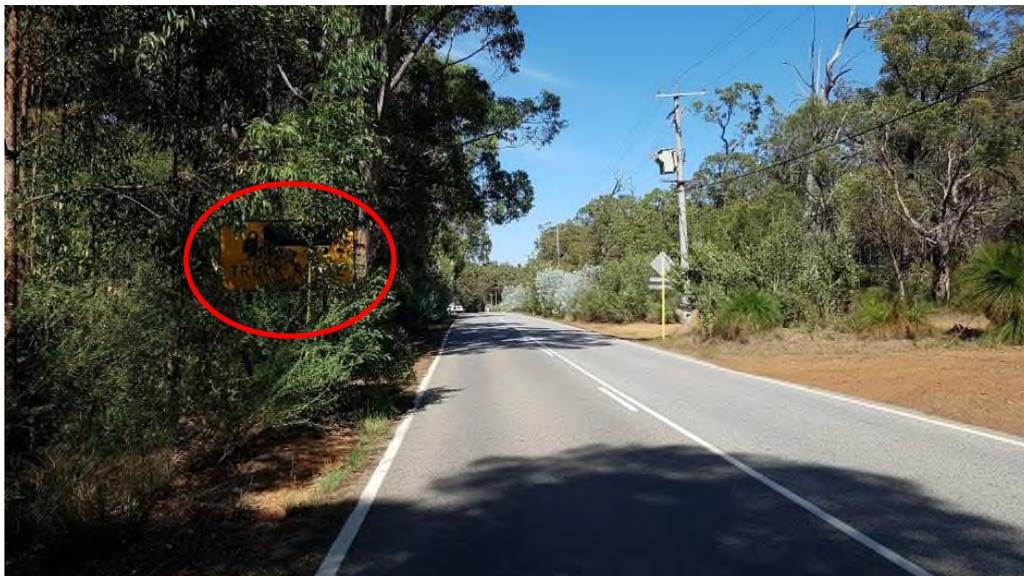
The truck route signs in the south direction are obscured by vegetation. See **Photo 52**.

Photo 52: Truck warning sign hidden by vegetation.

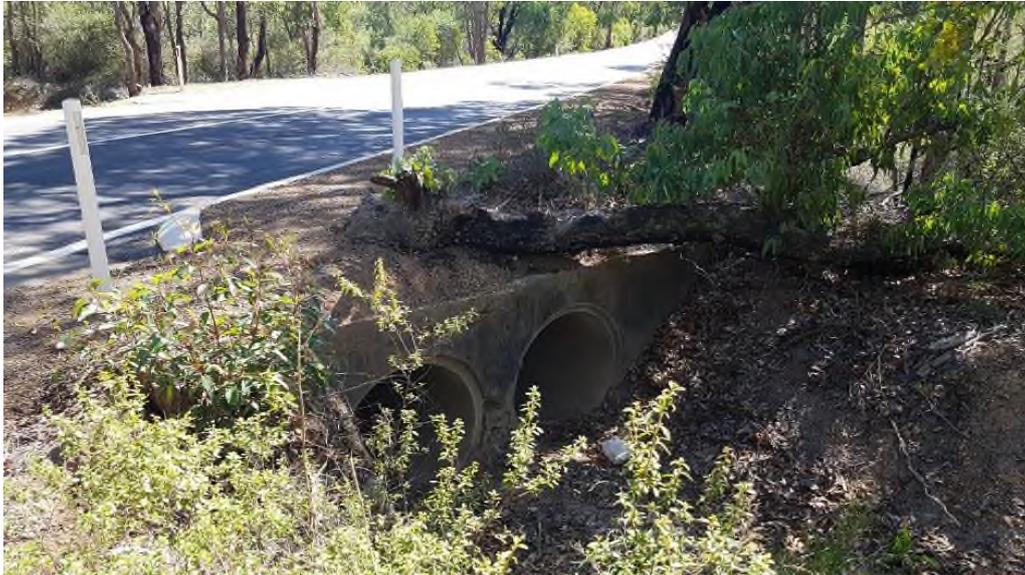
Other issues along this section of road include hazards within the clear zone such as culverts beneath the road, trees and drop offs.

Photo 53: Culvert close to road

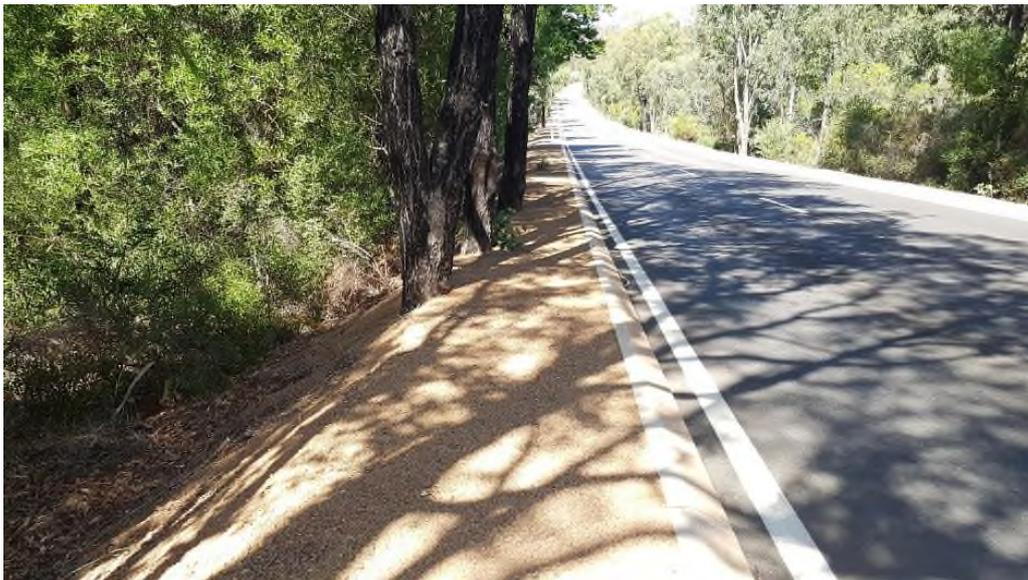
Photo 54: Trees near the road with significant drop off.

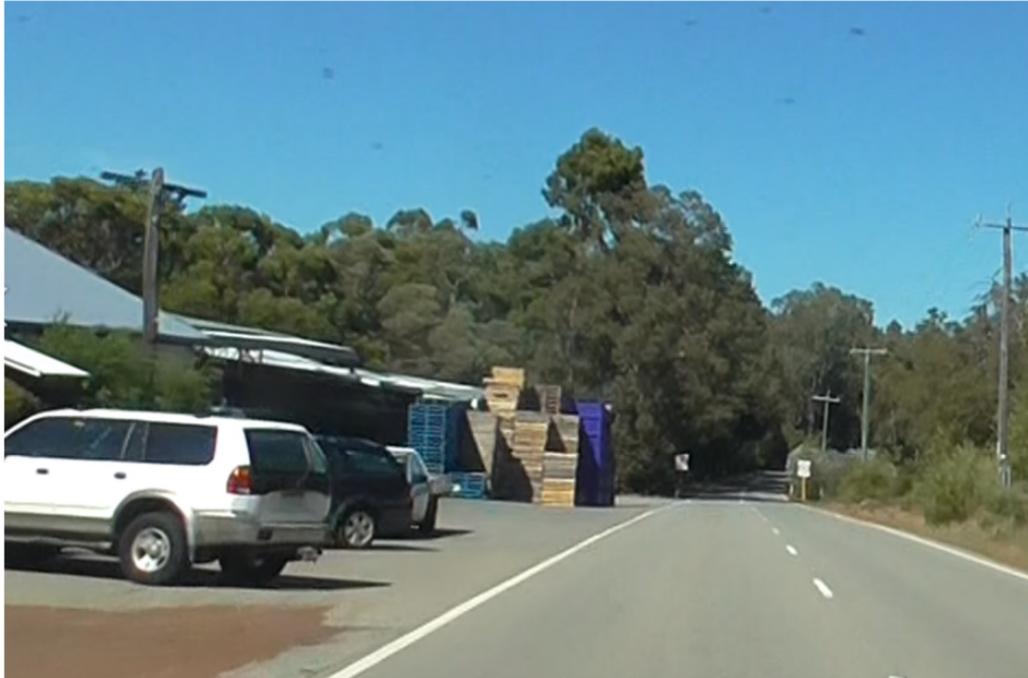
Photo 55: Pallets stacked within the clear zone.

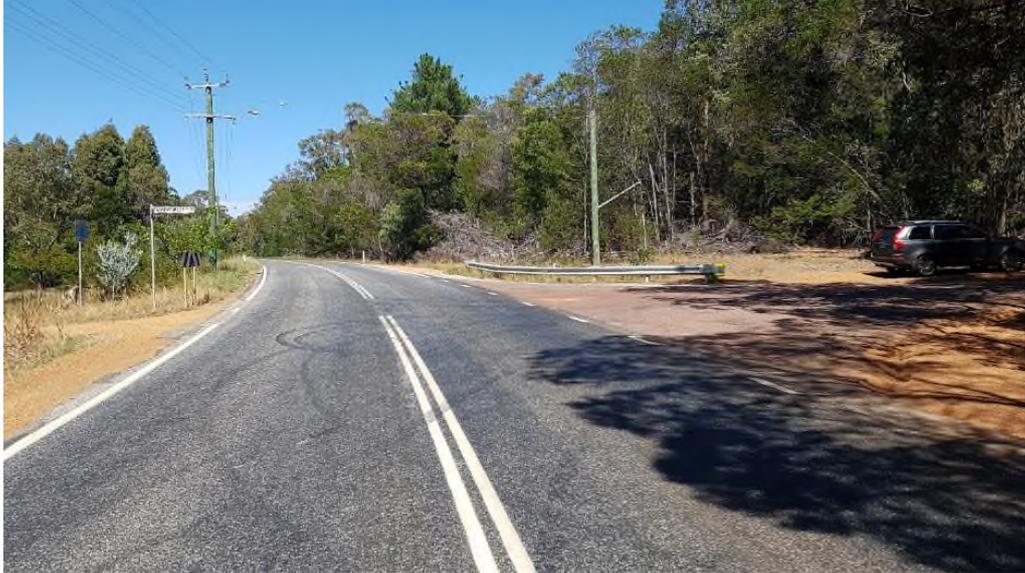
Photo 56: Limited visibility for right turn from Canning Road.

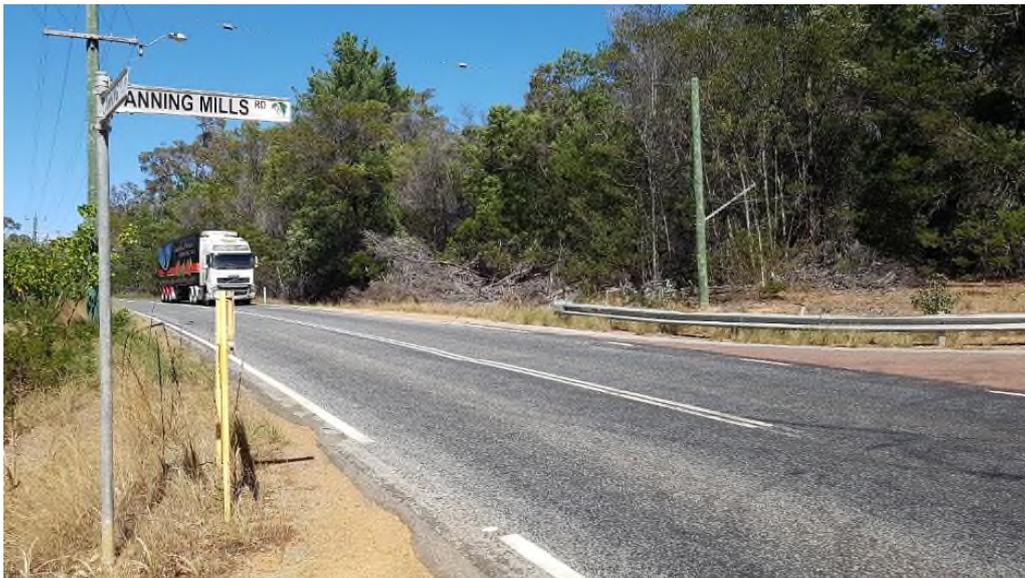
Photo 57: Poor visibility to the south from the fourth leg.

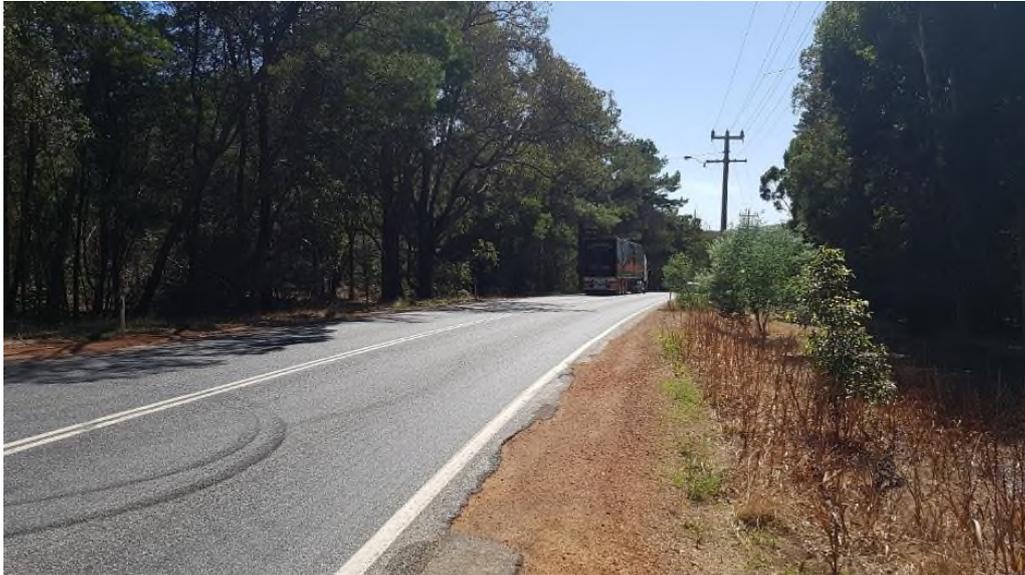
Photo 58: Limited visibility to the north from fourth leg.

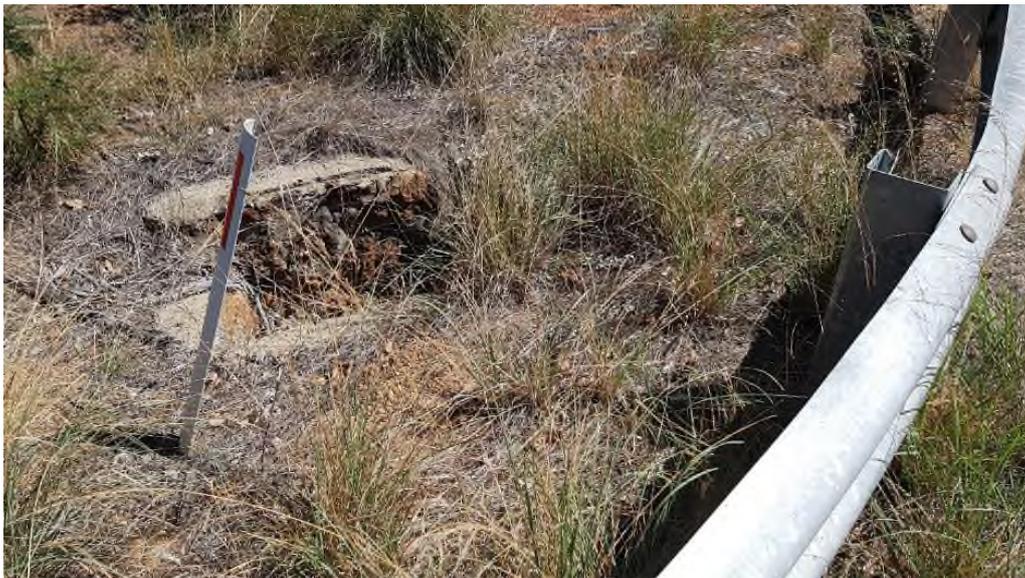
Photo 59: The safety fence appears to be protecting vehicles from this opening.

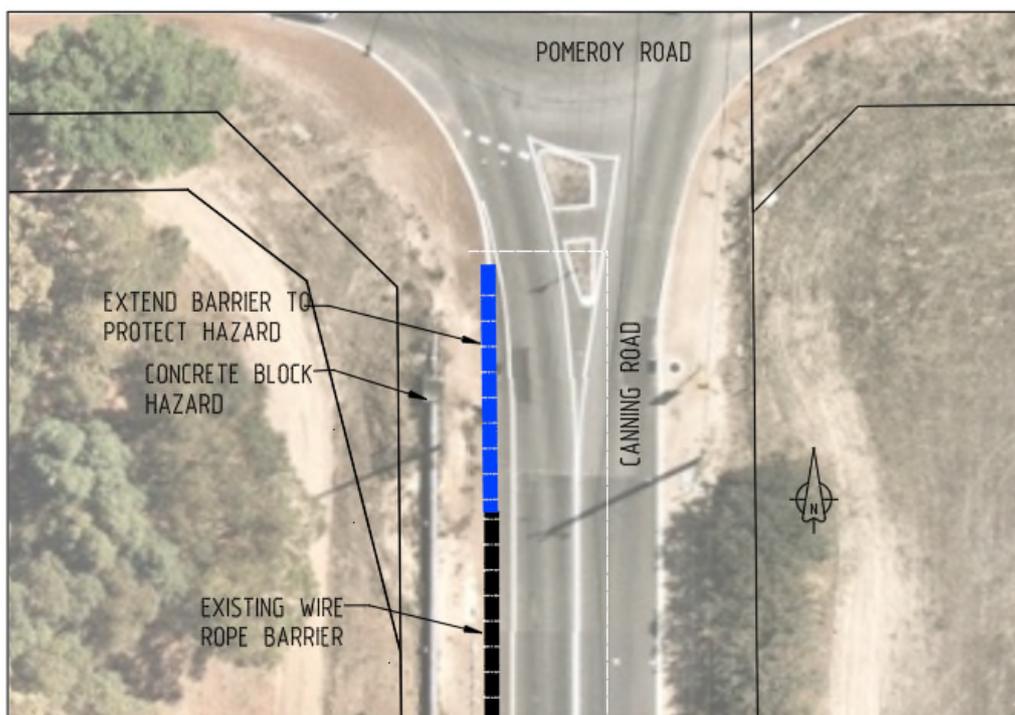
Figure 4.1: Recommendation to extend safety barrier north to protect existing hazard

Extend the safety fence to protect drivers from roadside hazards such as the above-ground pipe and concrete block. See **Figure 4.1** below.

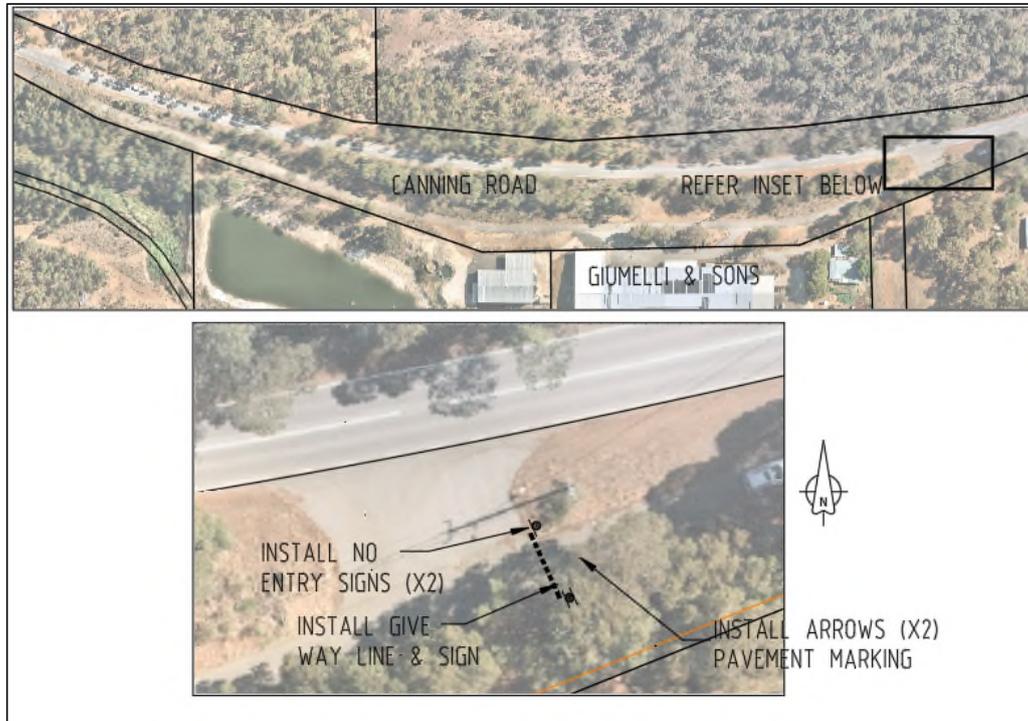
Figure 4.2: Temporary safety improvements at eastern access to Guimelli & Sons

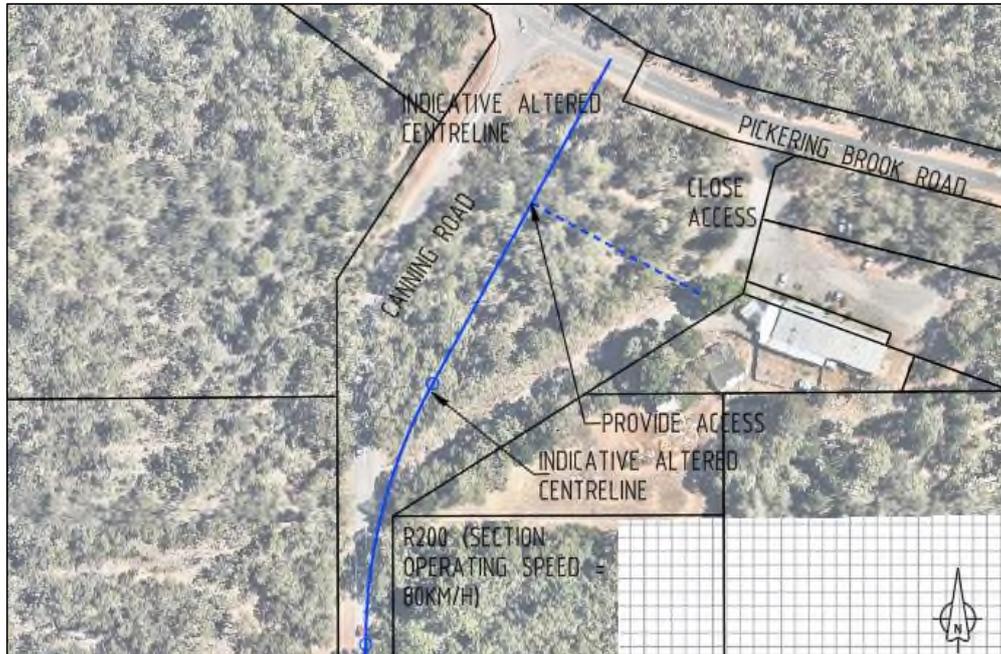
Figure 4.3: Conceptual realignment of Canning Road at Pickering Brook Road

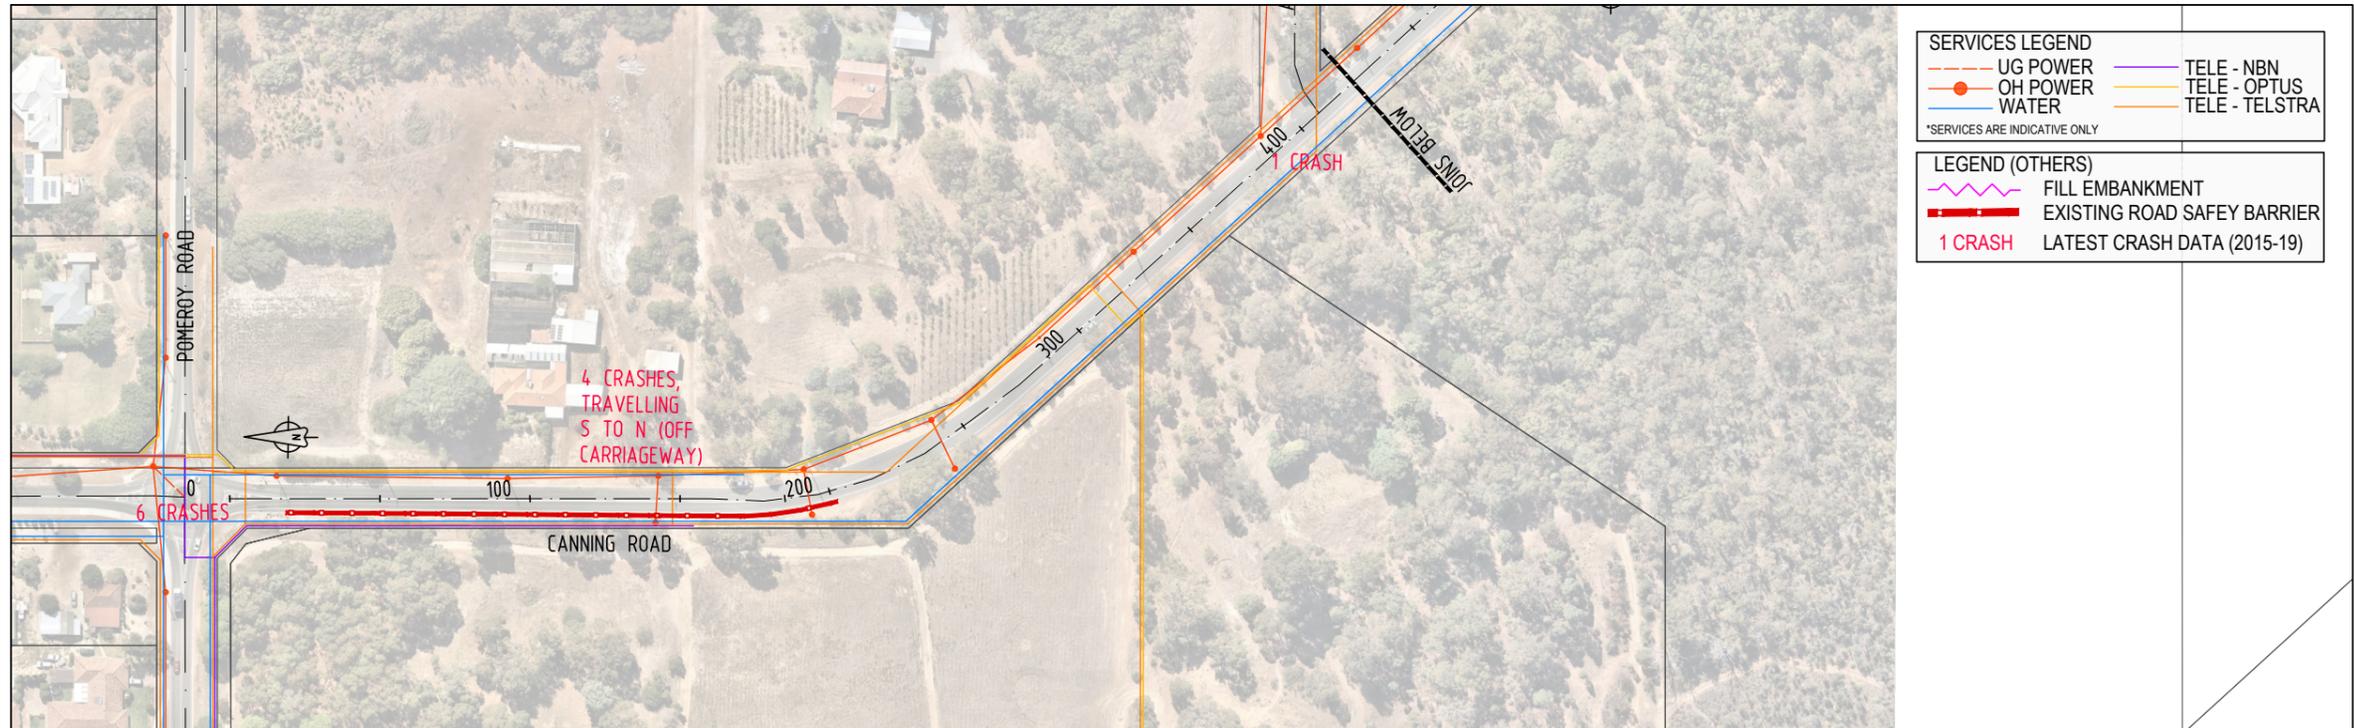
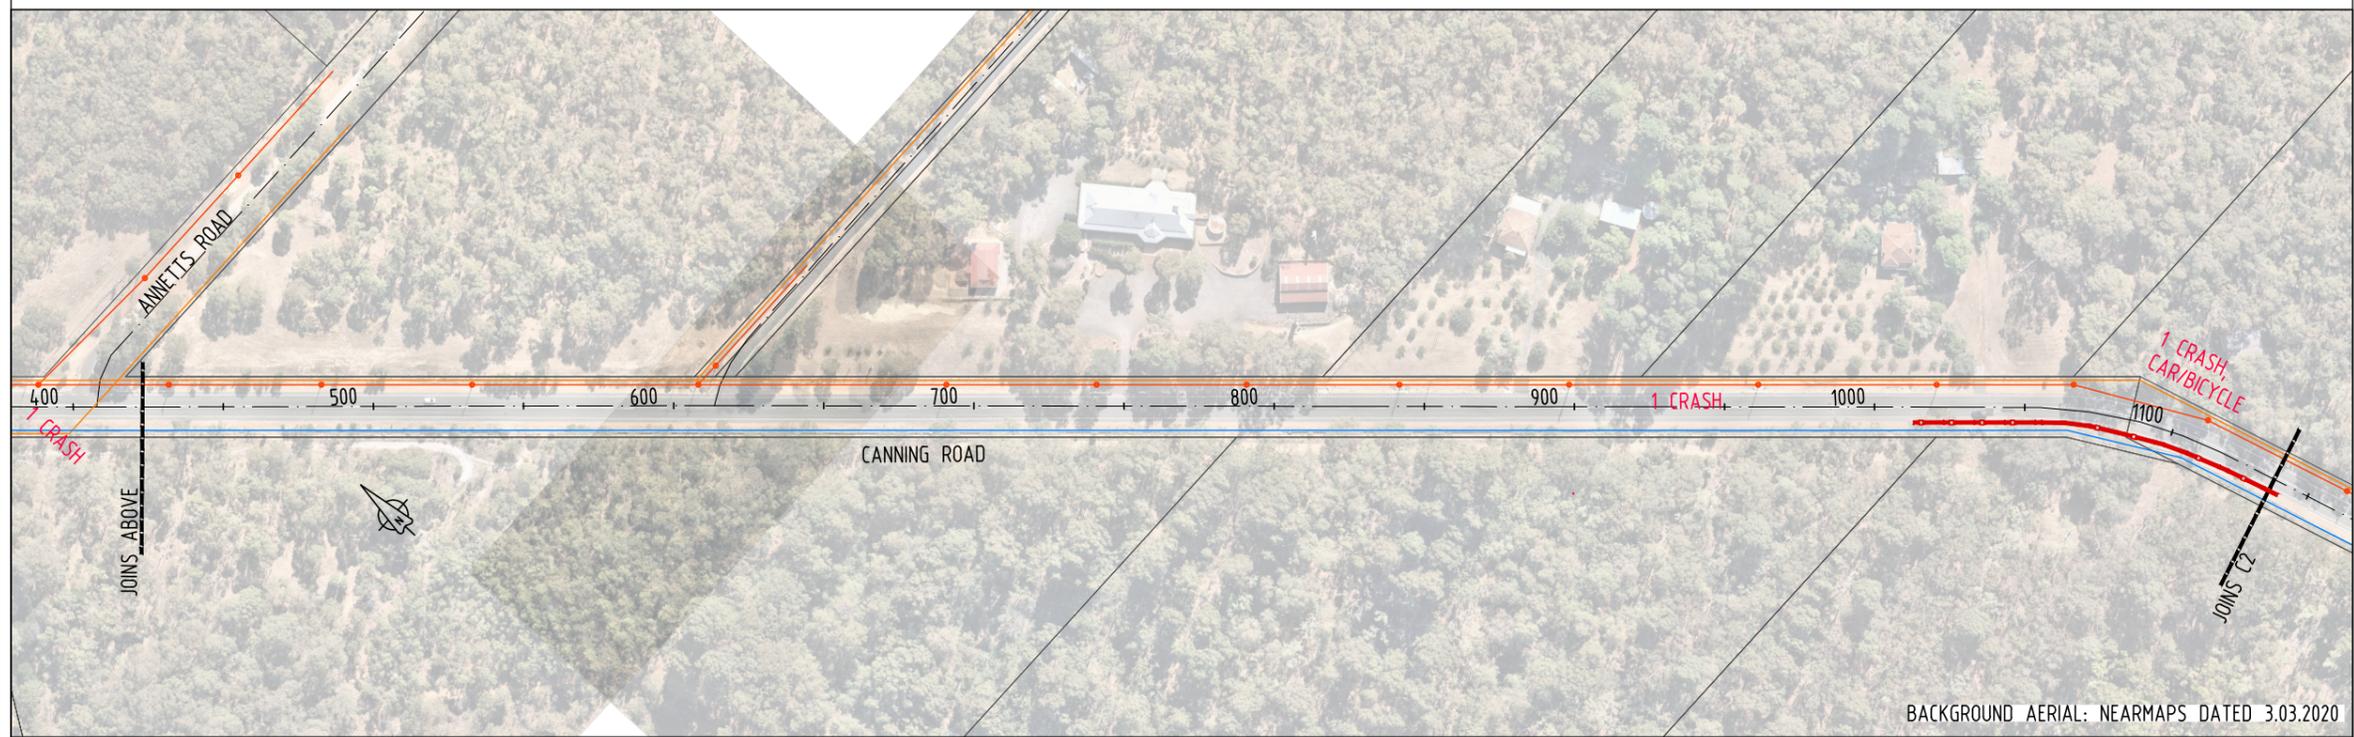
Project CANNING ROAD, POMEROY ROAD TO SLK 14.56, ROAD SAFETY INVESTIGATION	Designed	GTT	8.06.2020	Donald Veal Consultants 6 Burgess Street Midland WA 6056 Telephone +61 8 9274 7076 Facsimile +61 8 9274 4854	
	Drawn	GTT	25.08.2020		
Title CONSTRAINTS MAPPING & CRASH DATA (CHA 0 - 1150)	Checked	SY	25.08.2020		
Client CITY OF KALAMUNDA	Approved				
	Scale	1:2000 AT A3		Project Number	LG362
				Drawing File Name	DVC-LG362 Rev1
				Drawing Number	C1
				Revision	01

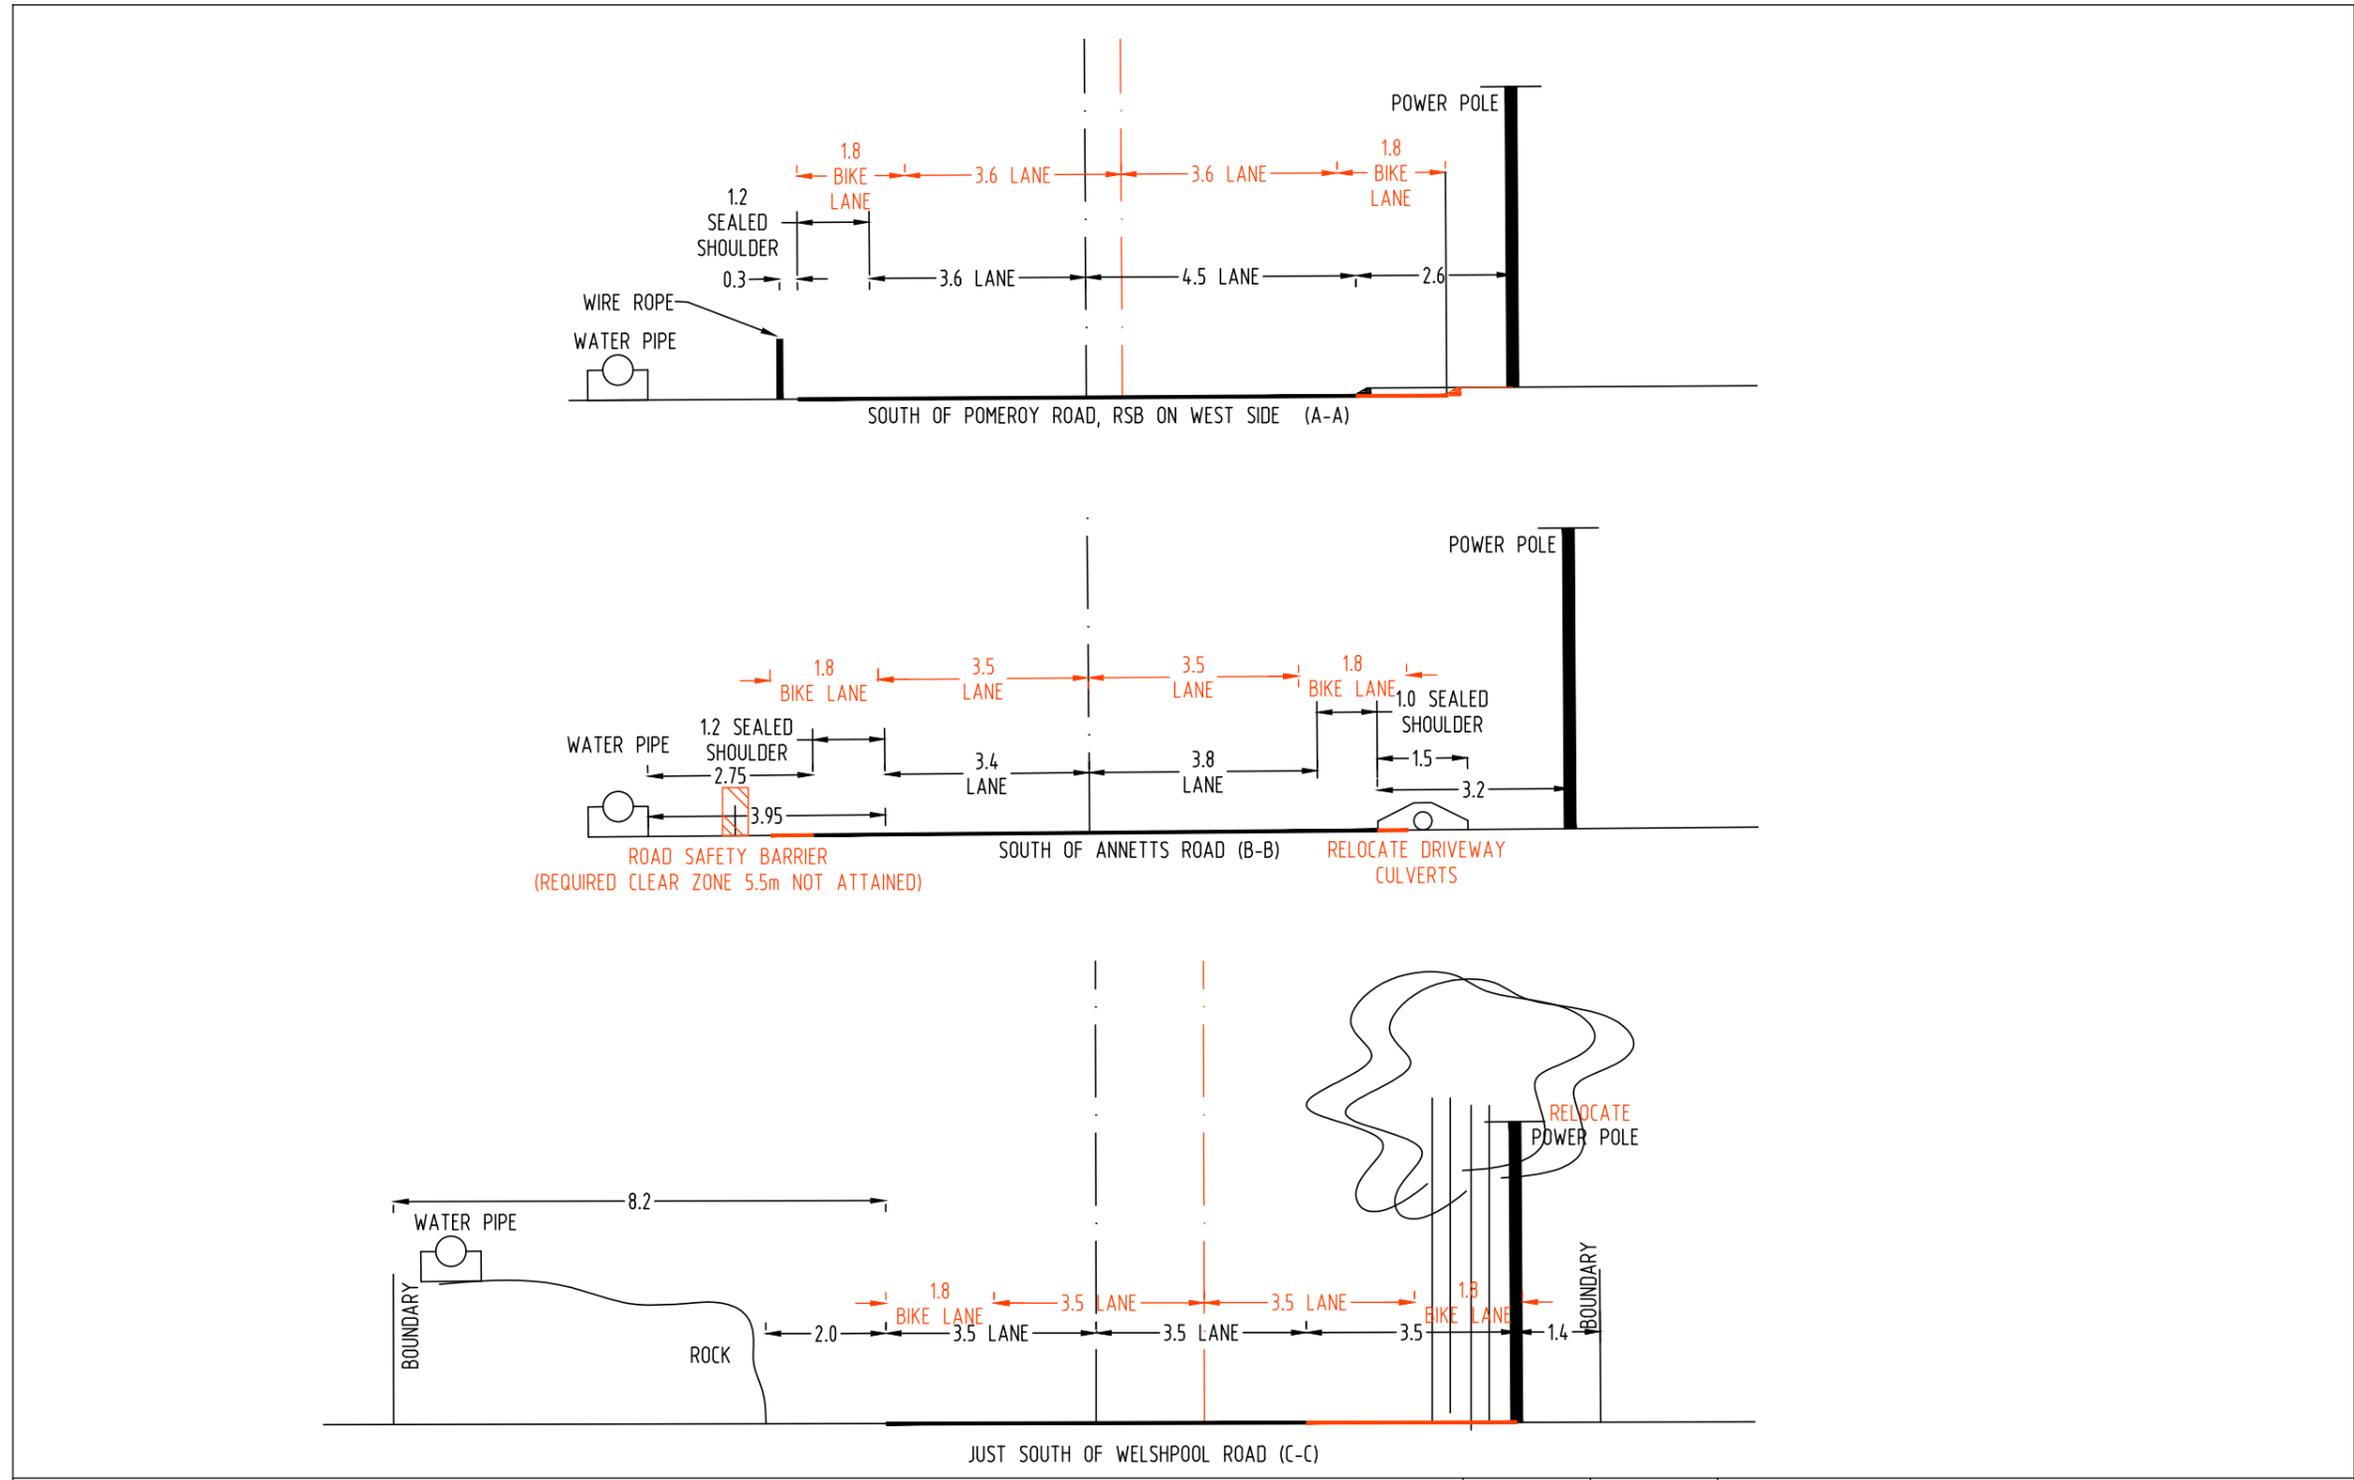
Chainage		Length (m)	Cross section proposed		
Start	End		Type	Description	Dwg
0	225	225	A-A	South of Pomeroy Road, RSB on west side	TXS1
225	400	225	A1-A1	South of Pomeroy Road, no existing RSB on west side	TXS5
400	1025	575	B-B	South of Annetts Road	TXS1
1025	1150	125	B1-B1	North of Carmel Road	TXS5
1150	1300	150	B-B	South of Annetts Road	TXS1
1300	1500	200	C-C	Just south of Welshpool Road East	TXS1
1500	1750	250	D-D	South of Welshpool Road East, kerbed length	TXS2
1750	2700	950	E-E	South of Masonmill Road (north)	TXS2
2700	3200	500	E1-E1	South of Masonmill Road (south)	TXS5
3200	3500	300	F1-F1	West of Glenisla Road	TXS6
3500	3750	150	F-F	Horizontal Curve West of Glenisla Road	TXS2
3750	4200	550	F1-F1	West of Glenisla Road	TXS6
4200	5200	1000	G-G	West of Pickering Brook Road	TXS3
5200	5450	250	H1-H1	Just south of Pickering Brook Road at Canning Road	TXS6
5450	7500	2050	H-H	South of Pickering Brook Road	TXS3

Project	CANNING ROAD, POMEROY ROAD TO SLK 14.56, ROAD SAFETY INVESTIGATION	Designed	GTT	8.06.2020	Donald Veal Consultants 6 Burgess Street Midland WA 6056 Telephone +61 8 9274 7076 Facsimile +61 8 9274 4854	
Title	TYPICAL CROSS SECTIONS	Drawn	GTT	25.08.2020		
Client	CITY OF KALAMUNDA	Checked	SY	25.08.2020		
		Approved				
		Scale	1:100 AT A3		Project Number	LG362
					Drawing File Name	DVC-LG362 Rev1
					Drawing Number	TXS1
					Revision	01
