September 2020

Canning Road Safety Investigation

Prepared For: City of Kalamunda

Final Report

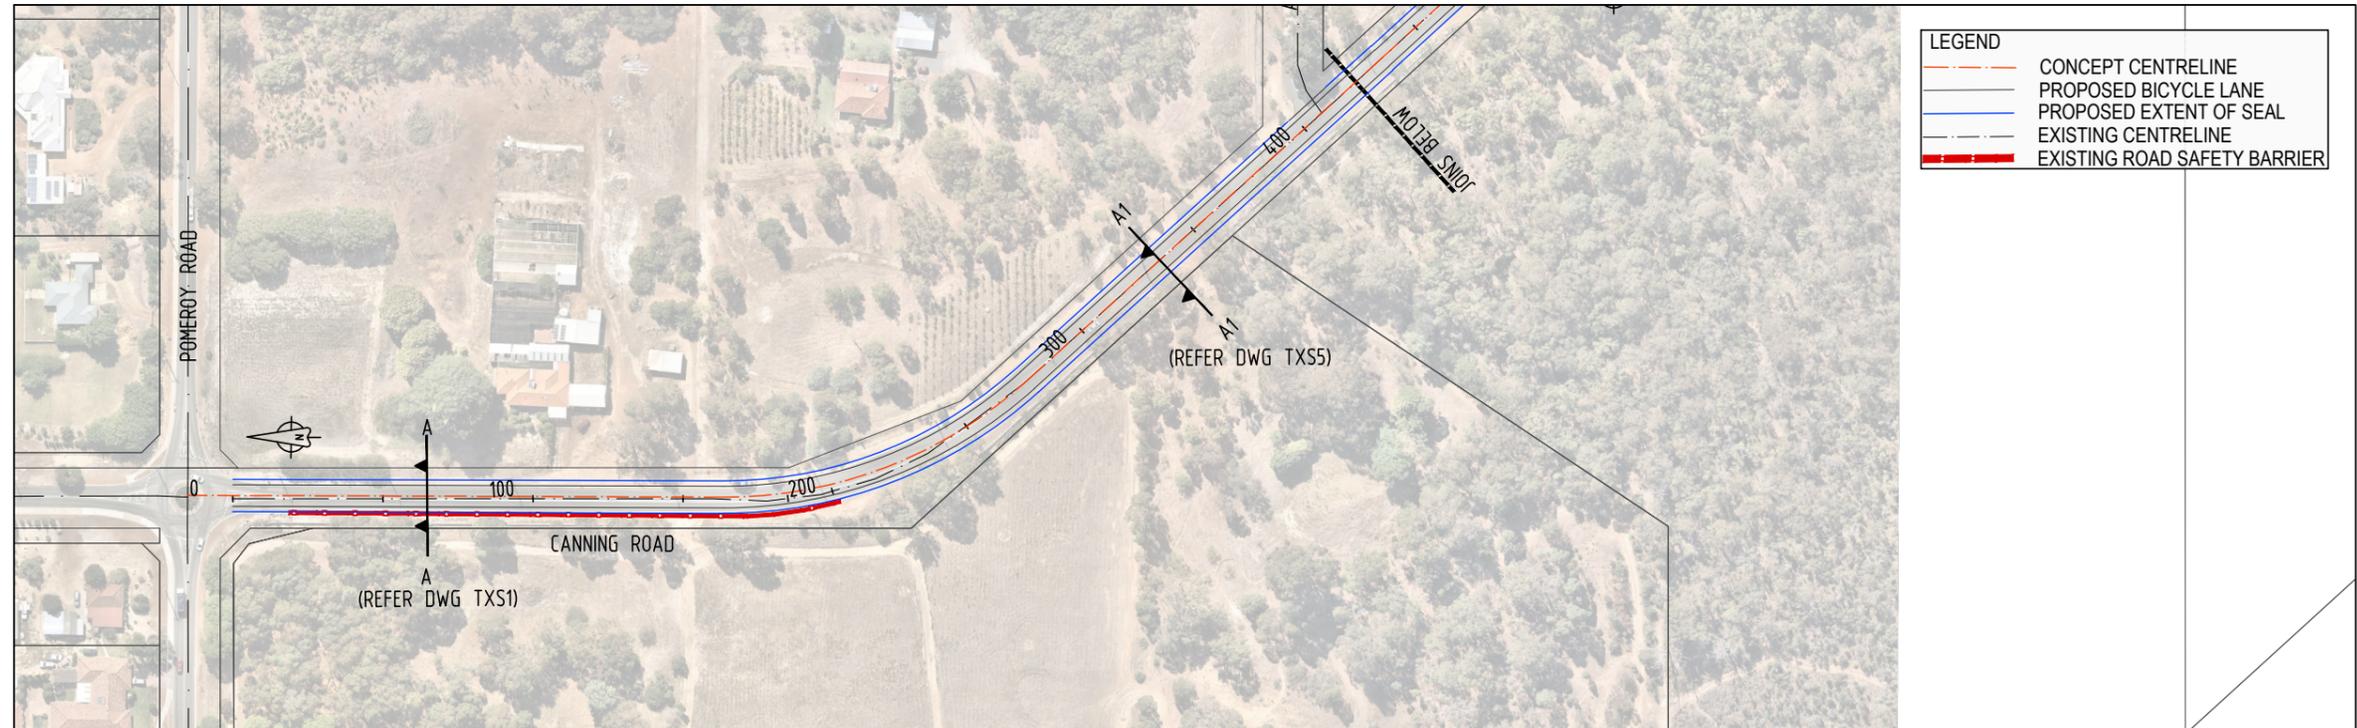
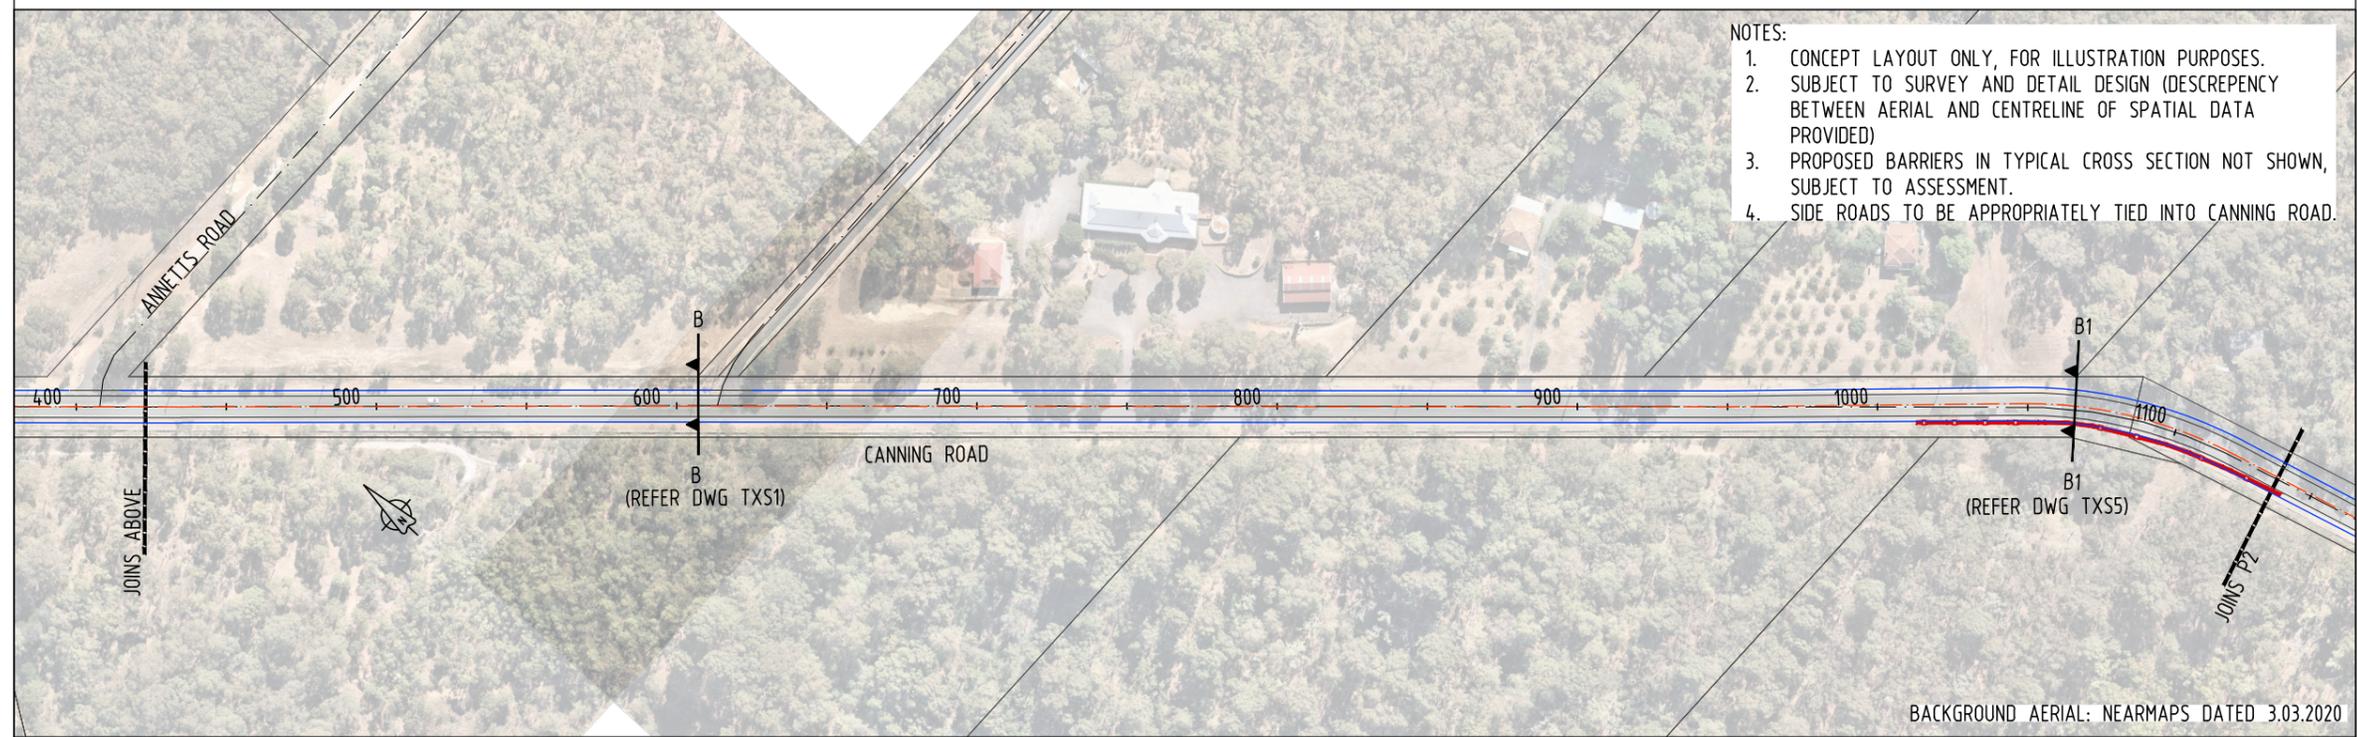
Project	CANNING ROAD, POMEROY ROAD TO SLK 14.56, ROAD SAFETY INVESTIGATION		Designed	GTT	25.08.2020	Donald Veal Consultants 6 Burgess Street Midland WA 6056 Telephone +61 8 9274 7076 Facsimile +61 8 9274 4854	
Title	CONCEPT LAYOUT (CHA 0 - 1150)		Drawn	GTT	25.08.2020		
Client	CITY OF KALAMUNDA		Checked	SY	25.08.2020		
			Approved				
			Scale	1:2000 AT A3		Project Number	LG362
						Drawing File Name	DVC-LG362 Rev1
						Drawing Number	P1
						Revision
