**BLACK SPOT PROGRAM**

NOMINATION FORM

FY2023/24

SPEED CUSHION
HALE-HAWTIN-BERKSHIRE RD
ROUNDABOUT
FORRESTFIELD

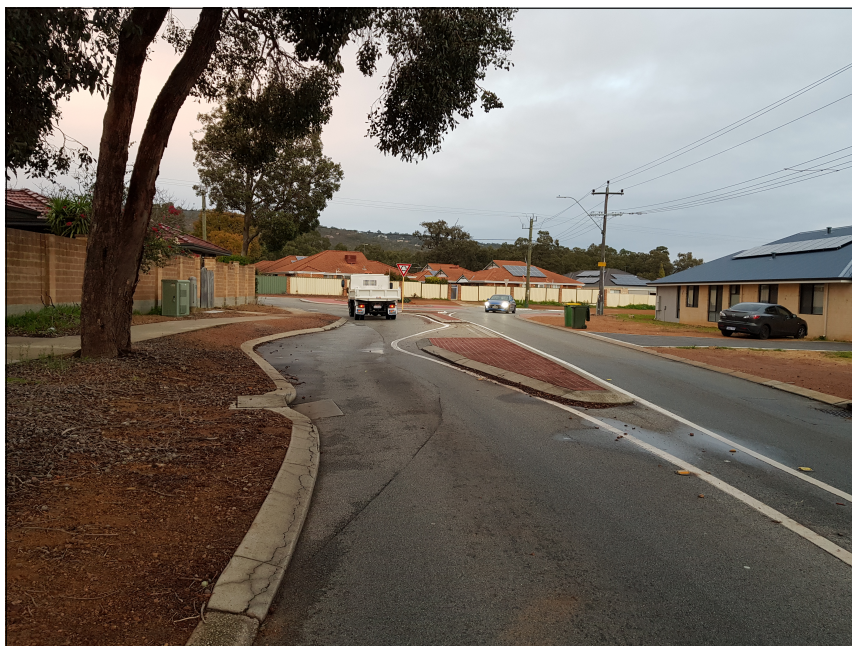
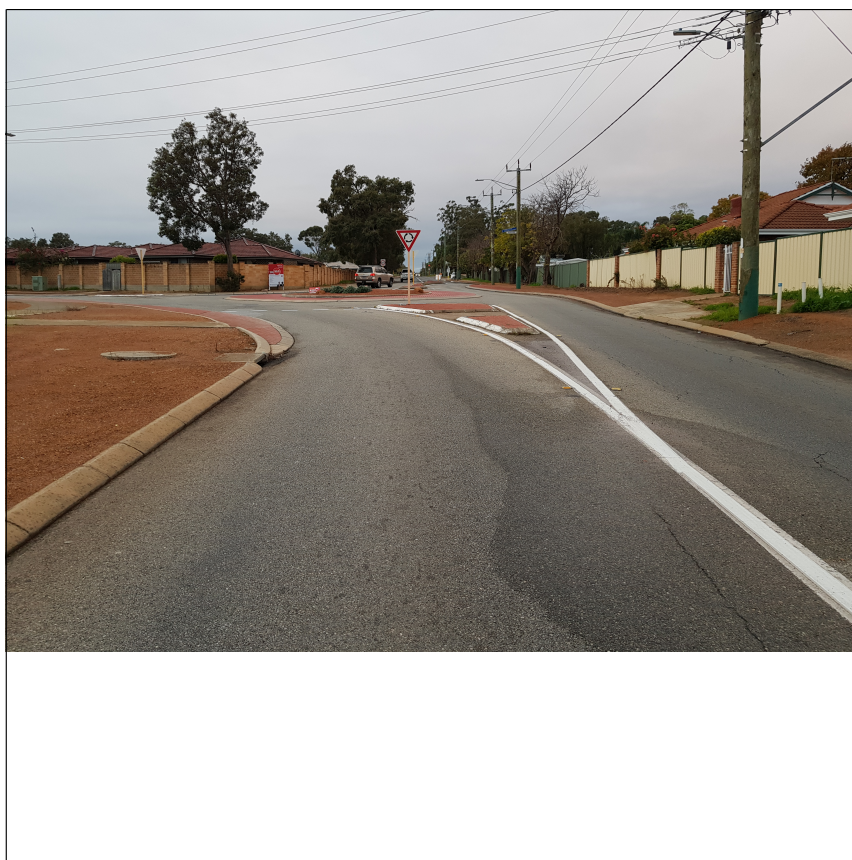
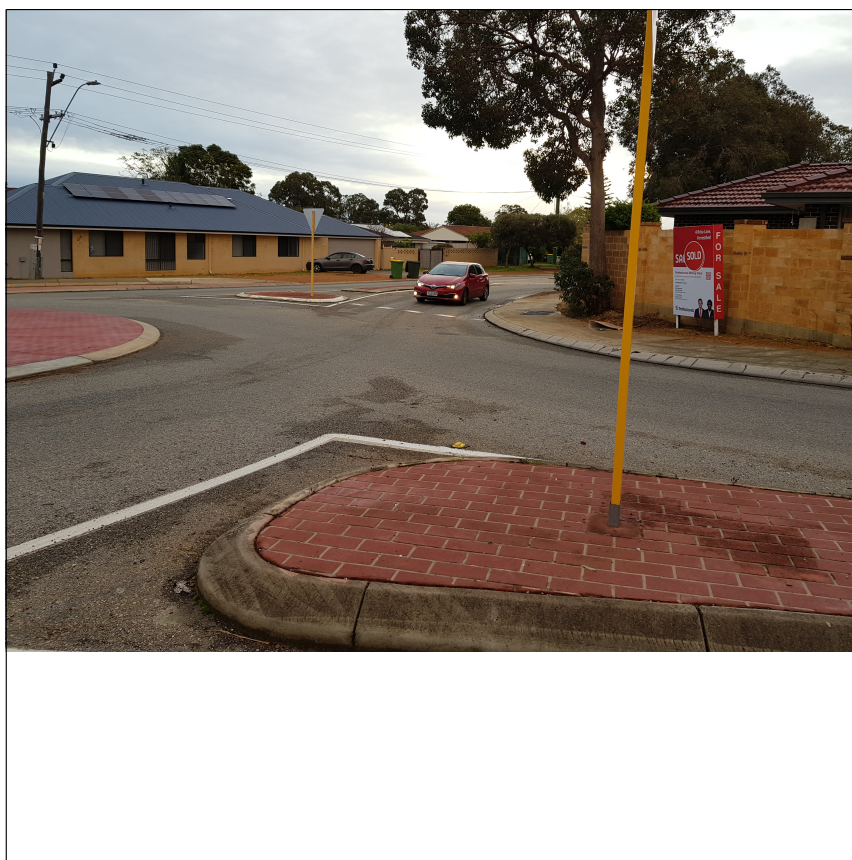
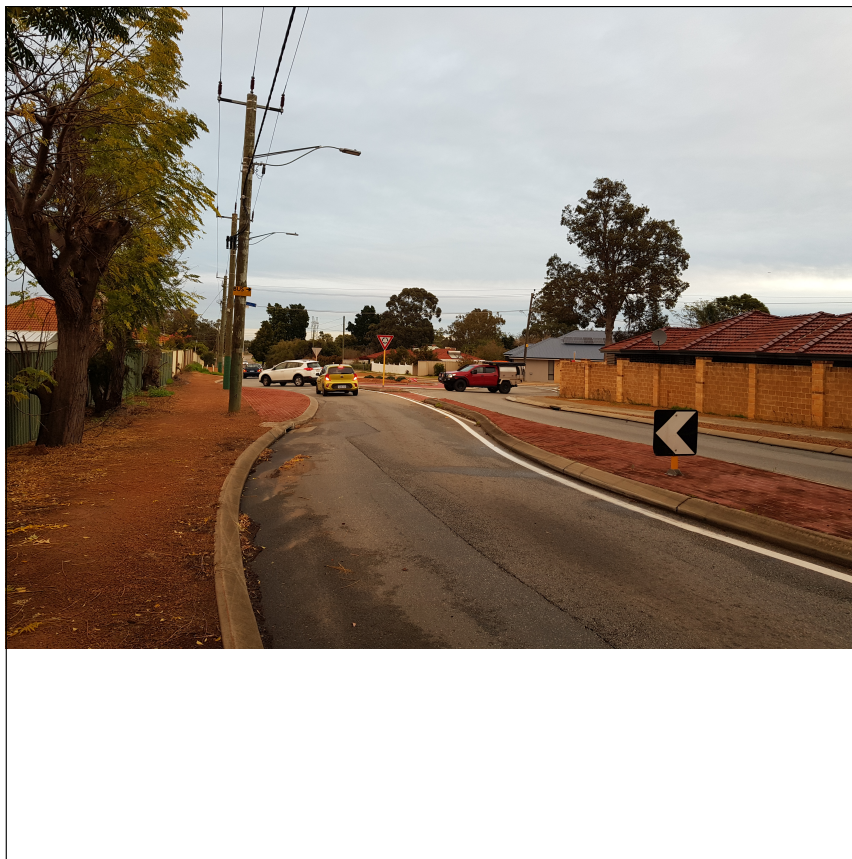
Inspection Photos

Site Description: Three way intersection with existing roundabout and minor pre-deflection on north and west legs. Moderate downhill gradient to the south. Surrounded by residential properties, with northern corner having a large wall that impedes sight lines for the northern leg traffic until the driver is at the holding line. Bus routes run through the intersection.

Existing pre-deflection on north and west side is not sufficient to slow traffic. In crash history, three crashes right angle eastbound colliding with southbound vehicle, suggests southbound drivers are not slowing and giving way. Two rear end crashes for western approach vehicles suggest drivers aren't slowing sufficiently on approach to the roundabout. This last concern is not recognised by Crash Map as being treatable by speed cushions.

Proposed speed cushion on northern approach leg only. Crash Map does not recognise the benefits of a speed cushion on the western or southern legs due to the crash types. The City will therefore be installing speed cushions on the western and southern approach legs separate to the Black Spot grant.

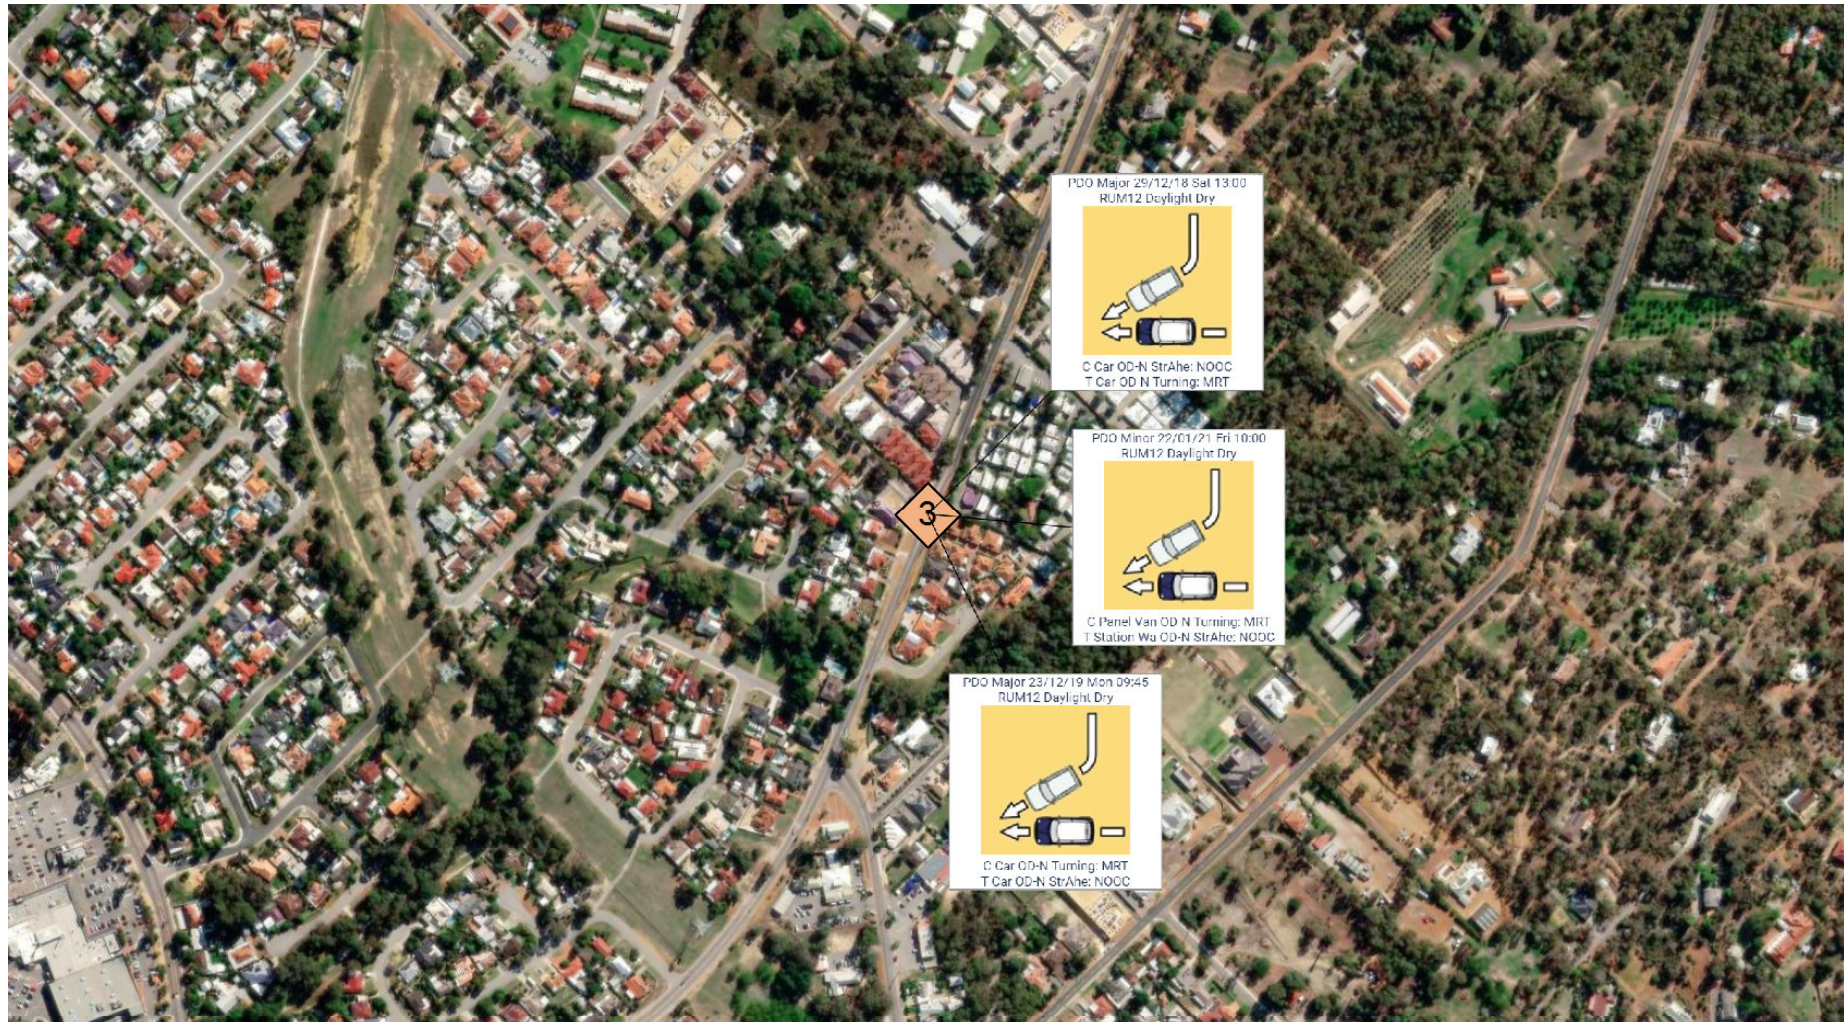
Collision Diagram for Treatment 3

Predominate crashes were three crashes involving colliding vehicle travelling from Berkshire to Hale crashing target vehicle travelling Hawtin to Hale. One rear end within roundabout from Hawtin approach, and two rear ends on Berkshire approach. All crashes are thought to arise from drivers approaching the intersection at too high speeds and not having time to react or slow down and give way safely.

Seven crashes, with three being right angle, and three being rear end, all property damage only. One crash arising from a WA Police pursuit leading to hospitalisation. All crashes were on level grade, daylight, in dry conditions.

3	Modify roundabout approaches to achieve safe operating speeds (e.g. pre-deflection or raised wombat crossings on approach legs)
---	---------------------------------------------------------------------------------------------------------------------------------
