Proposed Garden Centre, 720 Welshpool Road East, Wattle Grove

Preliminary Design Stage (Stage 2) Road Safety Audit

PREPARED FOR:
Peritas Group

November 2022

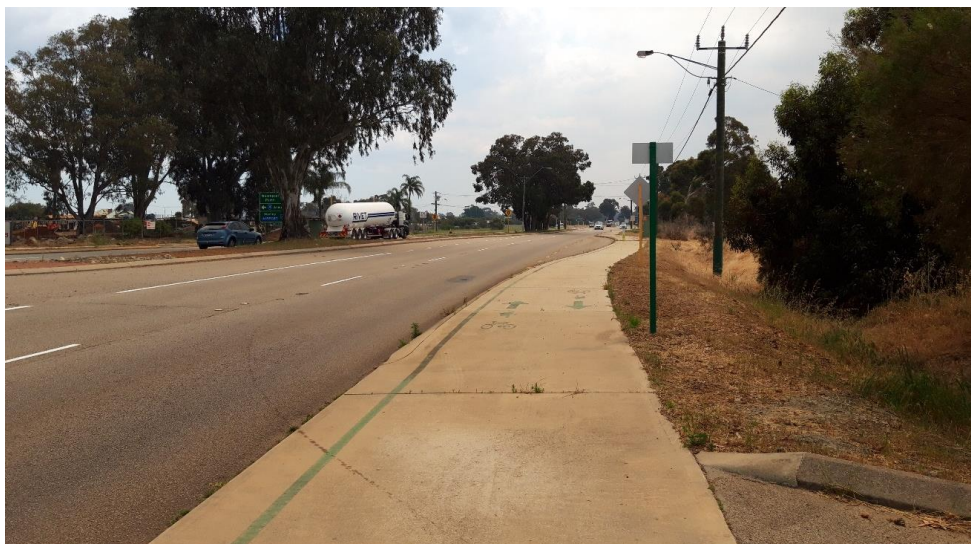
Figure 2: Westbound view along Welshpool Road East in the vicinity of the subject site

Welshpool Road East in the vicinity of the subject site is a four-lane dual carriageway road with a kerbed and landscaped central median. Each carriageway is approximately 7.4m wide and the median varies in width from approximately 4.5m near the western property boundary to approximately 8.5m wide near the eastern property boundary. Median breaks and turn pockets are provided at multiple locations in this vicinity. These turn pockets are not compliant with respect to the requirements of Austroads Guidelines as it relates to deceleration length requirements. A pedestrian footpath on the southern and a shared path on the northern side of Welshpool Road East is in place in the vicinity of the subject site.

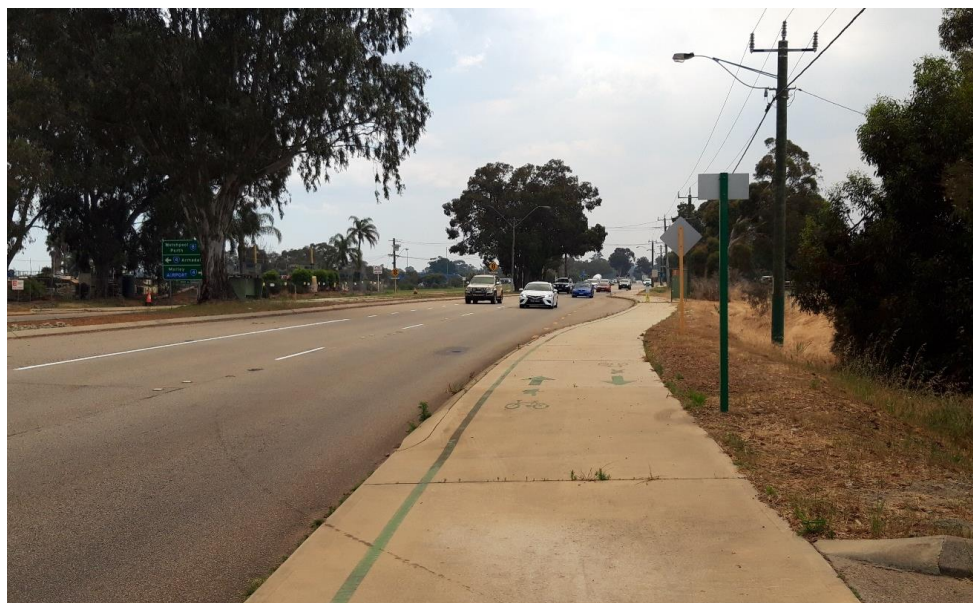
Figure 4: Westbound view along Welshpool Road East in the vicinity of the future garden centre crossover

The proposed left-turn deceleration facility for the new garden centre crossover incorporates an existing bus stop embayment. A bus parked within the embayment may impact on the sightlines to the Welshpool Road East traffic incoming from the west. Refer **Figure 4** for illustration.

This situation is potentially undesirable and can lead to drivers undertaking unsafe egress movements from the site as a result of restricted/inhibited sightlines.

Investigate sight lines at the proposed crossover when a bus is parked within the turn lane in accordance with AS2890.1 for a crossover/driveway. If the sight line is not adequate investigate the feasibility of relocation of the existing bus stop further east and downstream of the existing location or deeper within the verge through liaison with PTA in order to avoid impact on sightlines at the proposed garden centre crossover.
