ASBESTOS REGISTER

Anderson Road Community Centre, 24 Anderson Road, Forreestfield, WA

Report ID: **34724Br0**

Prepared for: **City of Kalamunda**

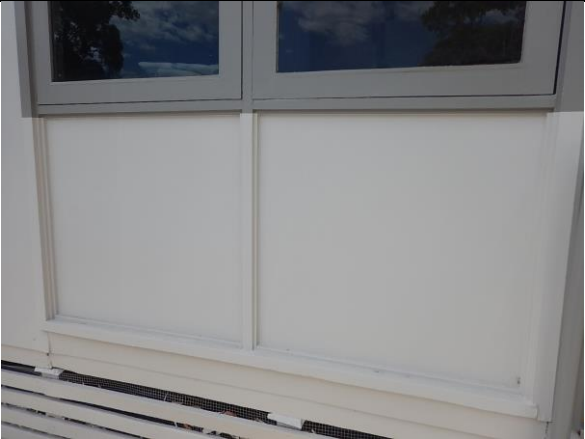
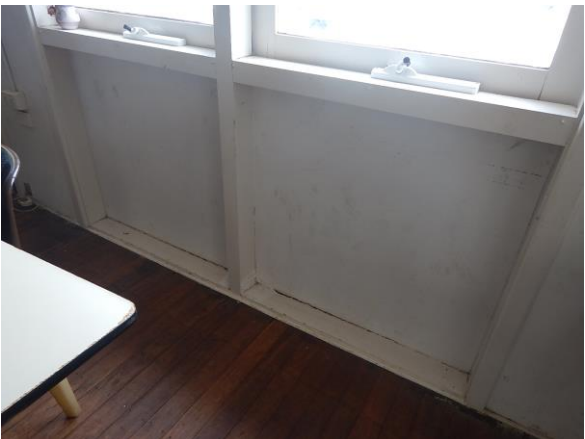
ID 2:- Fibre Cement Window Infill Panelling (Asbestos Detected)

Material	Chrysotile asbestos detected.	
Lab No.	Eurofins ARL Lab No. 21-10098-82.	
QED Sample No.	ID: 28204.	
Locations	External – Infill panels below windows.	
Condition	Good to fair, sealed, non-friable.	
Signage	Labelled.	
Potential for Disturbance	Low to medium.	
Risk	<p>The ACM are not friable and are in stable condition. Ensure that they remain clearly labelled and regularly inspect to ensure they are not deteriorating or otherwise contributing to an unacceptable health risk.</p>	
Management Actions	<p>Ensure inspections regularly occur on material; if damage/exposed areas are discovered, these areas should be encapsulated to ensure the material remain a low risk. May remain in-situ until replacement is required. Manage as per Asbestos Management Plan. Administrative – Follow safe work procedures during removal and maintenance. Personal protective equipment – P2 facemask and coveralls required when working on material.</p>

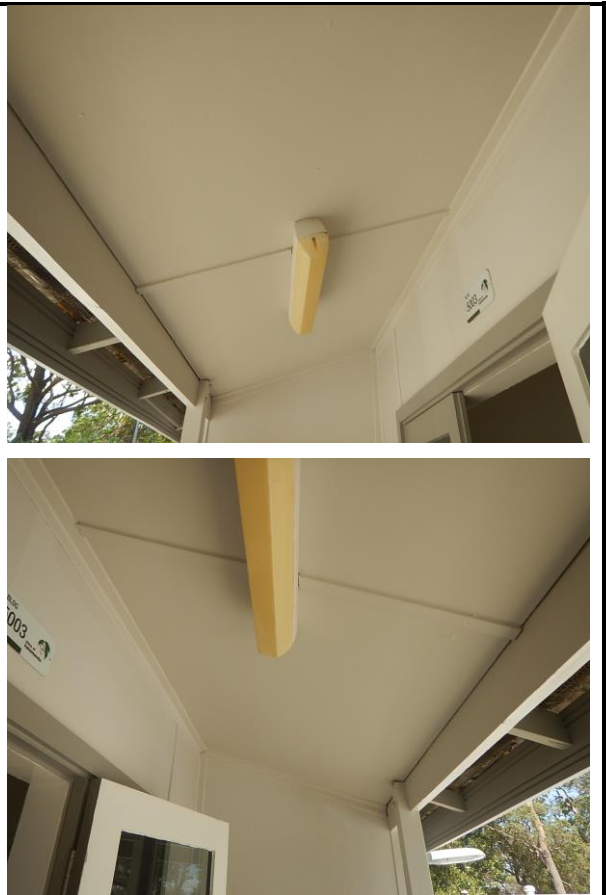
ID 3:- Fibre Cement Veranda Ceiling Panelling (Asbestos Detected)	
Material	Chrysotile and amosite asbestos detected.
Lab No.	Eurofins ARL Lab No. 21-10098-83.
QED Sample No.	ID: 28205.
Locations	External – Main Veranda/entry ceiling.
Condition	Good, sealed, non-friable.
Signage	Labelled.
Potential for Disturbance	Low to medium.
Risk	<p>The ACM are not friable and are in stable condition. Ensure that they remain clearly labelled and regularly inspect to ensure they are not deteriorating or otherwise contributing to an unacceptable health risk.</p>
Management Actions	<p>May remain in-situ until replacement is required. Manage as per Asbestos Management Plan. Administrative – Follow safe work procedures during removal and maintenance. Personal protective equipment – P2 facemask and coveralls required when working on material.</p>
References (See Appendices)	<p>Safe Work Australia, Code of Practice: How to Manage and Control Asbestos in the Workplace. WHS Appendix G—Recommended safe working practices Safe work practice 1—Drilling of ACM Safe work practice 2—Sealing, painting, coating and cleaning of asbestos cement products</p> <p>Safe Work Australia, Code of Practice: How to Safely Remove Asbestos Appendix E—Examples of asbestos removal work Asbestos cement products</p>

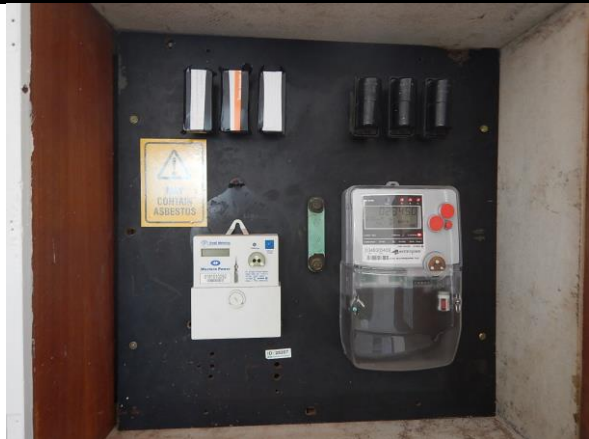
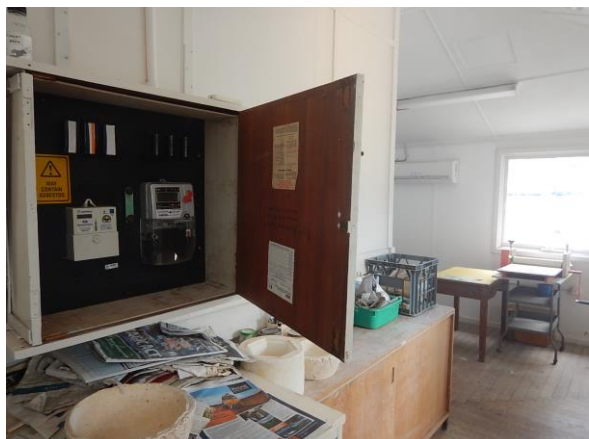
ID 4:- Electrical Mounting Board (Asbestos Detected)

Material	Chrysotile asbestos detected.	
Lab No.	Eurofins ARL Lab No. 21-10098-85.	
QED Sample No.	ID: 28207.	
Locations	Internal – Pottery room, electrical cabinet.	
Condition	Good, non-friable.	
Signage	Labelled.	
Potential for Disturbance	Low to medium.	
Risk	<p>The ACM are not friable and are in stable condition. Ensure that they remain clearly labelled and regularly inspect to ensure they are not deteriorating or otherwise contributing to an unacceptable health risk.</p>

Management Actions	<p>May remain in-situ until replacement is required. Manage as per Asbestos Management Plan. Administrative – Follow safe work procedures during removal and maintenance. Personal protective equipment – P2 facemask and coveralls required when working on material.</p>	
References (See Appendices)	<p>Safe Work Australia, Code of Practice: How to Manage and Control Asbestos in the Workplace. WHS Appendix G—Recommended safe working practices Safe work practice 5—Working on electrical mounting boards (switchboards) containing asbestos</p> <p>Safe Work Australia, Code of Practice: How to Safely Remove Asbestos Appendix E—Examples of asbestos removal work Asbestos cement products</p>

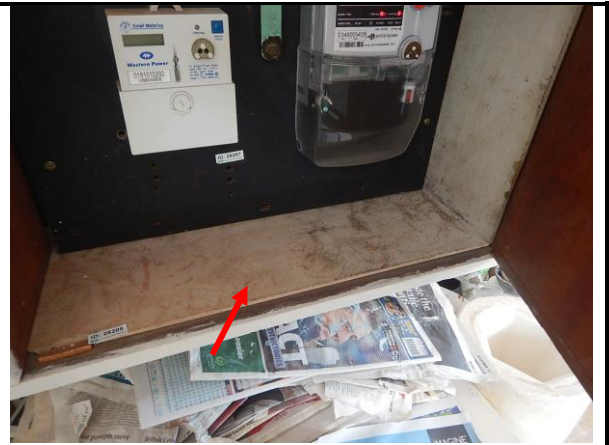
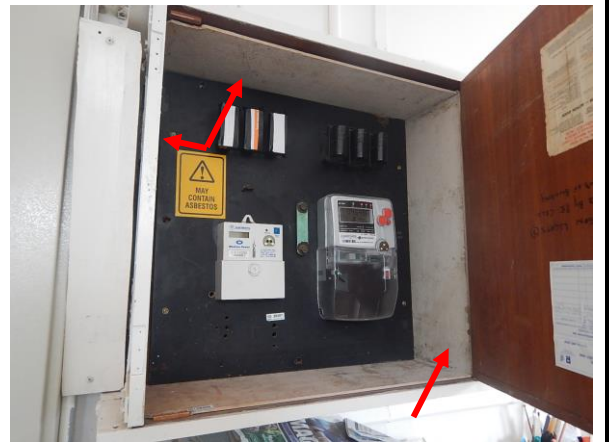
ID 5:- Electrical Cabinet Fibre Cement Lining (Asbestos Detected)	
Material	Chrysotile asbestos detected.
Lab No.	Eurofins ARL Lab No. 21-10098-86.
QED Sample No.	ID: 28208.
Locations	Internal – Pottery room, electrical cabinet (lining of cabinet).
Condition	Good to fair, unsealed, non-friable.
Signage	Labelled.
Potential for Disturbance	Low to medium.
Risk	<p>The ACM are not friable and are in stable condition. Ensure that they remain clearly labelled and regularly inspect to ensure they are not deteriorating or otherwise contributing to an unacceptable health risk.</p>
Management Actions	<p>Due to the material being unsealed, removal would be preferable, however encapsulation would extend the materials' serviceable life span. May remain in-situ until replacement is required. Manage as per Asbestos Management Plan. Administrative – Follow safe work procedures during removal and maintenance. Personal protective equipment – P2 facemask and coveralls required when working on material.</p>

ID #	Product	Location
5	Electrical Cabinet Fibre Cement Lining.	Internal – Pottery room, electrical cabinet (lining of cabinet).
	<i>Recommendations:</i> Due to the material being unsealed, removal would be preferable, however encapsulation would extend the materials' serviceable life span.	
10	Cable Sheathing.	Internal – Kiln Room, loose/stored mechanical equipment.
	<i>Recommendations:</i> Remove as soon as practical. Material/equipment is loose/stored.	
12	Under Sink Membrane.	External – Western area of site, Loose/stored equipment.
	<i>Recommendations:</i> Specific sampling may be required to determine asbestos containing material are removed. Until such a time as removal occurs, ensure access is restricted and materials are regularly inspected to ensure an unacceptable health risk is not present.

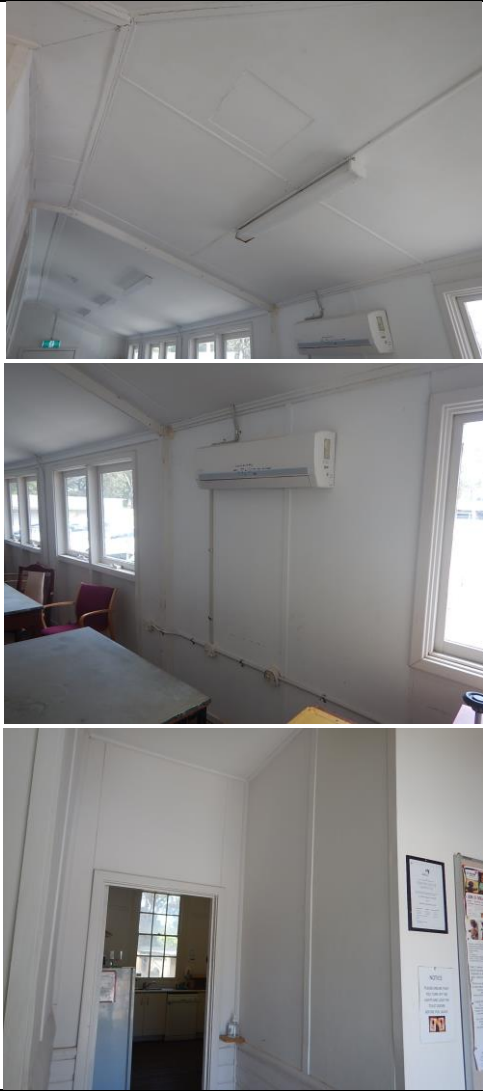
ID 6:- Fibre Cement Ceiling and Wall Panels (Asbestos Detected)

Material	Chrysotile and amosite asbestos detected.	
Lab No.	Eurofins ARL Lab No. 21-10098-87 (ceiling). Eurofins ARL Lab No. 21-10098-88 (walls).	
QED Sample No.	ID: 28209 (ceilings) 28210 (walls).	
Locations	Internal – Pottery room (including storeroom), foyer area near kitchen door, kitchen pantry, men’s shed office and eastern classroom – walls and ceilings.	
Condition	Good, sealed, non-friable.	
Signage	Labelled.	
Potential for Disturbance	Low to medium.	
Risk	<p>The ACM are not friable and are in stable condition. Ensure that they remain clearly labelled and regularly inspect to ensure they are not deteriorating or otherwise contributing to an unacceptable health risk.</p>	
Management Actions	May remain in-situ until replacement is required. Manage as per Asbestos Management Plan . Administrative – Follow safe work procedures during removal and maintenance. Personal protective equipment – P2 facemask and coveralls required when working on material.

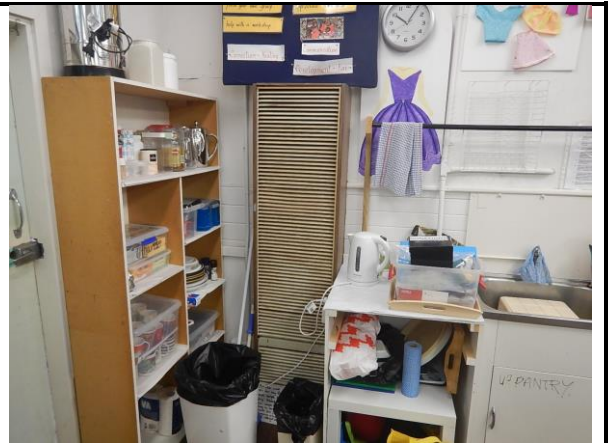
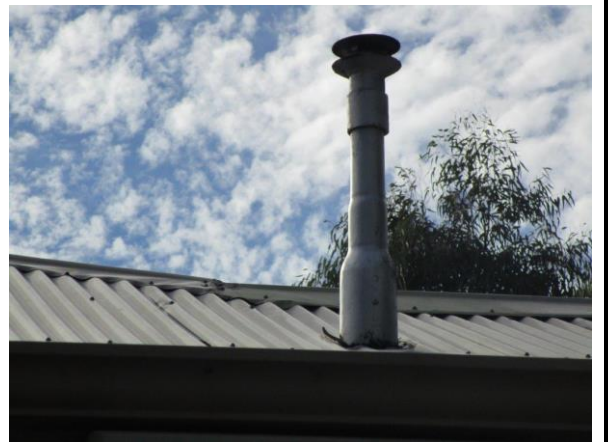
ID 7:- Fibre Cement Pipe/Flue (Suspected Asbestos Containing Material)	
Material	Suspected asbestos containing material.
Lab No.	N/A.
QED Sample No.	ID: Observed.
Locations	Internal – Throughout heating units on site – exhaust flue pipe.
Condition	Good, sealed, non-friable.
Signage	Labelled.
Potential for Disturbance	Low.
Risk	<p>The ACM are not friable and are in stable condition. Ensure that they remain clearly labelled and regularly inspect to ensure they are not deteriorating or otherwise contributing to an unacceptable health risk.</p>
Management Actions	<p>May remain in-situ until replacement is required. Manage as per Asbestos Management Plan. Administrative – Follow safe work procedures during removal and maintenance. Personal protective equipment – P2 facemask and coveralls required when working on material.</p>
References (See Appendices)	<p>Safe Work Australia, Code of Practice: How to Manage and Control Asbestos in the Workplace. WHS Appendix G—Recommended safe working practices Safe work practice 1—Drilling of ACM Safe work practice 2—Sealing, painting, coating and cleaning of asbestos cement products</p> <p>Safe Work Australia, Code of Practice: How to Safely Remove Asbestos Appendix E—Examples of asbestos removal work Asbestos cement products</p>

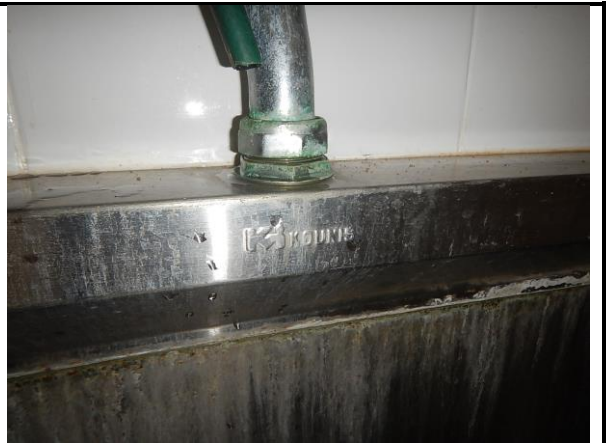
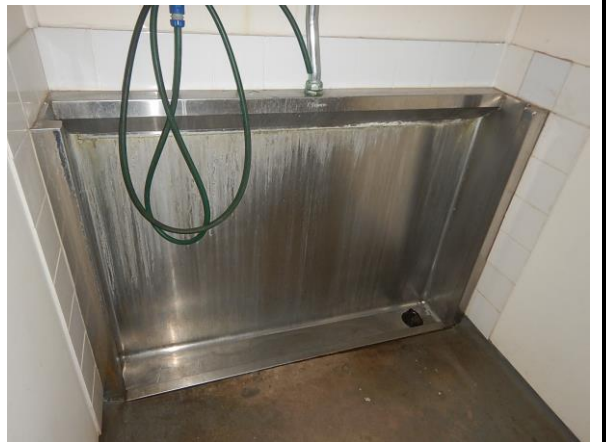
ID 8:- Urinal Backing Membrane (Kounis) (Suspected Asbestos Containing Material)	
Material	Suspected asbestos containing material.
Lab No.	Unable to sample (encapsulated)
QED Sample No.	ID: N/A.
Locations	Internal – Toilet Block, Male toilets
Condition	Encased, intact, non-friable.
Signage	Unable to adequately label.
Potential for Disturbance	Low.
Risk	<p>The ACM are not friable and are in stable condition. Ensure that they are regularly inspected to ensure they are not deteriorating or otherwise contributing to an unacceptable health risk.</p>
Management Actions	<p>May remain in-situ until replacement is required. Manage as per Asbestos Management Plan. Administrative – Follow safe work procedures during removal and maintenance. Personal protective equipment – P2 facemask and coveralls required when working on material.</p>
References (See Appendices)	<p>Safe Work Australia, Code of Practice: How to Manage and Control Asbestos in the Workplace. Safe Work Australia, Code of Practice: How to Safely Remove Asbestos Appendix E—Examples of asbestos removal work Removing bituminous (malthoid) products</p>

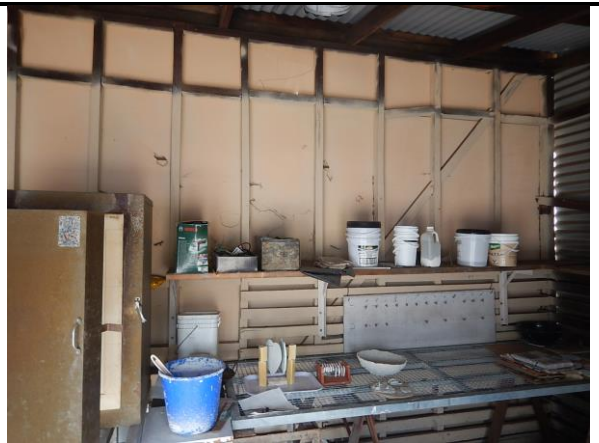
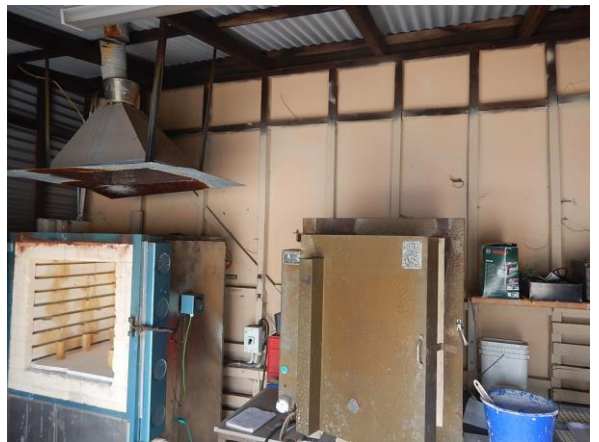
ID 9:- Fibre Cement Wall Panels (Suspected Asbestos Containing Material)	
Material	Suspected asbestos containing material.
Lab No.	N/A.
QED Sample No.	ID: Observed.
Locations	Internal – Kiln Room, upper wall panels.
Condition	Some damage, but edges sealed, non-friable.
Signage	Labelled.
Potential for Disturbance	Low to medium.
Risk	<p>The ACM are not friable and are in stable condition. Ensure that they remain clearly labelled and regularly inspect to ensure they are not deteriorating or otherwise contributing to an unacceptable health risk.</p>
Management Actions	<p>May remain in-situ until replacement is required. Manage as per Asbestos Management Plan. Administrative – Follow safe work procedures during removal and maintenance. Personal protective equipment – P2 facemask and coveralls required when working on material.</p>
References (See Appendices)	<p>Safe Work Australia, Code of Practice: How to Manage and Control Asbestos in the Workplace. WHS Appendix G—Recommended safe working practices Safe work practice 1—Drilling of ACM Safe work practice 2—Sealing, painting, coating and cleaning of asbestos cement products</p> <p>Safe Work Australia, Code of Practice: How to Safely Remove Asbestos Appendix E—Examples of asbestos removal work Asbestos cement products</p>

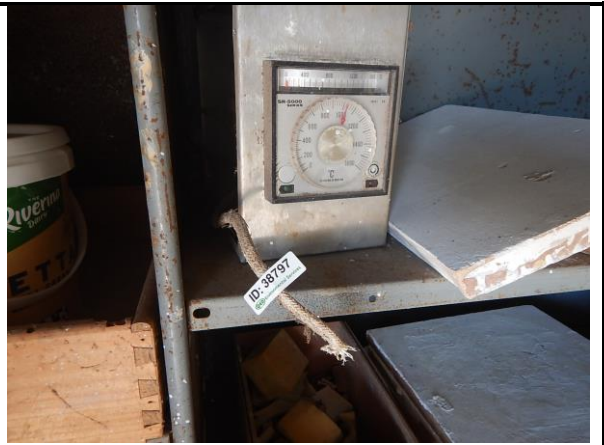
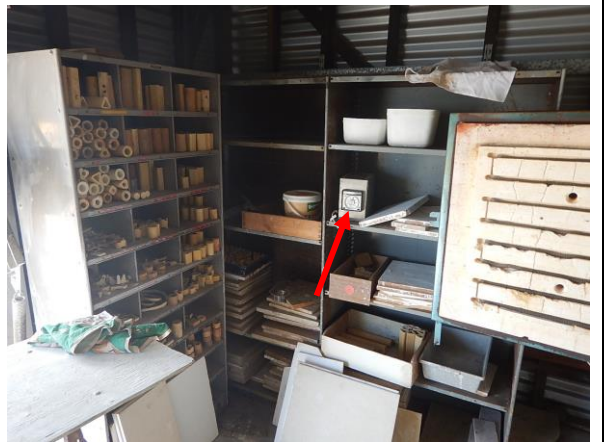
ID 10:- Cable Sheathing (Suspected Asbestos Containing Material)	
Material	Suspected asbestos containing material.
Lab No.	Unable to obtain suitable sample (sample restrictions).
QED Sample No.	ID: Observed.
Locations	Internal – Kiln Room, loose/stored mechanical equipment.
Condition	Fair, unsealed, friable.
Signage	None.
Potential for Disturbance	Medium.
Risk	<p>The ACM are not friable and are in stable condition. Ensure that they remain clearly labelled and regularly inspect to ensure they are not deteriorating or otherwise contributing to an unacceptable health risk.</p>
Management Actions	<p>Remove as soon as practical. Material/equipment is loose/stored. May remain in-situ until replacement is required. Manage as per Asbestos Management Plan. Administrative – Follow safe work procedures during removal and maintenance. Personal protective equipment – P2 facemask and coveralls required when working on material.</p>

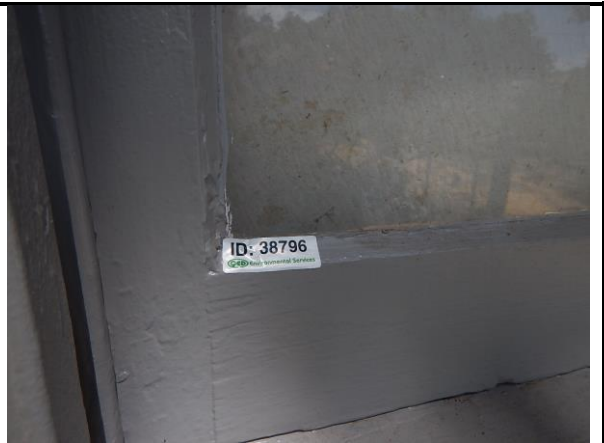
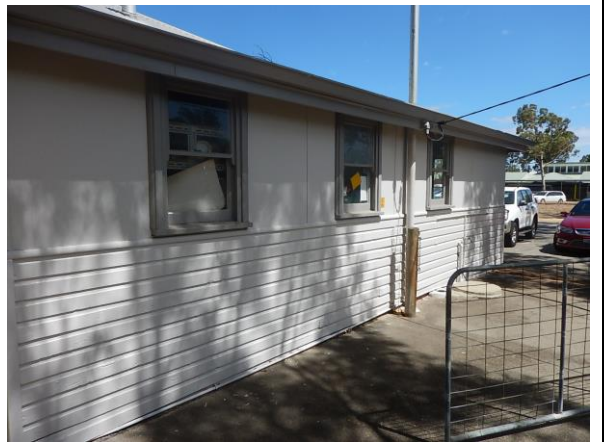
ID 11:- Window Mastic (Asbestos Detected)	
Material	Suspected asbestos containing material.
Lab No.	Unable to obtain suitable sample (sample restrictions).
QED Sample No.	ID: Observed.
Locations	External – Building perimeter, windows.
Condition	Good, intact, non-friable.
Signage	None.
Potential for Disturbance	Low.
Risk	<p>The ACM are not friable and are in stable condition. Ensure that they remain clearly labelled and regularly inspect to ensure they are not deteriorating or otherwise contributing to an unacceptable health risk.</p>
Management Actions	<p>Label when practical.</p> <p>Due to the potential variety of mastics used throughout the windows within the building, it is recommended that specific sampling be conducted prior to disturbance or removal of windows within the building or if the condition of the material deteriorates.</p> <p>Manage as per Asbestos Management Plan.</p> <p>Administrative – Follow safe work procedures during removal and maintenance.</p> <p>Personal protective equipment – P2 facemask and coveralls required when working on material.</p>

Window mastics were observed within the window frames of the building. It is assumed that the mastic contains asbestos. However, due to the potential variety of mastics used throughout the building and the potential for variation in the installation dates, it is recommended that specific sampling be conducted prior to disturbance or removal of windows or if the condition of the material deteriorates.

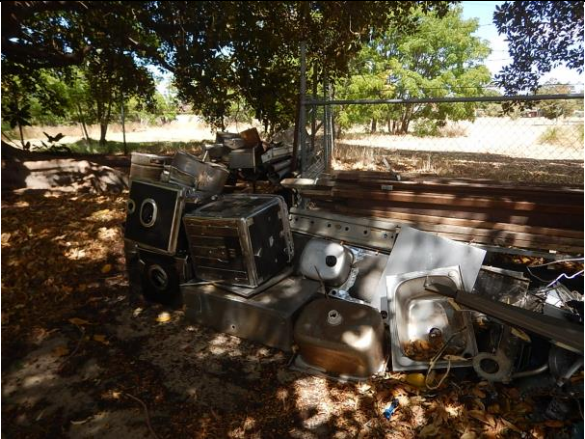
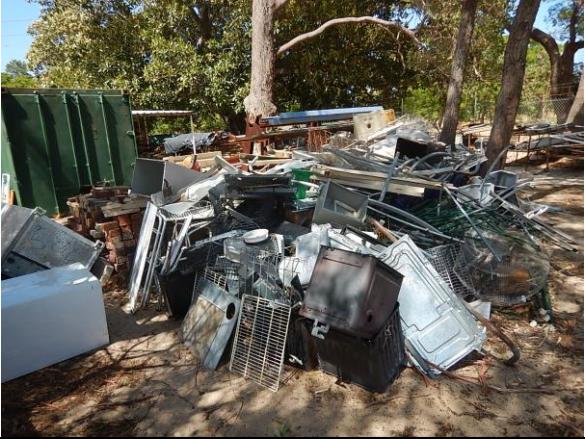
ID 12:- Under Sink Membrane (Suspected Asbestos Containing Material)

Material	Suspected asbestos containing material.	
Lab No.	N/A.	
QED Sample No.	ID: Observed.	
Locations	External – Western area of site, Loose/stored equipment.	
Condition	Varying.	
Signage	None.	
Potential for Disturbance	Medium.	
Risk	<p>The ACM are not friable and are in stable condition. Ensure that they remain clearly labelled and regularly inspect to ensure they are not deteriorating or otherwise contributing to an unacceptable health risk.</p>

Management Actions	<p>Specific sampling may be required to determine asbestos containing material are removed. Until such a time as removal occurs, ensure access is restricted and materials are regularly inspected to ensure an unacceptable health risk is not present.</p> <p>Manage as per Asbestos Management Plan.</p> <p>Administrative – Follow safe work procedures during removal and maintenance.</p> <p>Personal protective equipment – P2 facemask and coveralls required when working on material.</p>

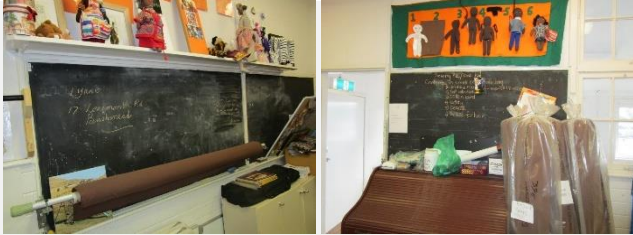
Item Description	Lab No.	Location	Photo	Comments
Chalkboards	Eurofins ARL Lab No. 21-10098-92 QED ID: 28214	Left & right classroom.

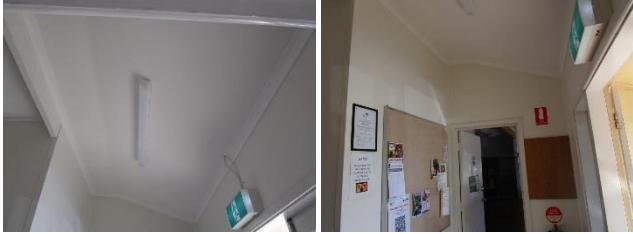
No asbestos detected. Organic fibres detected.
Main foyer area Wall & Ceiling	N/A	Main foyer area

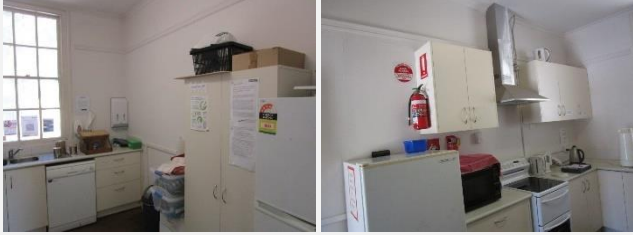
Removed 2019. Information taken from the City of Kalamunda register: Building: Anderson Road Community Centre Asset ID: BD_5003-00 Date Inspected: Feb-2019
Kitchen wall cladding	Eurofins ARL Lab No. 21-10098-93 QED ID: 28215	Kitchen area
