# ASBESTOS MATERIALS REGISTER

Report ID: 28635r1 – Supersedes  
28635r0

**Building 7068 – Maida Vale Reserve Kiosk,  
Acacia Road, Maida Vale WA 6057**

**Reinspection conducted by City of Kalamunda**

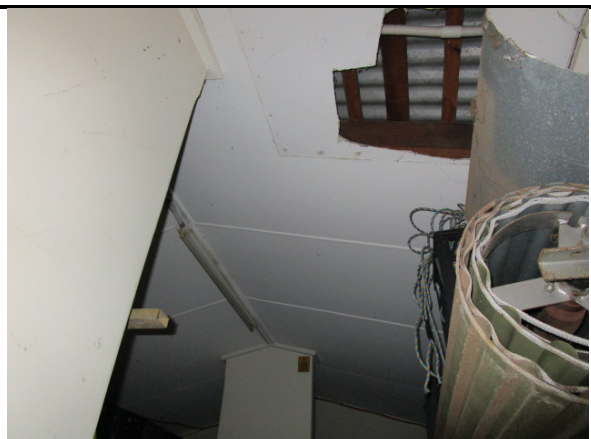
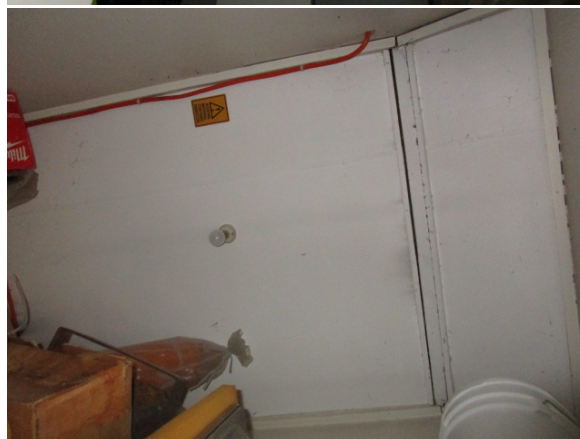
ID 1:- Ceiling Panelling (Asbestos Detected)	
Material	Chrysotile asbestos detected.
Lab No.	ARL Lab No. 21-04932-A-1.
QED Sample No.	ID: 32410.
Locations	Main kiosk and small storeroom ceilings.
Condition	Fair, typically sealed, however damaged in the main kiosk area, non-friable.
Signage	Labelled.
Potential for Disturbance	Low.
<b>Risk</b>	<p>The ACM are not friable and are in stable condition. In accordance with [NOHSC: 2018 (2005)], ensure that they remain clearly labelled and regularly inspect to ensure they are not deteriorating or otherwise contributing to an unacceptable health risk.</p>
Management Actions	<p>May remain in-situ until replacement is required.</p> <p>Manage as per <b>Asbestos Management Plan</b>.</p> <p>Administrative – Follow safe work procedures during removal and maintenance.</p> <p>Personal protective equipment – P2 facemask and coveralls required when working on material.</p>

Photos from March 2021 inspection.

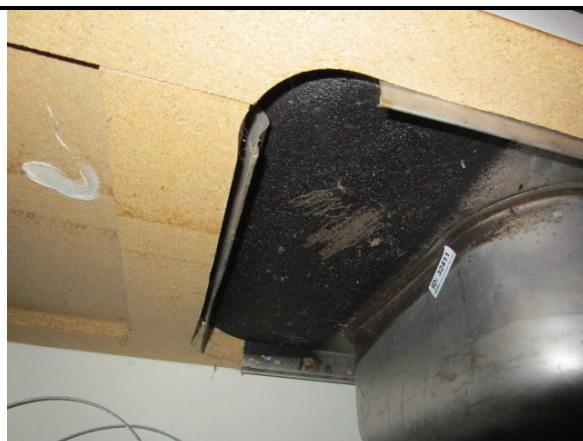
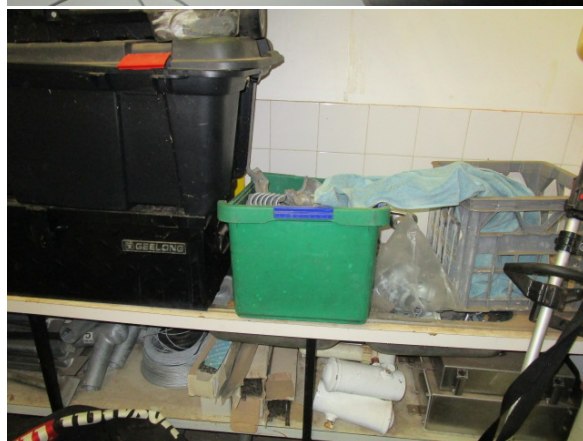
ID 2:- Under Sink Membrane (Asbestos Detected)	
Material	Chrysotile asbestos detected.
Lab No.	ARL Lab No. 21-04932-A-1.
QED Sample No.	ID: 32410.
Locations	Underneath the main kiosk sink.
Condition	Good, intact, non-friable.
Signage	None.
Potential for Disturbance	Medium.
<b>Risk</b>	<p>The ACM are not friable and are in stable condition. In accordance with [NOHSC: 2018 (2005)], ensure that they remain clearly labelled and regularly inspect to ensure they are not deteriorating or otherwise contributing to an unacceptable health risk.</p>
Management Actions	<p>Label immediately. May remain in-situ until replacement is required. Manage as per <b>Asbestos Management Plan</b>. Administrative – Follow safe work procedures during removal and maintenance. Personal protective equipment – P2 facemask and coveralls required when working on material.</p>
References (See Appendices)	<p>NOHSC 2018 (2005) Appendix C: Selection and use of Personal Protective Equipment (PPE). NOHSC 2002 (2005) Part 12 Section 12.6 Removal of Asbestos Mastics and Bitumen.</p>

Photos from March 2021 inspection.

Service Record	<p>Review in 12 Months – December 2022. Company: Date: Works: Clearance certificate:</p>
