September 2022 Final

Mundaring Weir Rd - Road Safety Investigation

Prepared For: City of Kalamunda

Final Report

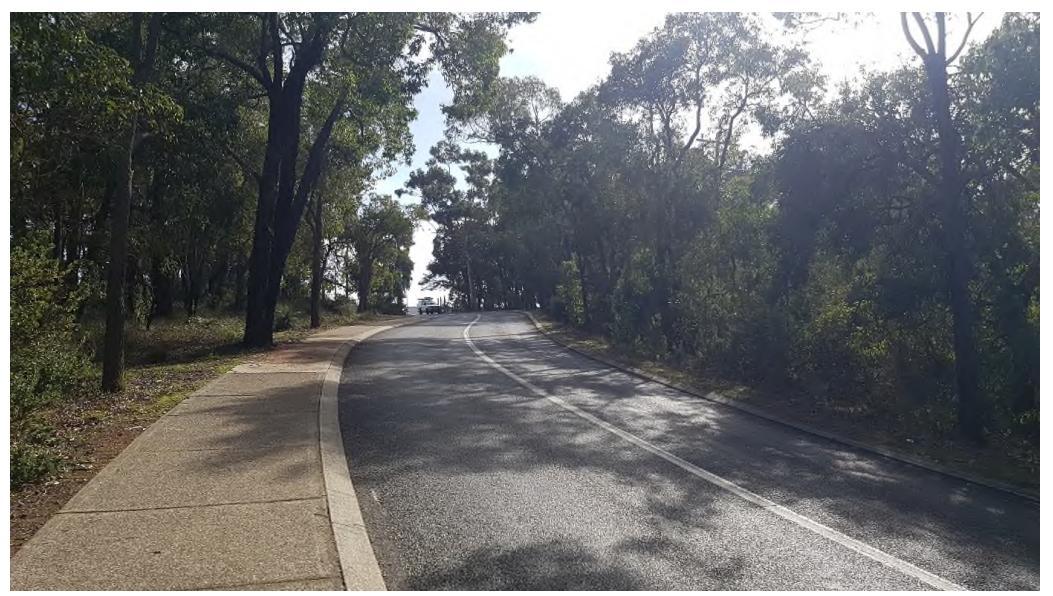
Photo 1: Bends on approach to the Railway Road roundabout, looking west.

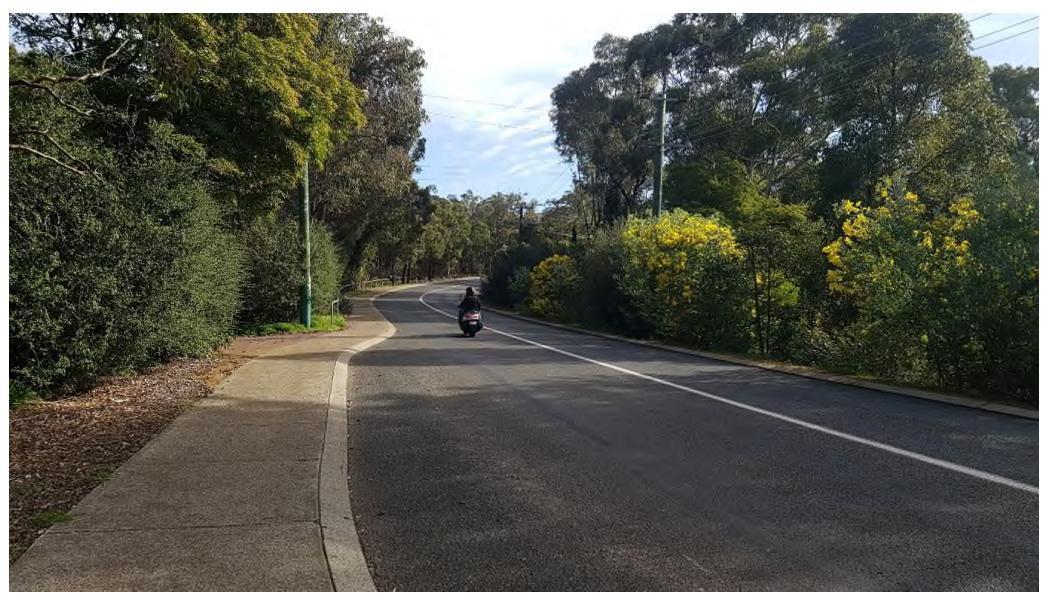
Photo 2: Motorcycle approaching bend just west of Schmitt Road.

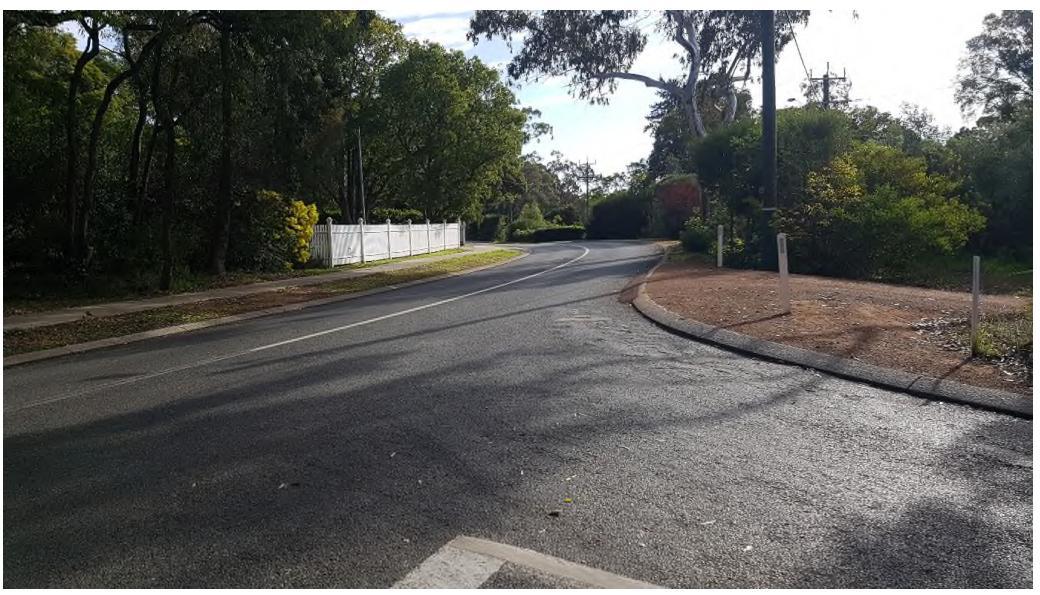
Photo 3: The bend near Hummerston Road lies within the 60 km/h speed limit zone.

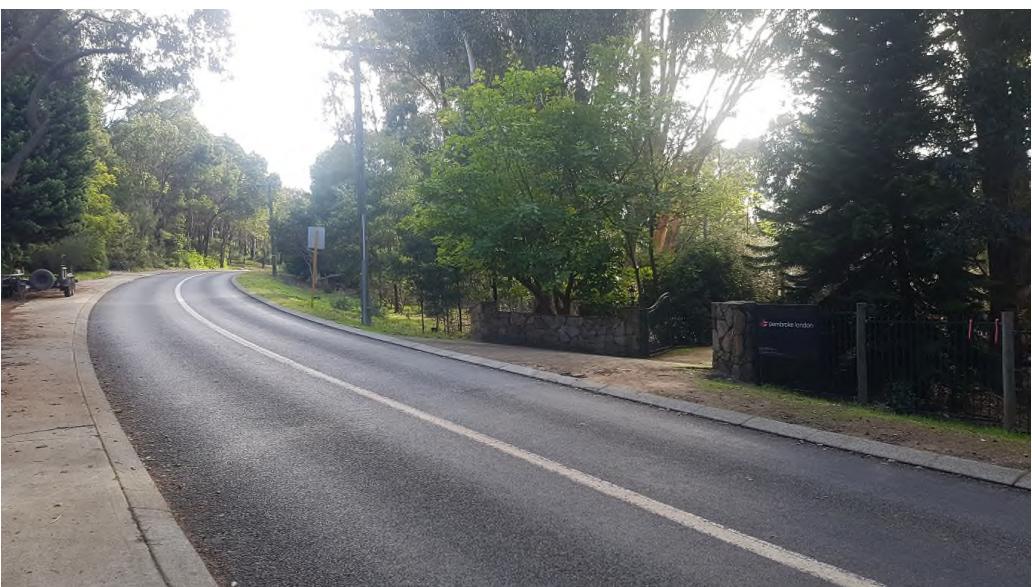
Photo 4: Bend in Mundaring Weir Road, east of King Road, looking west

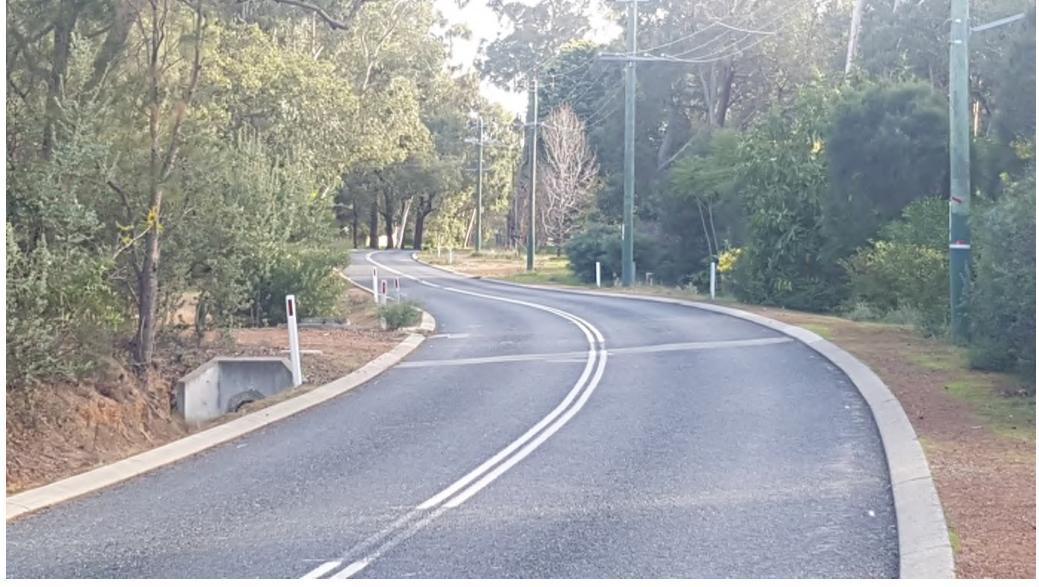
Photo 5: Curves on Mundaring Weir Road between Croxton Road and Hinkler Road, looking west.

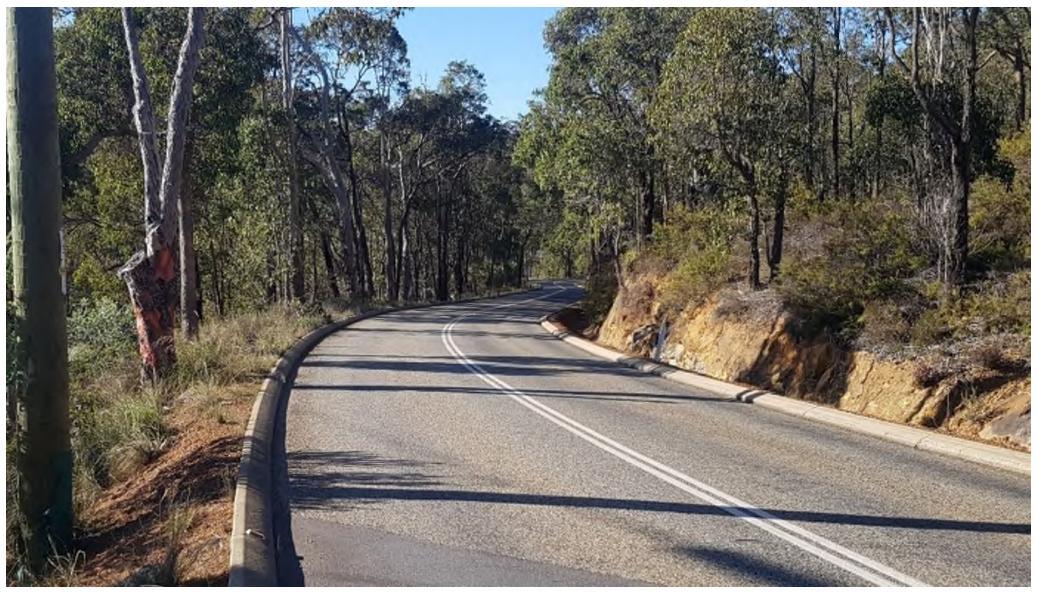
Photo 6: Typical s-bends within this section of Mundaring Weir Road, between Croxton Road and Aldersyde Road.

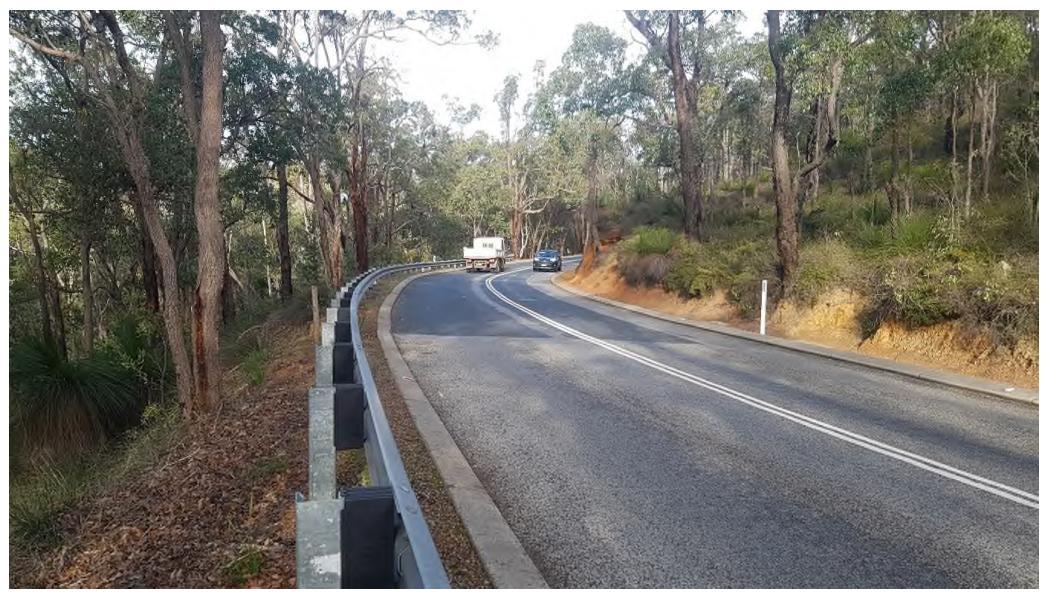
Photo 7: Typical bend within this section, equipped with safety fencing, west of Aldersyde Road.

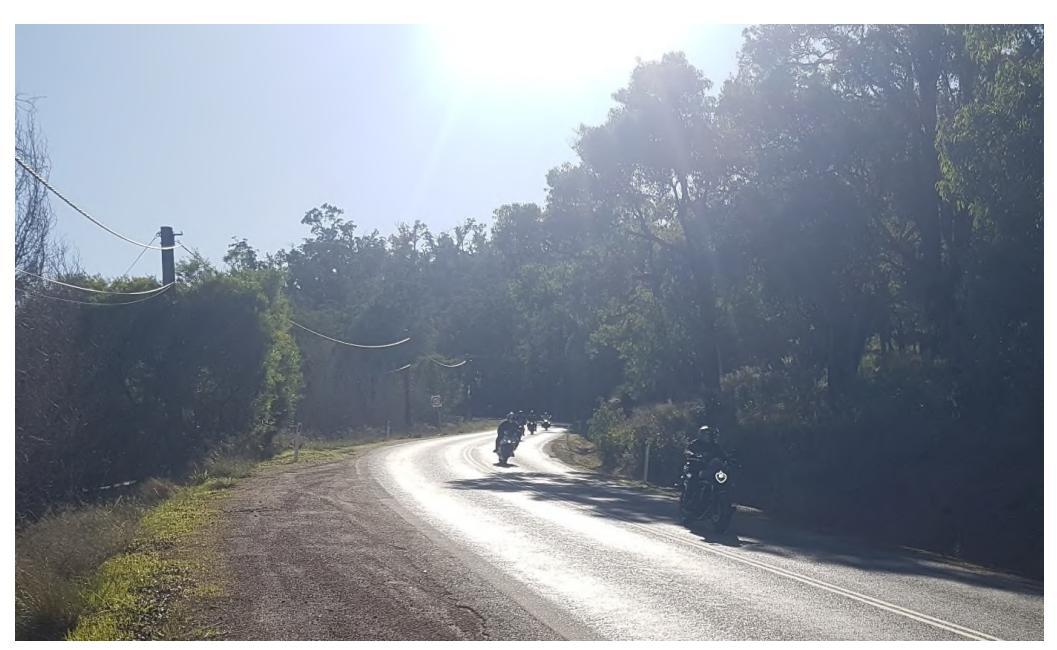
Photo 8: Motorcyclists enjoying the sweeping curves of Mundaring Weir Road, north of Aldersyde Road.

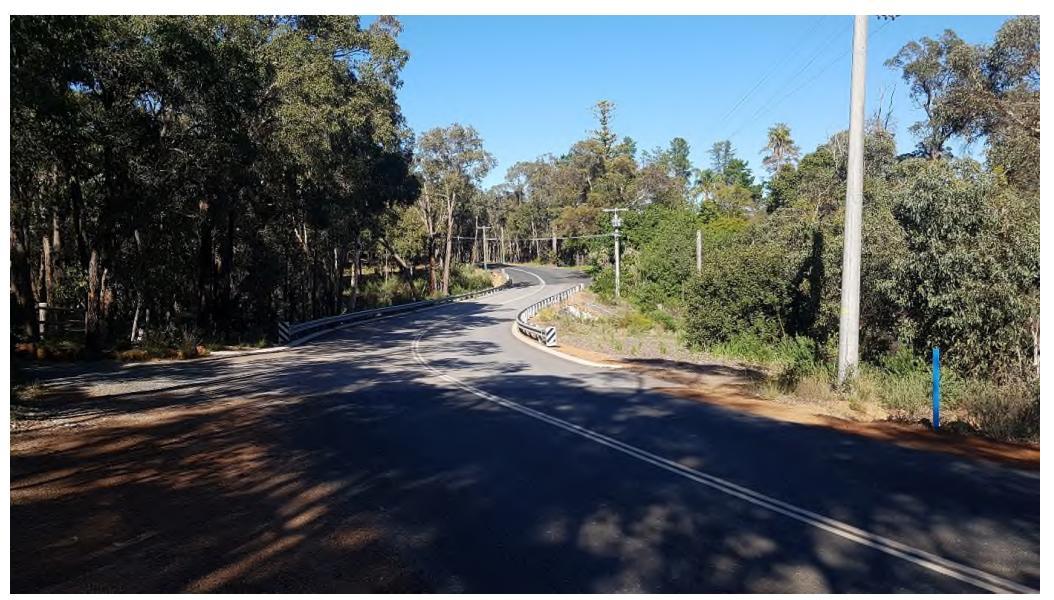
Photo 9: Curves over the bridge near Chalet Rigi.

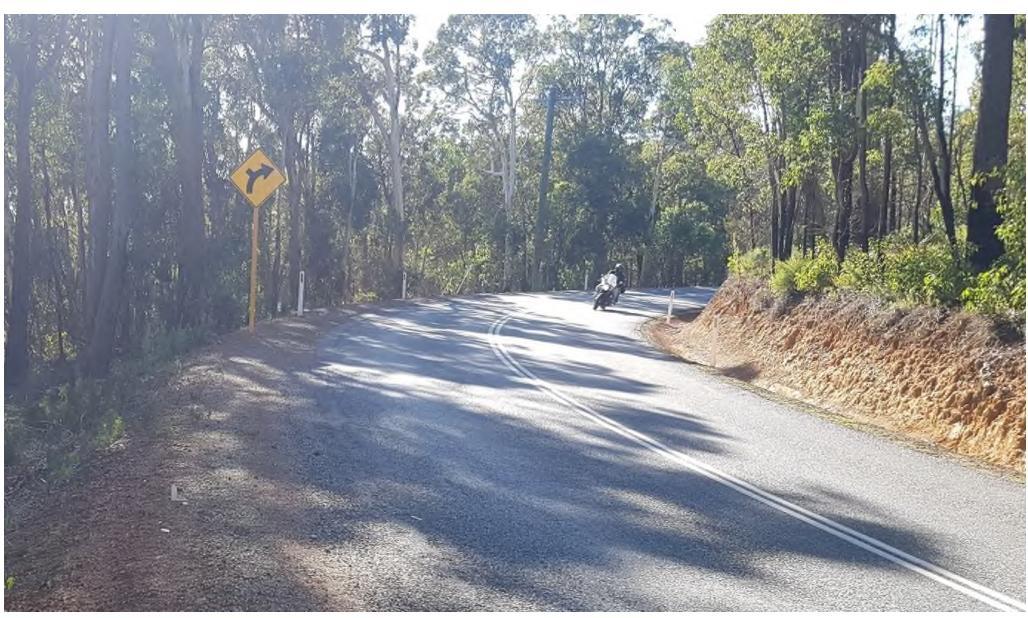
Photo 10: Motorcyclist negotiating the bend just west of Fern Road.

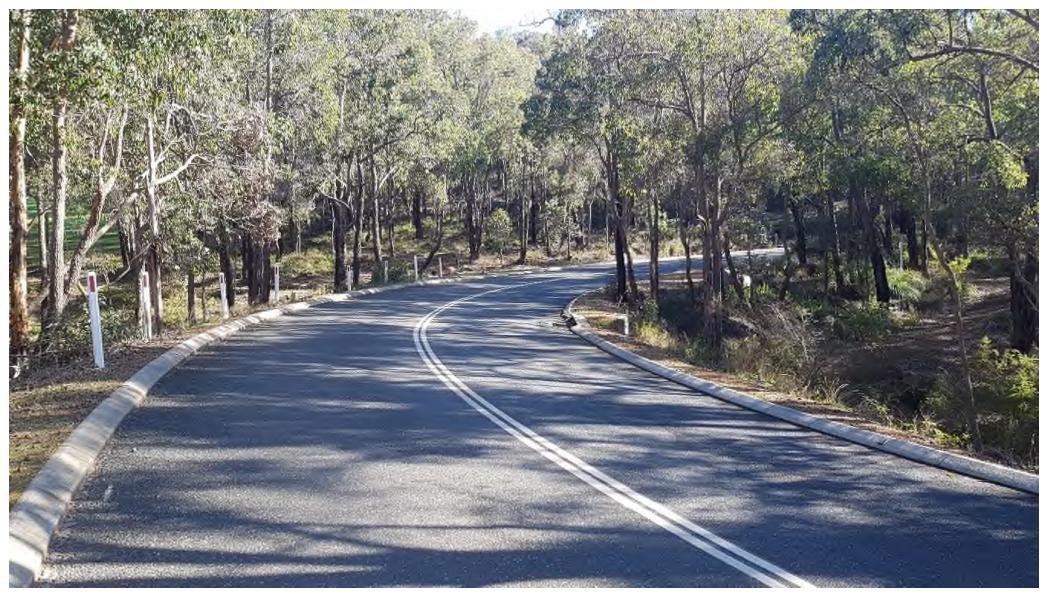
The exceptions to the above include the sharp bend at Chainage 3400, just northwest of the northern Aldersyde Road intersection. This bend is estimated to have a radius of around 35m and a corresponding operating speed of 50 km/h. However, advisory 40km/h signs are already installed on both approaches. See **Photos 11 to 12a**.

Photo 11: This bend has a radius of around 55m.

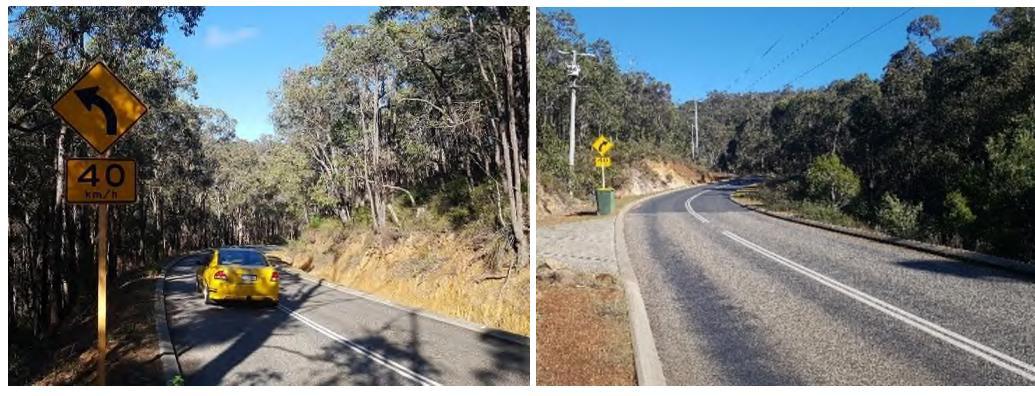
Photos 12 & 12a: Advisory speed signs are already installed.

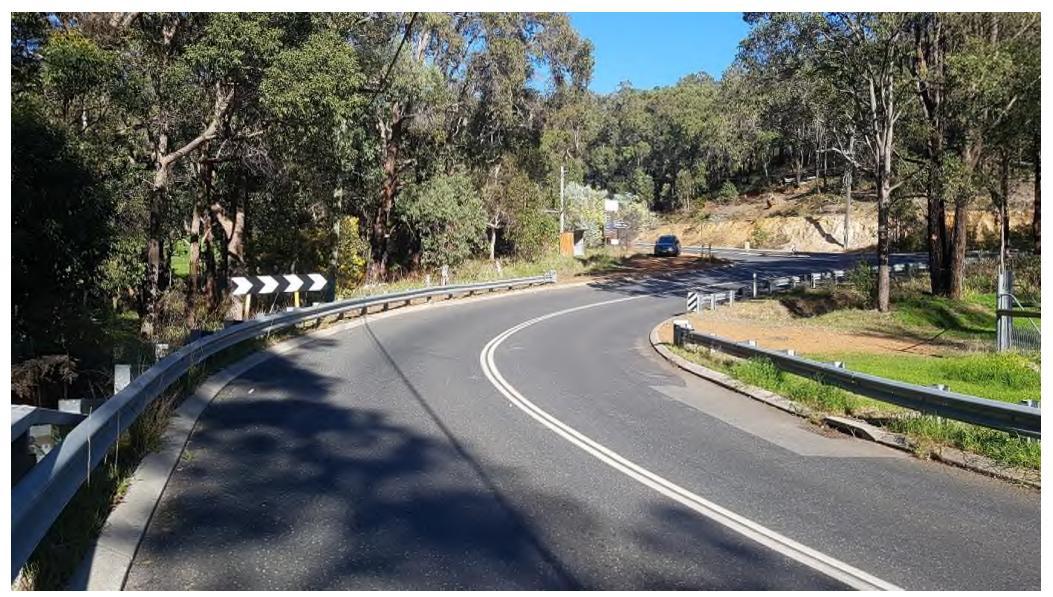
Also located within this section is the sharp curve at Chainage 3900, adjacent the southern Aldersyde Road intersection. This is estimated to have a radius of only 35m, and therefore requires a maximum operating speed of 30 km/h.

Photo 13: This bend has a radius of approximately 35m.

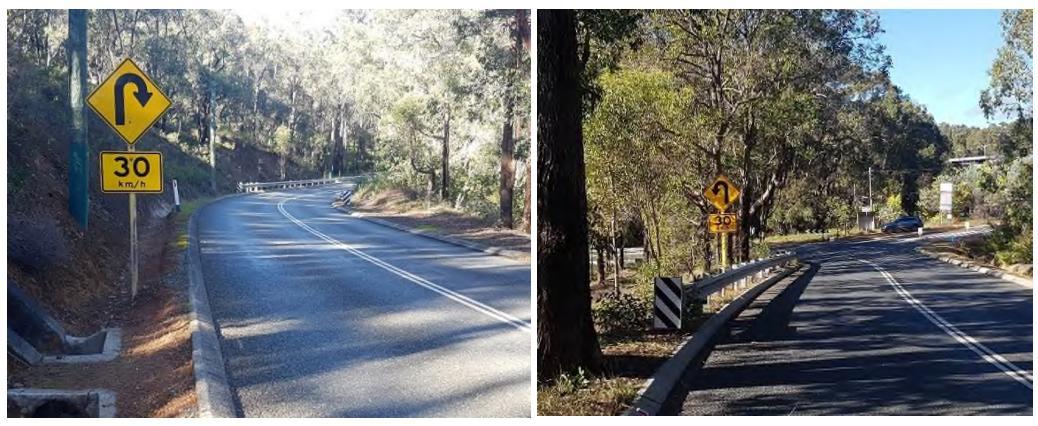
As can be seen in **Photos 13 to 14a**, advisory speed signs are already installed on both approaches to this location.

Photos 14 & 14a: Advisory speed signs installed on both approaches.

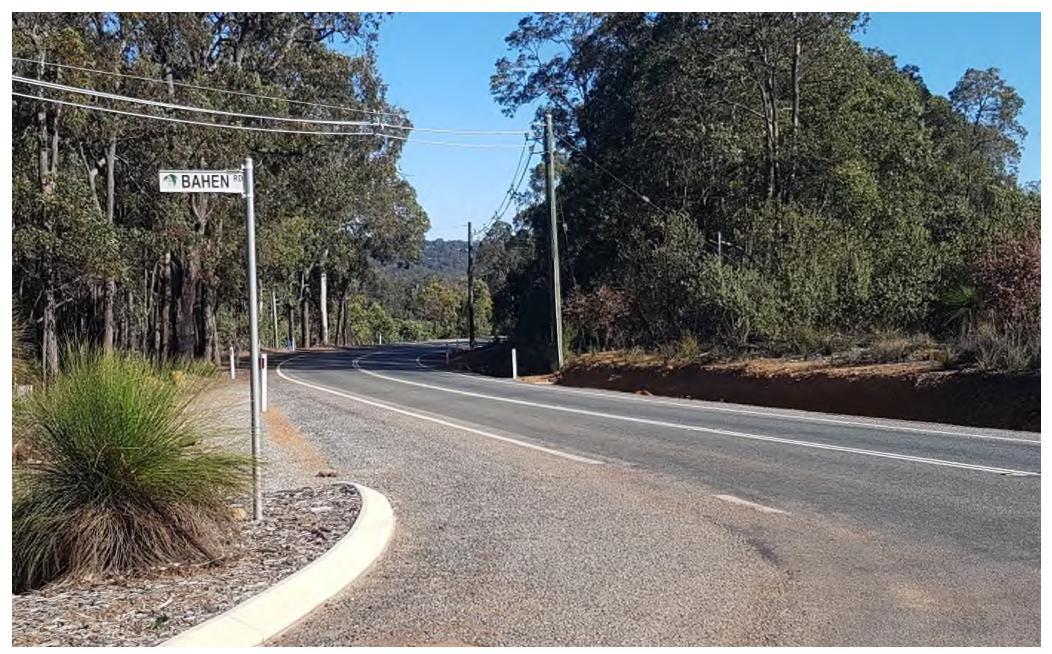
Photo 15: Sharp bend just west of Bahen Road intersection.

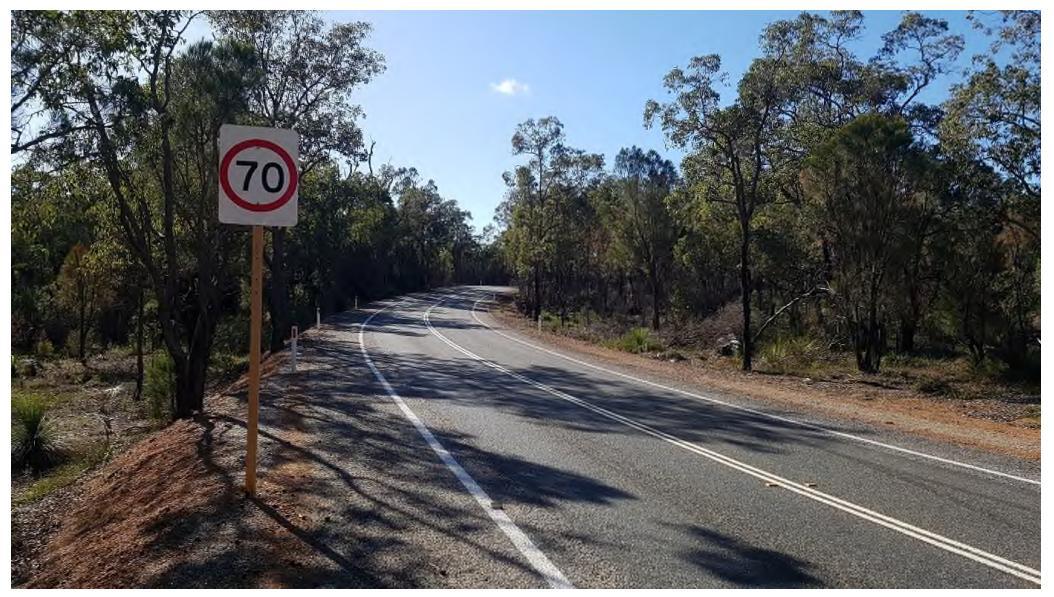
Photo 16: Horizontal and vertical curves between Paulls Valley Road and Asher Road intersections.

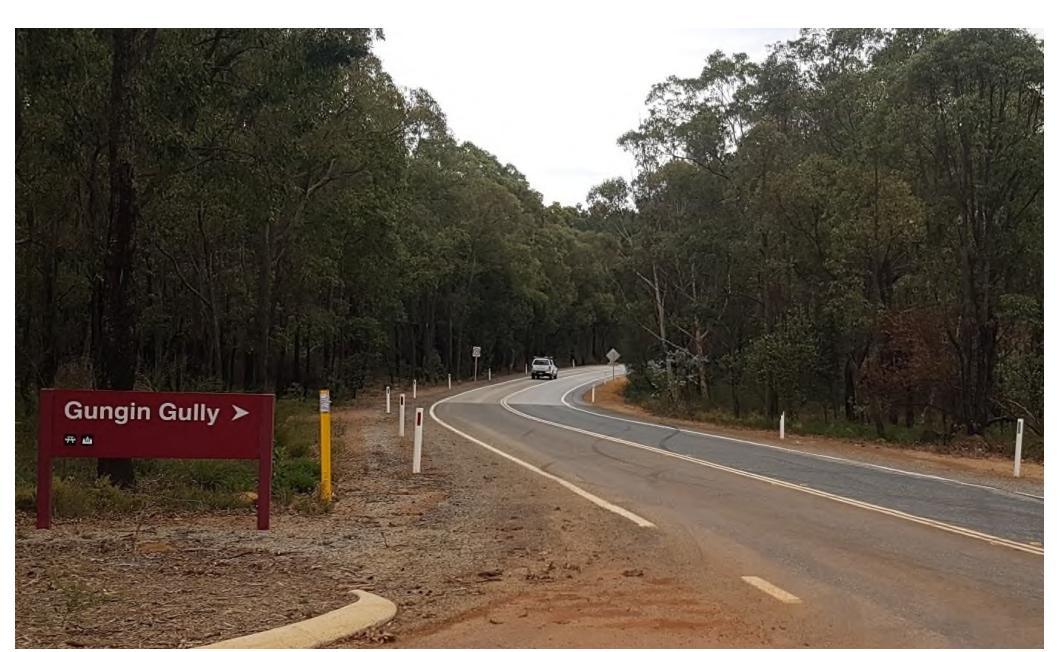
Photo 17: Bend to the west of Lockwood Road.

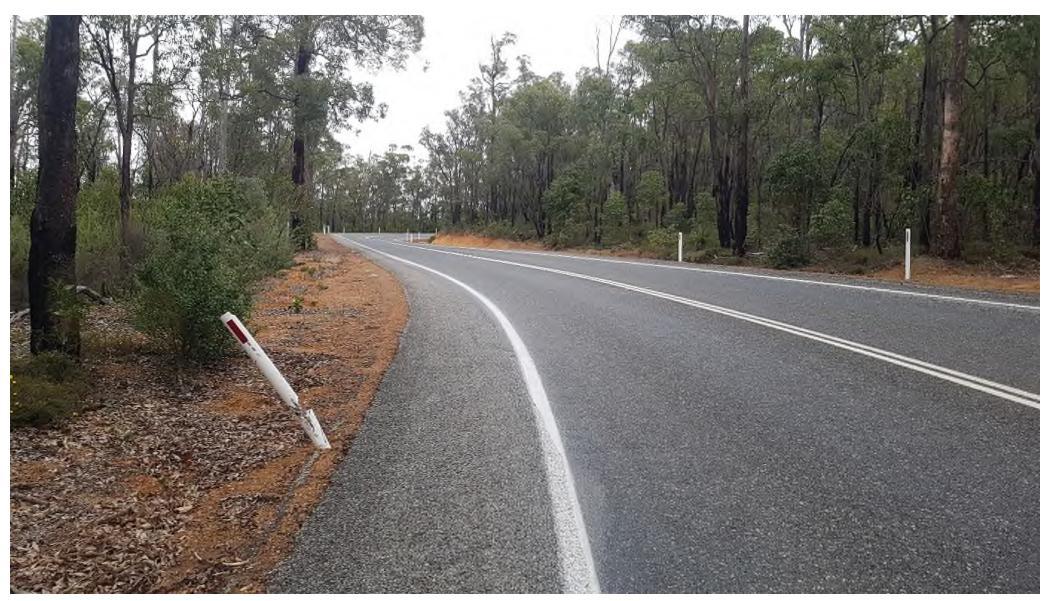
Photo 18: S-bends near Reservoir Road.

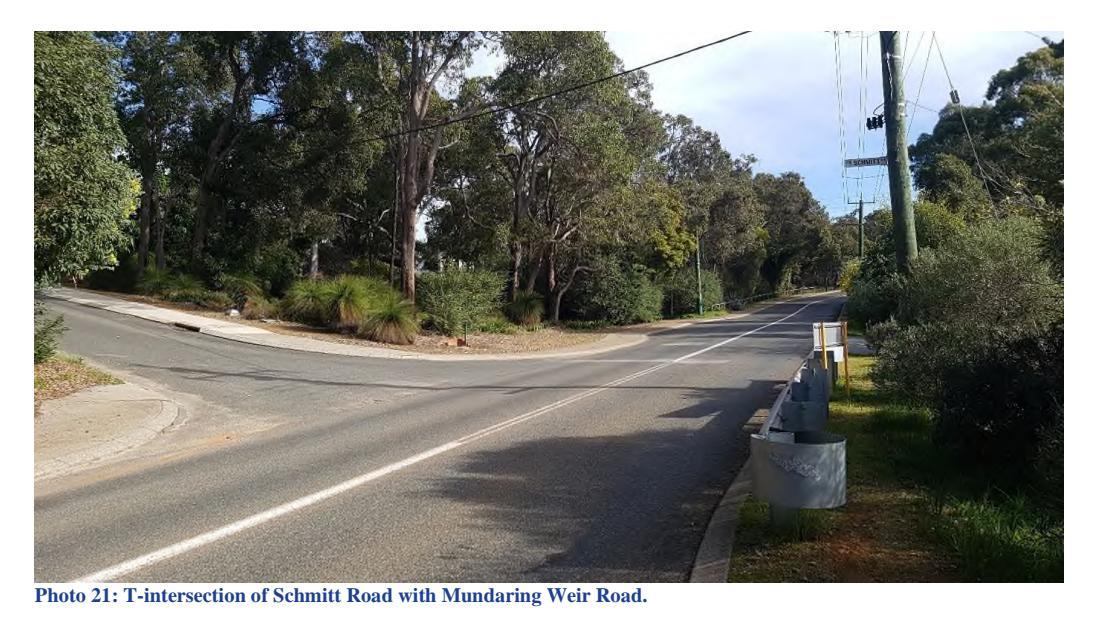
The side road at this intersection approaches from the south on a significant downhill gradient. There is an existing hazard board opposite the approach, but no Give Way (or Stop) signs or line marking. See **Photo 21.**

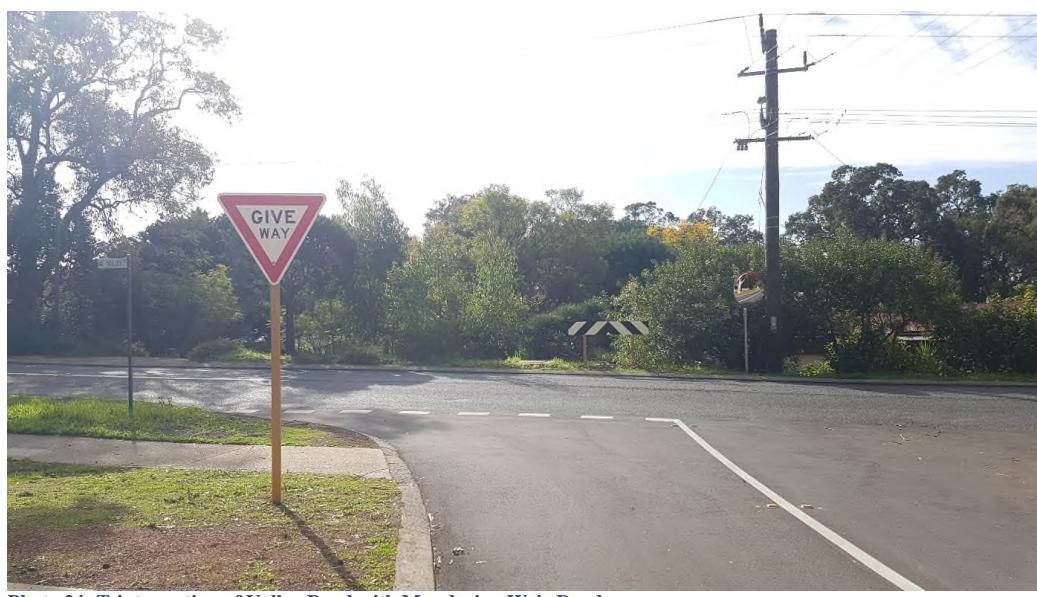
Valley Road meets Mundaring Weir Road in a T-intersection, and provides access to residential properties to the south. The intersection is equipped with Give Way and centre lines, a Give Way sign and a hazard board.

Photo 24: T-intersection of Valley Road with Mundaring Weir Road.

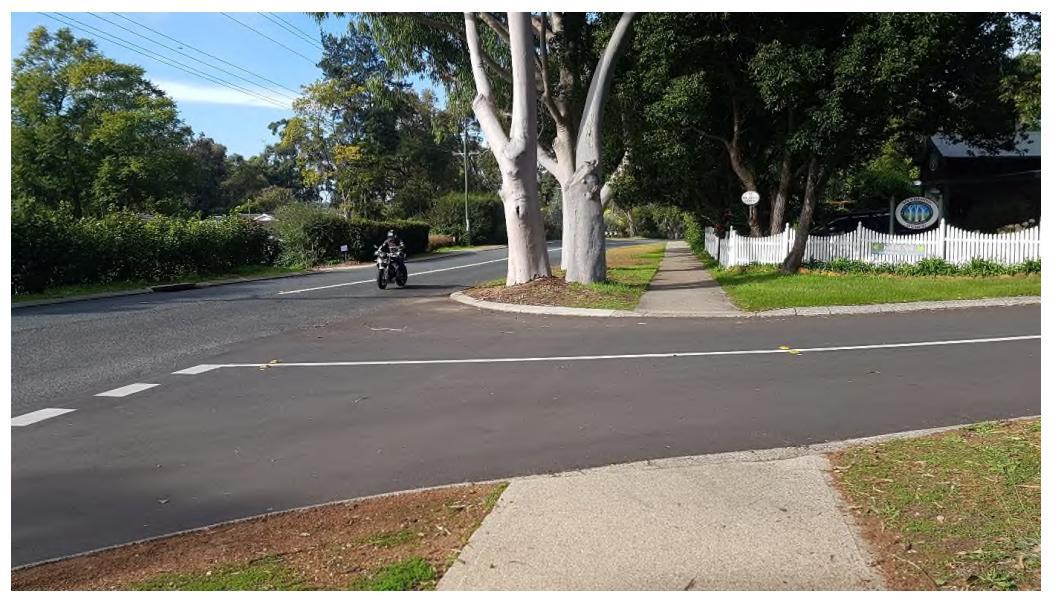
There is also a convex mirror installed, to aid with visibility, probably due to the presence of three large trees in the verge.

Photo 25: Large trees in close proximity may limit visibility to the east.

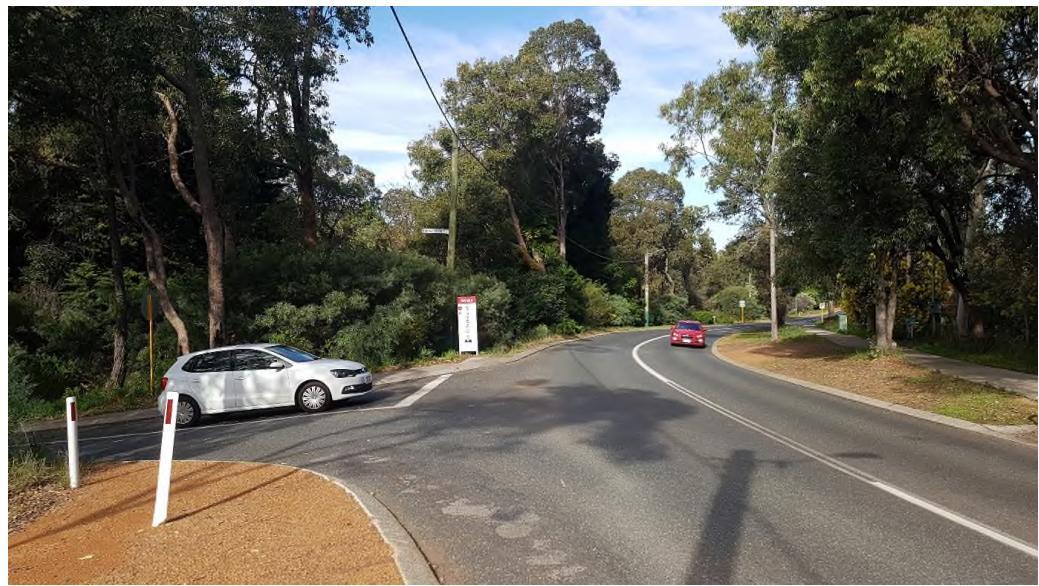
Hummerston Road provides access to large rural properties to the north of Mundaring Weir Road. It forms an alternative link through to Fern Road, whilst also intersecting with Roach Road, Croxton Road and Aldersyde Road. Its intersection with Mundaring Weir Road is located on the outside of a bend. See **Photo 26**.

Photo 26: T-intersection of Hummerston Road with Mundaring Weir Road.

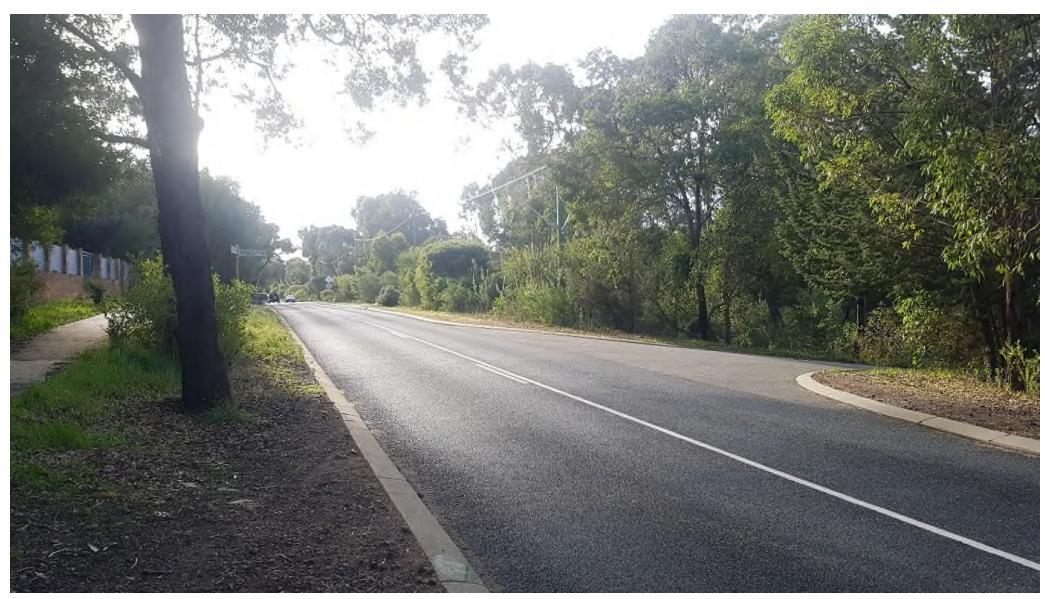
The T-intersection with Roach Road is priority controlled, but has no signs or line markings on approach. Visibility is good from the side road in both directions along Mundaring Weir Road. See **Photo 28**.

Photo 28: T-intersection of Roach Road with Mundaring Weir Road.

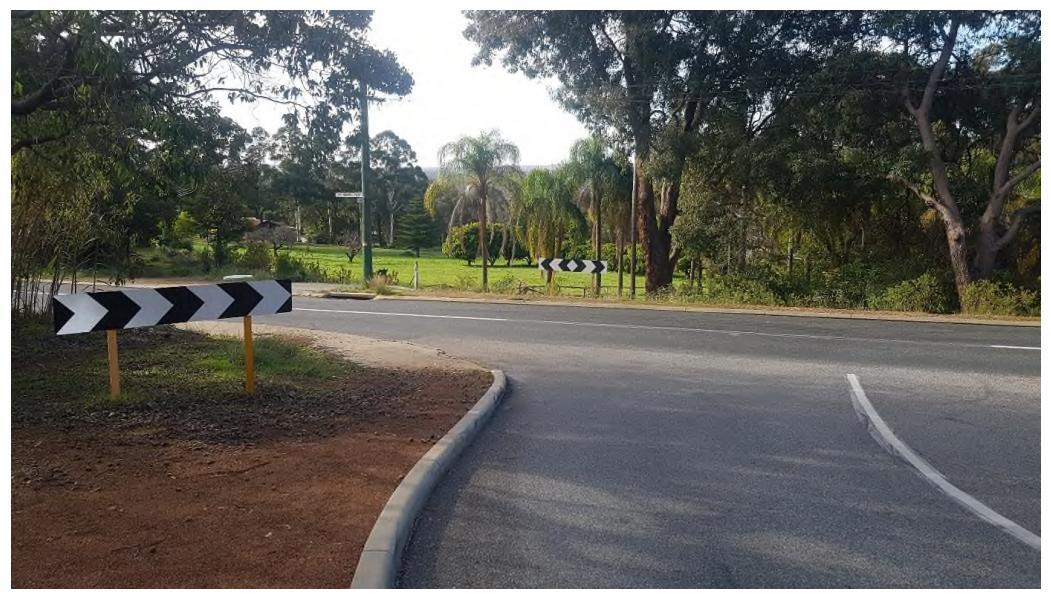
The geometry of the intersection with King Road is not ideal. The side road approaches at an acute angle, before swinging down and right to meet the through road at 90°. However, overgrown verge vegetation limits visibility. The intersection has a hazard board opposite the side road, as well as for the change in alignment on approach, but no Give Way or Stop signs or lines. See **Photos 29 & 30**.

Photo 30: Side road approach has no Give Way signs or lines.

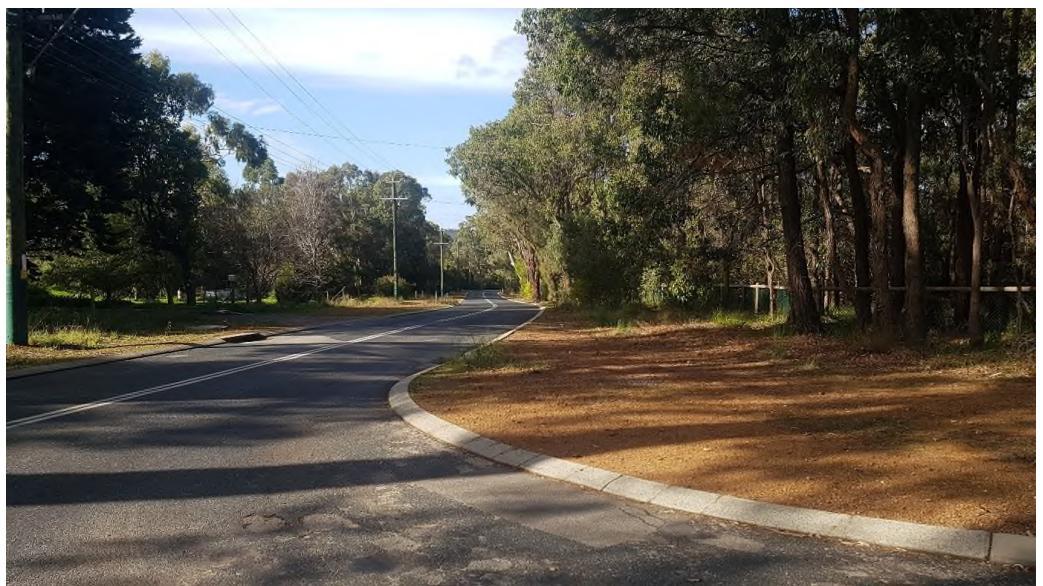
Visibility from Hinkler Road is limited by the road alignment to the right and roadside vegetation, particularly to the left. See **Photos 31 & 32**.

Photo 31: T-intersection of Hinkler Road with Mundaring Weir Road. Visibility to the right is good.

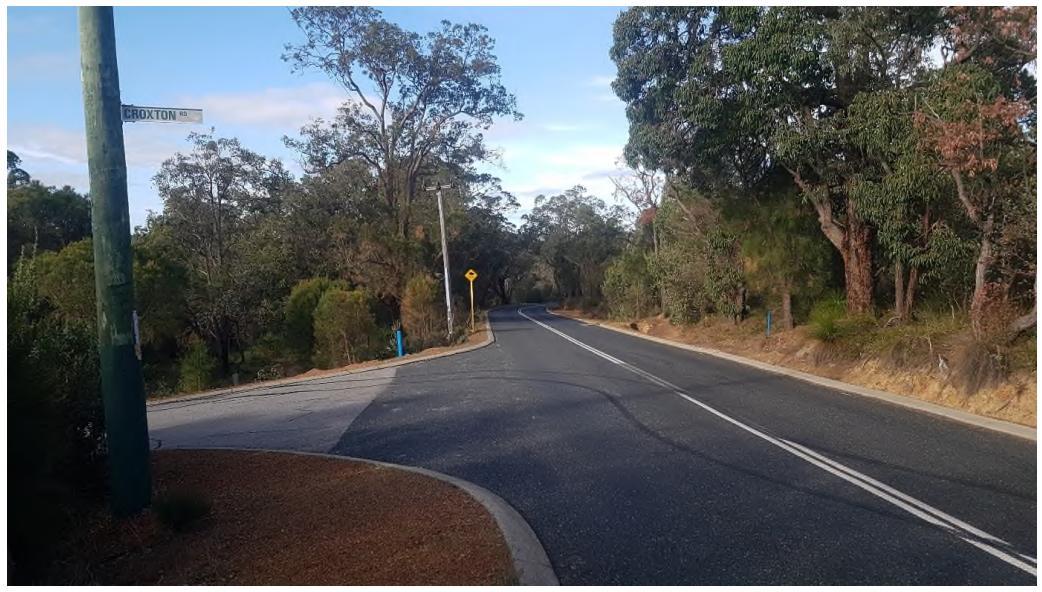
The intersection with Croxton Road has no signs or lines installed. Visibility is limited in both directions due to the horizontal alignment of Mundaring Weir Road. See **Photos 33 to 34a**.

Photo 33: T-intersection with Croxton Road with Mundaring Weir Road.

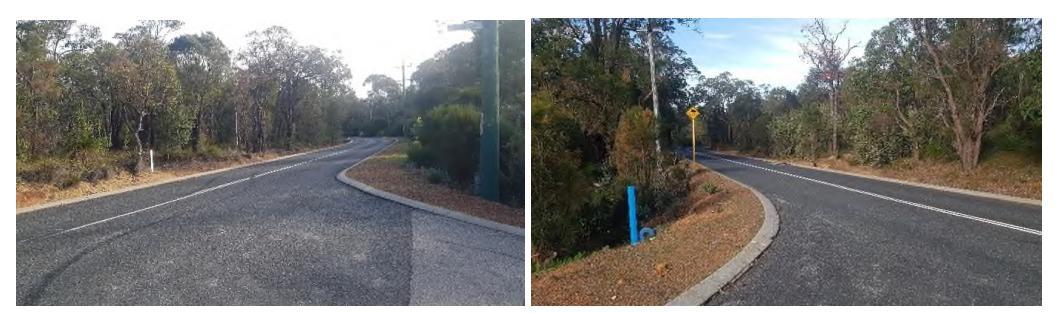
Photos 34 & 34a: Visibility is limited in both directions by bends in the through road.

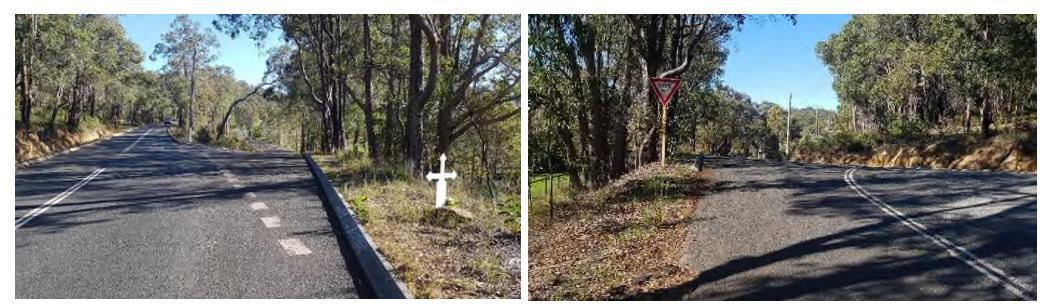
The northern section of Aldersyde Road intersects Mundaring Weir Road, on an uphill gradient, in an acute Y-intersection layout, as seen in **Photos 35 & 35a**.

Photos 35 & 35a: Northern of the two Aldersyde Road connections forms an acute Y-intersection.

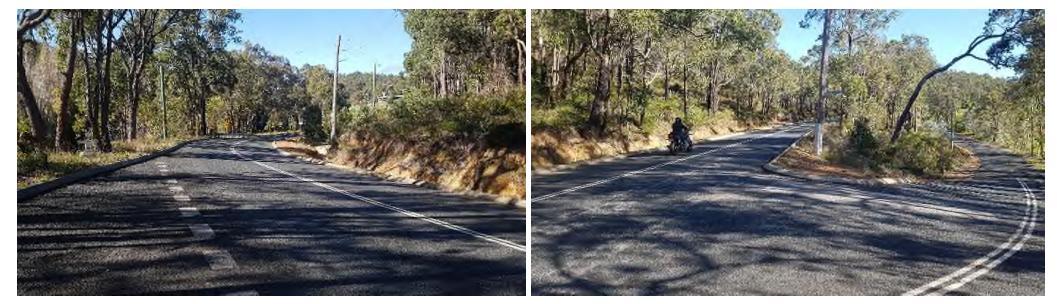
Visibility is limited in either direction from the side road, due to the horizontal and vertical alignments of Mundaring Weir Road. This is exacerbated by roadside vegetation.

Photos 36 & 36a: Visibility is limited in both directions.

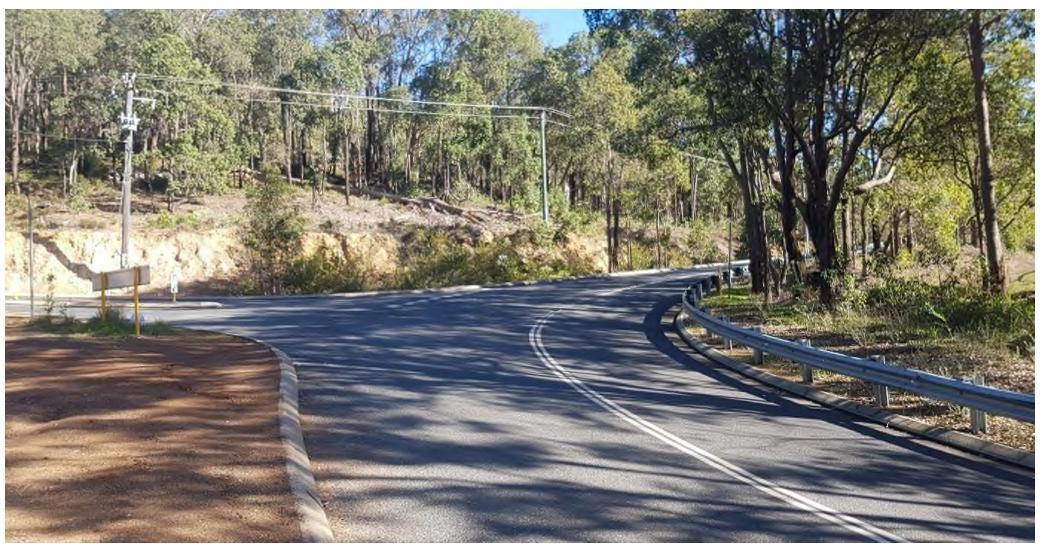
The southern Aldersyde Road intersection meets Mundaring Weir Road on the outside of a sharp bend, as shown in **Photo 37**. However, visibility is still compromised in both directions by the alignment of the road. See **Photos 38 & 38a**.

Photo 37: Southern of the two Aldersyde Road intersections.

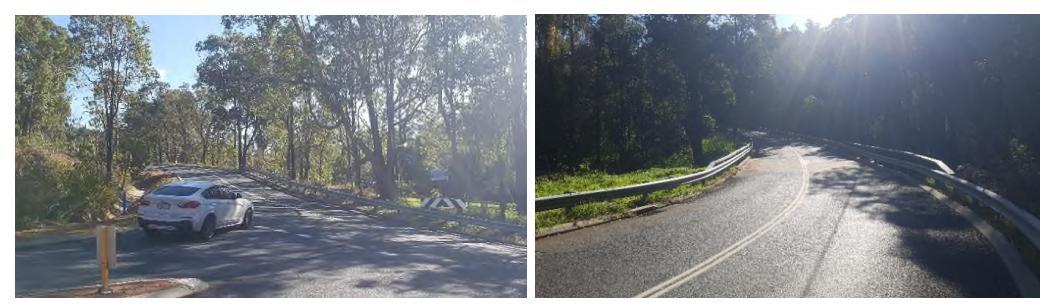
Photos 38 & 38a: Visibility from the side road is limited in both directions.

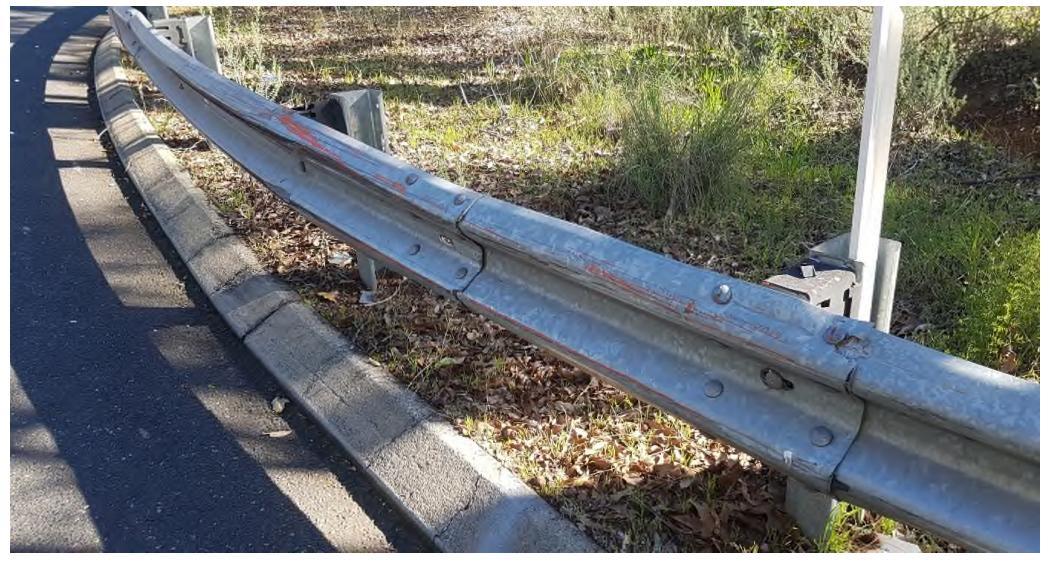
W-beam safety fence has been installed on the inside of the bend, but is very close to the kerb line. The fencing has been struck multiple times, as can be seen in **Photo 39**.

Photo 39: Safety barrier is very close to kerb line and has been struck several times.

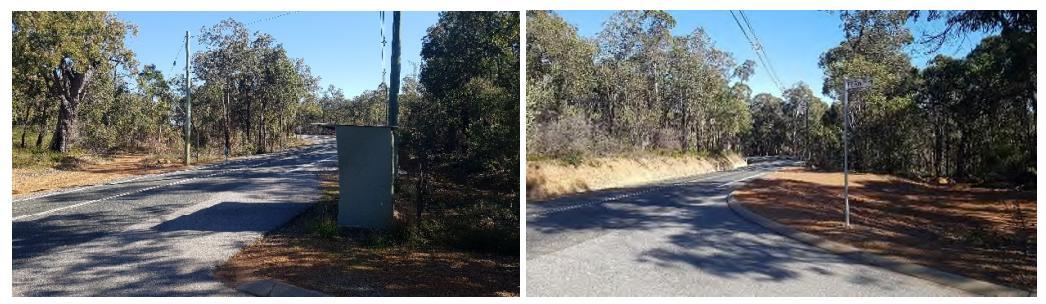
Fern Road forms a T-intersection with Mundaring Weir Road, located on a short straight between two sweeping bends. Visibility is limited to some extent to the left by the presence of a disused bus shelter, and to the right by a horizontal curve. The intersection has no Give Way lines or signs, no hazard board and a non-standard section of edge line. See **Photos 40 to 41a**.

Photo 41 & 41a: Visibility is limited in either direction.

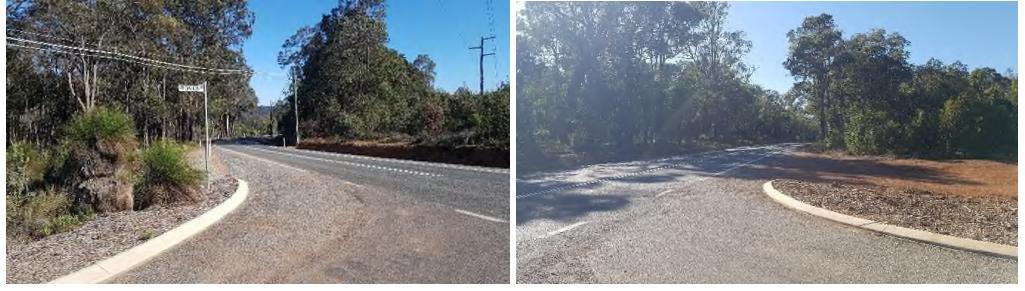
The intersection of Mundaring Weir Road with Bahen Road is a T-intersection. It has no Give Way signs or lines and no hazard board opposite. Visibility is limited in both directions by horizontal and vertical alignment issues. See **Photos 42 to 43a**.

Photos 43 & 43a: Visibility is limited in both directions.

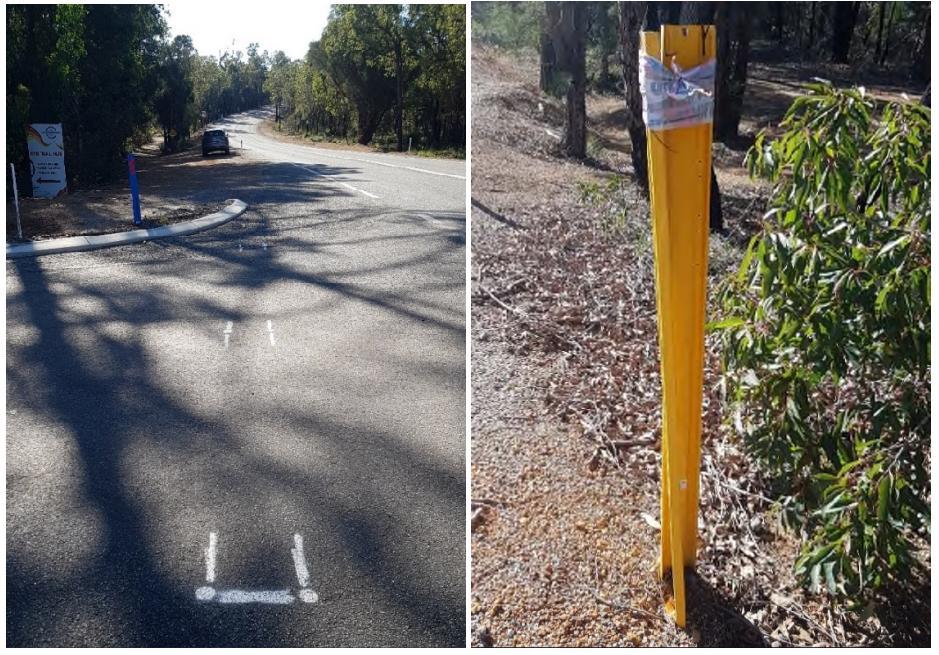
The intersection of Mundaring Weir Road with Paulls Valley Road is a T-intersection. It has no Give Way signs or lines and no hazard board opposite. However, it appears from markings and other evidence on site that upgrades to this intersection have yet to be completed. Visibility is limited in both directions by horizontal and vertical alignment issues. See **Photos 44 to 45a**.

Photos 45 & 45a: Upgrades may still be incomplete.

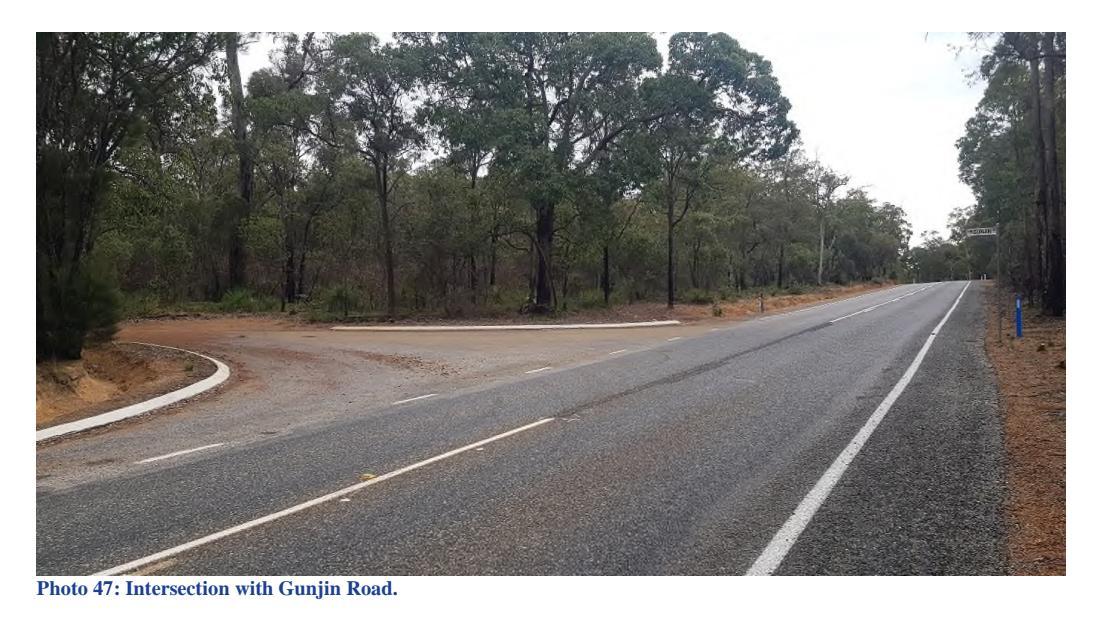
Gunjin Road has been sealed for a short distance back from Mundaring Weir Road. Similarly to other nearby intersections, it has kerbed radii but no signs or lines. See **Photo 47**.

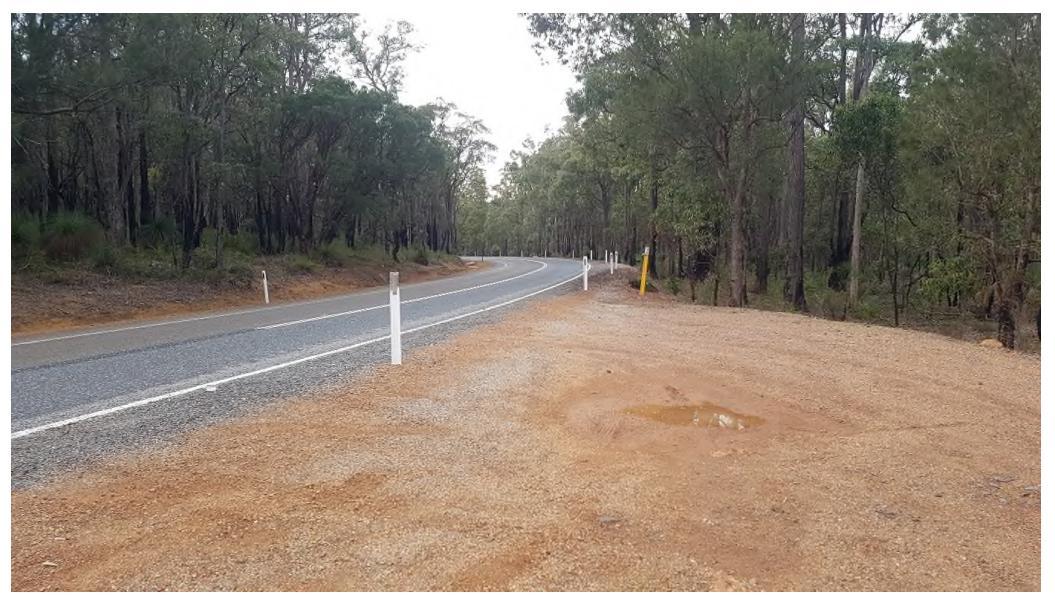
Little Oven Road is a very minor, unsealed road. As can be seen in **Photo 50**, the side road approach has not been sealed, and even has a guidepost installed within the intersection. There are no signs or line markings.

Photo 50: Little Oven Road is unsealed.
