September 2022 Final

Mundaring Weir Rd - Road Safety Investigation

Prepared For: City of Kalamunda

Final Report

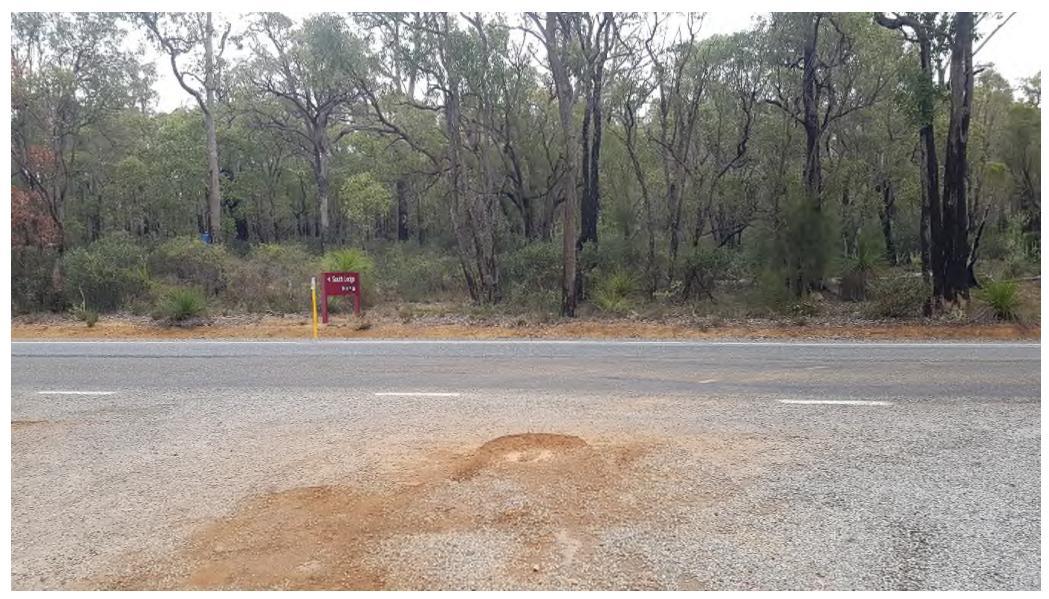
S Ledge Road is a very minor, poorly sealed road. As can be seen in **Photo 52**, the side road approach has not been properly sealed, and has various pot holes. There are no signs or line markings, and the intersection radii have not been kerbed. See **Photos 53 & 53a**.

Photo 52: S Ledge Road intersection.

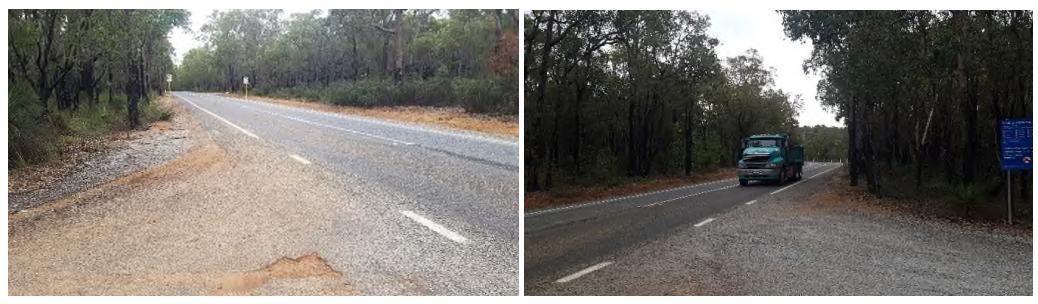
Photos 53 & 53a: The side road radii are not kerbed.

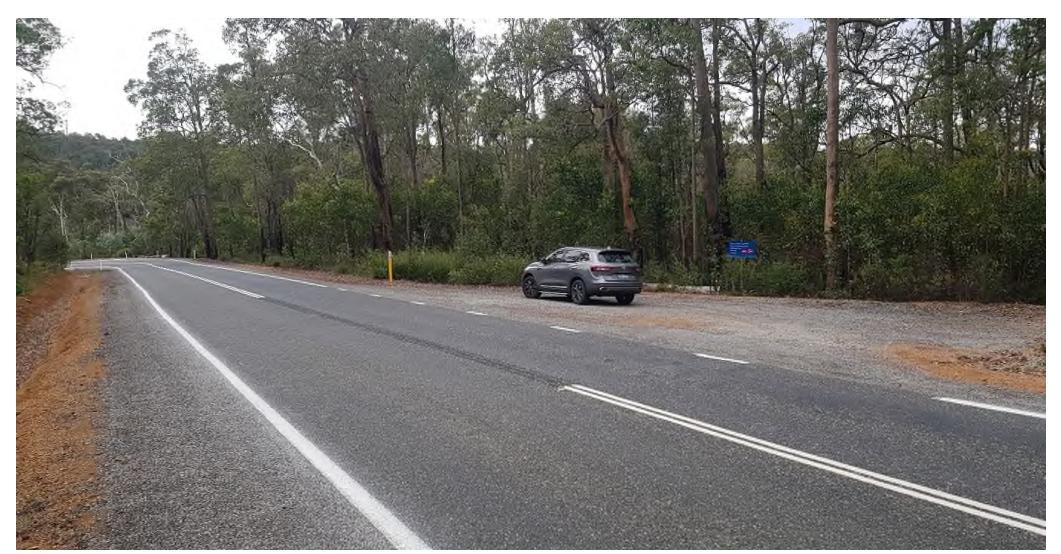
Photo 54: Reservoir Road

Reservoir Road is a very minor, poorly sealed road. As can be seen in **Photo 54**, the side road approaches at an acute angle and has not been properly sealed. The appropriate junction ahead sign should be installed on the approach to Mundaring Weir Road. There are no signs or line markings, and the intersection radii have not been kerbed.

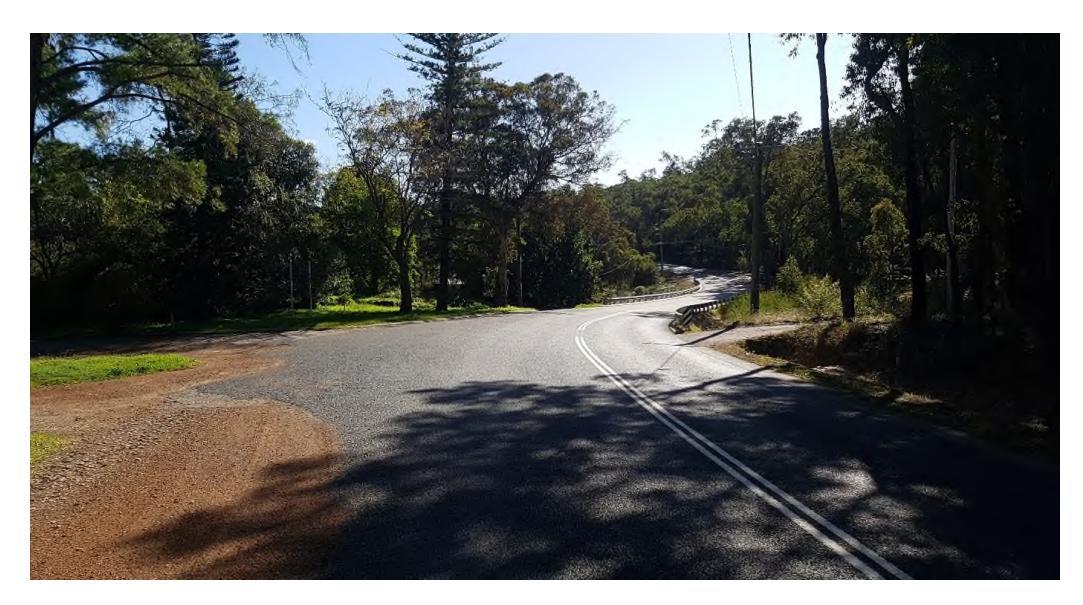
Chalet Rigi lies just to the south of a series of significant S-bends. The property currently has two partly sealed accesses. A widened section of seal forms an unmarked, pseudo left turn lane. See **Photo 55**.

Photo 55: The partly sealed accesses to the Chalet Rigi car parks are on the left. There is no edge line.

It is understood that an application has been received from the property owners to upgrade the facilities at Chalet Rigi, including a proposed slip lane and revised crossover. These are noted, but it is important that the access is well signed, and that the edge of the carriageway is well defined as a part of any upgrades, particularly at night.

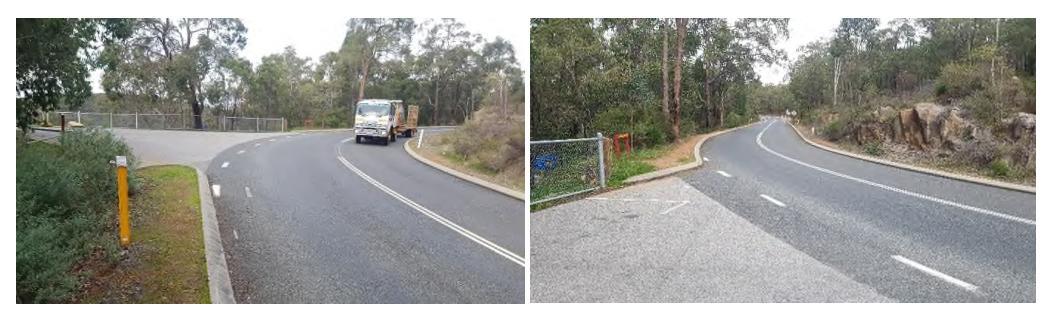
At the southern end of Mundaring Weir, there are two car park accesses, located between two significant horizontal curves. As the eastern access is located on the outside of the bend, visibility is reasonably good. See **Photos 56 & 56a**.

Photos 56 & 56a: Eastern Mundaring Weir car parking access.

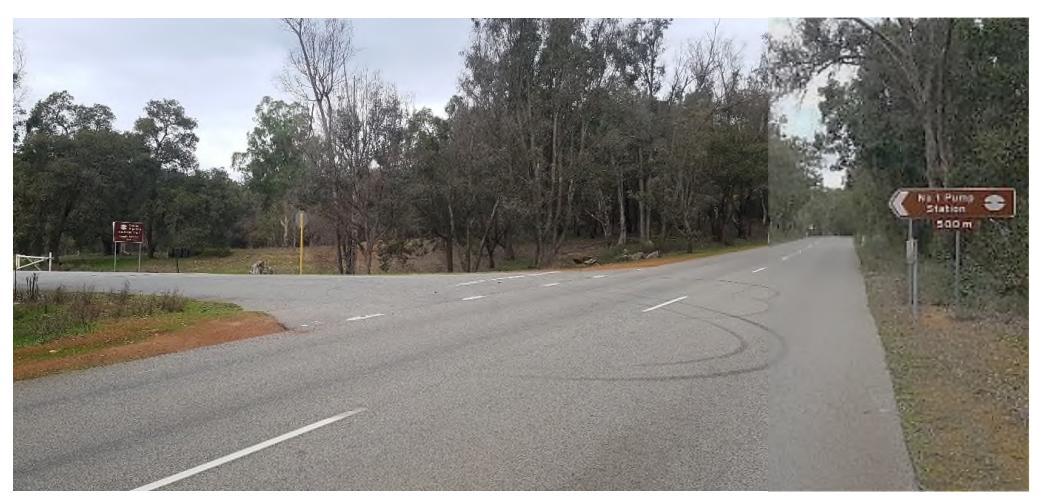
Photo 58: Access Road to No.1 Pump Station.

The access road to No 1 Pump Station is on a straight section of road, with reasonably good visibility. The access has a Stop sign and line. See **Photos 58 to 60**.

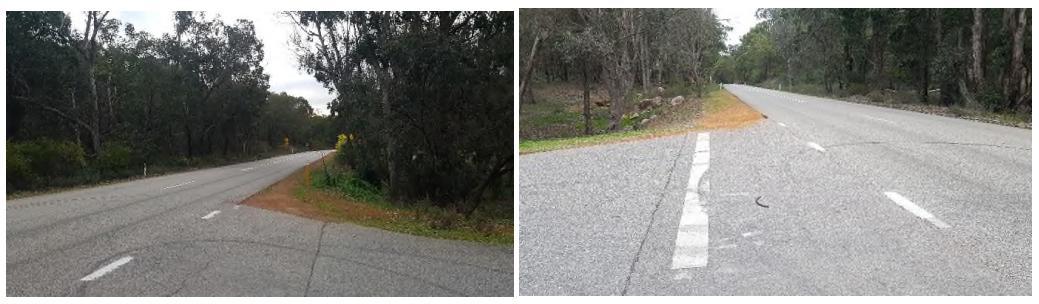
Photo 59 & 59a: Visibility from the No. 1 Pump Station access road.

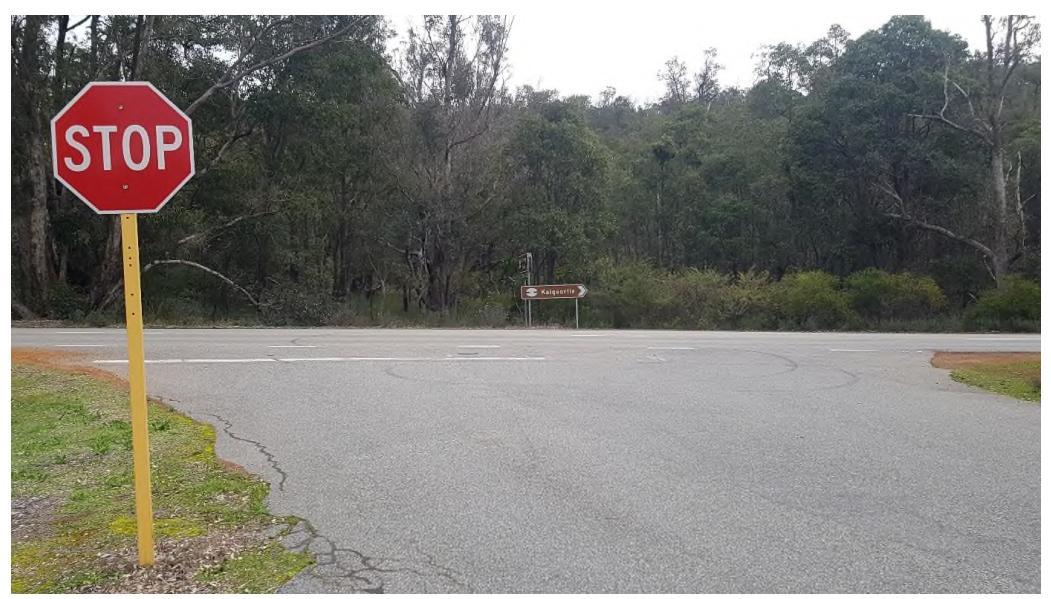
Photo 60: The access is not kerbed, but does have a Stop sign and line.

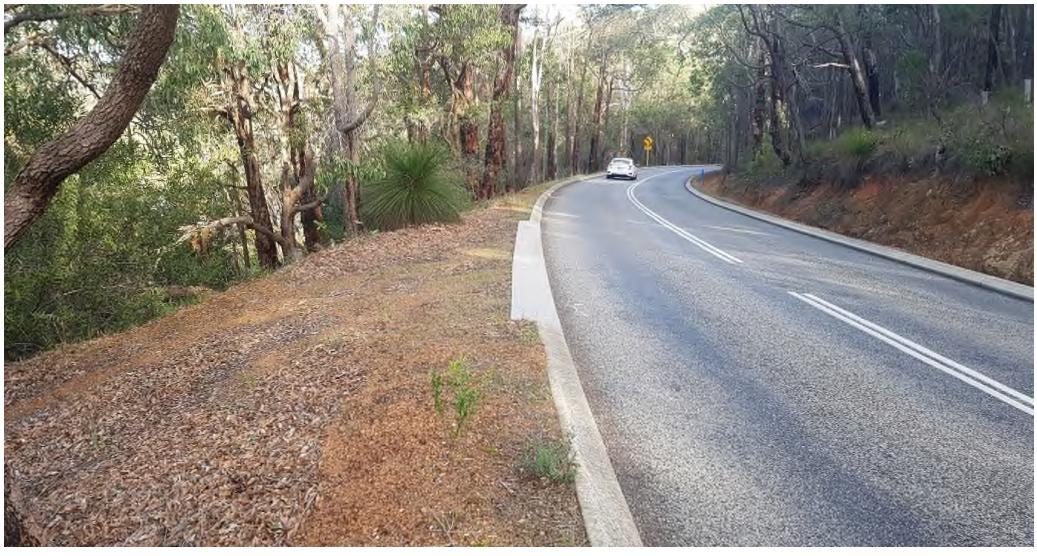
There are individual residential property accesses located all along the three of the sections of this road being investigated, with many of them having steep gradients and limited visibility.

Photo 61: Extremely steep unsealed property access with crossover.

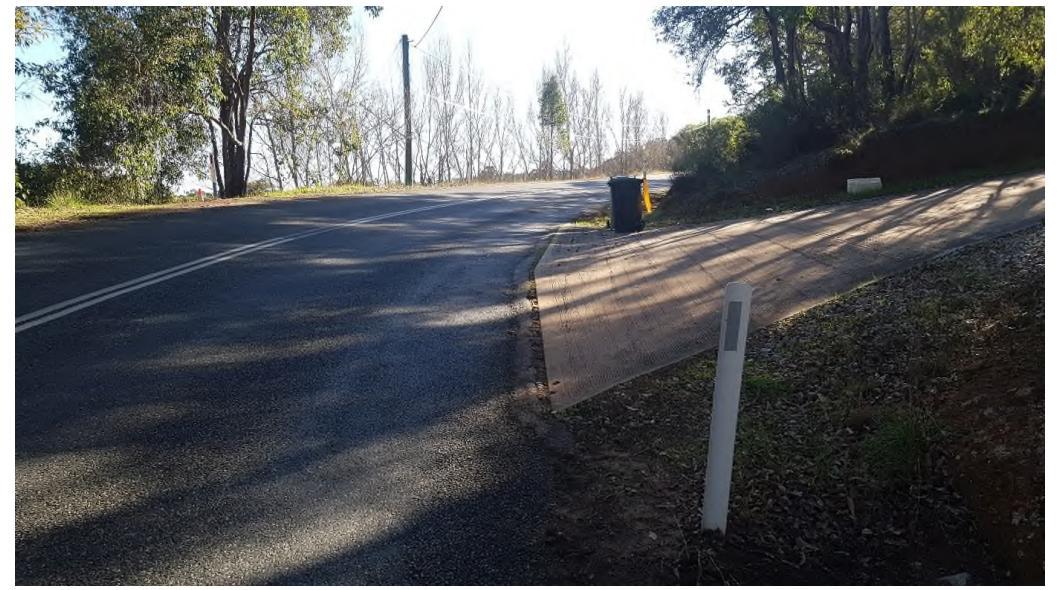
Photo 62: Steep concrete driveway on inside of curve gives limited visibility.

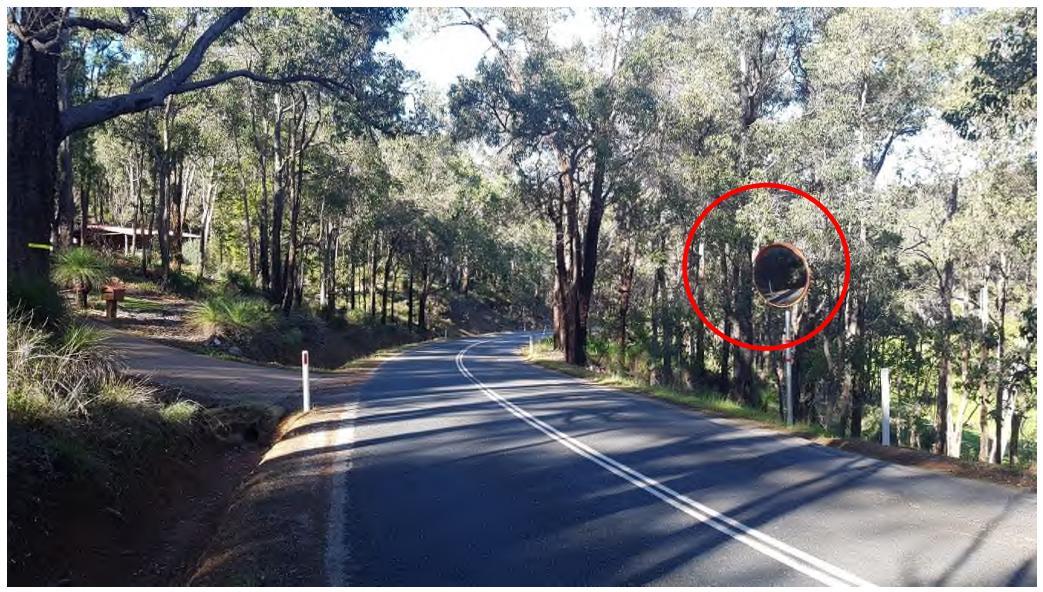
Some have installed convex mirrors, to assist with visibility when turning out onto Mundaring Weir Road. However, the majority simply have to exercise caution whenever they enter or leave their driveways. A few examples are shown in **Photos 61 to 63**.

Photo 63: Convex mirror installed to assist with visibility.

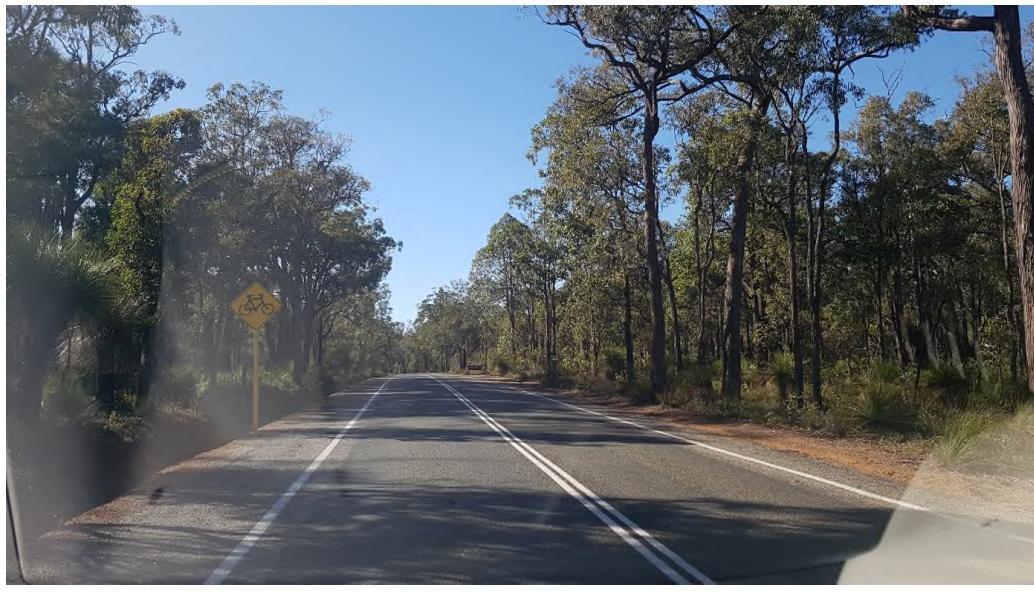
Photo 64: It is not clear why the cyclist warning sign is required in this location.

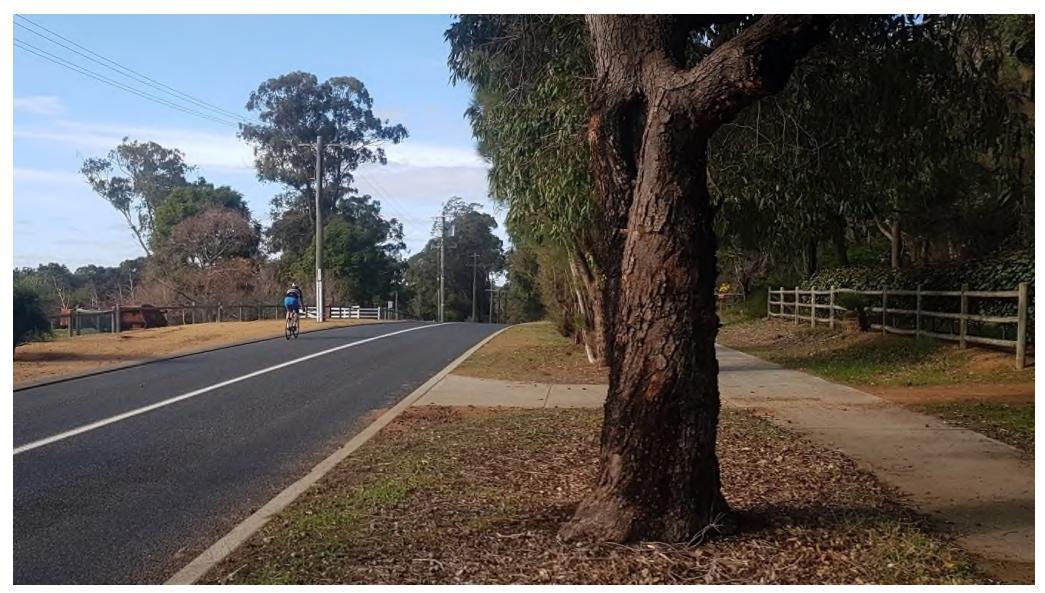
Whilst there is a footpath along this section, albeit on one side of the road only, it is not generally suitable for cyclists, and falls well below current design standards, in several regards.

Photo 65: Cyclists have to use the traffic lanes, or a very poor standard footpath.

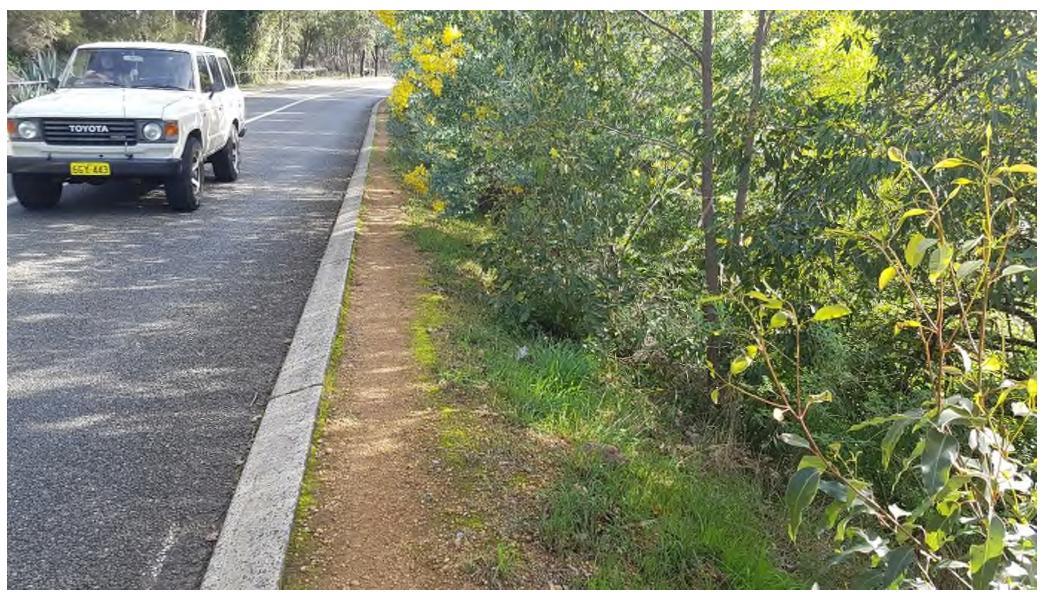
There is also evidence that the opposite verge is regularly trafficked by pedestrians.

Photo 66: Evidence of regular foot traffic along this verge.

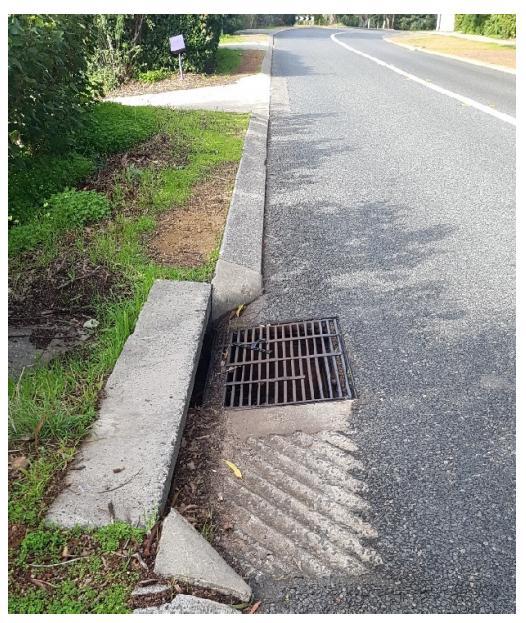
In addition, there are a number of drainage grids that are very poorly designed in terms of cyclist safety. See **Photo 76**.

Photo 76: Typical 'Cycle-unfriendly' drainage facility.

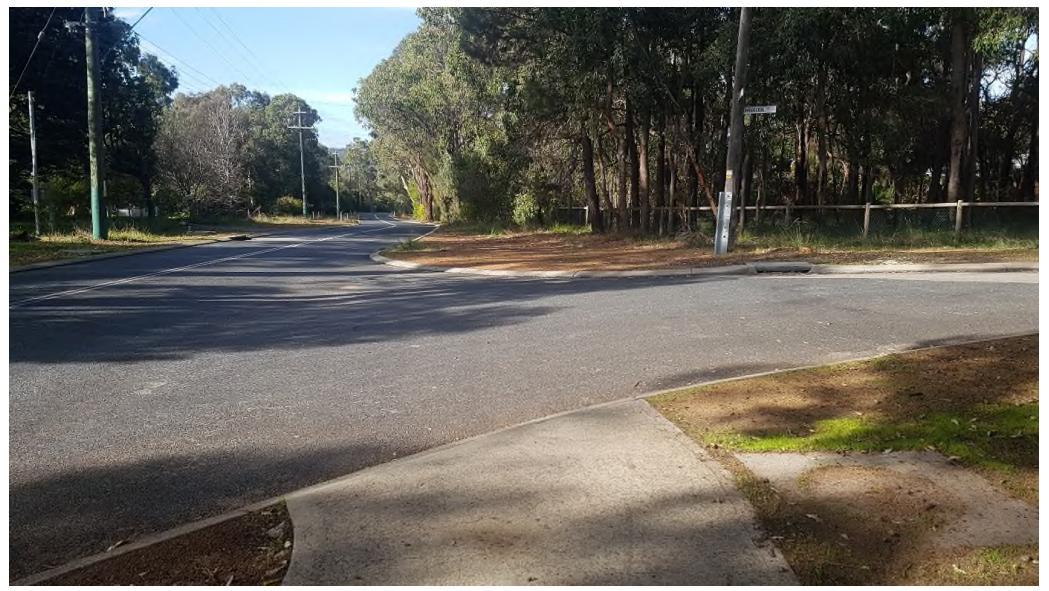
The footpath ends at the Hinkler Road intersection, with no continuation along either road.

Photo 77: The footpath terminates at this point, with no continuation along either road.

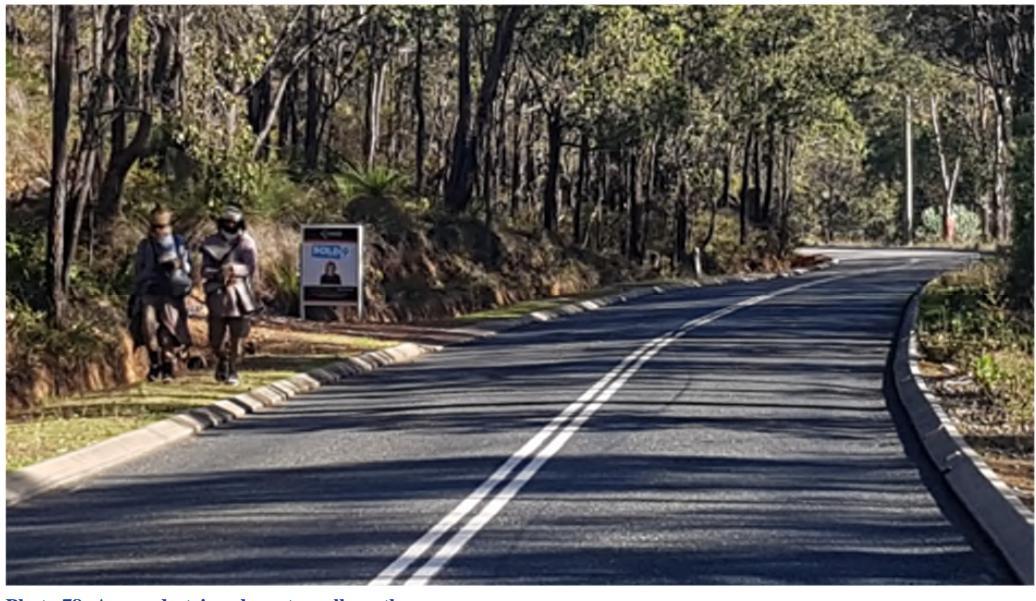
There are no on road cycle lanes, no hard shoulders and no footpaths along this section of Mundaring Weir Road. The road is kerbed between the Hinkler Road and southern Aldersyde Road intersections, giving no space for cyclists to manoeuvre when being overtaken. See **Photo 78**.

Photo 78: Any pedestrians have to walk on the verge.

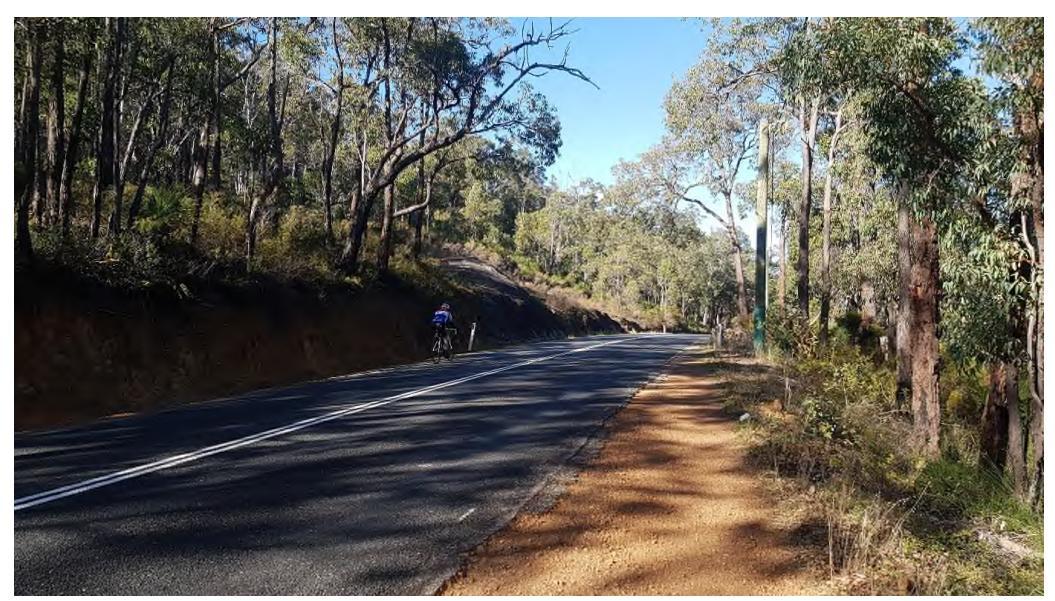
Beyond Aldersyde Road, the road is mostly unkerbed, with unsealed shoulders and verges.

Photo 80: Only the occasional cyclist was seen using this section of the road.

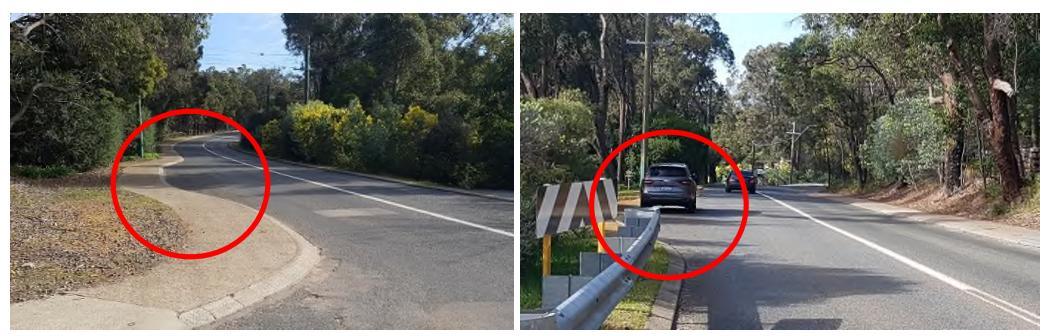
There are a number of other hazards adjacent the carriageway on this stretch of Mundaring Weir Road, including root damaged kerbing and narrow parking bays. See **Photos 85 to 86a**.

Photos 86 & 86a: Parking bays (possibly former bus embayments?) are unmarked, and not really wide enough.

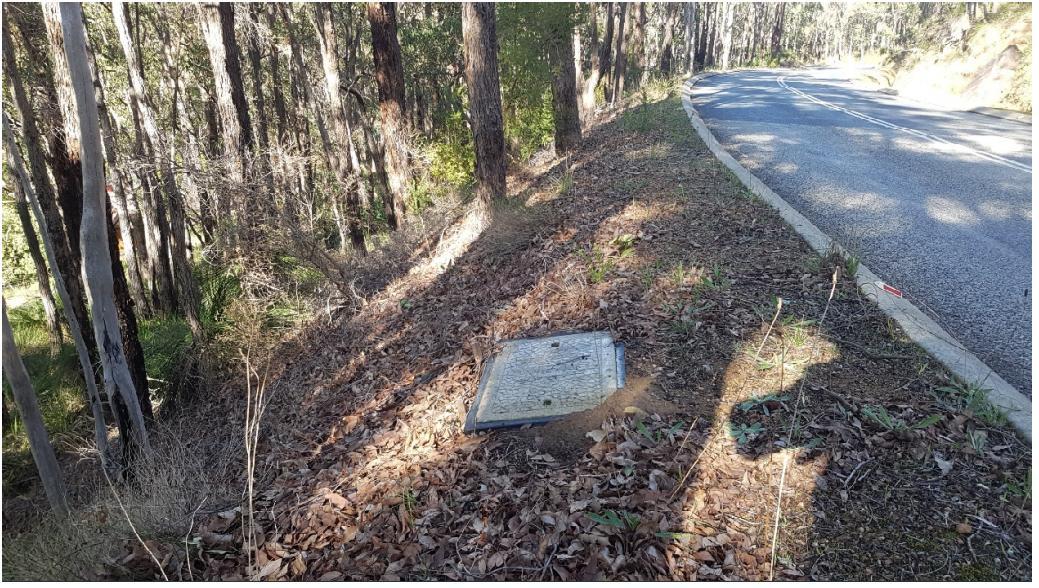
Photo 88: Unrecoverable batter with a significant drop off. Note service lid.

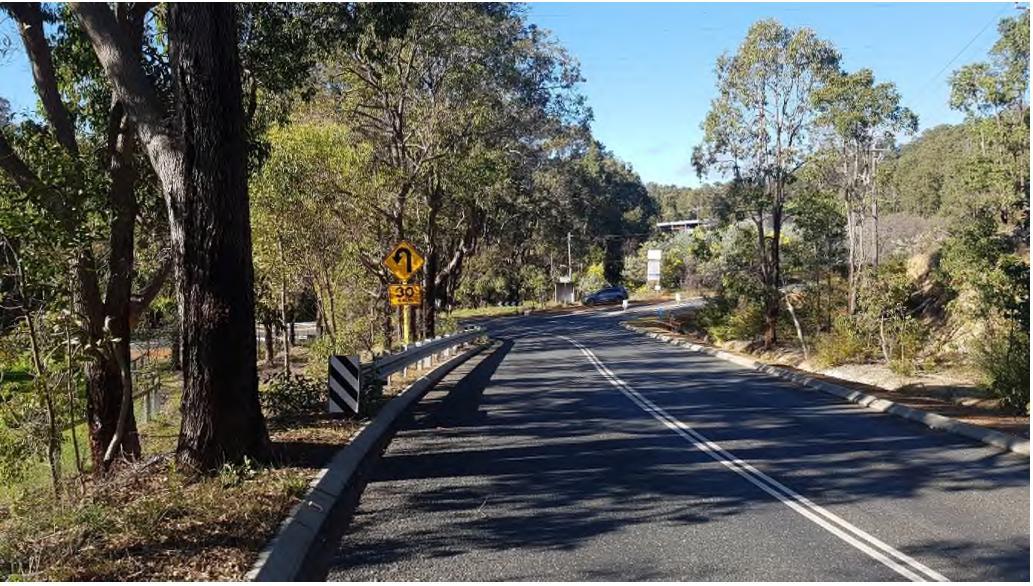
Although the safety barriers do protect errant vehicles from some of the roadside hazards along this section of road, it can be seen in **Photos 94 & 95** that there are many more that remain exposed.

Photo 95: A large tree stands exposed just before the safety barrier commences.

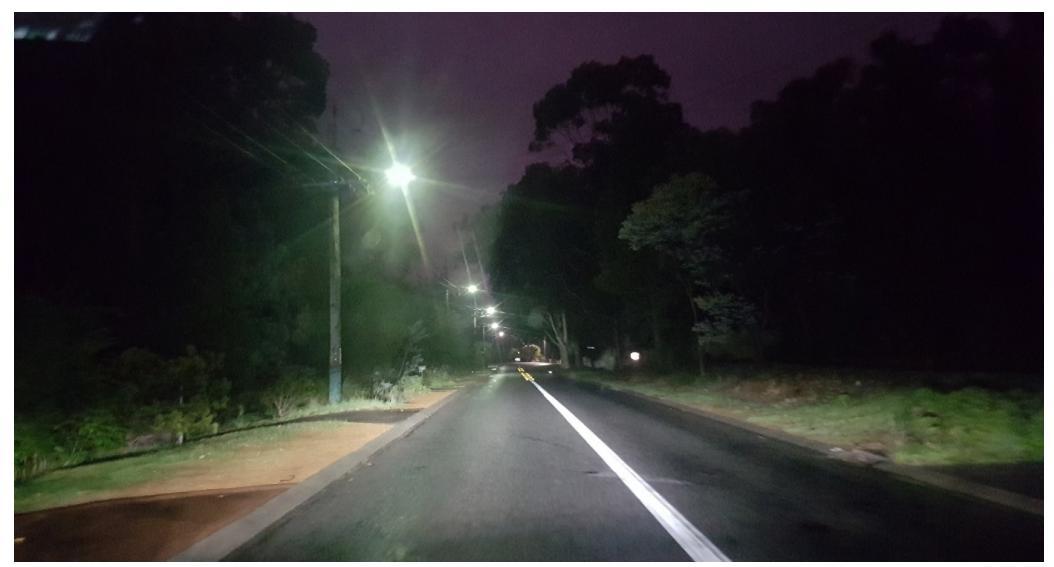
The standard of lighting along the sections of Mundaring Weir Road being investigated is inconsistent, and generally poor. The provision of lighting is limited, with illumination levels provided by the differing types of lighting also being inconsistent. See **Photos 103 & 104**.

Photo 103: Street lighting west of Valley Road, looking east.

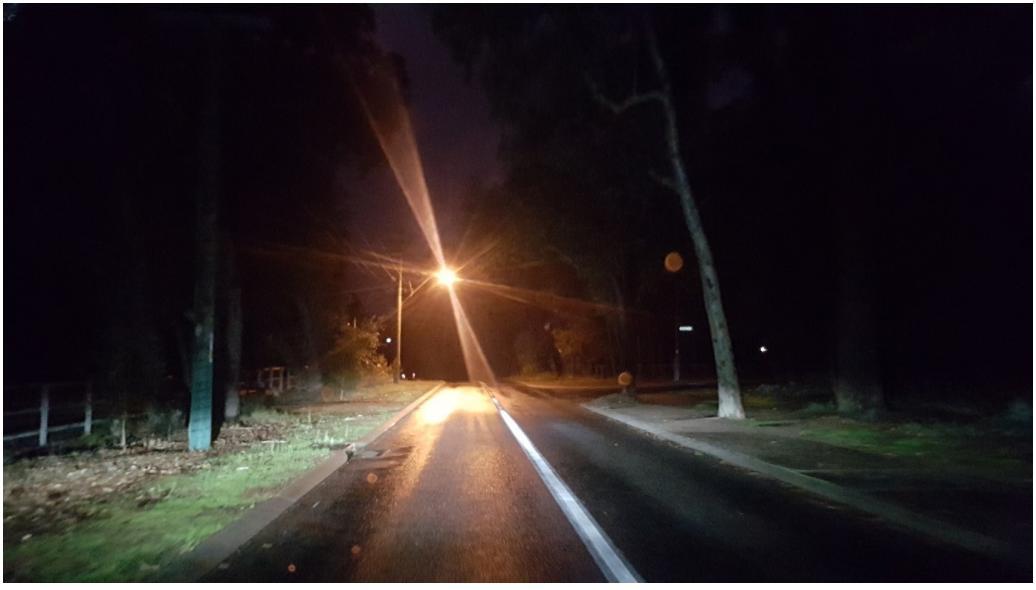
Photo 104: Street light at Hinkler Road intersection.

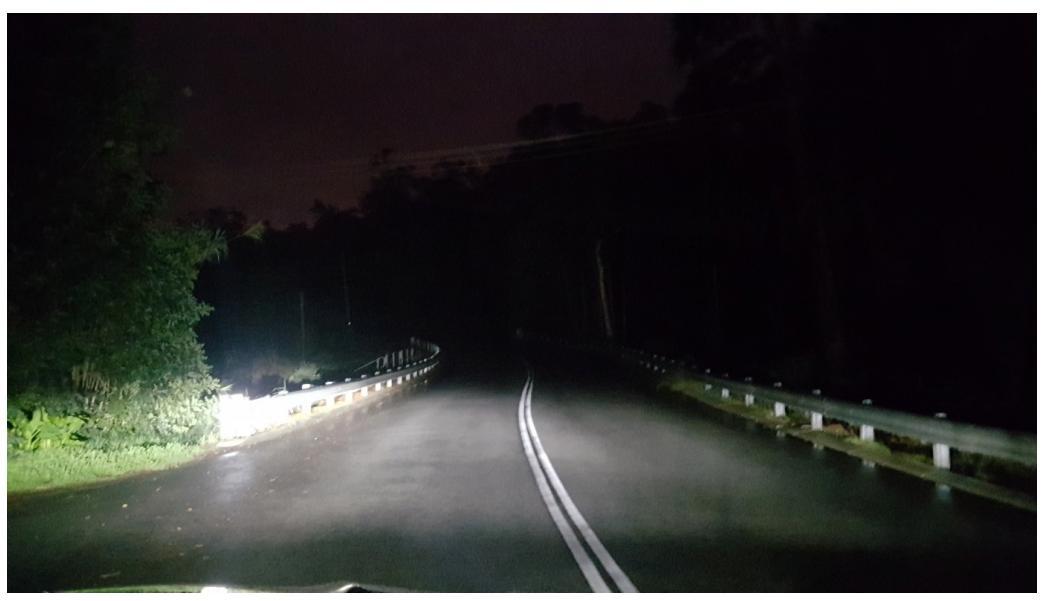
Photo 105: The alignment through the bridge is not well delineated at night.

These issues need to be addressed, potentially with street lighting being installed, but as a minimum RRPMs should be installed along the centreline, and reflectors fitted at intervals along the safety barriers.
