September 2022

## Mundaring Weir Rd - Road Safety Investigation

Prepared For: City of Kalamunda

## Final Report

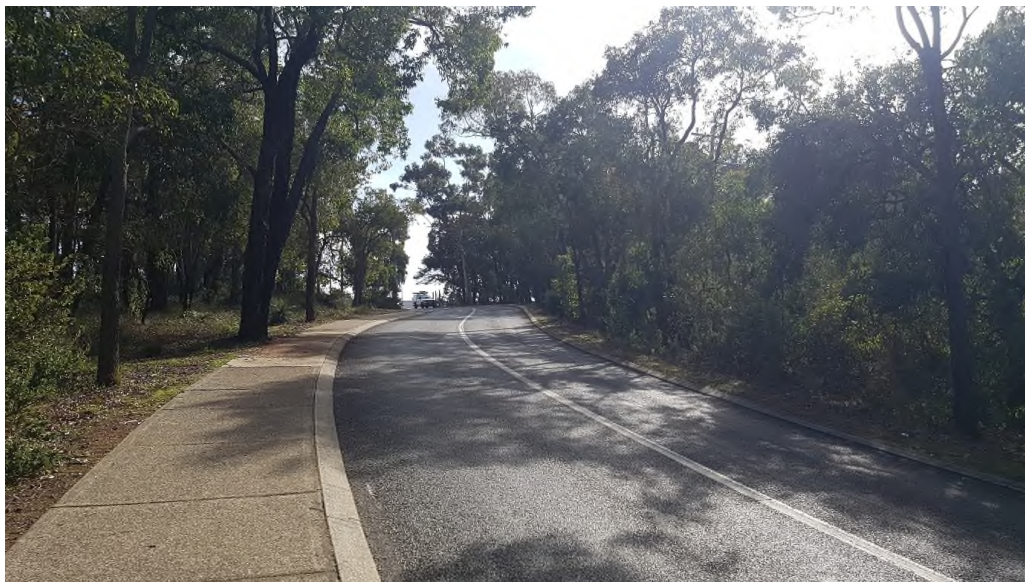
**Photo 1: Bends on approach to the Railway Road roundabout, looking west.**

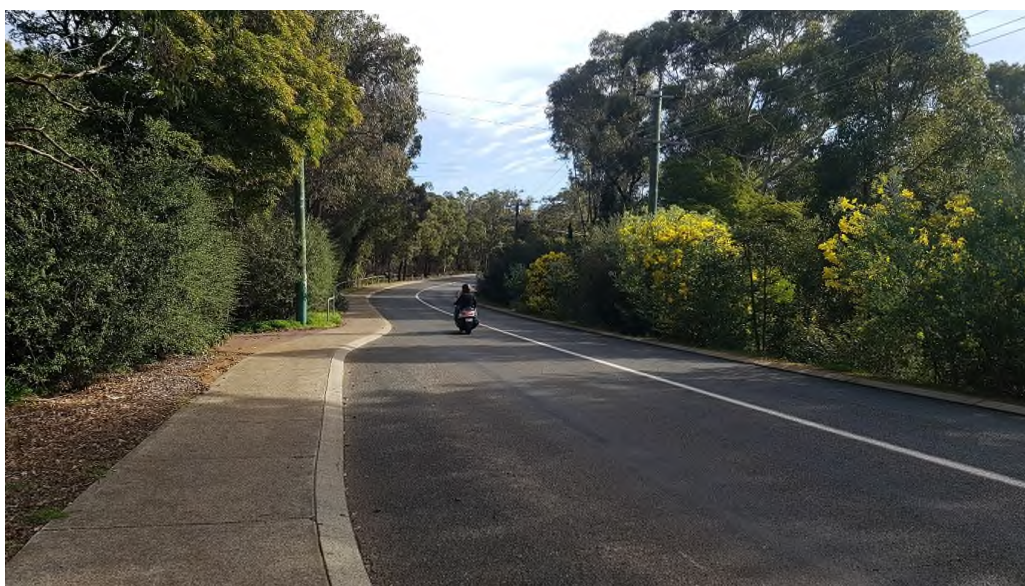
**Photo 2: Motorcycle approaching bend just west of Schmitt Road.**

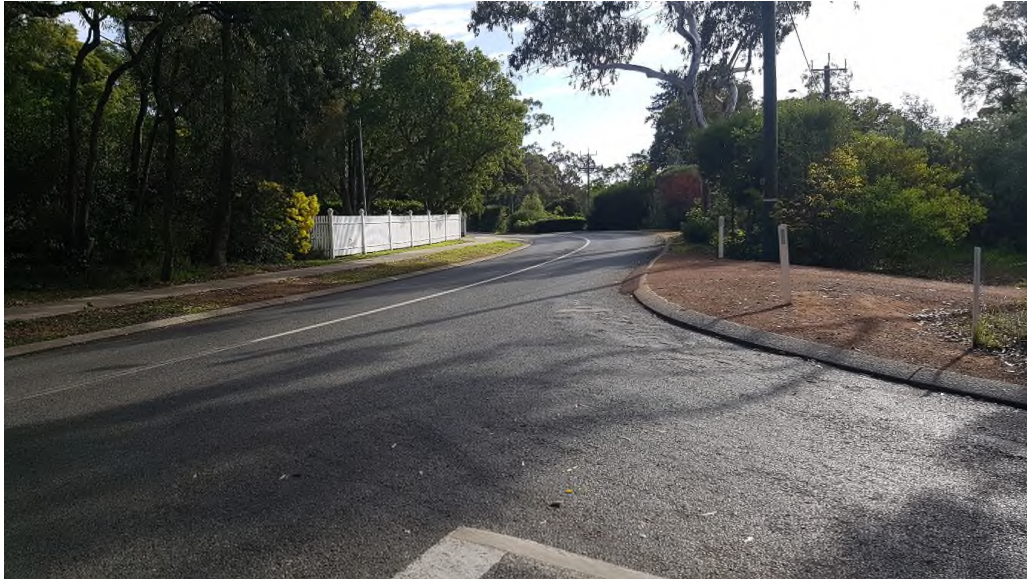
**Photo 3: The bend near Hummerston Road lies within the 60 km/h speed limit zone.**

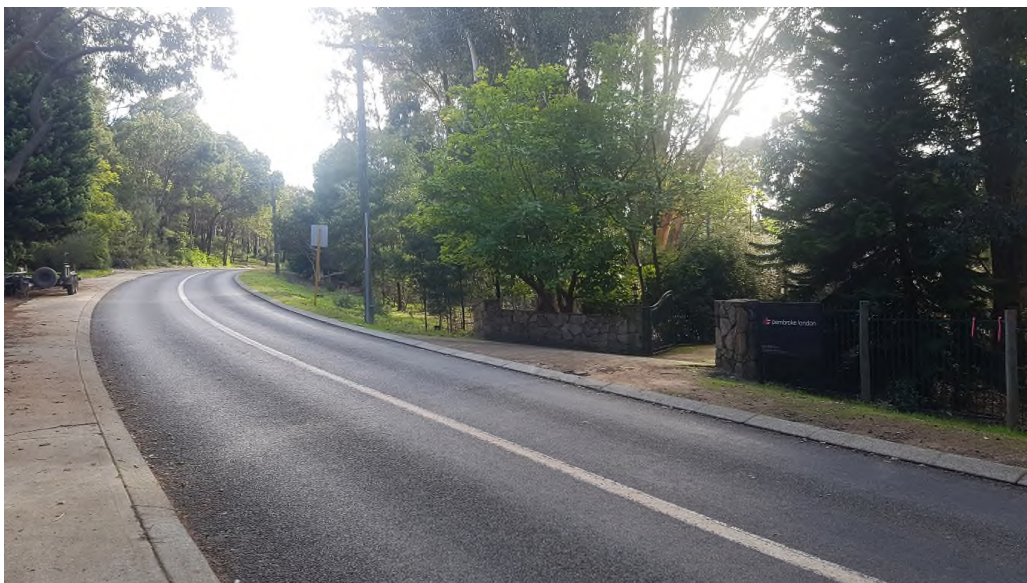
**Photo 4: Bend in Mundaring Weir Road, east of King Road, looking west**

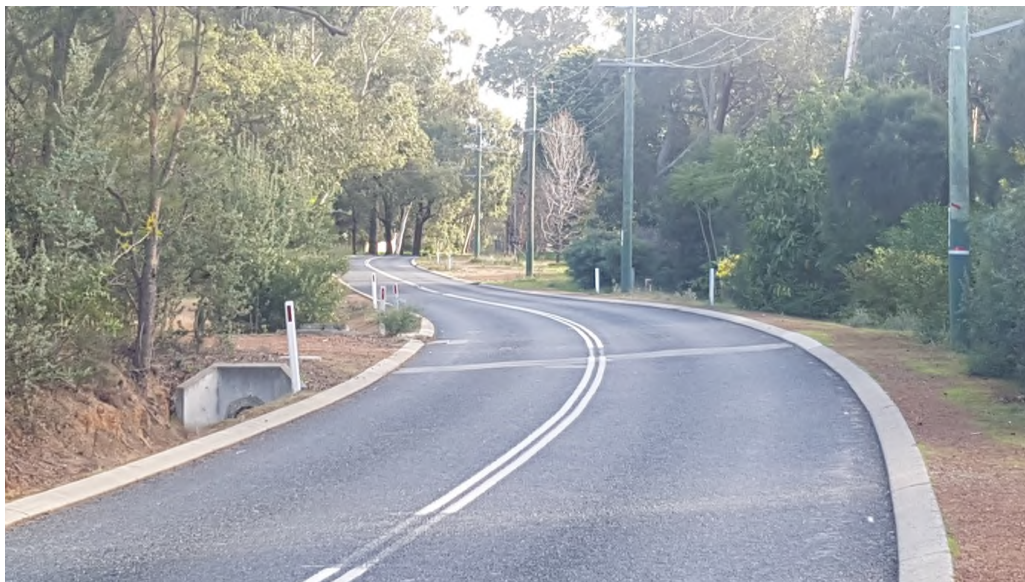
**Photo 5: Curves on Mundaring Weir Road between Croxton Road and Hinkler Road, looking west.**

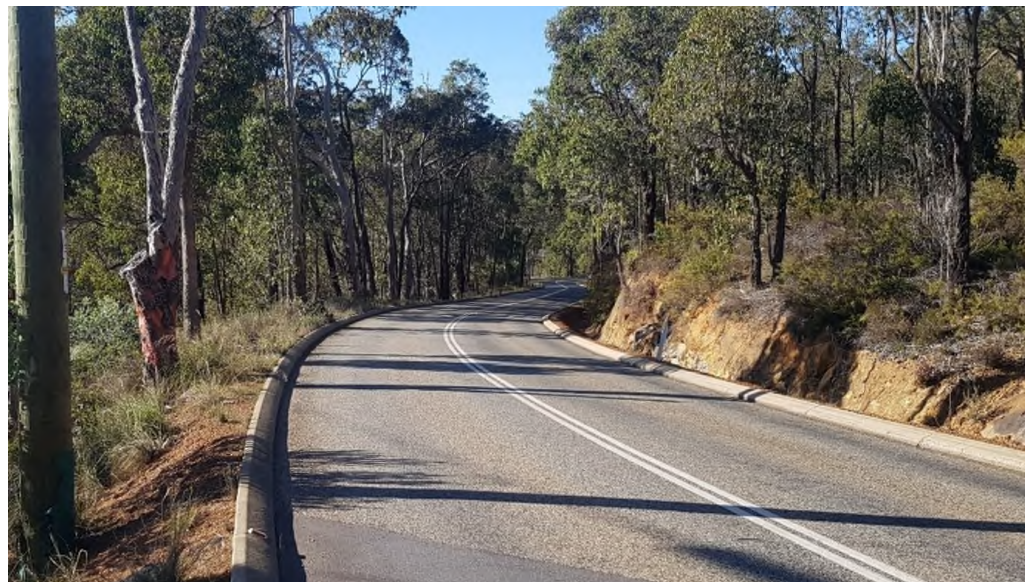
**Photo 6: Typical s-bends within this section of Mundaring Weir Road, between Croxton Road and Aldersyde Road.**

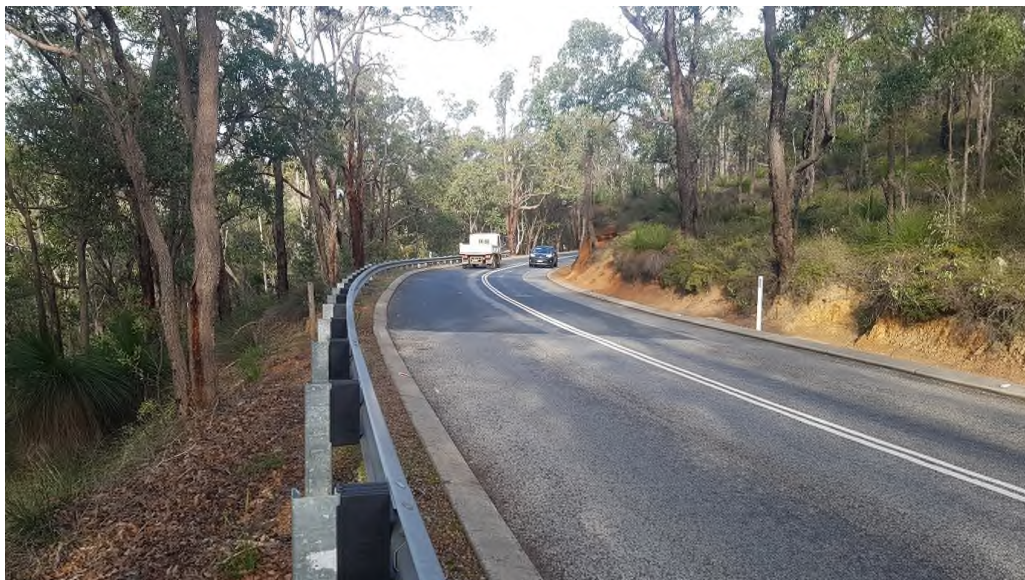
**Photo 7: Typical bend within this section, equipped with safety fencing, west of Aldersyde Road.**

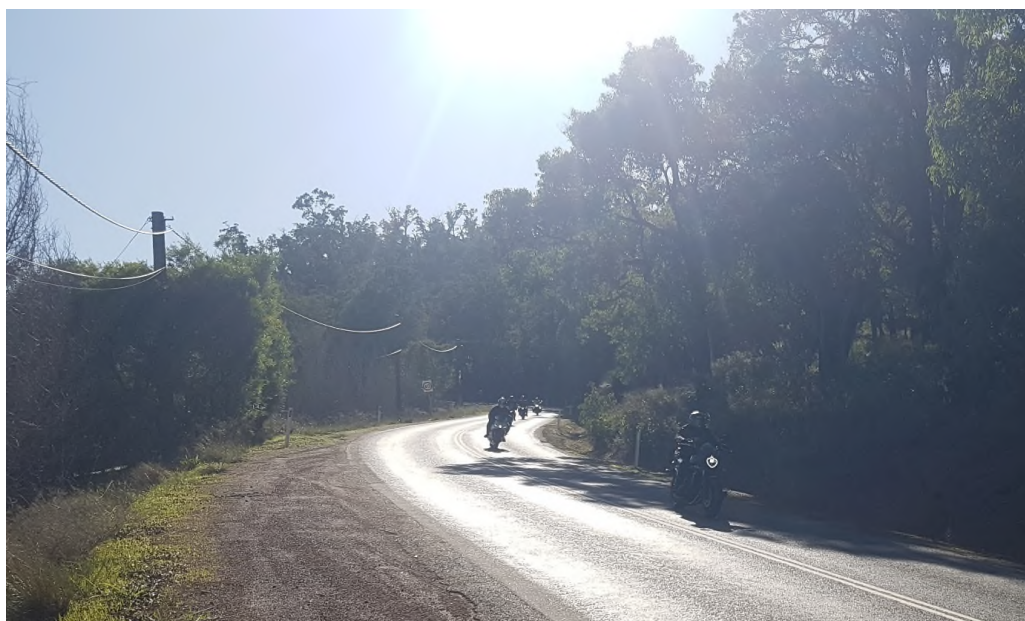
**Photo 8: Motorcyclists enjoying the sweeping curves of Mundaring Weir Road, north of Aldersyde Road.**

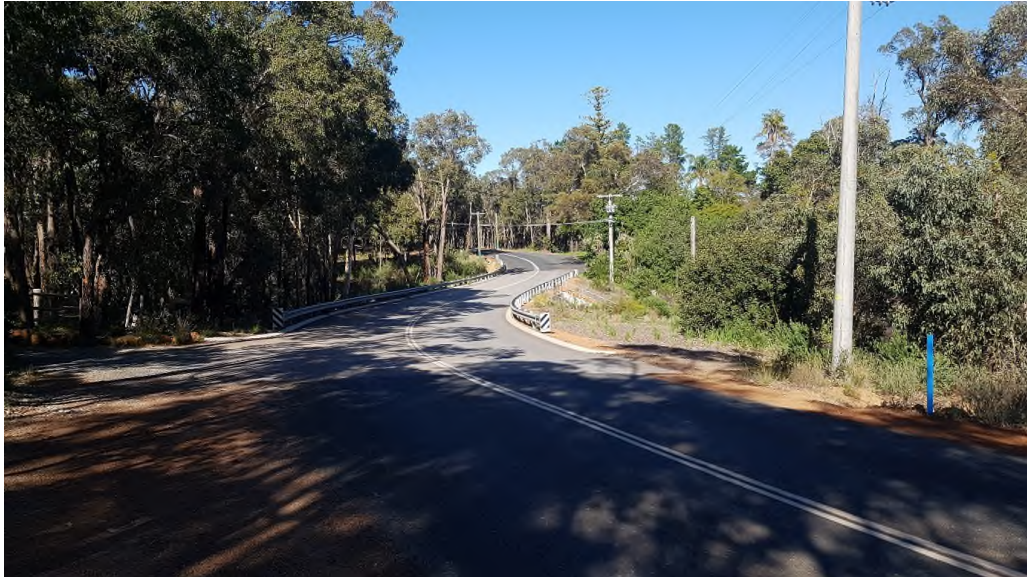
**Photo 9: Curves over the bridge near Chalet Rigi.**

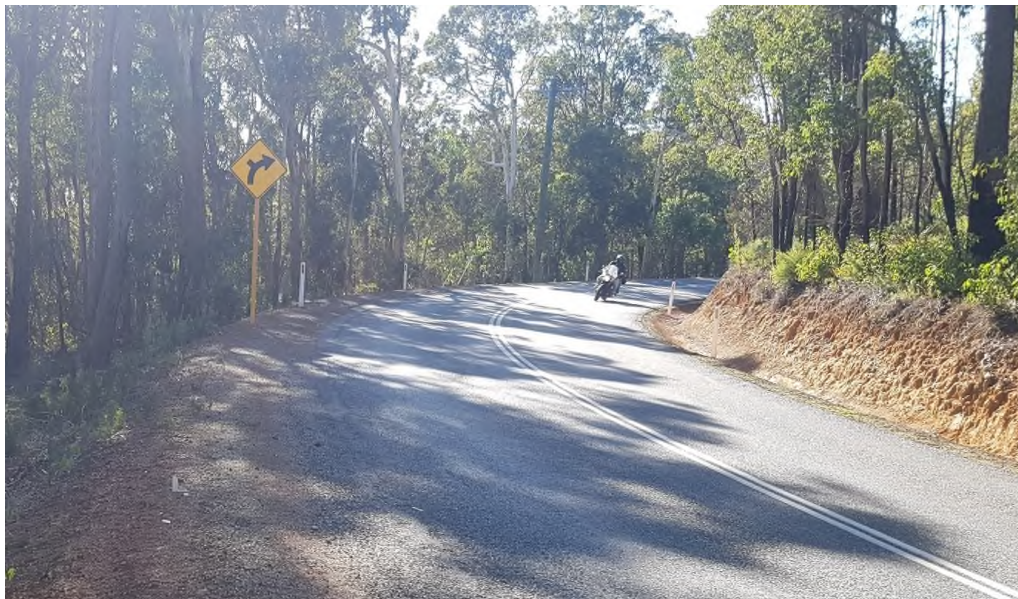
**Photo 10: Motorcyclist negotiating the bend just west of Fern Road.**

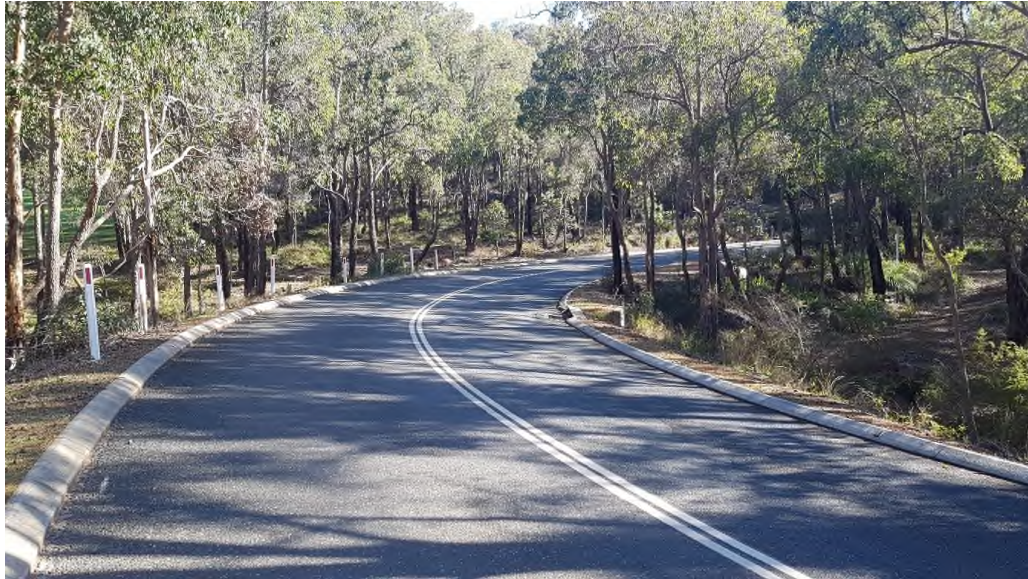
The exceptions to the above include the sharp bend at Chainage 3400, just northwest of the northern Aldersyde Road intersection. This bend is estimated to have a radius of around 35m and a corresponding operating speed of 50 km/h. However, advisory 40km/h signs are already installed on both approaches. See **Photos 11 to 12a**.

Photo 11: This bend has a radius of around 55m.

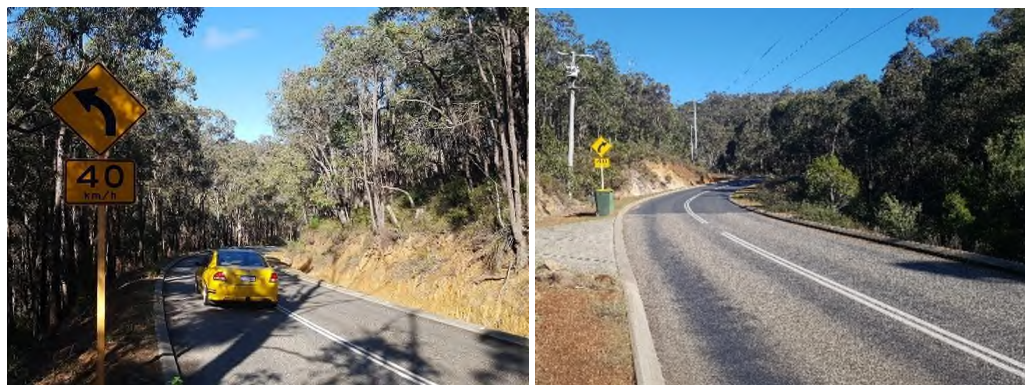
Photos 12 & 12a: Advisory speed signs are already installed.

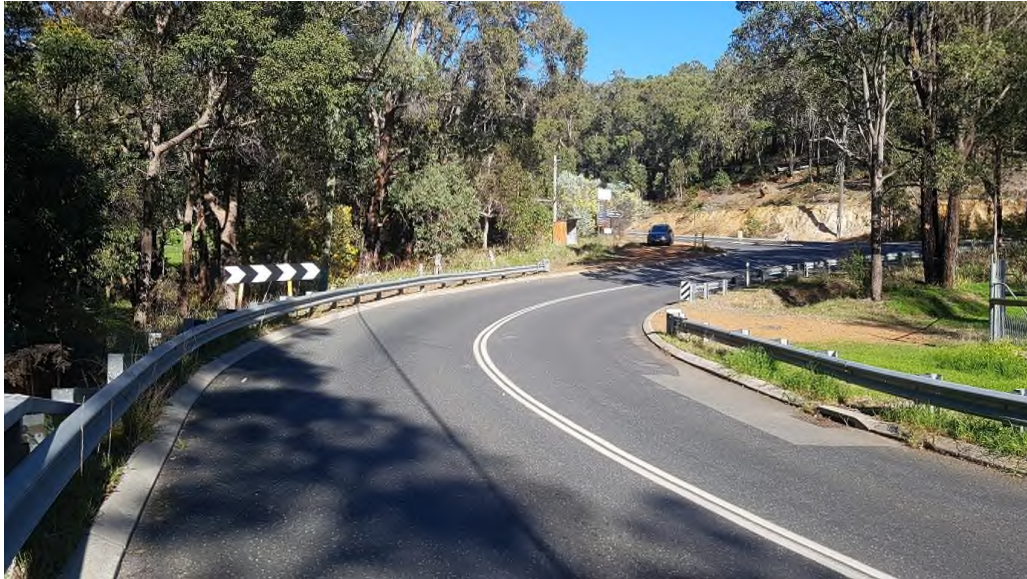
Also located within this section is the sharp curve at Chainage 3900, adjacent the southern Aldersyde Road intersection. This is estimated to have a radius of only 35m, and therefore requires a maximum operating speed of 30 km/h.

Photo 13: This bend has a radius of approximately 35m.

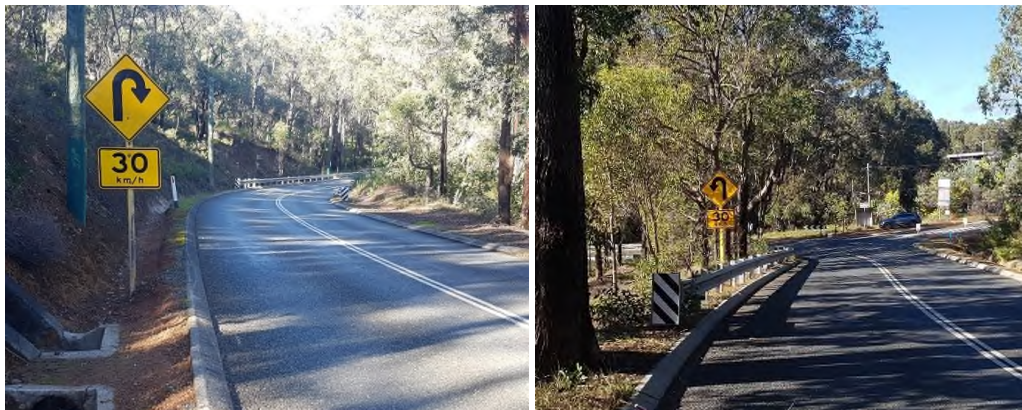
Photos 14 & 14a: Advisory speed signs installed on both approaches.

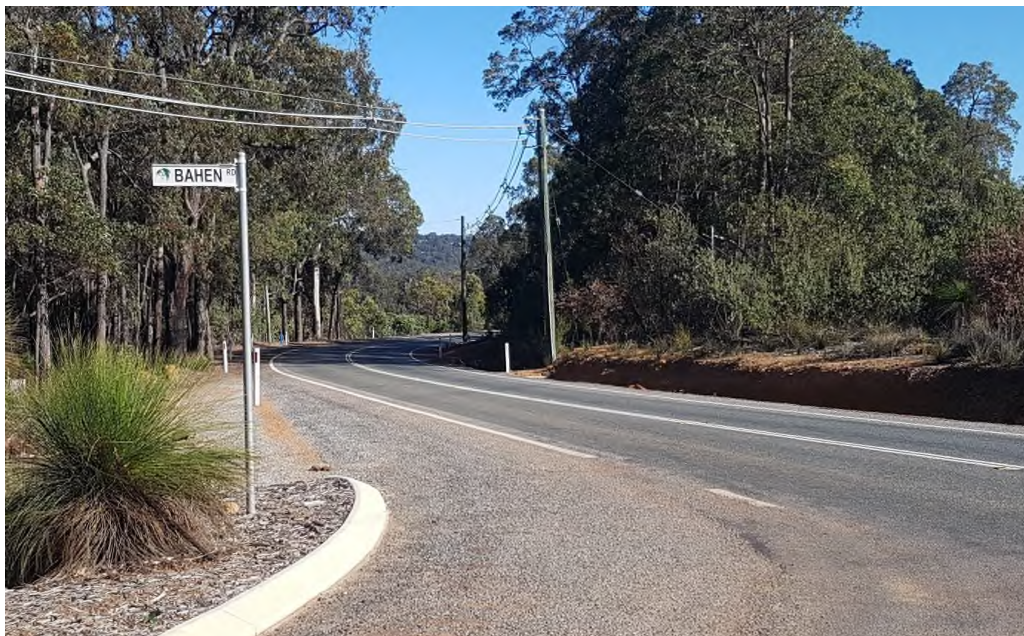
**Photo 15: Sharp bend just west of Bahen Road intersection.**

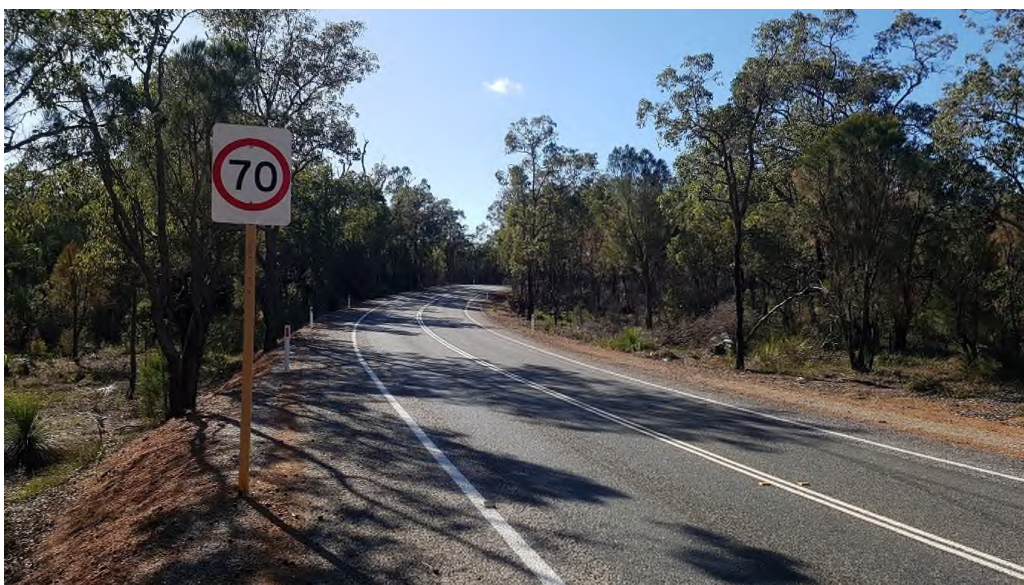
**Photo 16: Horizontal and vertical curves between Paulls Valley Road and Asher Road intersections.**

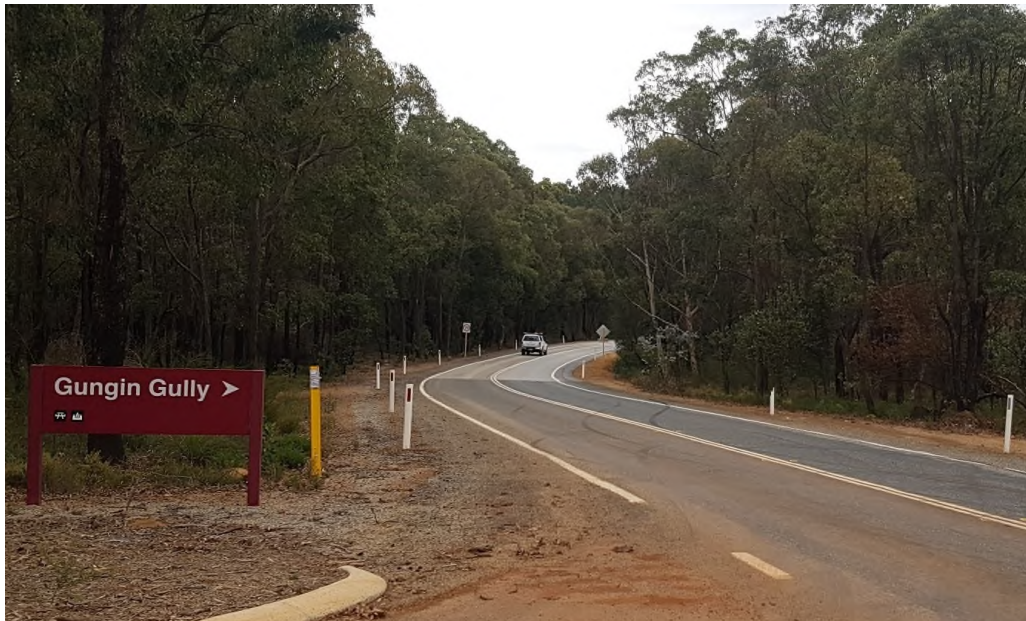
Photo 17: Bend to the west of Lockwood Road.

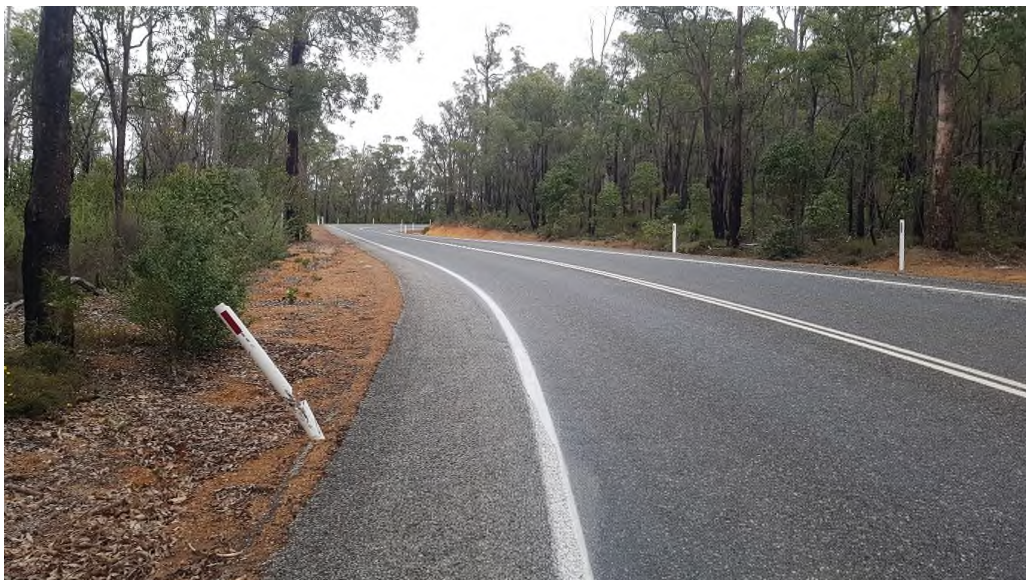
Photo 18: S-bends near Reservoir Road.

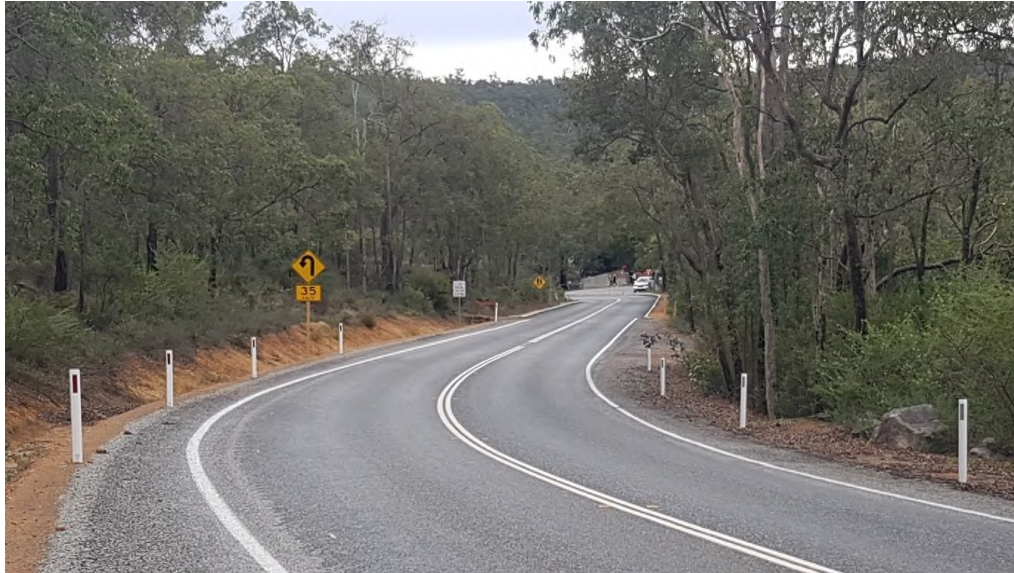
The exceptions to the above include the two sharp bends near the car park at the southern end of Mundaring Weir, chainage 14950 to 15150. These bends have been estimated to have radii of approximately 45m, giving a maximum operating speed of around 50 km/h.

Thus, despite the posted speed limit through this section being only 60 km/h, these curves do not comply. However, both curves currently have advisory speed limit signs installed. See **Photos 19 & 20**.

**Photo 19: Sharp left hand bend adjacent Mundaring Weir car park.**

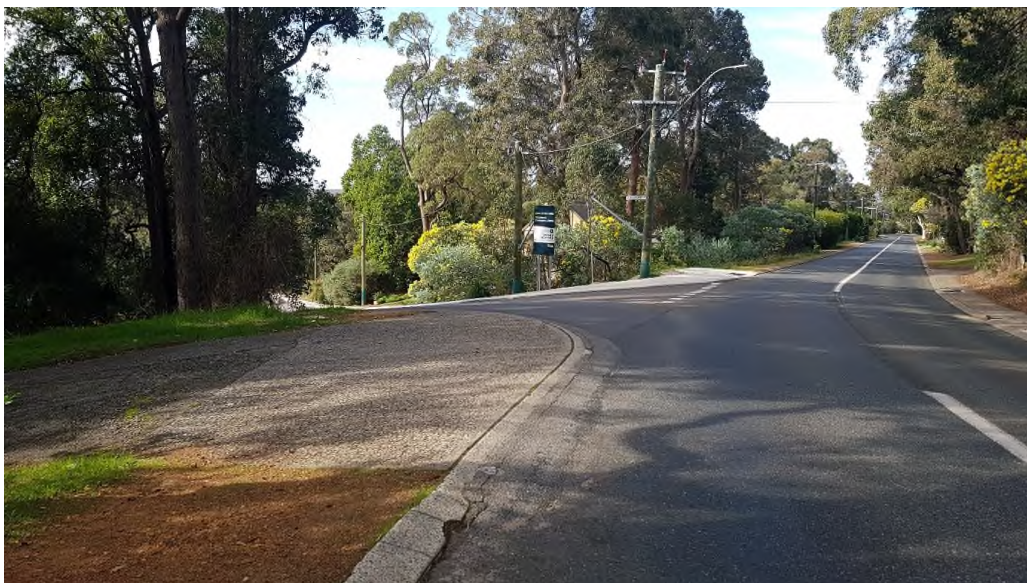
**Photo 23: T-intersection of Crescent Road with Mundaring Weir Road.**

The side road has Give Way and centre line markings, but no Give Way sign or hazard board. However, due to the acute angle of approach to Mundaring Weir Road, an advance warning sign on Crescent Road for the junction ahead would be more suitable and recommended.

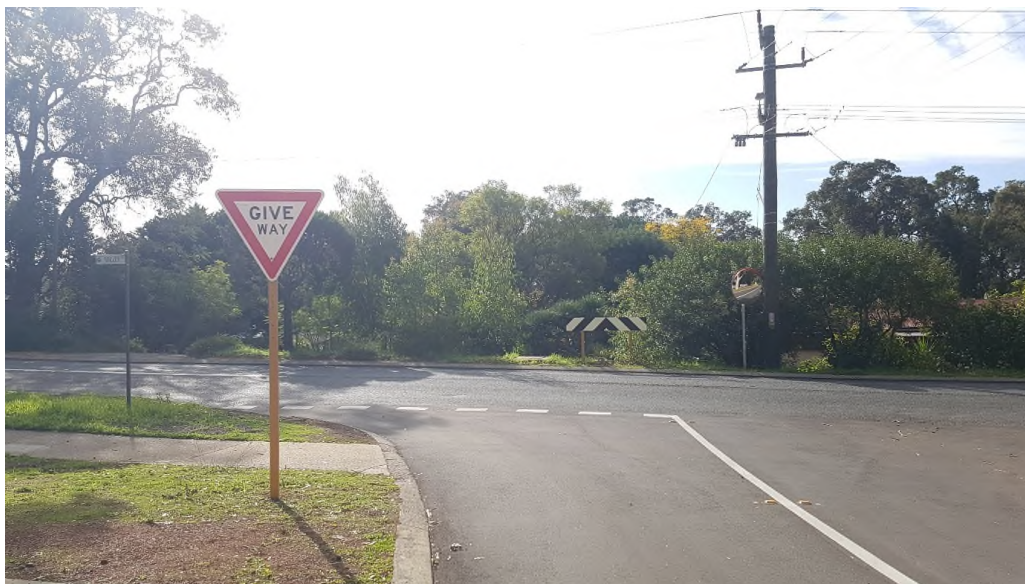
Valley Road meets Mundaring Weir Road in a T-intersection, and provides access to residential properties to the south. The intersection is equipped with Give Way and centre lines, a Give Way sign and a hazard board.

**Photo 24: T-intersection of Valley Road with Mundaring Weir Road.**

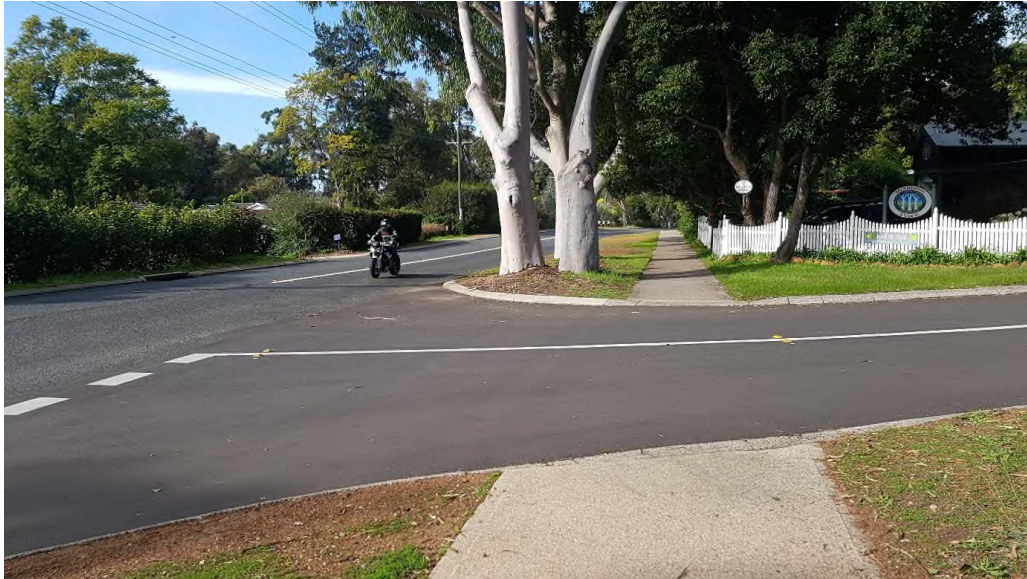
There is also a convex mirror installed, to aid with visibility, probably due to the presence of three large trees in the verge.

**Photo 25:** Large trees in close proximity may limit visibility to the east.

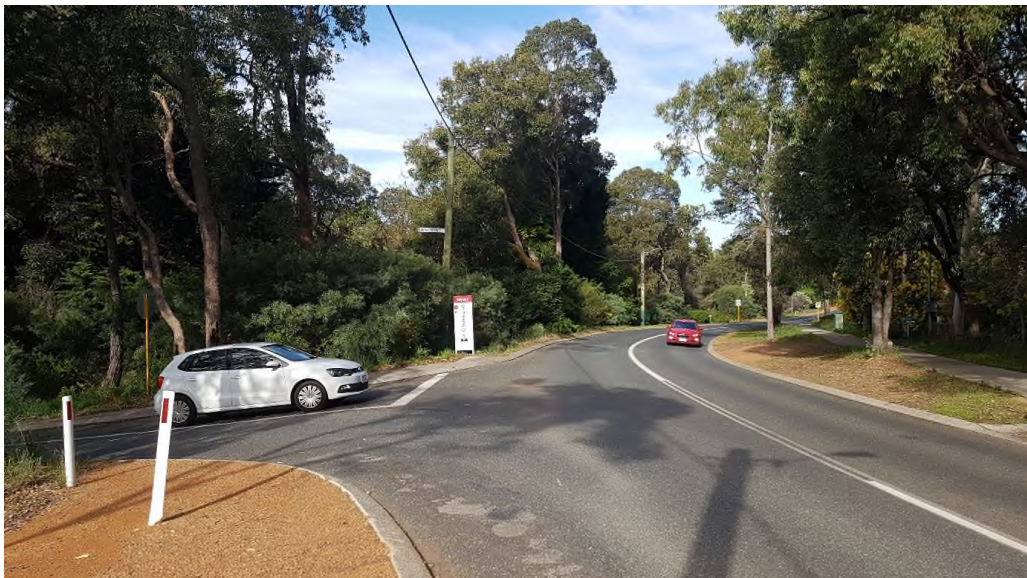
Hummerston Road provides access to large rural properties to the north of Mundaring Weir Road. It forms an alternative link through to Fern Road, whilst also intersecting with Roach Road, Croxton Road and Aldersyde Road. Its intersection with Mundaring Weir Road is located on the outside of a bend. See **Photo 26**.

**Photo 26:** T-intersection of Hummerston Road with Mundaring Weir Road.

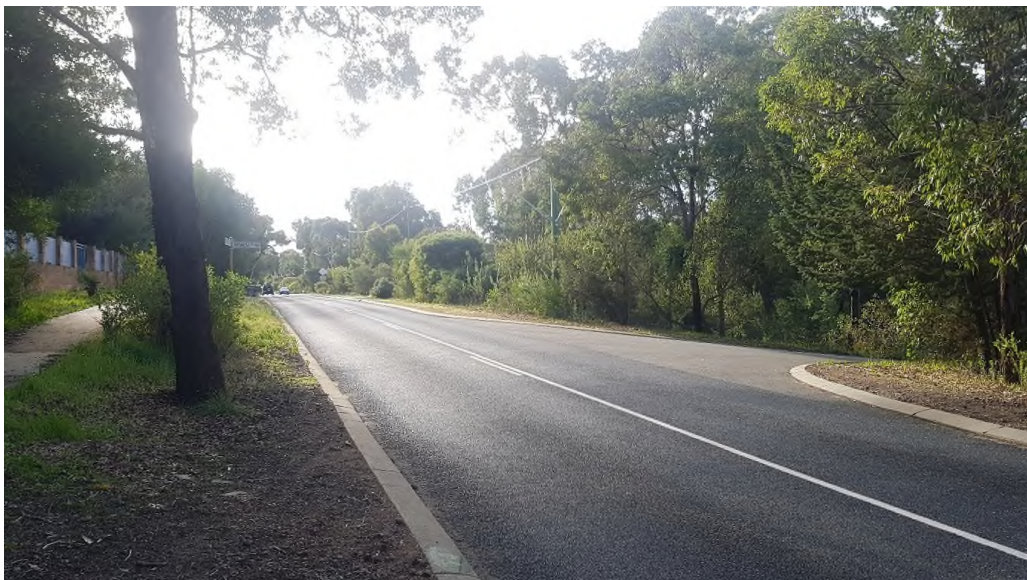
The T-intersection with Roach Road is priority controlled, but has no signs or line markings on approach. Visibility is good from the side road in both directions along Mundaring Weir Road. See **Photo 28**.

**Photo 28: T-intersection of Roach Road with Mundaring Weir Road.**

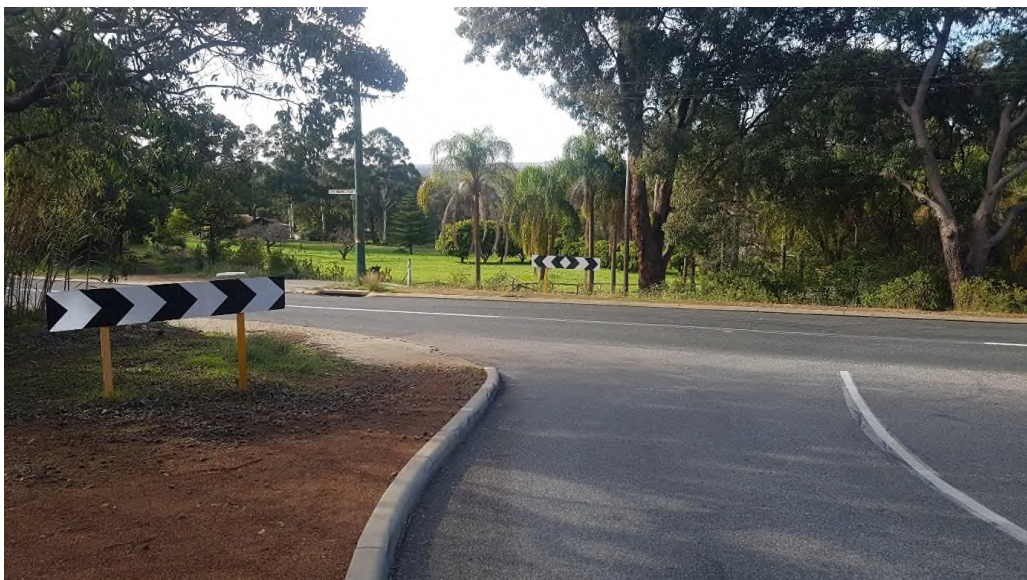
The geometry of the intersection with King Road is not ideal. The side road approaches at an acute angle, before swinging down and right to meet the through road at 90°. However, overgrown verge vegetation limits visibility. The intersection has a hazard board opposite the side road, as well as for the change in alignment on approach, but no Give Way or Stop signs or lines. See **Photos 29 & 30**.

**Photo 30: Side road approach has no Give Way signs or lines.**

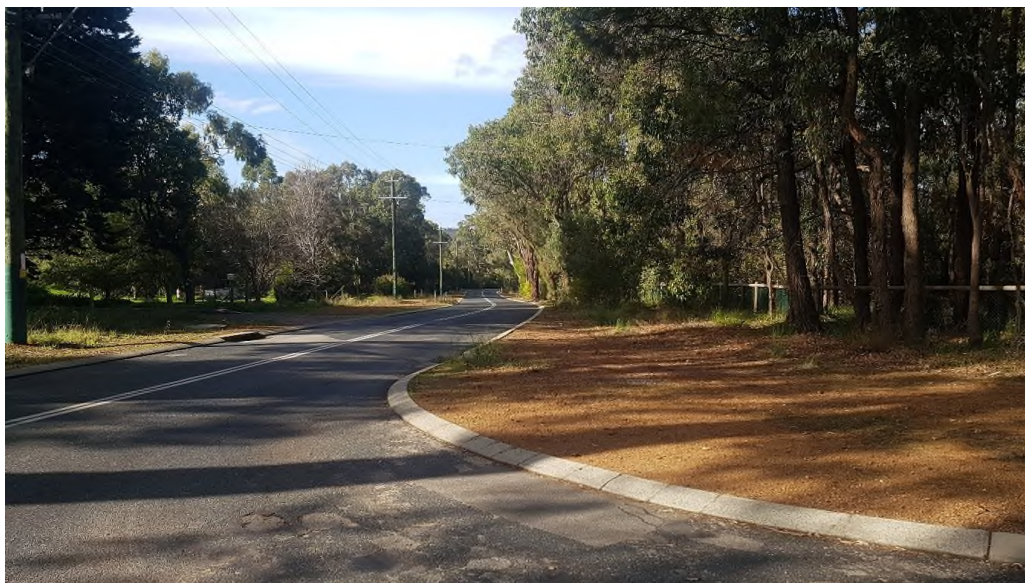
Visibility from Hinkler Road is limited by the road alignment to the right and roadside vegetation, particularly to the left. See **Photos 31 & 32**.

**Photo 31: T-intersection of Hinkler Road with Mundaring Weir Road. Visibility to the right is good.**

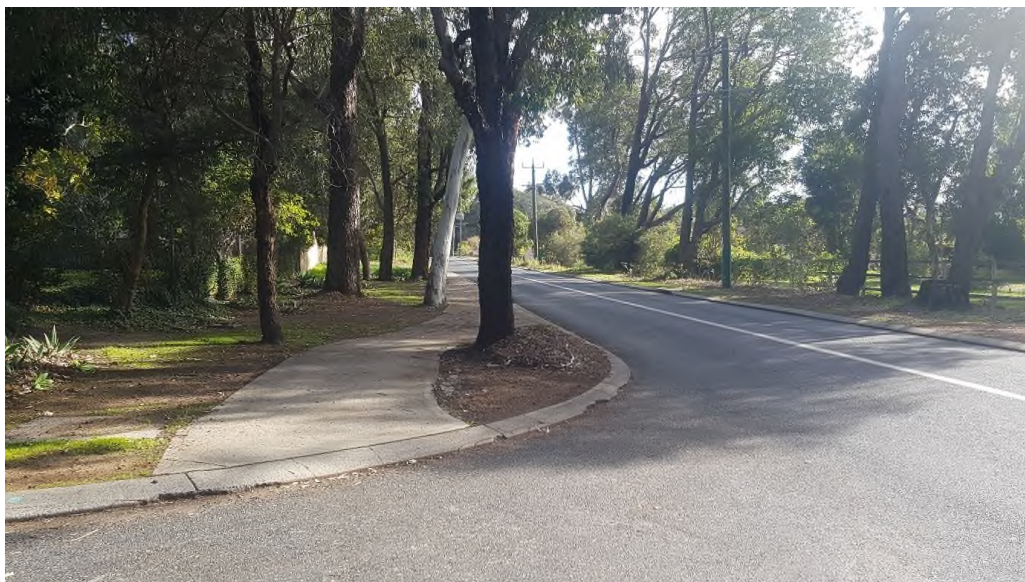
**Photo 32: Visibility to the left is compromised by verge trees.**

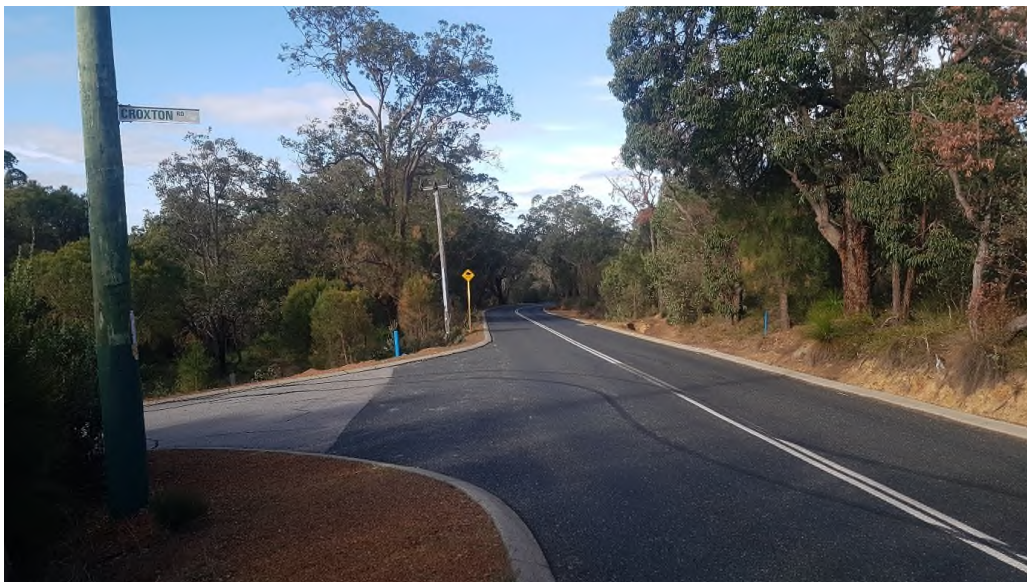
The intersection with Croxton Road has no signs or lines installed. Visibility is limited in both directions due to the horizontal alignment of Mundaring Weir Road. See **Photos 33 to 34a**.

**Photo 33: T-intersection with Croxton Road with Mundaring Weir Road.**

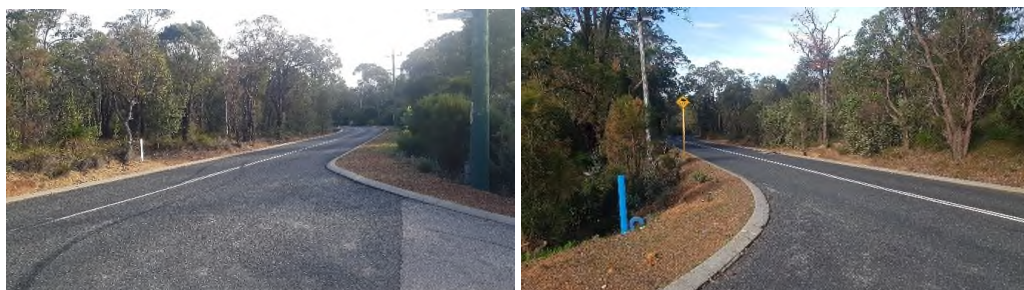
**Photos 34 & 34a: Visibility is limited in both directions by bends in the through road.**

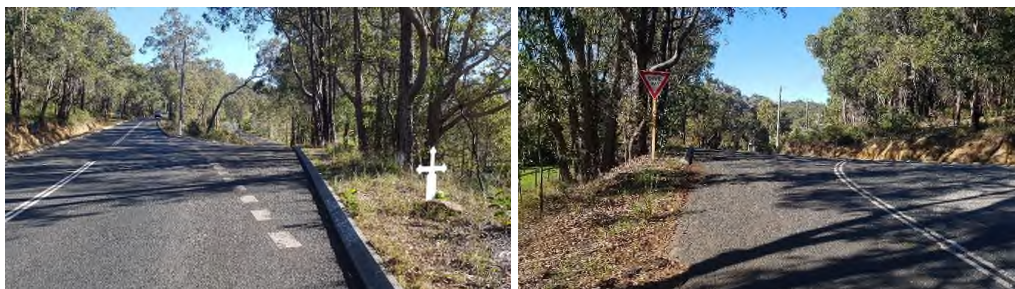
The northern section of Aldersyde Road intersects Mundaring Weir Road, on an uphill gradient, in an acute Y-intersection layout, as seen in **Photos 35 & 35a**.

**Photos 35 & 35a: Northern of the two Aldersyde Road connections forms an acute Y-intersection.**

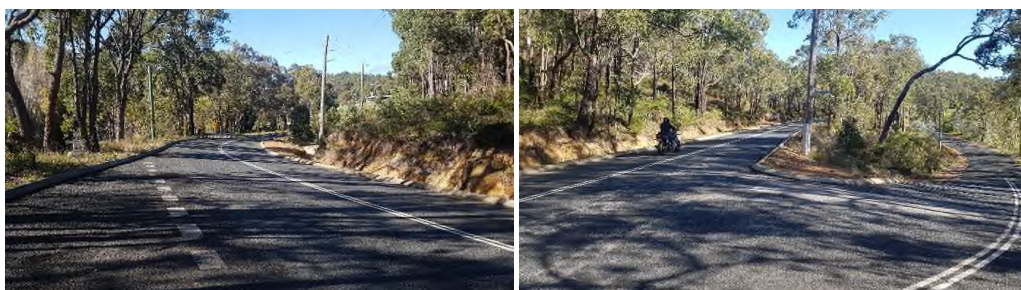
Visibility is limited in either direction from the side road, due to the horizontal and vertical alignments of Mundaring Weir Road. This is exacerbated by roadside vegetation.

**Photos 36 & 36a: Visibility is limited in both directions.**

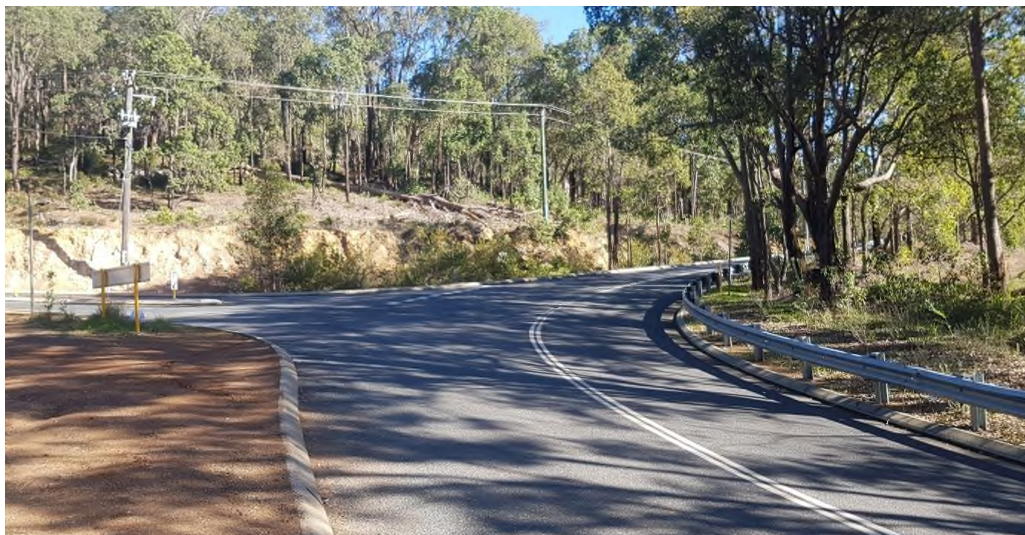
The southern Aldersyde Road intersection meets Mundaring Weir Road on the outside of a sharp bend, as shown in **Photo 37**. However, visibility is still compromised in both directions by the alignment of the road. See **Photos 38 & 38a**.

**Photo 37: Southern of the two Aldersyde Road intersections.**

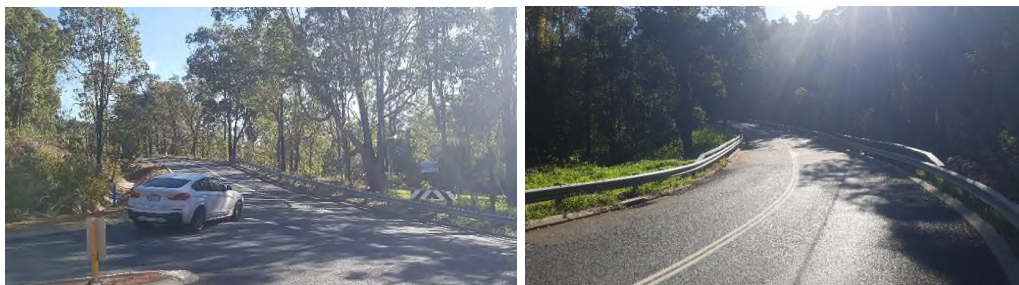
**Photos 38 & 38a: Visibility from the side road is limited in both directions.**

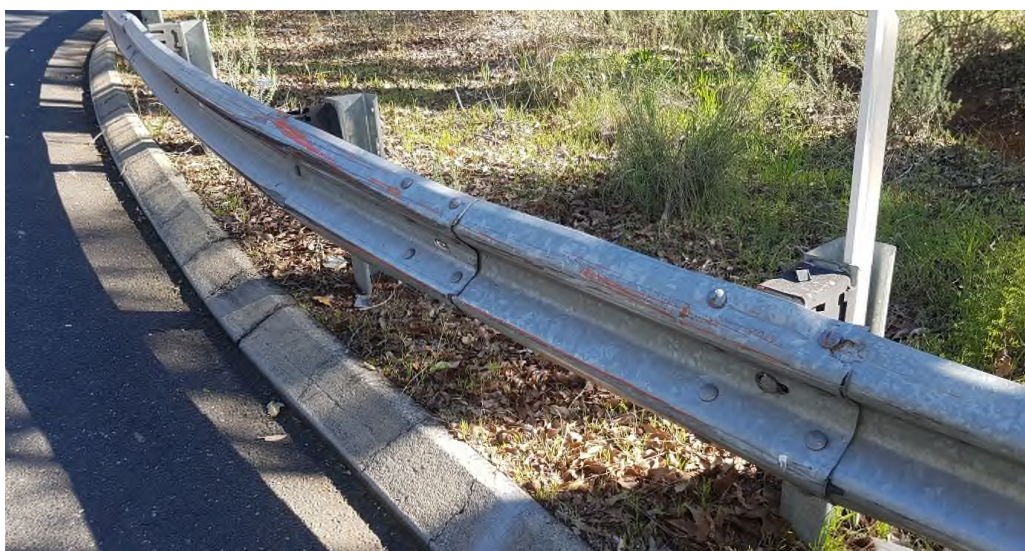
W-beam safety fence has been installed on the inside of the bend, but is very close to the kerb line. The fencing has been struck multiple times, as can be seen in **Photo 39**.

**Photo 39: Safety barrier is very close to kerb line and has been struck several times.**

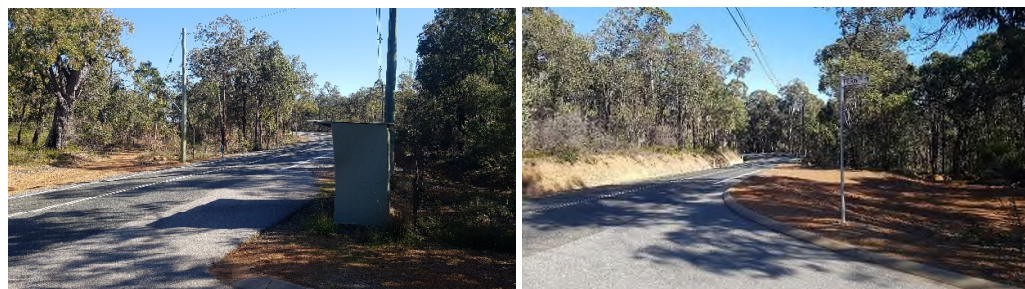
Fern Road forms a T-intersection with Mundaring Weir Road, located on a short straight between two sweeping bends. Visibility is limited to some extent to the left by the presence of a disused bus shelter, and to the right by a horizontal curve. The intersection has no Give Way lines or signs, no hazard board and a non-standard section of edge line. See **Photos 40 to 41a**.

**Photo 41 & 41a: Visibility is limited in either direction.**

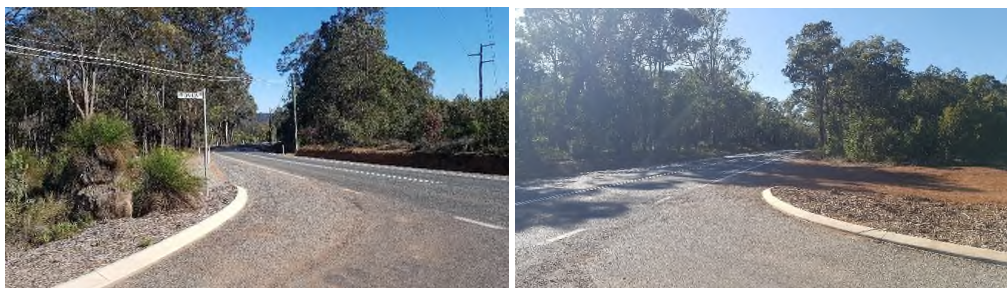
The intersection of Mundaring Weir Road with Bahen Road is a T-intersection. It has no Give Way signs or lines and no hazard board opposite. Visibility is limited in both directions by horizontal and vertical alignment issues. See **Photos 42 to 43a**.

**Photos 43 & 43a: Visibility is limited in both directions.**

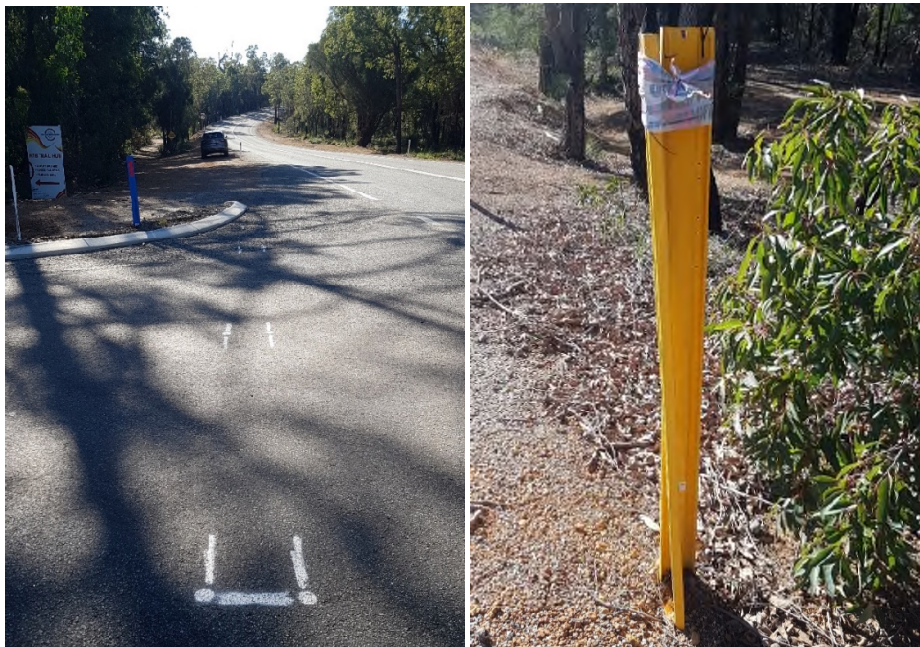
The intersection of Mundaring Weir Road with Paulls Valley Road is a T-intersection. It has no Give Way signs or lines and no hazard board opposite. However, it appears from markings and other evidence on site that upgrades to this intersection have yet to be completed. Visibility is limited in both directions by horizontal and vertical alignment issues. See **Photos 44 to 45a**.

**Photos 45 & 45a:** Upgrades may still be incomplete.

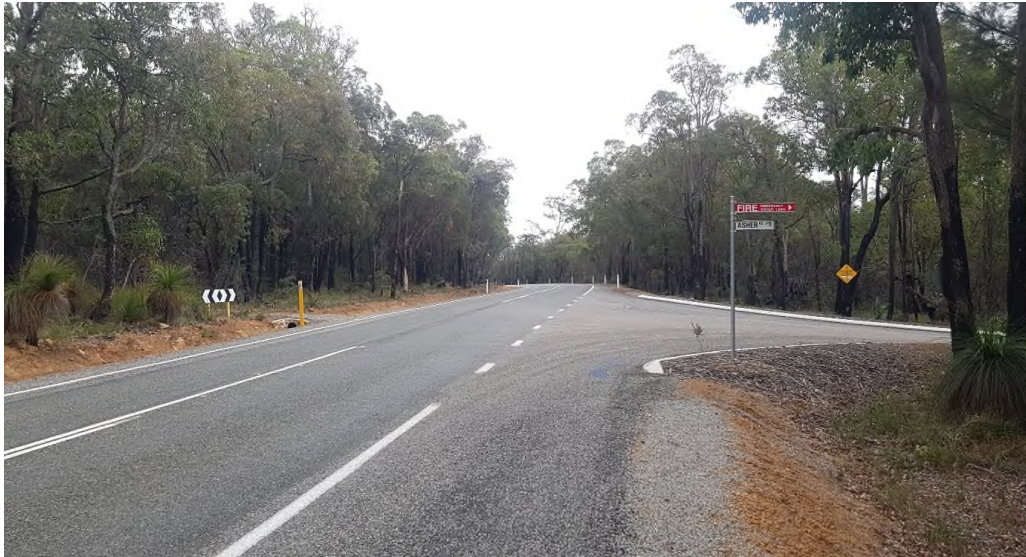
**Photo 46: Intersection with Asher Road.**

The intersection of Asher Road has a hazard board, but no Give Way signs or lines. The radii have been kerbed. Visibility is reasonable. See **Photo 46**.
