September 2022

## Mundaring Weir Rd - Road Safety Investigation

Prepared For: City of Kalamunda

## Final Report

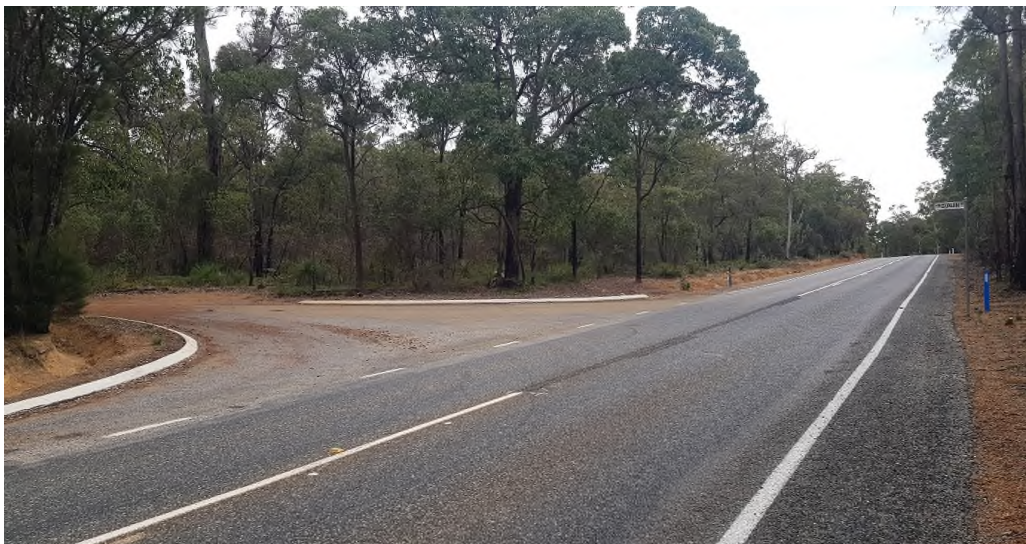
**Photo 47: Intersection with Gunjin Road.**

Gunjin Road has been sealed for a short distance back from Mundaring Weir Road. Similarly to other nearby intersections, it has kerbed radii but no signs or lines. See **Photo 47**.

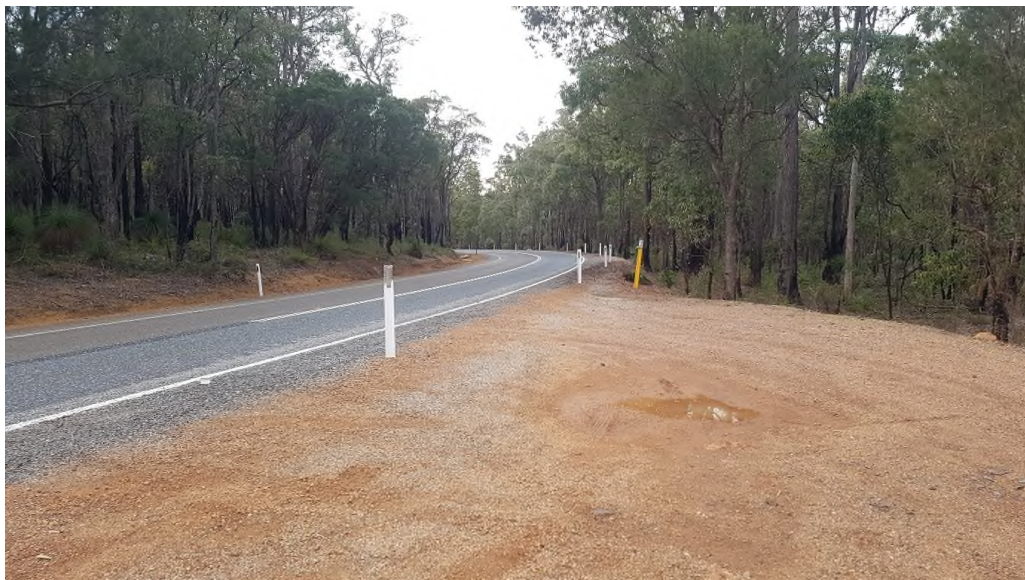
Little Oven Road is a very minor, unsealed road. As can be seen in **Photo 50**, the side road approach has not been sealed, and even has a guidepost installed within the intersection. There are no signs or line markings.

**Photo 50: Little Oven Road is unsealed.**

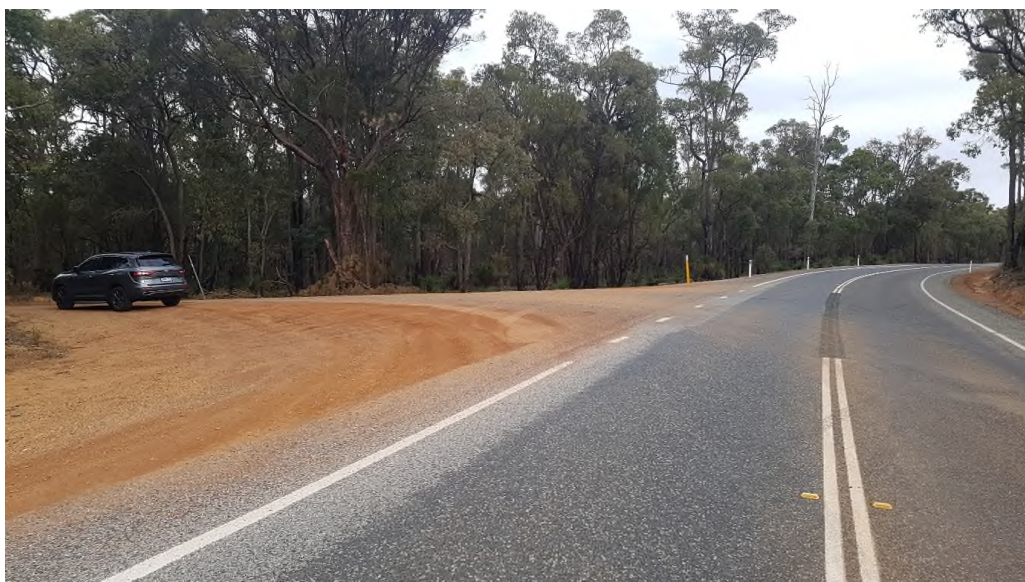
Ashendon Road is a very minor, unsealed road. As can be seen in **Photo 51**, the side road approach has not been sealed. There are no signs or line markings.

**Photo 51: Ashendon Road approach is unsealed.**

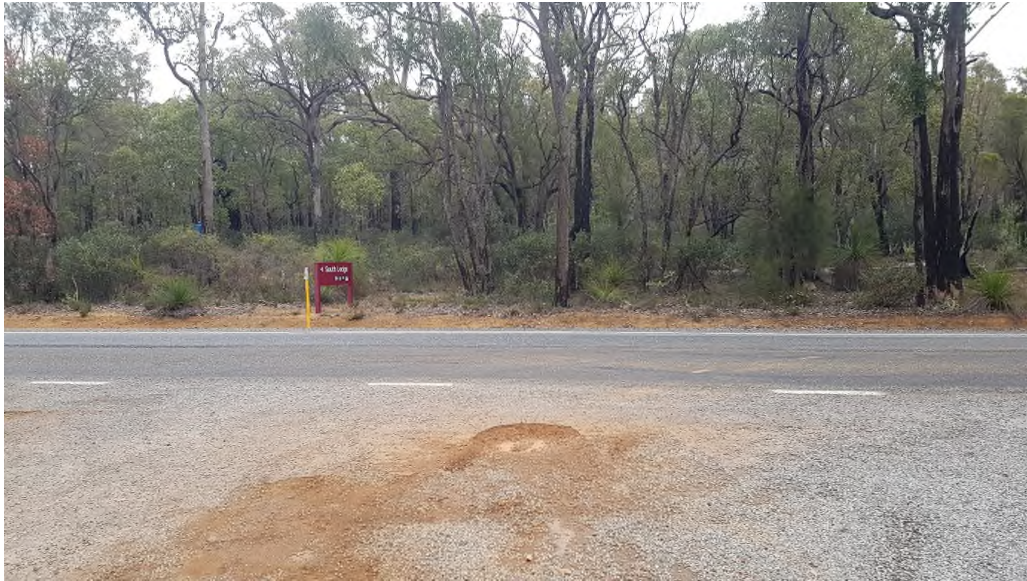
**Photo 52: S Ledge Road intersection.**

S Ledge Road is a very minor, poorly sealed road. As can be seen in **Photo 52**, the side road approach has not been properly sealed, and has various pot holes. There are no signs or line markings, and the intersection radii have not been kerbed. See **Photos 53 & 53a**.

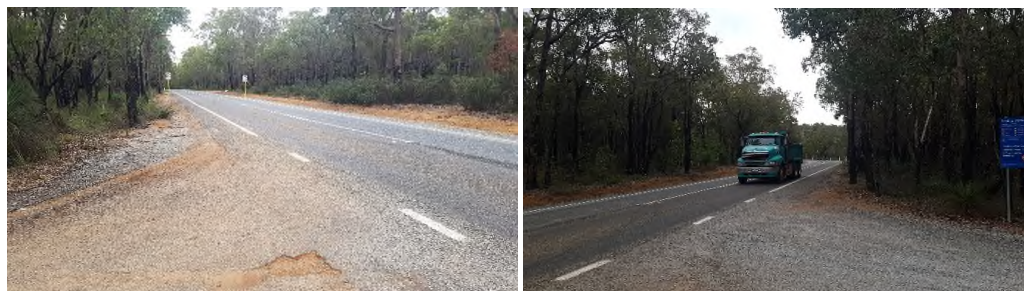
**Photos 53 & 53a: The side road radii are not kerbed.**

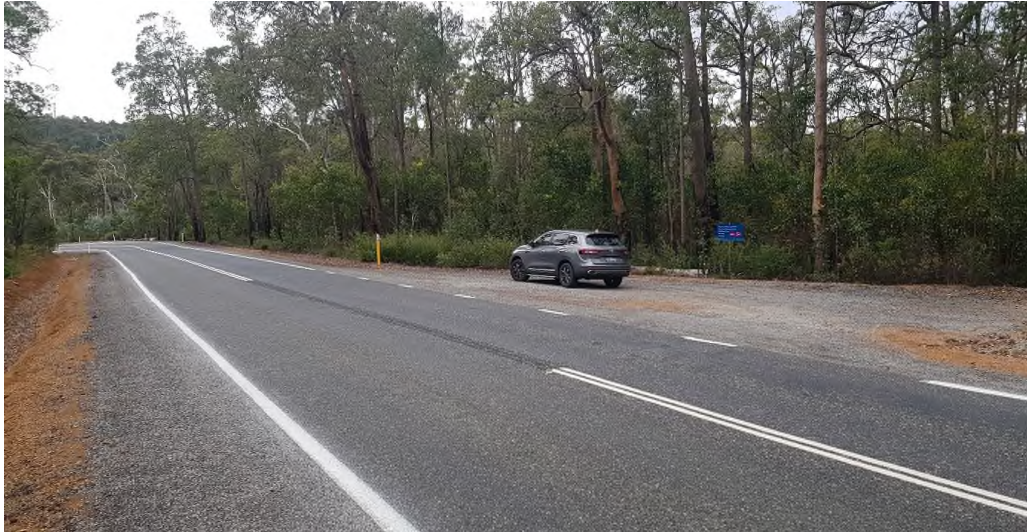
**Photo 54: Reservoir Road**

Reservoir Road is a very minor, poorly sealed road. As can be seen in **Photo 54**, the side road approaches at an acute angle and has not been properly sealed. The appropriate junction ahead sign should be installed on the approach to Mundaring Weir Road. There are no signs or line markings, and the intersection radii have not been kerbed.

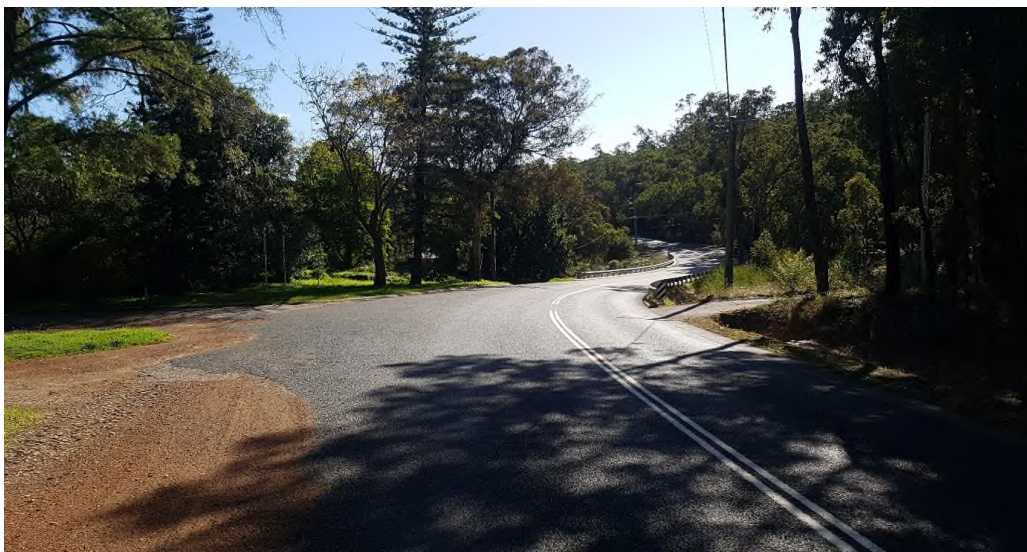
Chalet Rigi lies just to the south of a series of significant S-bends. The property currently has two partly sealed accesses. A widened section of seal forms an unmarked, pseudo left turn lane. See **Photo 55**.

**Photo 55:** The partly sealed accesses to the Chalet Rigi car parks are on the left. There is no edge line.

It is understood that an application has been received from the property owners to upgrade the facilities at Chalet Rigi, including a proposed slip lane and revised crossover. These are noted, but it is important that the access is well signed, and that the edge of the carriageway is well defined as a part of any upgrades, particularly at night.

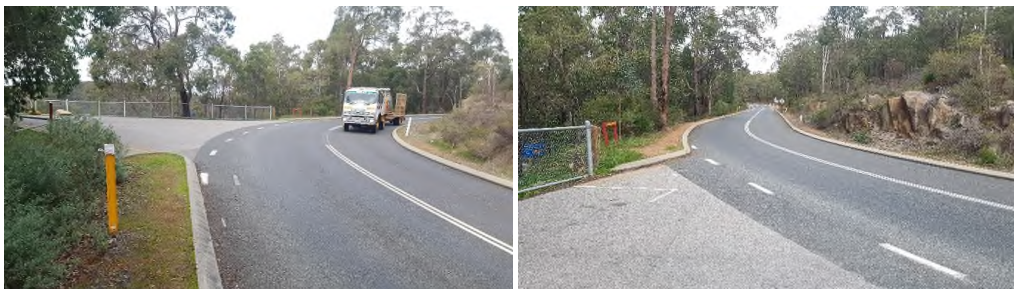
At the southern end of Mundaring Weir, there are two car park accesses, located between two significant horizontal curves. As the eastern access is located on the outside of the bend, visibility is reasonably good. See **Photos 56 & 56a**.

**Photos 56 & 56a:** Eastern Mundaring Weir car parking access.

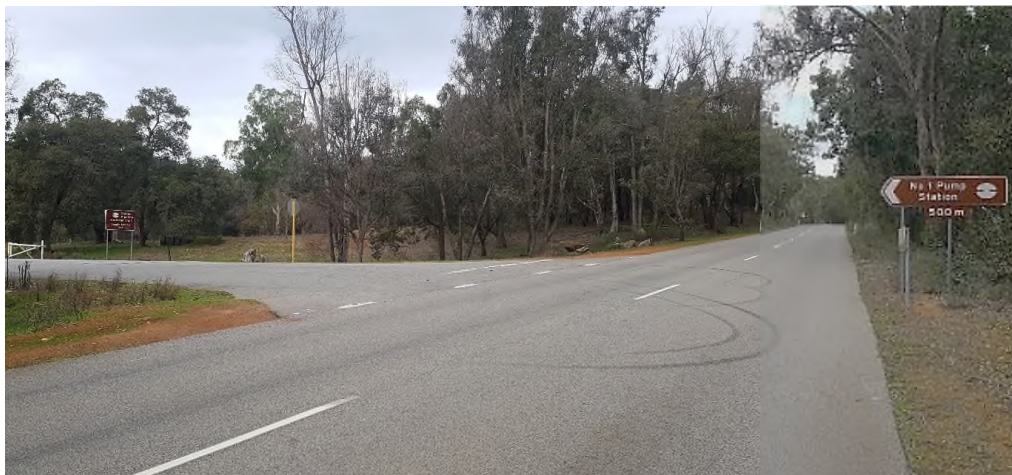
**Photo 58: Access Road to No.1 Pump Station.**

The access road to No 1 Pump Station is on a straight section of road, with reasonably good visibility. The access has a Stop sign and line. See **Photos 58 to 60**.

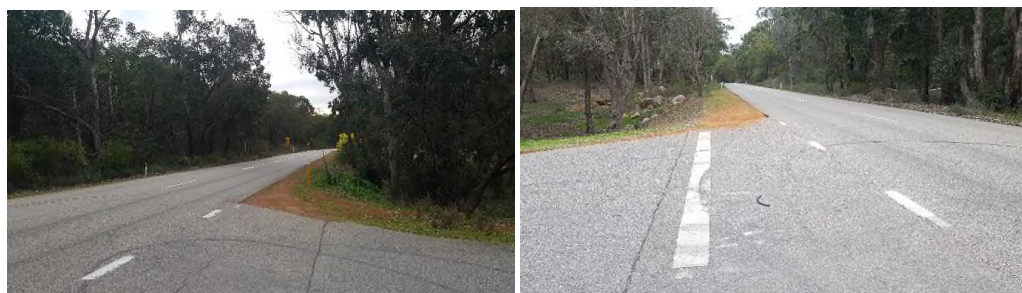
**Photo 59 & 59a: Visibility from the No. 1 Pump Station access road.**

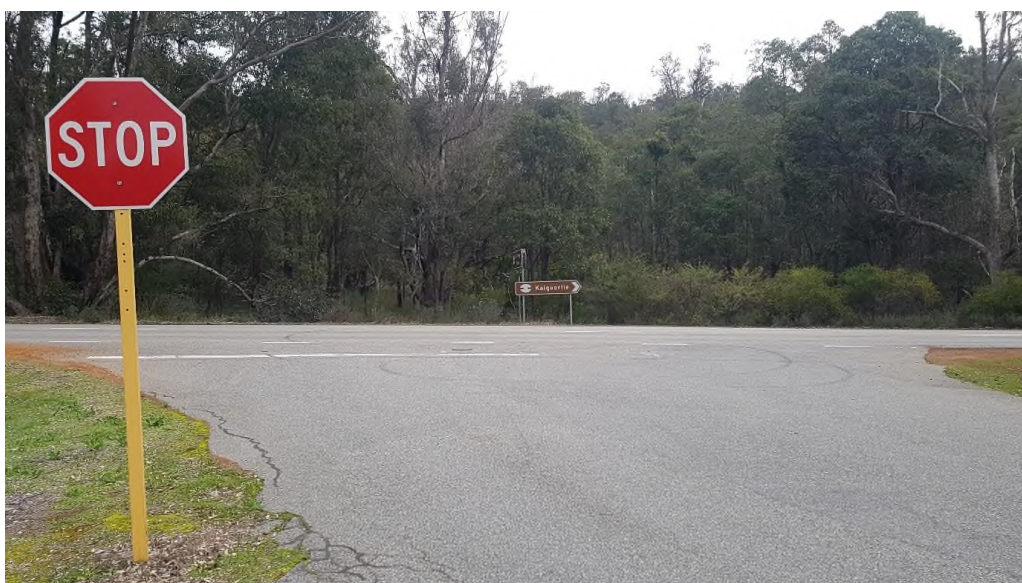
**Photo 60: The access is not kerbed, but does have a Stop sign and line.**

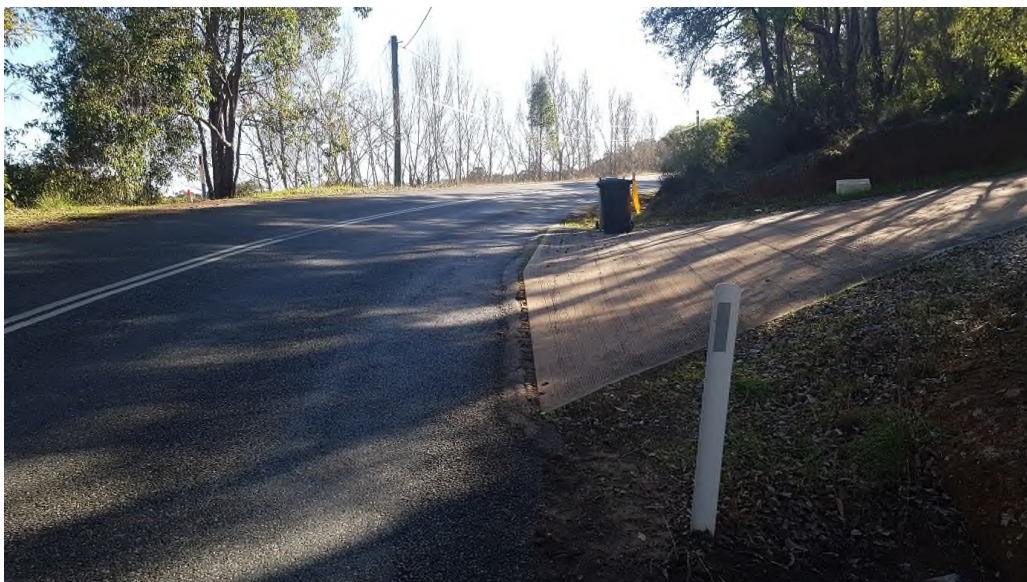
**Photo 62: Steep concrete driveway on inside of curve gives limited visibility.**

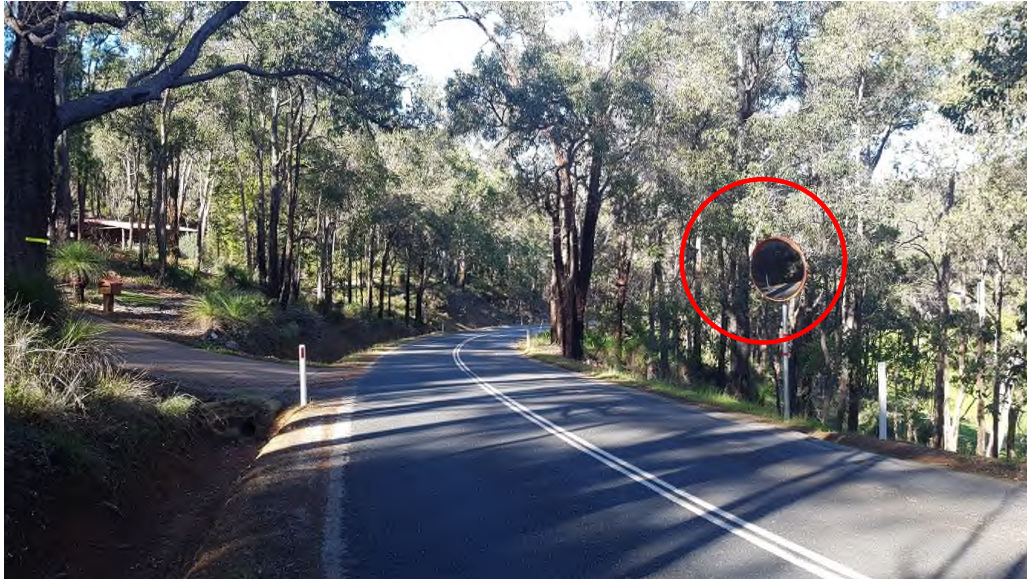
**Photo 63:** Convex mirror installed to assist with visibility.

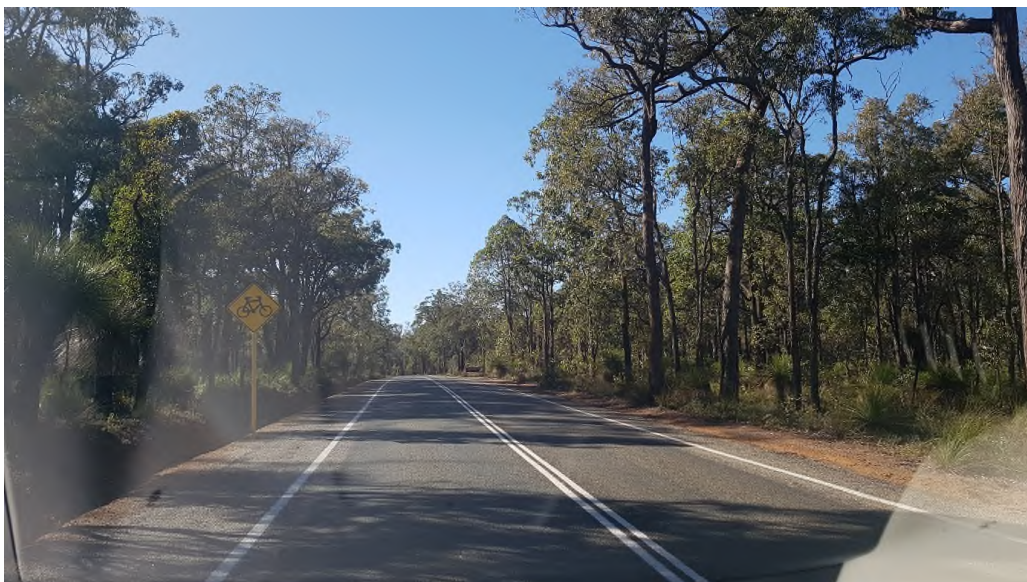
**Photo 64:** It is not clear why the cyclist warning sign is required in this location.

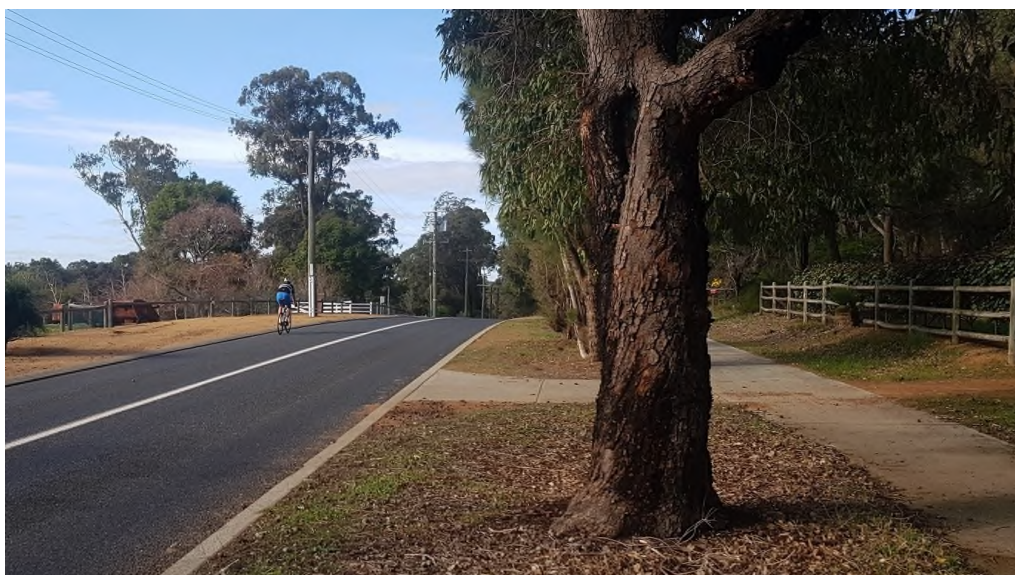
Whilst there is a footpath along this section, albeit on one side of the road only, it is not generally suitable for cyclists, and falls well below current design standards, in several regards.

**Photo 65: Cyclists have to use the traffic lanes, or a very poor standard footpath.**

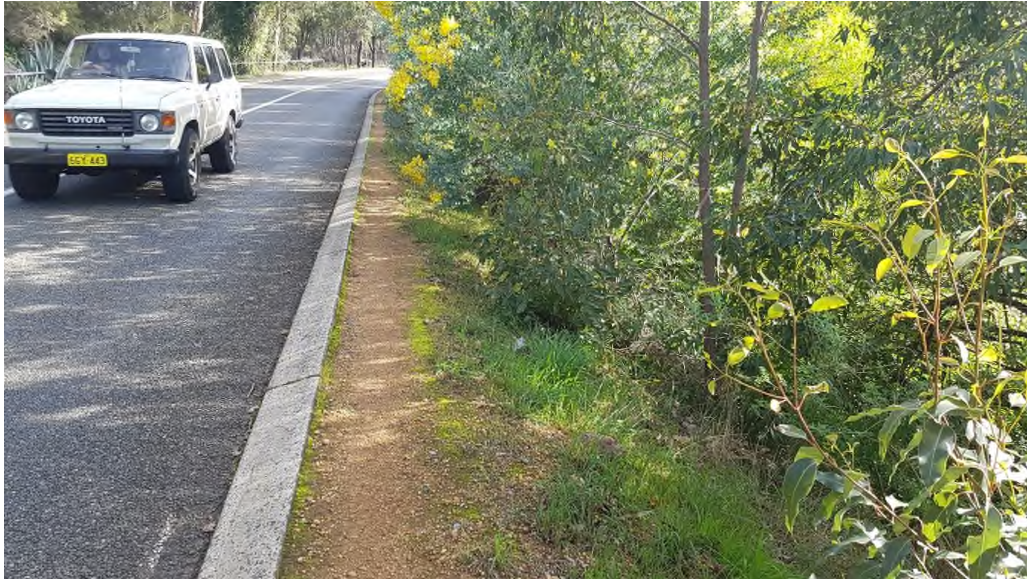
There is also evidence that the opposite verge is regularly trafficked by pedestrians.

**Photo 66:** Evidence of regular foot traffic along this verge.

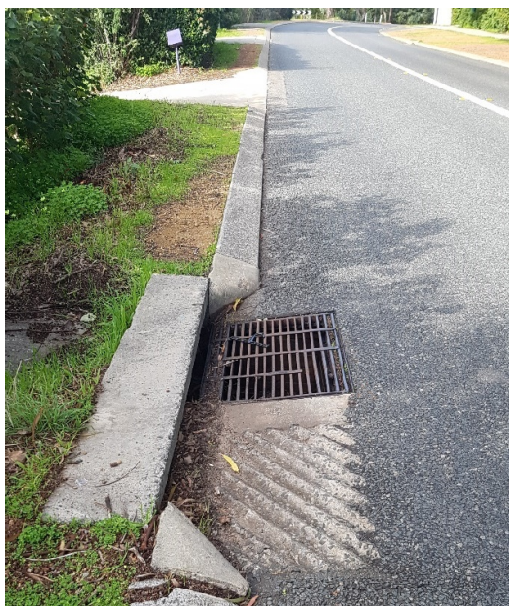
In addition, there are a number of drainage grids that are very poorly designed in terms of cyclist safety. See **Photo 76**.

**Photo 76: Typical 'Cycle-unfriendly' drainage facility.**

A number of unsuitable drainage features were identified, at various locations, which, although designed to channel water flow into the kerbside gulleys, also present a significant hazard to cyclists and possibly motorcyclists. These should be replaced with gratings designed to meet current standards.

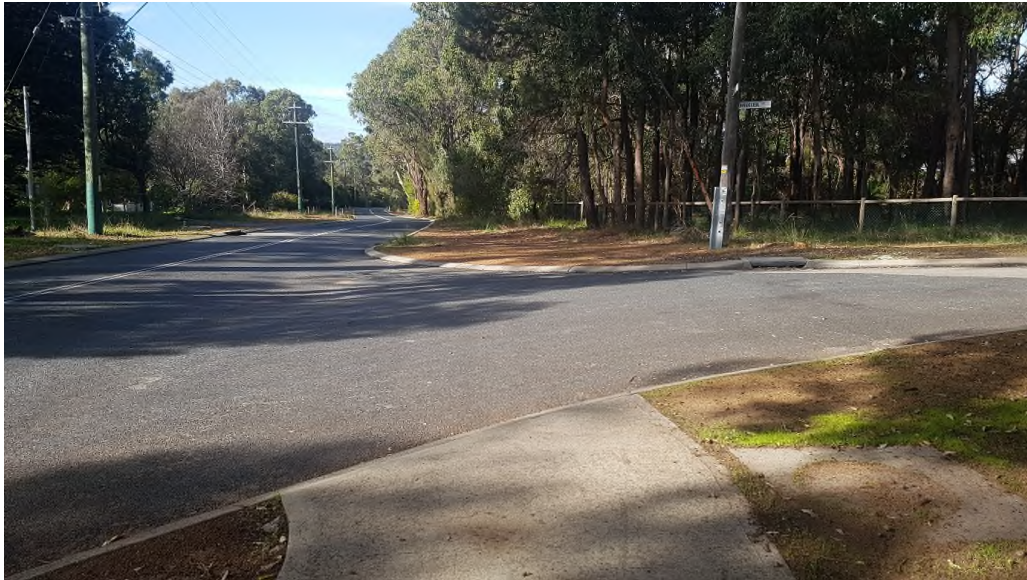
The footpath ends at the Hinkler Road intersection, with no continuation along either road.

**Photo 77:** The footpath terminates at this point, with no continuation along either road.

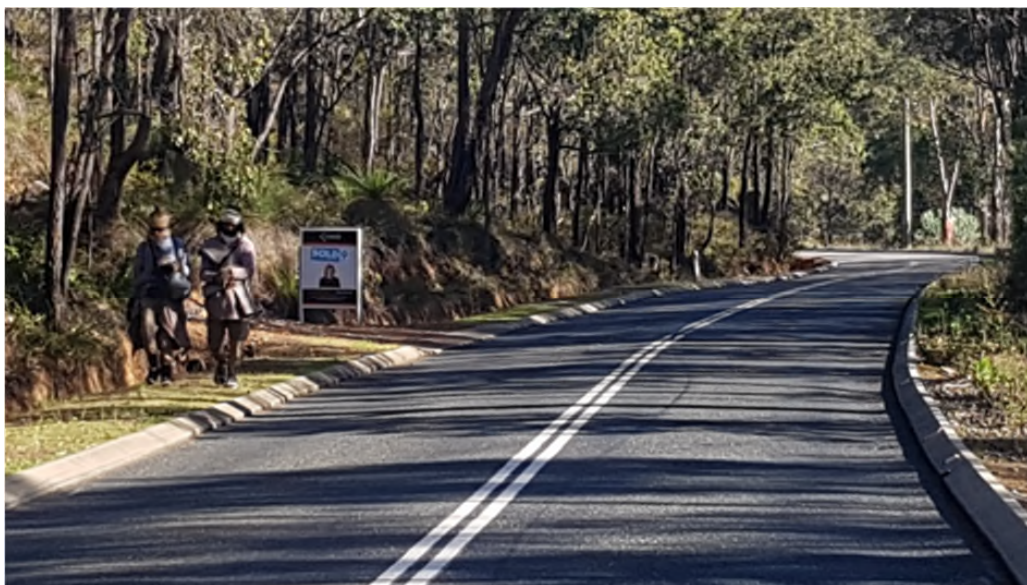
There are no on road cycle lanes, no hard shoulders and no footpaths along this section of Mundaring Weir Road. The road is kerbed between the Hinkler Road and southern Aldersyde Road intersections, giving no space for cyclists to manoeuvre when being overtaken. See **Photo 78**.

**Photo 78:** Any pedestrians have to walk on the verge.

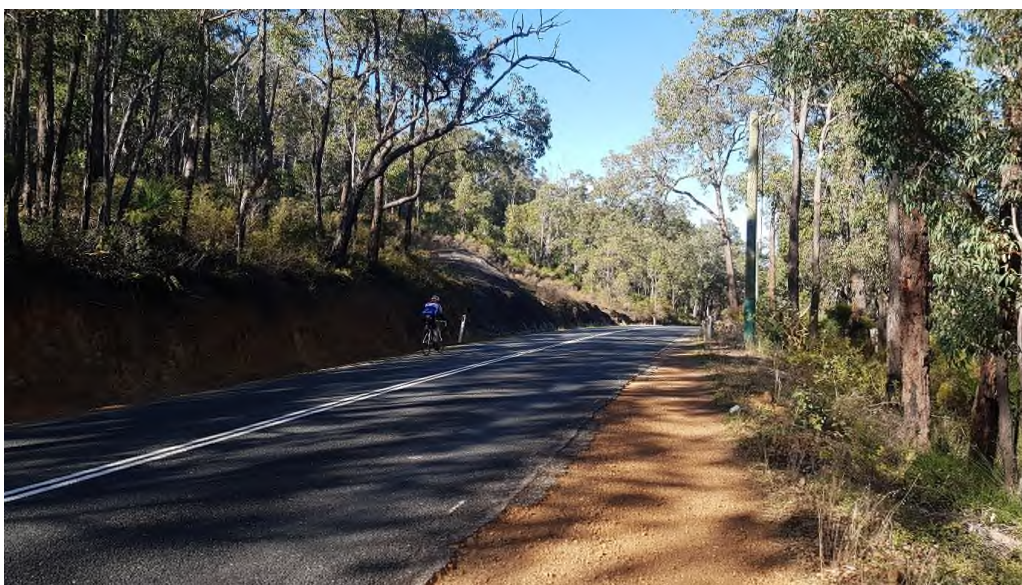
Beyond Aldersyde Road, the road is mostly unkerbed, with unsealed shoulders and verges.

**Photo 80:** Only the occasional cyclist was seen using this section of the road.

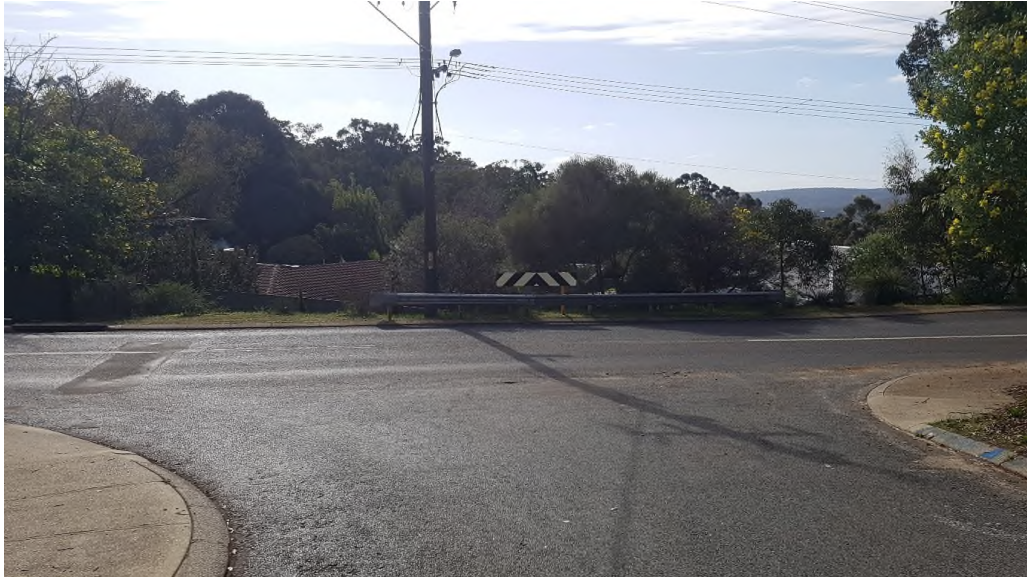
There is a drop off on the northern side of Mundaring Weir Road, opposite the Schmitt Road intersection. A short section of W-beam has been installed, but this is not an acceptable solution. See **Photos 79 & 80**.

**Photo 82: Schmitt Road: No Give way signs or lines. Note unsuitable use of not-to-standard W-beam.**

Typically, W-beam is not intended to be used to withstand 90° impacts. The section as installed is also too short to provide effective protection from acute angle collisions, and has non-crashworthy end treatments.

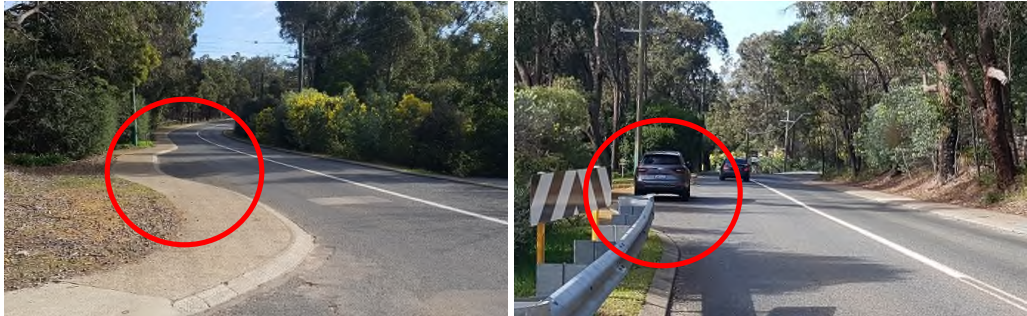
There are a number of other hazards adjacent the carriageway on this stretch of Mundaring Weir Road, including root damaged kerbing and narrow parking bays. See **Photos 85 to 86a**.

**Photos 86 & 86a:** Parking bays (possibly former bus embayments?) are unmarked, and not really wide enough.

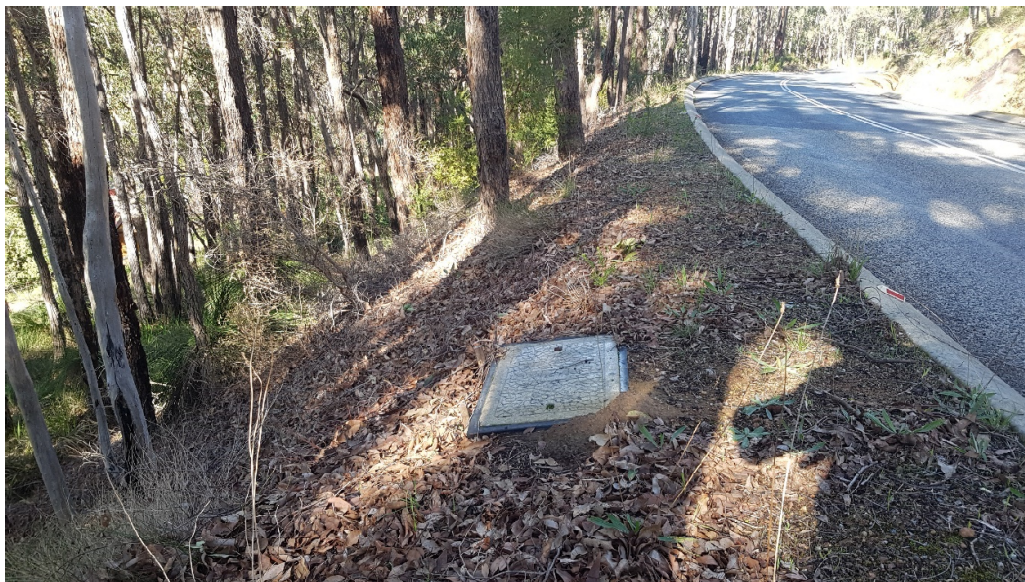
**Photo 88: Unrecoverable batter with a significant drop off. Note service lid.**

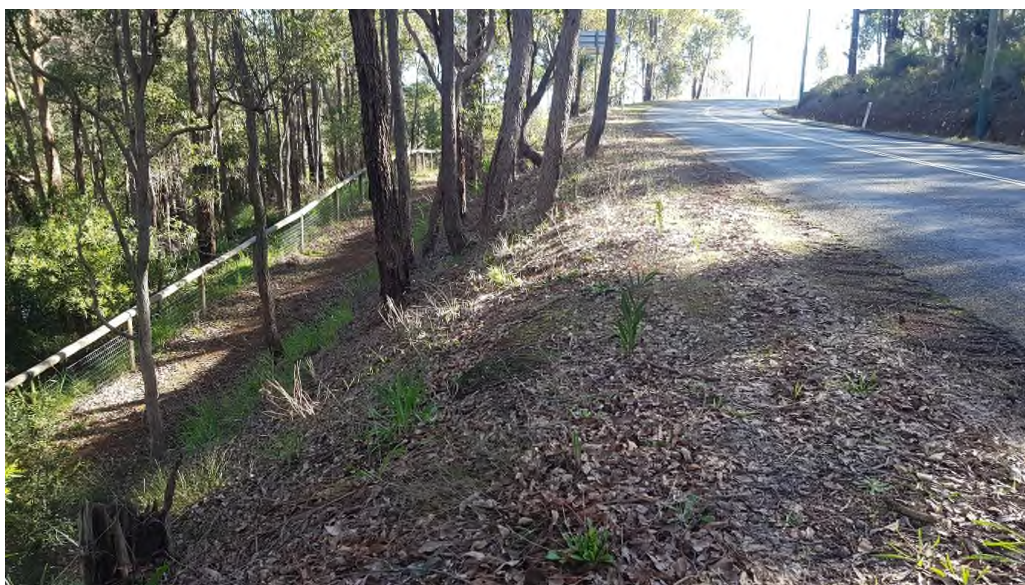
**Photo 89: Another typical drop off along this section.**

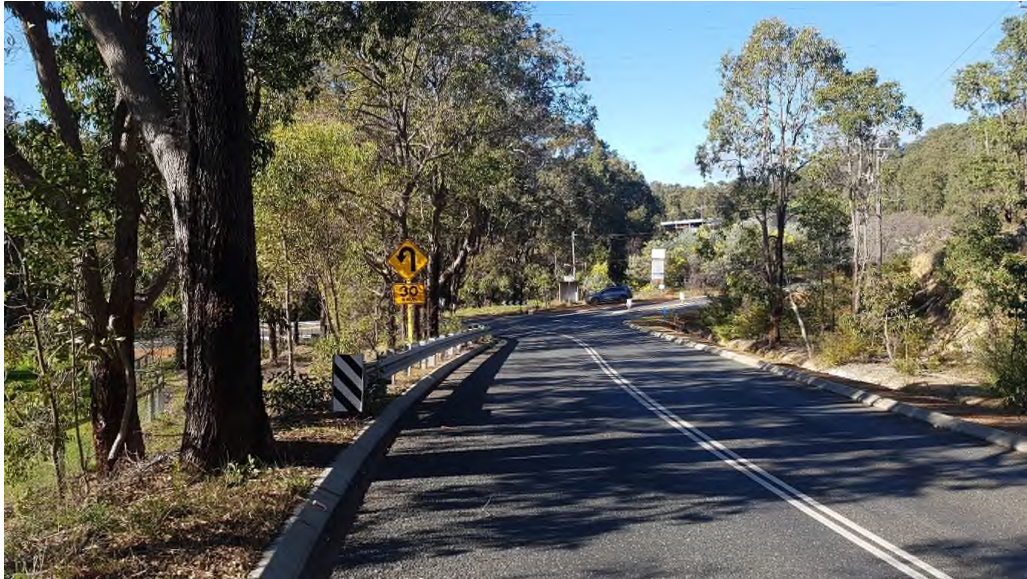
Although the safety barriers do protect errant vehicles from some of the roadside hazards along this section of road, it can be seen in **Photos 94 & 95** that there are many more that remain exposed.

**Photo 95:** A large tree stands exposed just before the safety barrier commences.

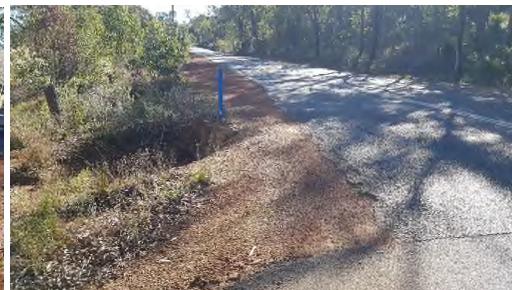
As well as trees, steep embankments and safety barriers, there are a number of other roadside hazards awaiting errant vehicles along this stretch. See **Photos 97 to 97f**.

Photo 97 to 97f: Other roadside hazards include head walls, culverts and large rocks.

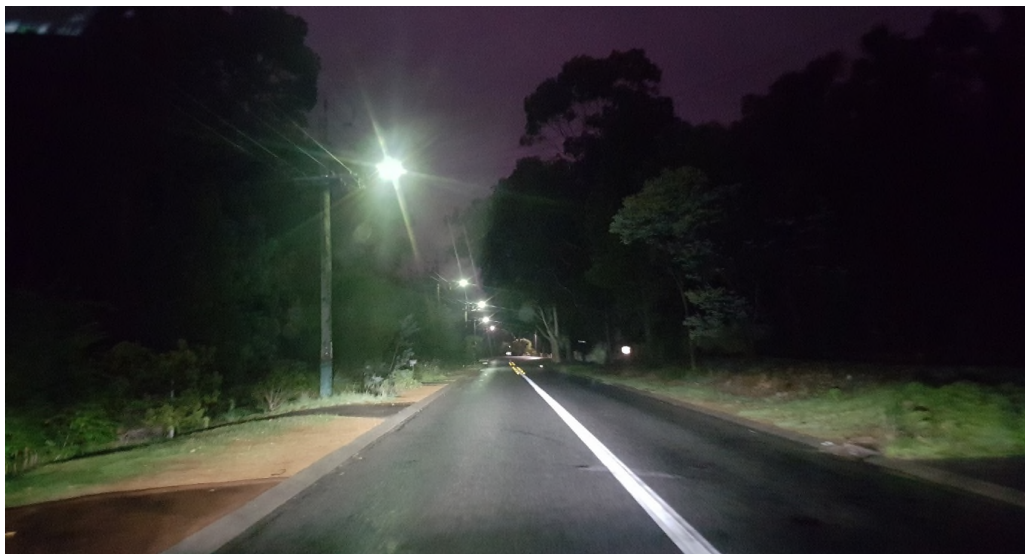
The standard of lighting along the sections of Mundaring Weir Road being investigated is inconsistent, and generally poor. The provision of lighting is limited, with illumination levels provided by the differing types of lighting also being inconsistent. See **Photos 103 & 104**.

Photo 103: Street lighting west of Valley Road, looking east.

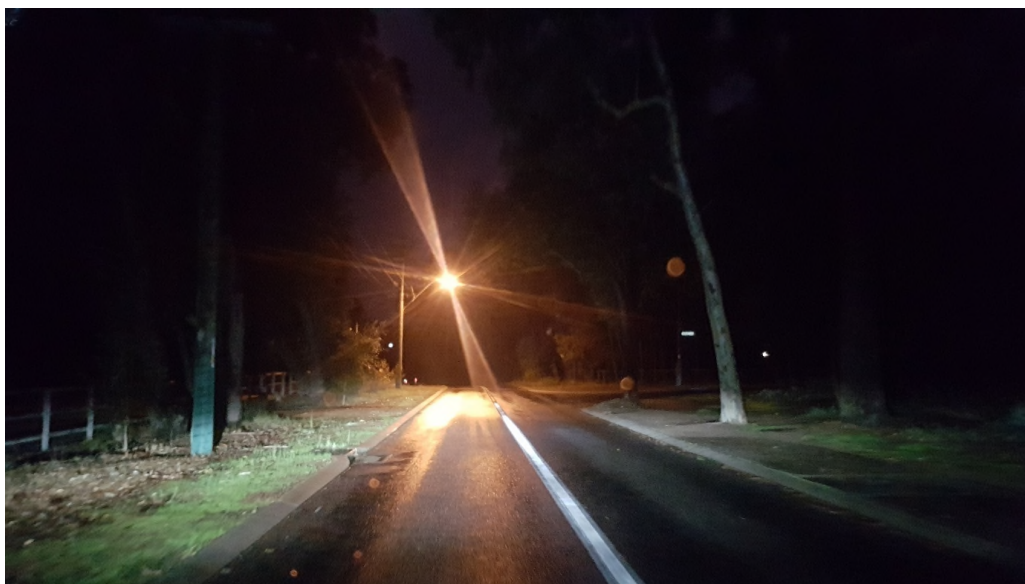
Photo 104: Street light at Hinkler Road intersection.

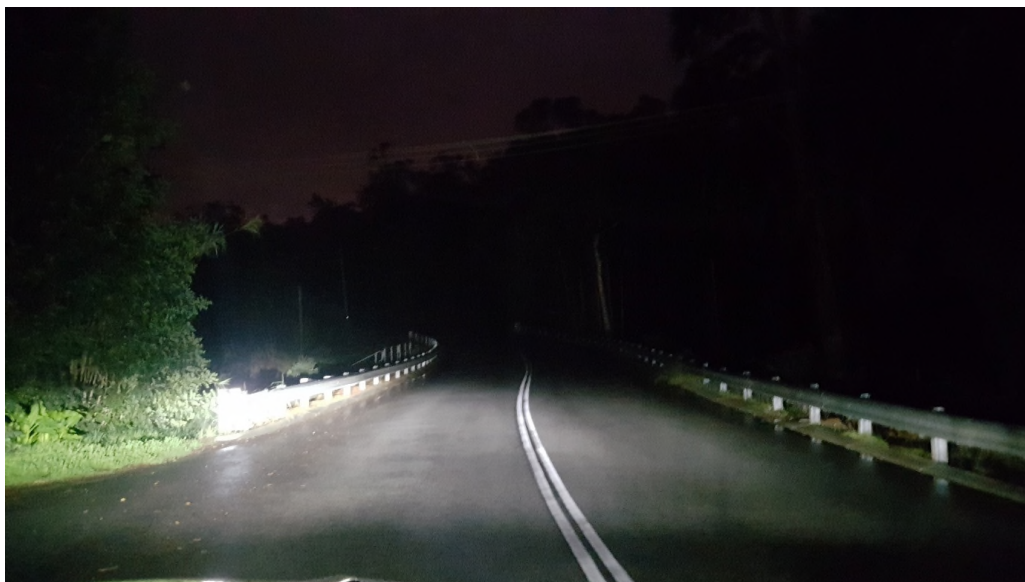
**Photo 105:** The alignment through the bridge is not well delineated at night.

These issues need to be addressed, potentially with street lighting being installed, but as a minimum RRPMs should be installed along the centreline, and reflectors fitted at intervals along the safety barriers.
