Lot 192 Hale Road

Wattle Grove

Preliminary Arborist Report

September 2023

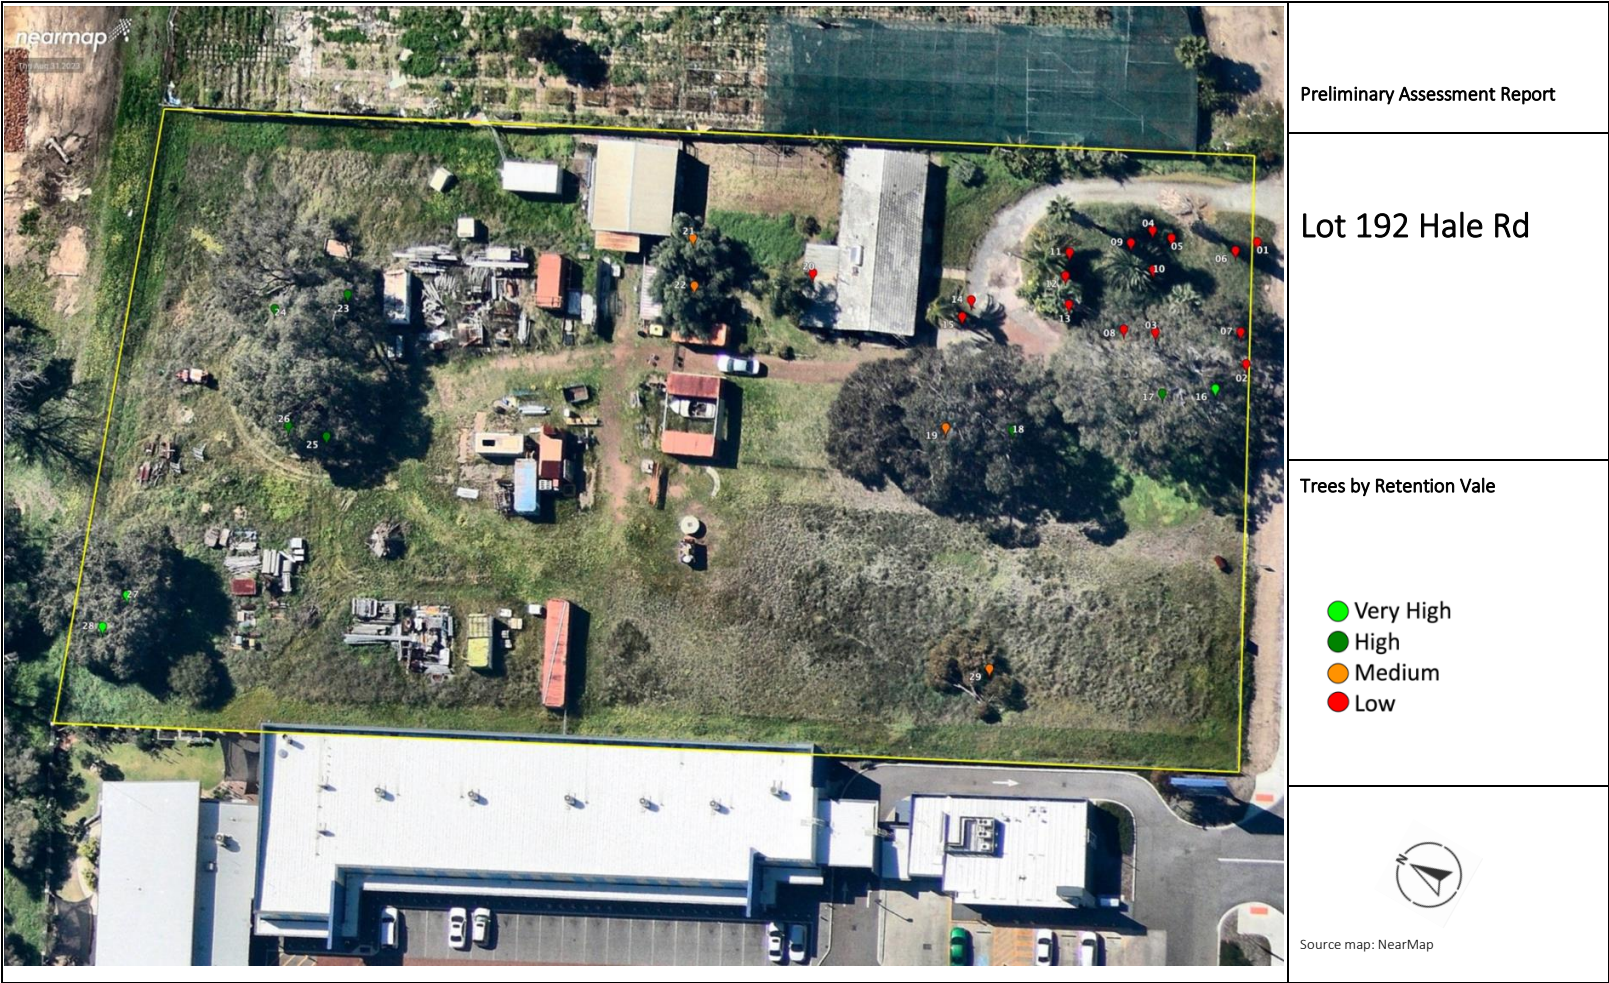
1.2 Map – Trees by retention value

With one exception all trees with a high or very high retention values have been incorporated into the current design. Trees 16 and 17 are a pair of large lemon scented gums (*Corymbia citriodora*) closest to the road. The current design has a tree 16 on the landscaped verge with tree 17 in a traffic island with driveway on both sides. Both have a minimum deep soil area which is lower than the recommended 64m² recommended in LPP33 Table 1.2 for large trees, but both do meet the recommended 40m² as contained in Table 2.1 Minimum planting area requirements for car parks. There are also rootable soil volumes surrounding these areas and in conjunction with careful use of materials for the driveway this will minimise the impact on these trees and allow them to continue to be a prominent feature in the landscape.

Tree 18 is a large mature Tasmanian blue gum (*Eucalyptus globulus*) which is not compatible with the current design. While the retention of a mature tree such as this is to be preferred there appears to be no practical way to incorporate this tree into the design. This tree is currently in good condition but its longevity is uncertain. It is tree endemic to Tasmania, and like most Tasmanians it prefers a cooler wetter climate than is typical of Perth area. It is likely in good condition currently due to high water availability, which may change with the site development.

Trees 23-26 are a group of 4 marri (*Corymbia calophylla*), which are endemic natives. These trees have been deemed to have high retention value primarily due to their size and that they are endemic. However, they are currently only in fair condition with sparse canopy and excessive twig dieback, and are likely suffering stress from excess water, either from high water table or a legacy of the nursery next door. The retention of these is compatible with the current design if they are carefully managed during the construction process. These trees are however located in the area earmarked for a potential expansion of the building. There doesn't appear to be a straightforward design alternative to retain these trees should the proposed building expansion proceed. Consideration should be given to pre-emptive replacement planting as soon as practical if these are being considered for removal. This will allow for the replacement canopy to become established which in turn will minimise any canopy loss during the transition.

Trees 28 and 28 are very large mature Weeping peppermints (*Agonis flexuosa*) located at the very rear of the property. These are in excellent condition, especially considering their age class and size. These should not be impacted by the development but must be protected nonetheless.
