# Elmore Park, City of Kalamunda - Dog Park Concept

## Design Examples

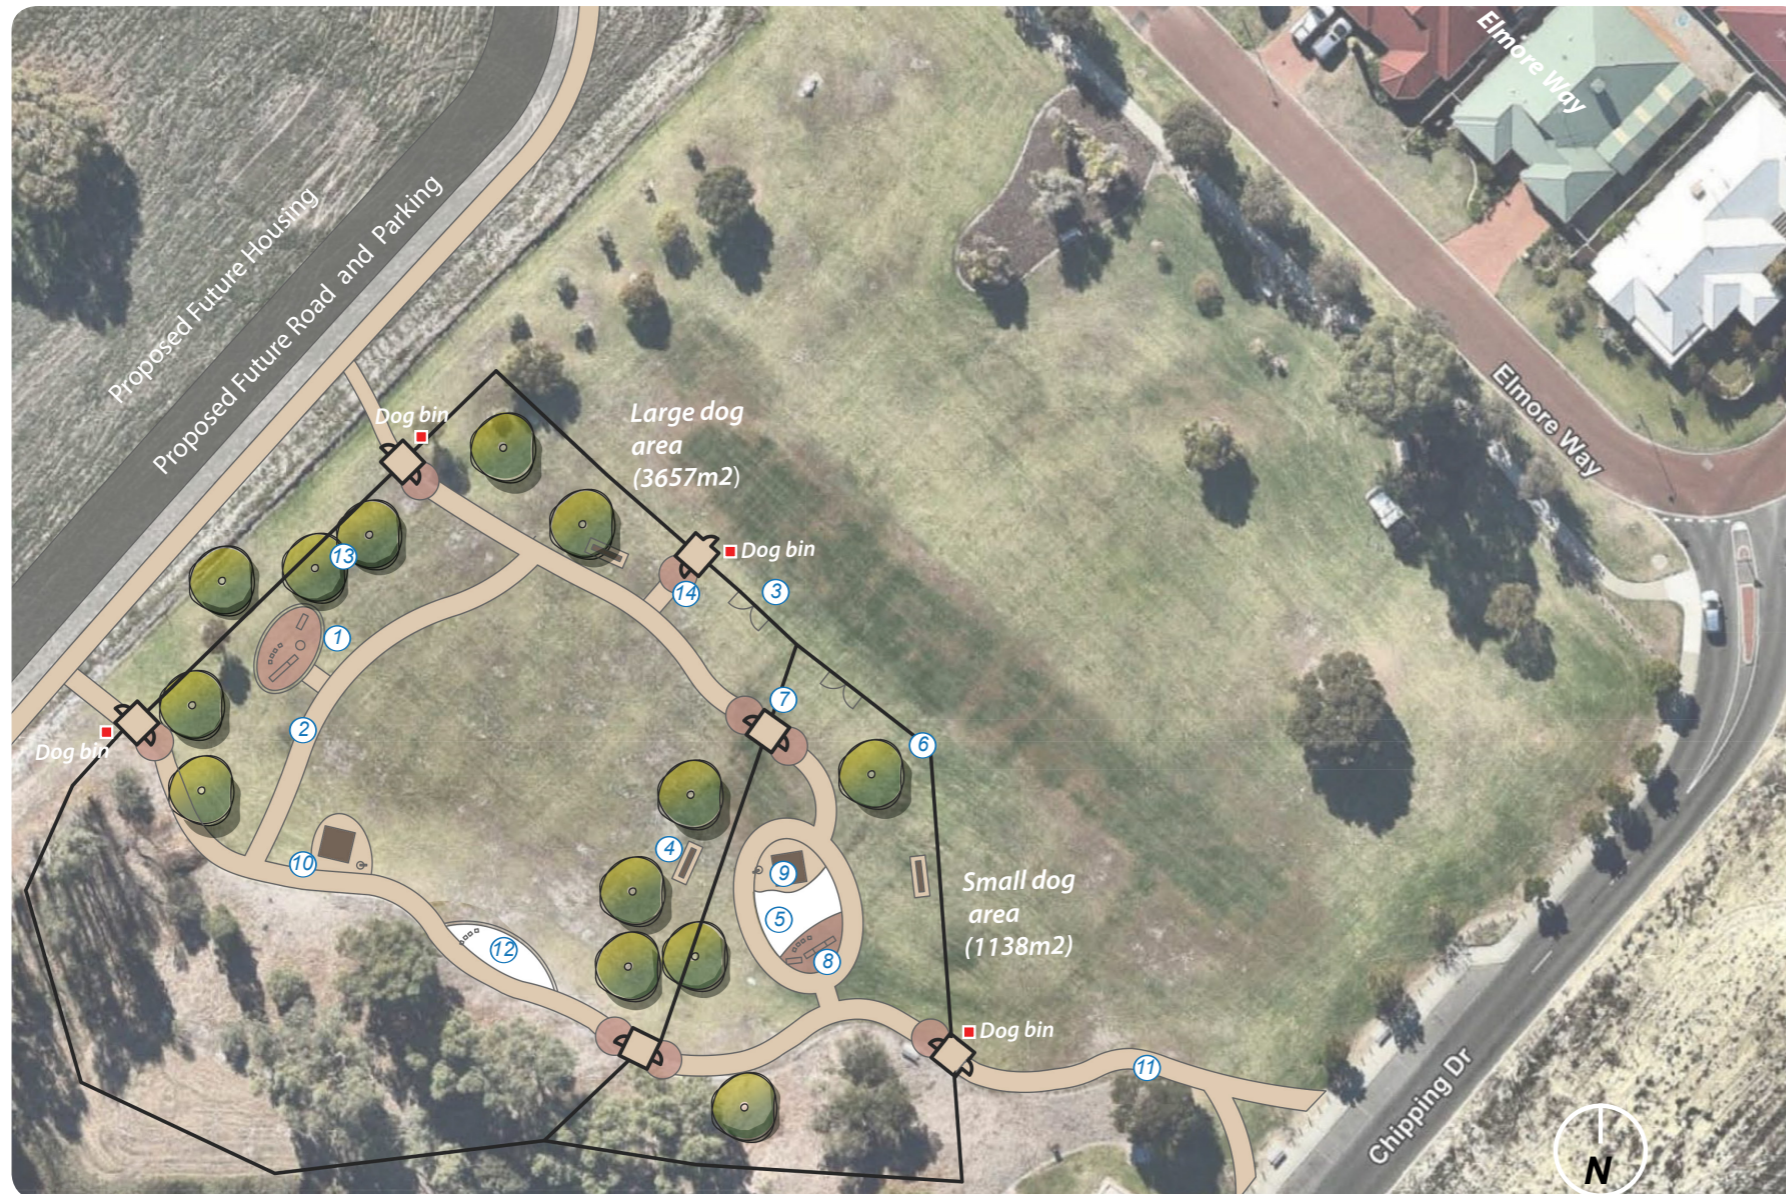
### Design Features / Legend

- ① Dog agility equipment area surfaced with woodchips
- ② Circulation footpath surfaced with exposed aggregate insitu concrete
- ③ Double access gates for maintenance staff

- ④ Park bench
- ⑤ Dog sand play / dig area; edged with a flush 150mm concrete kerb and limestone block seats
- ⑥ Black PVC coated chainlink mesh style fencing, with top and bottom rail and 150mm concrete strip at base

- ⑦ Central gate crossing between the two areas
- ⑧ Dog agility equipment area surfaced with woodchips
- ⑨ Park shelter with seating and drink fountain with tippable dog bowl

- ⑩ Park shelter with seating and drink fountain with tippable dog bowl
- ⑪ Insitu concrete path connection to entry off Chipping Dve. and proposed street.

- ⑫ Dog sand play / dig area; edged with a flush 150mm concrete kerb and limestone block seats
- ⑬ New Trees
- ⑭ Mulched Gate entry point to slow dogs and avoid potential conflict
