Elmore Park, City of Kalamunda - Dog Park Concept

10 20 30m Rev. 5 Sep 2019

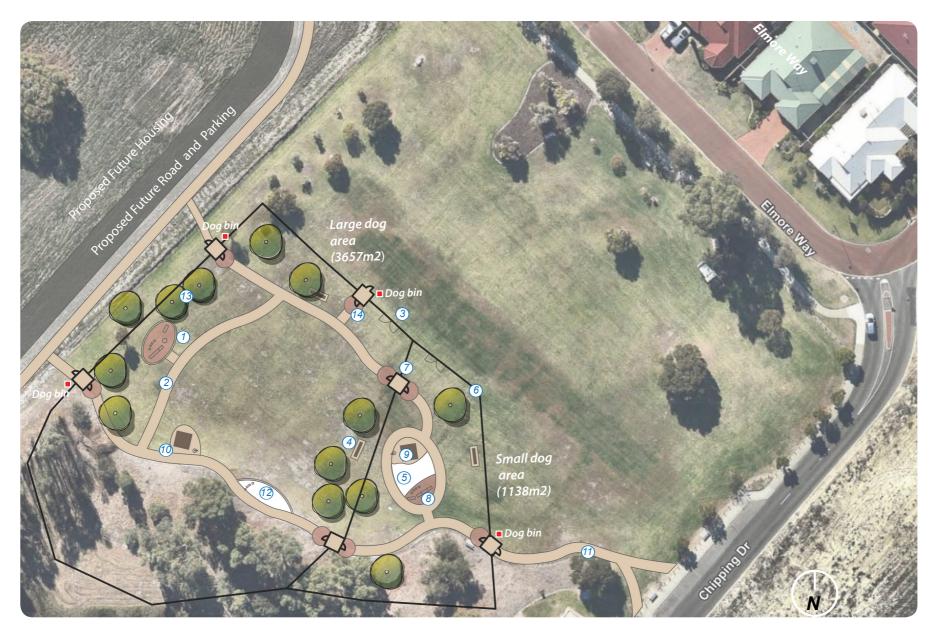
Design Features / Legend

- 1) Dog agility equipment area surfaced with woodchips
- (2) Circulation footpath surfaced with exposed aggregate insitu concrete
- (3) Double access gates for maintenance staff
- 4 Park bench

- 5 Dog sand play / dig area; edged with a flush 150mm concrete kerb and limestone block seats
- 6 Black PVC coated chainlink mesh style fencing, with top and bottom rail and 150mm concrete strip at base
- 7 Central gate crossing between the two areas

- 8) Dog agility equipment area surfaced with woodchips
- Park shelter with seating and drink fountain with tippable dog bowl
- (10) Park shelter with seating and drink fountain with tippable dog bowl
- 1 Insitu concrete path connection to entry off Chipping Dve. and proposed street.
- Dog sand play / dig area; edged with a flush150mm concrete kerb and limestone block seats
- (13) New Trees
- (14) Mulched Gate entry point to slow dogs and avoid potential conflict
