Hartfield Park Recreation Centre Asset Management Plan 2021

City of Kalamunda – Hartfield Park Recreation Centre Asset Management Plan

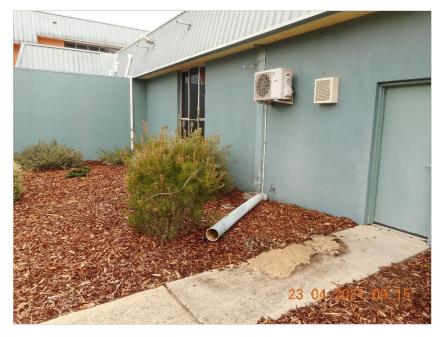
Replacement of gutter downpipes

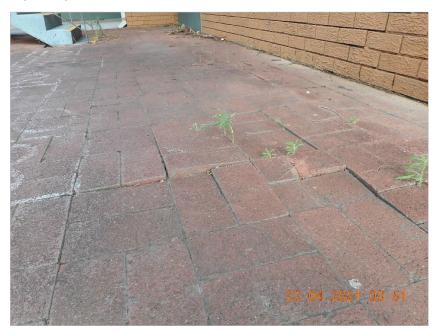
Repair of paved areas

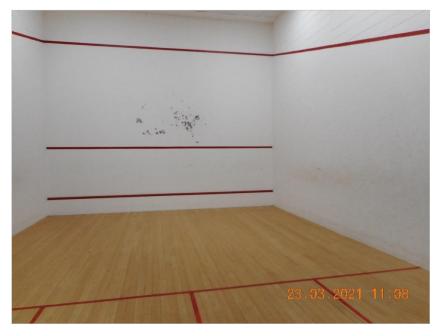
Painting of internal walls

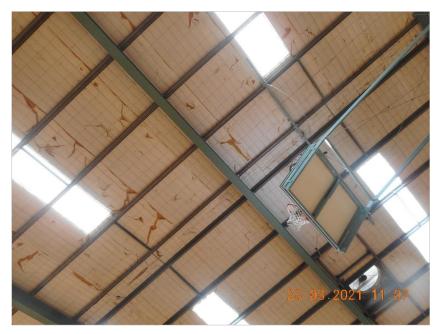
Replacement of roof sheeting and lining

2036/2037	Main Basketball Roof Area: Replace roof sheeting, sky lighting, Sisalation Blanket, Top hat Battens, Box Gutters & Downpipes and all other associated parts	\$365,500
Total		\$1,194,450
Annual Avera	age	\$79,630

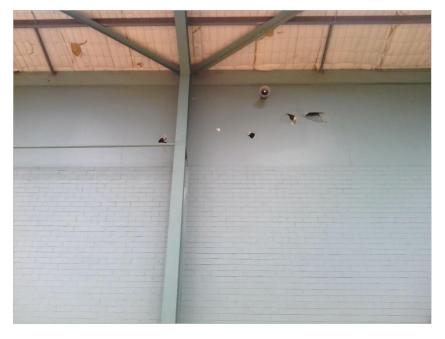
Replacement of internal hall panelling

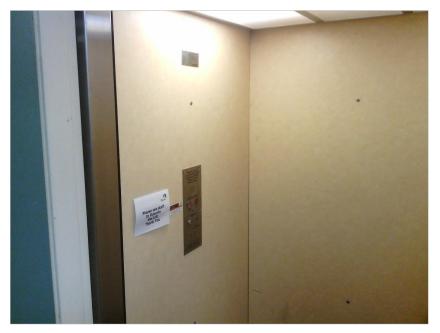
Repair of lift

Year	Description	Cost
2024/2025	Squash Courts Court Two: Squash Court Renovations to include new Ceiling Tiles, LED Lighting, fans, repairs to render and repaint, repairs re- sand/sealing of floors and remarking of lines	\$20,000
2025/2026	Lift in main foyer area: Renewal of 43-year-old internals to revitalise appearance. Includes items like wall and ceiling panels, lighting, electrical switch panel, carpet to match foyer, door seals etc.	\$15,000
2025/2026	Main Basketball Roof Area: Full renewal of exhaust extraction fans	\$20,000
2025/2026	Main Foyer, Creche: Renew Gas Heated Evaporative air conditioner	\$40,000
2025/2026	Squash Courts Court Three: Squash Court Renovations to include new Ceiling Tiles, LED Lighting, fans, repairs to render and repaint, repairs re- sand/sealing of floors and remarking of lines	\$20,000
2026/2027	Ground floor Multi use, Reception, Creche Kitchen: Renew Vinyl flooring	\$4,200
