Forrestfield North Residential Precinct LWMS

Local Water Management Strategy

Prepared for
Element
by Strategen-JBS&G

December 2020

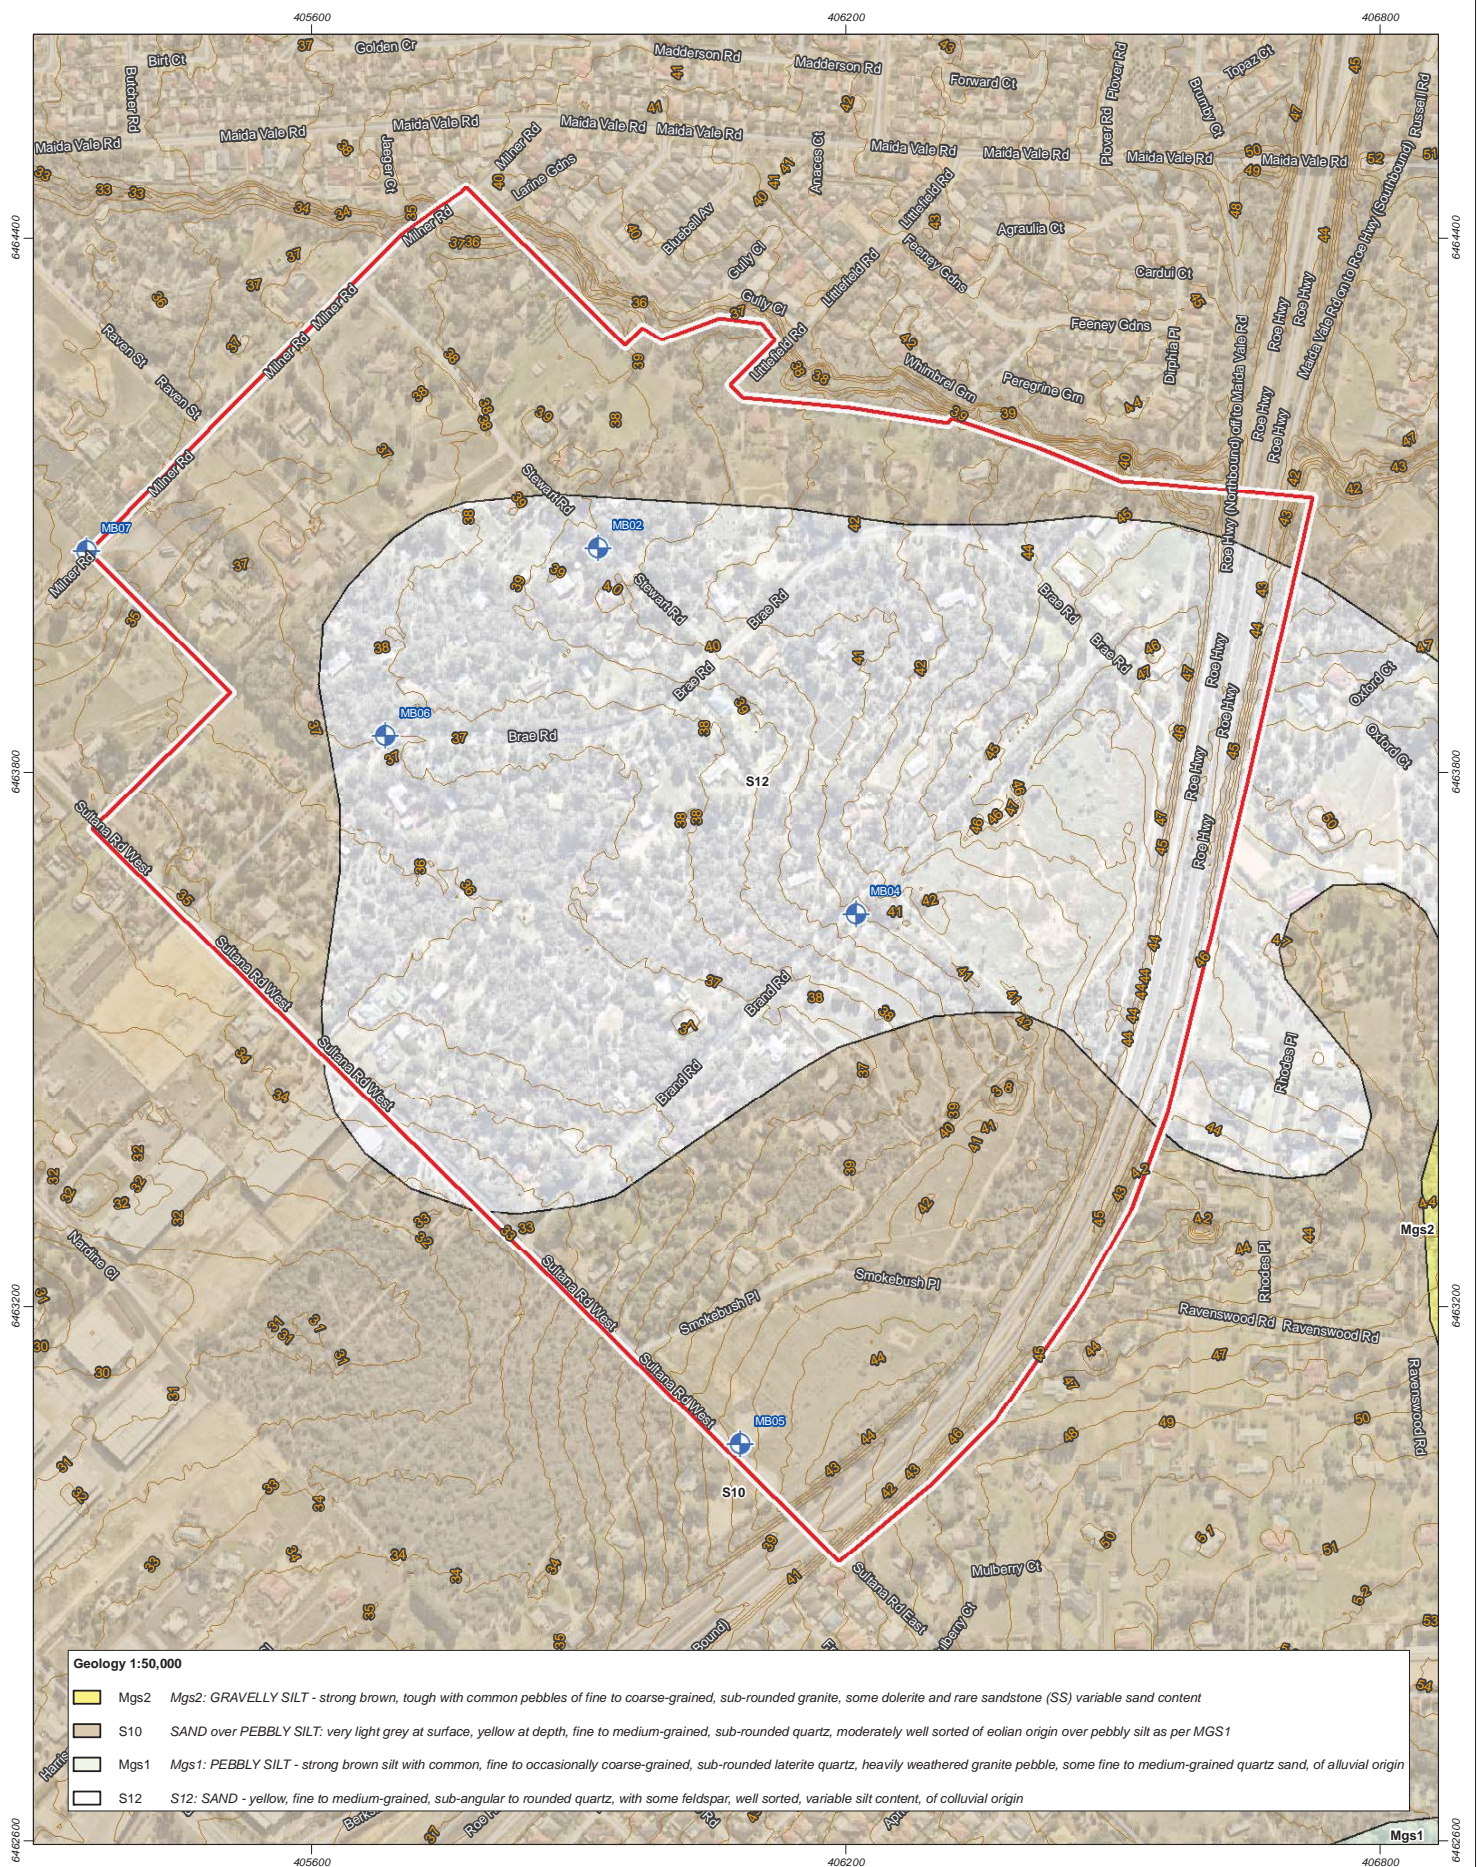
Figure 3: Topography and soils

The topography of the precinct ranges from approximately 46 m Australian Height Datum (AHD) in the north-eastern section to approximately 35 m AHD in the south-western corner. Topographic contours for the precinct are shown in Figure 3.

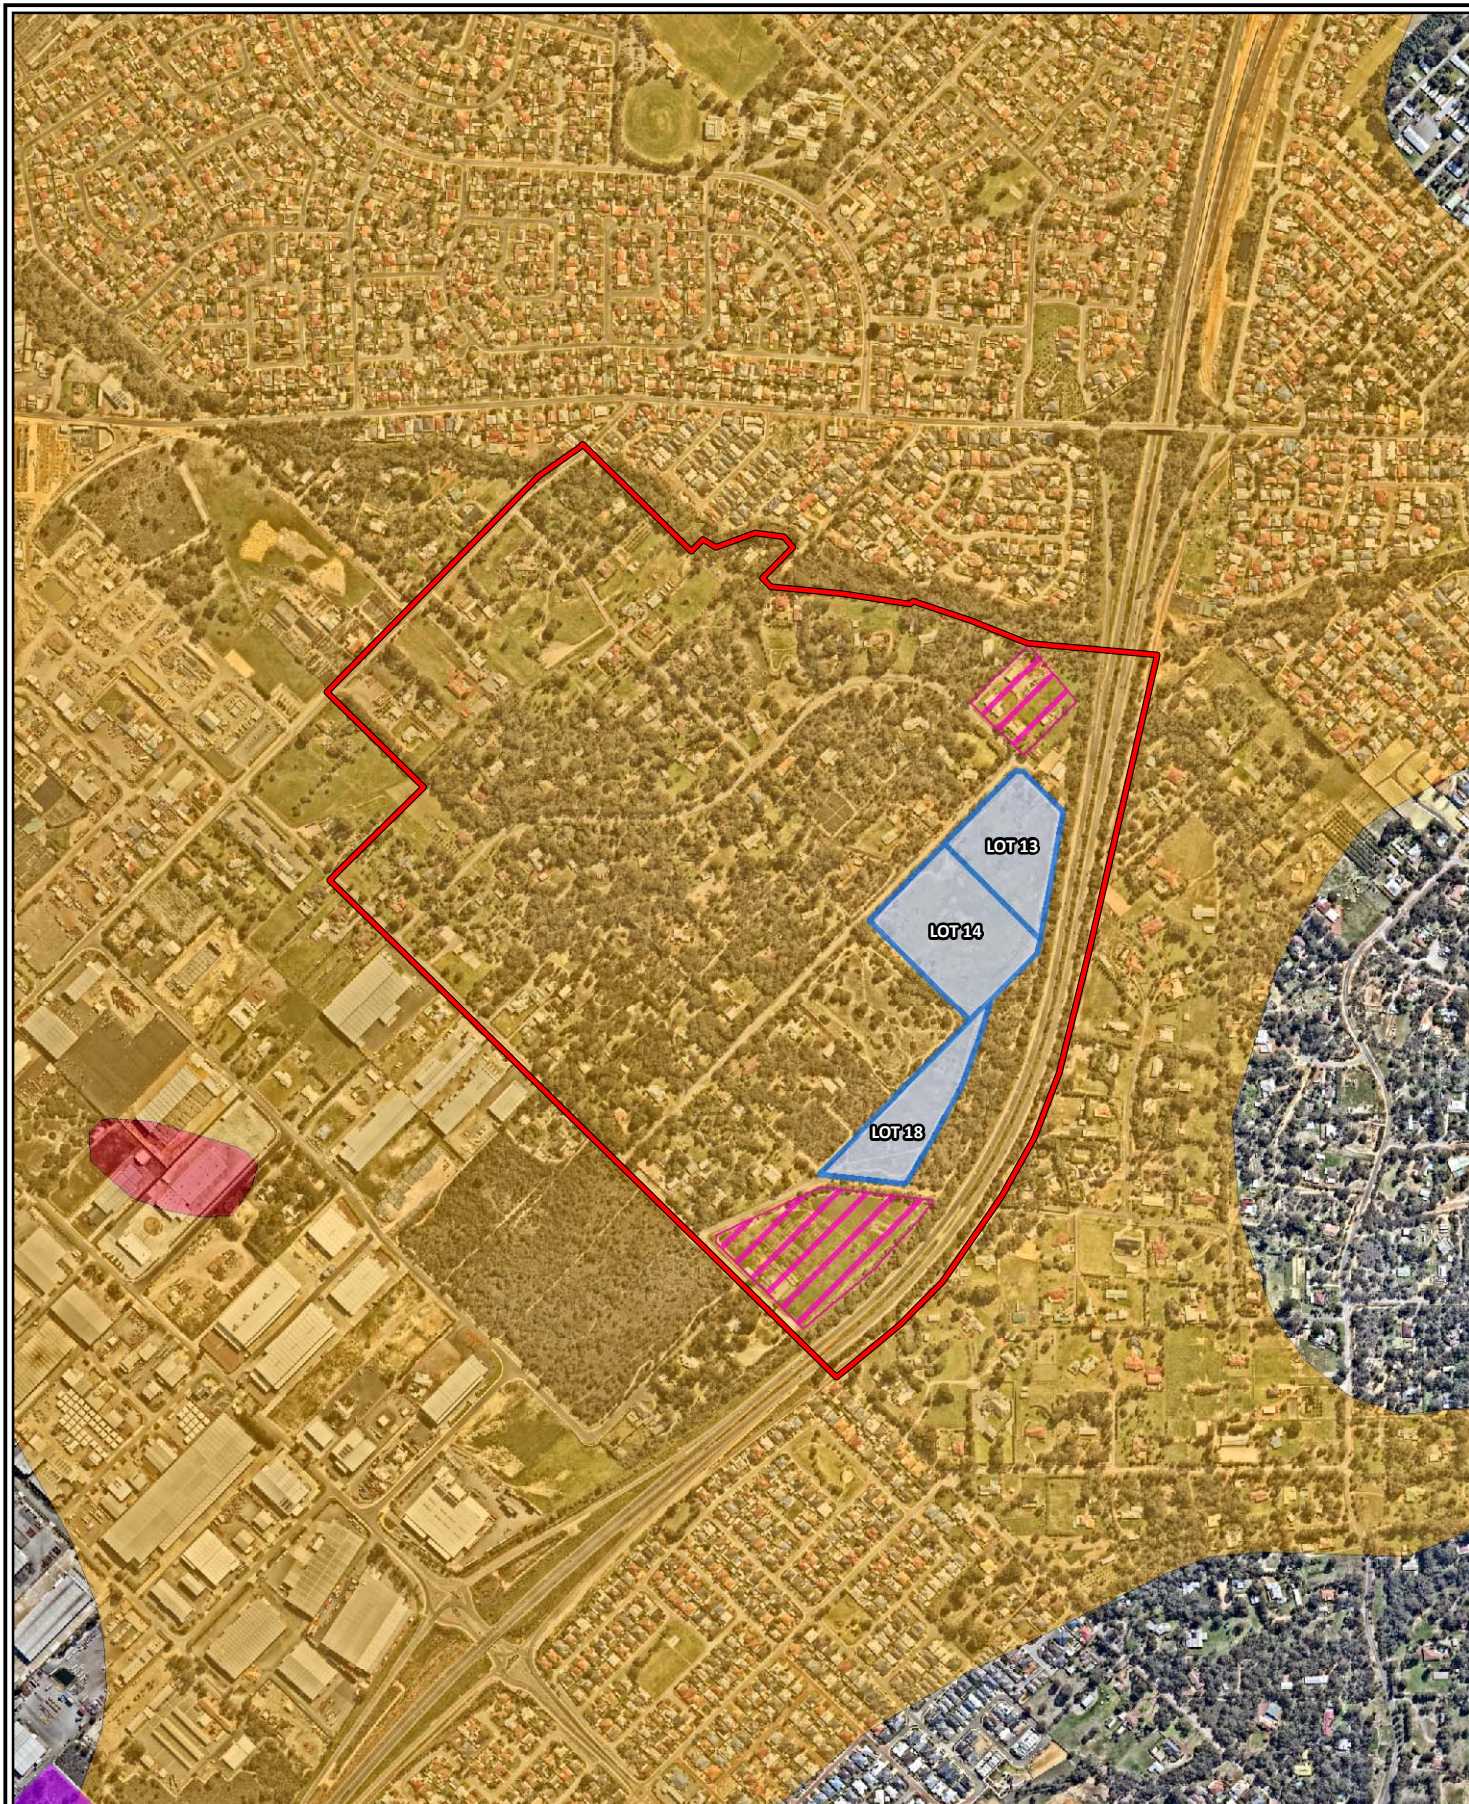
- Residential precinct
- Indicative landfill (source: GHD 2010)
- Historical orchard activity
- Acid sulfate soil (DWER)
 - High to moderate risk
 - Moderate to low risk
- DWER registered contaminated sites
 - Contaminated - remediation required

Based on historical aerial photography, there have been several hobby farms and/or orchards within Lots 94 and 98 Brae Road and Lots 100, 101, 102 and 103 Smokebush Place High Wycombe (Figure 5). These land uses and their associated activities are potentially contaminating due to the use of metals, organochlorine pesticides, organophosphate pesticides, carbamate and fuels (DoE 2004).

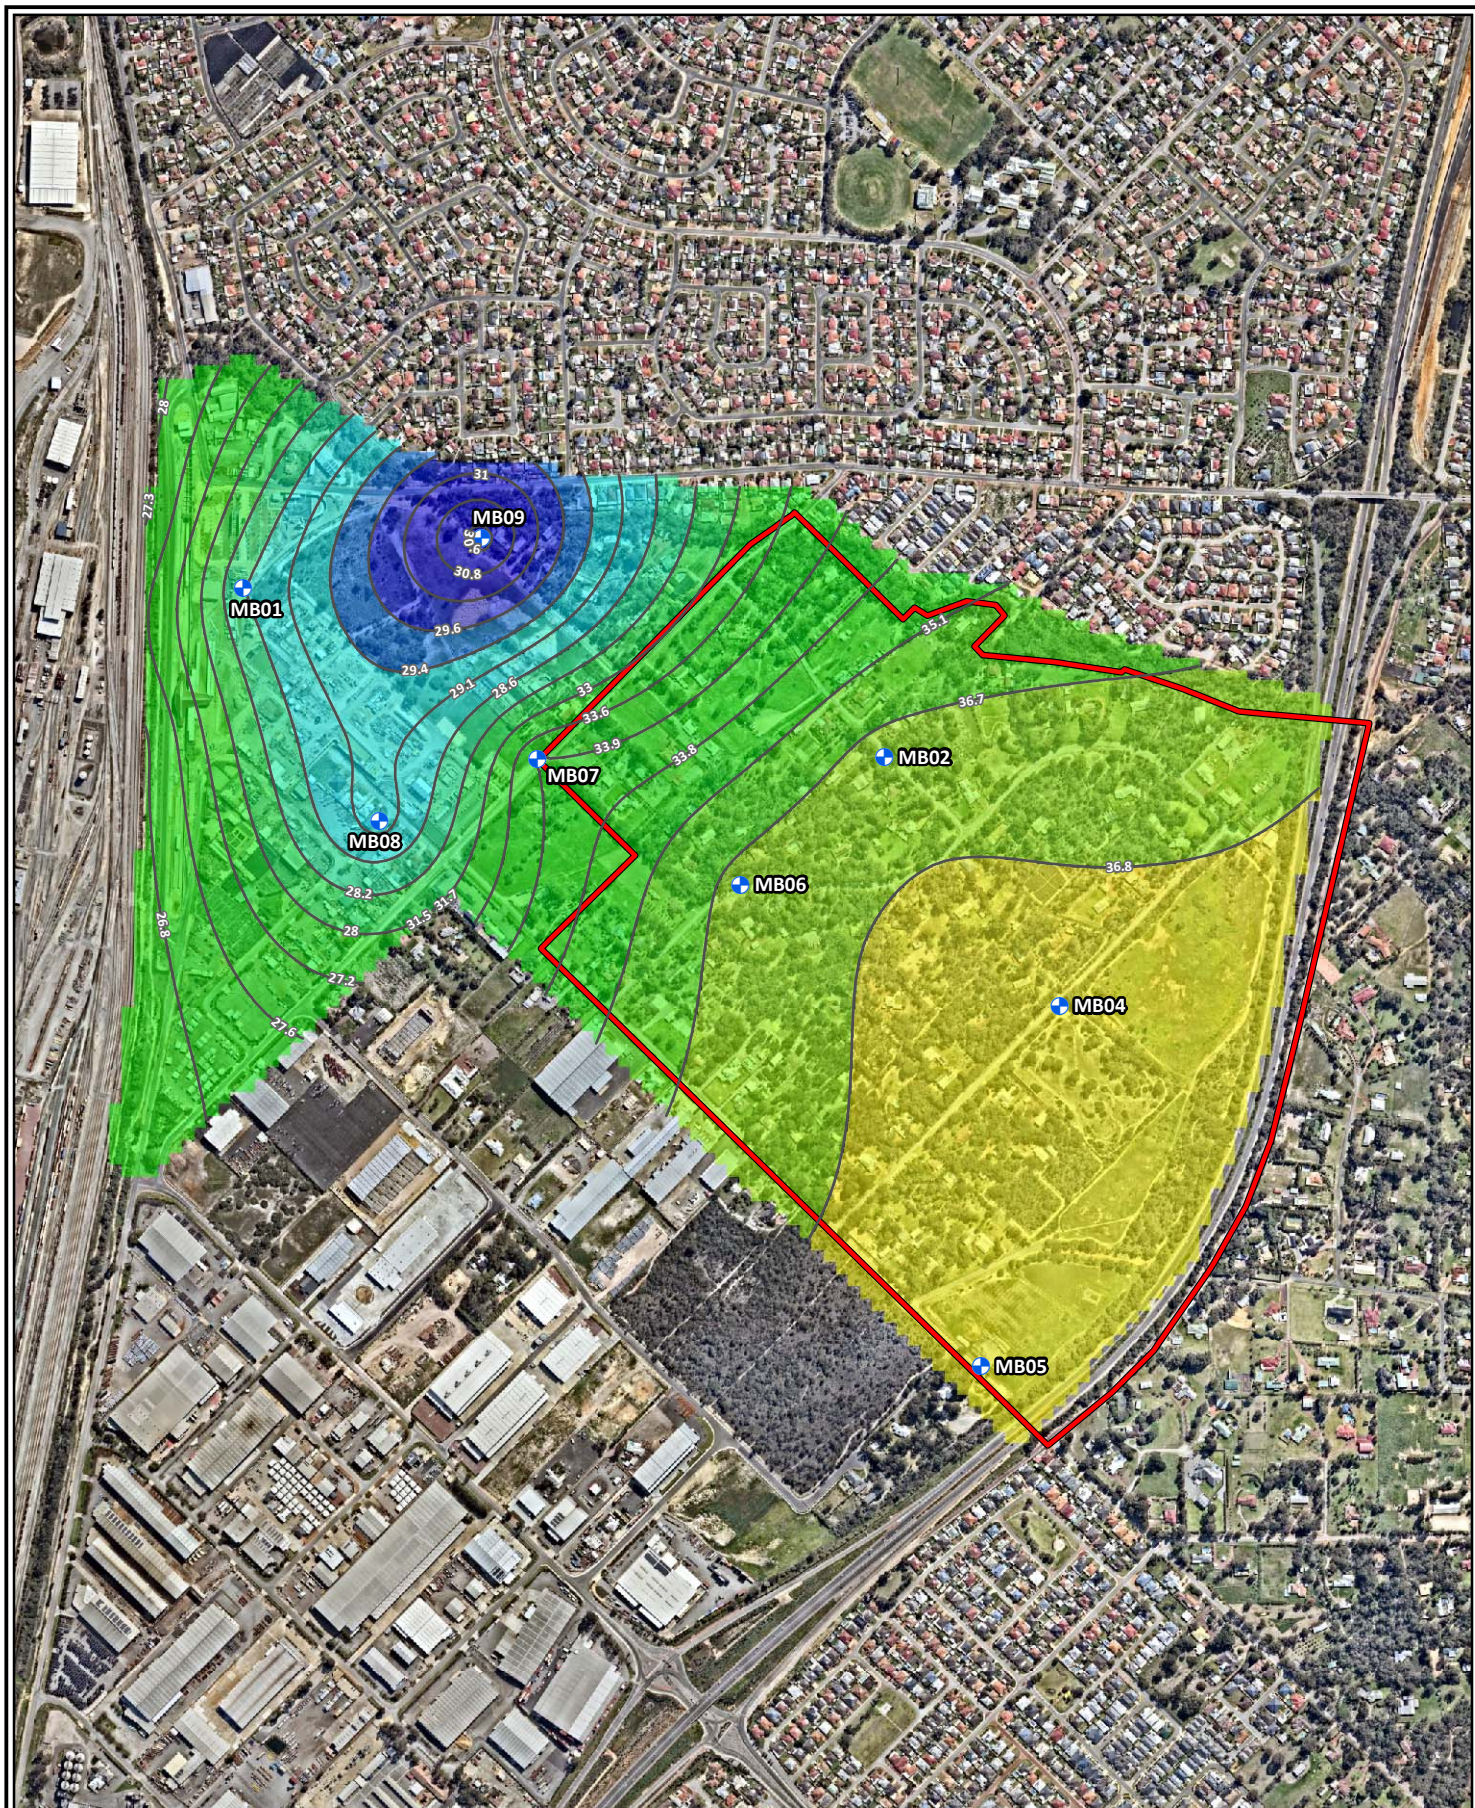
- Residential precinct
- Groundwater contour (mAHD)
- Monitoring bore location (2012)

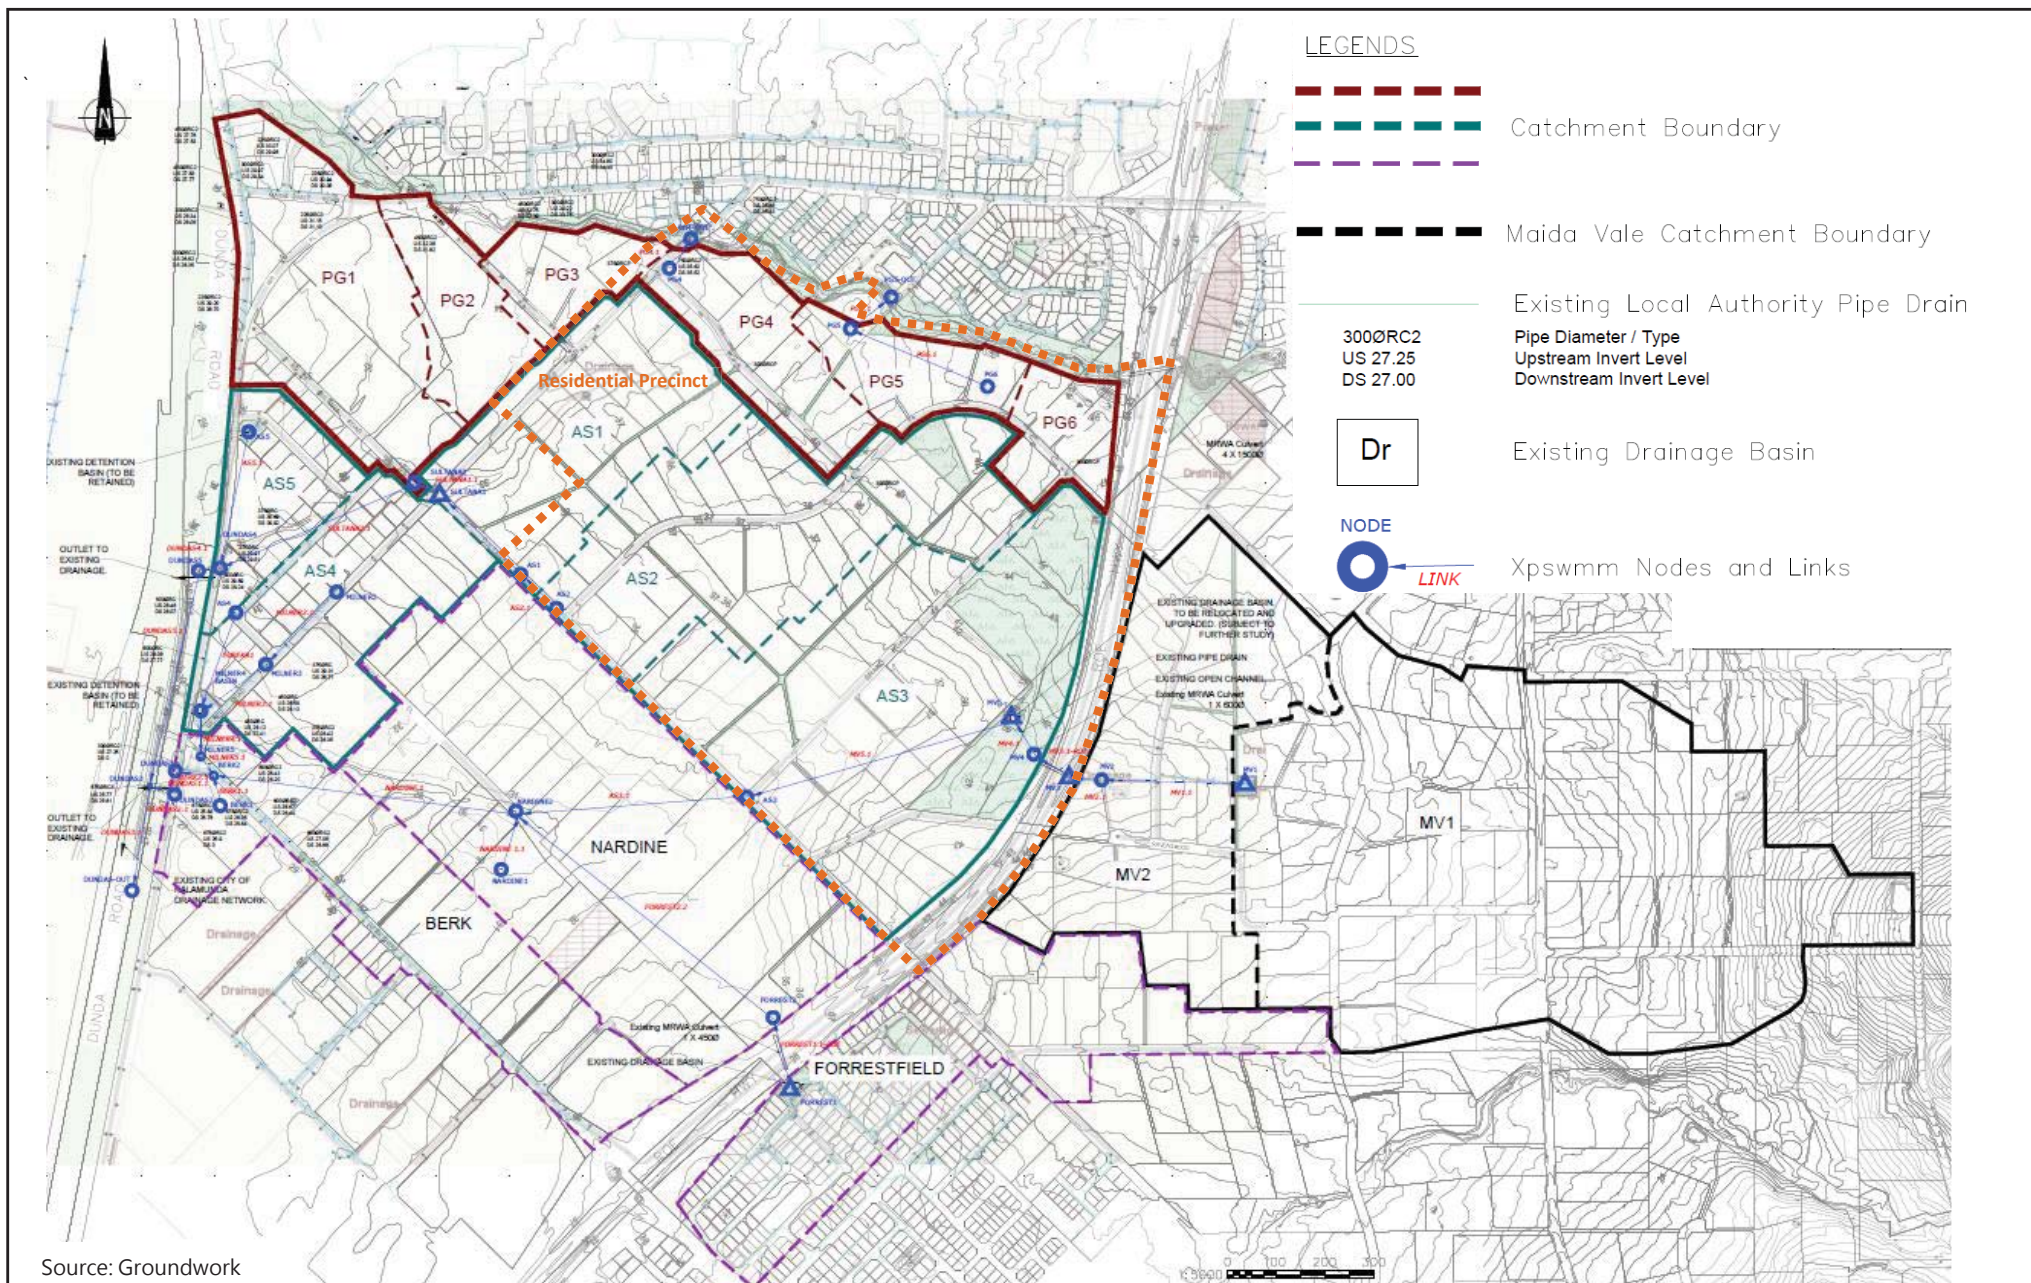
Figure 8: Surface Water Catchments

The Airport South catchment includes approximately 114 ha of land to the west of Roe Highway in Maida Vale (MV1 and MV2) (Figure 8). Historically, any water not infiltrated in MV1, MV2 or the RP would have run through the AS4/AS5 and Nardine Catchments and discharged to the west of Dundas Road as shown in Figure 8. Recent industrial development in the Nardine Catchment has impeded the flow path from AS3 to the Dundas Road area, where filling of low-lying areas identified as flow paths in the 1% AEP event by Water Corporation (2007) has occurred.

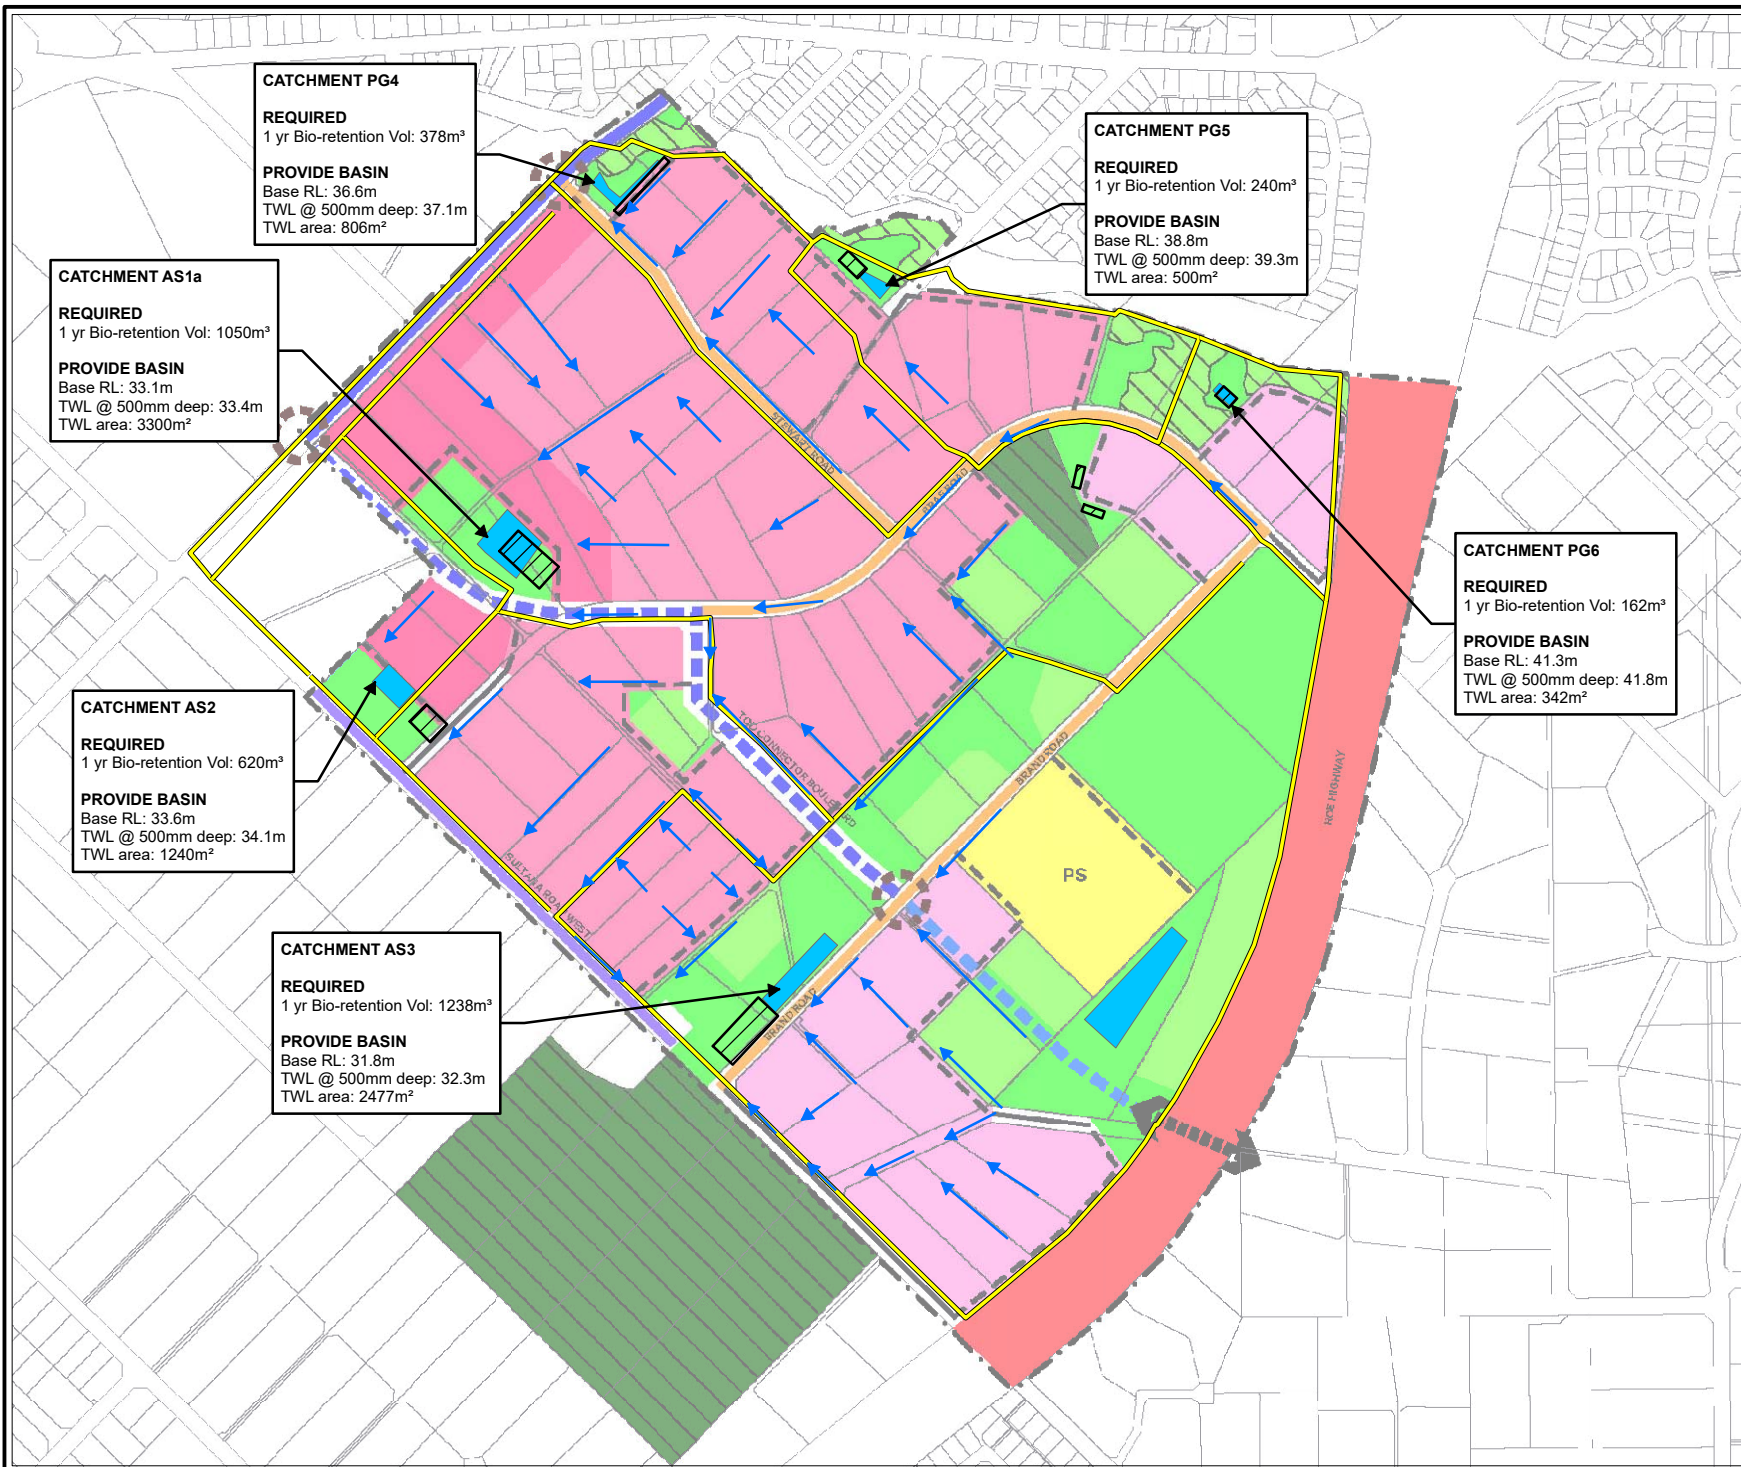
FIGURE 11

- 18% AEP (5yr ARI) (below ground)
- Storage tank conceptual shape stormtech MC3500 or similar
- 63% AEP (1yr ARI) TWL conceptual shape; 63% AEP (1yr ARI) TWL conceptual shape
- Catchment boundary
- Flow direction

The Airport South catchment includes approximately 114 ha of land to the west of Roe Highway in Maida Vale which drains into a basin on the site via a Main Roads culvert, referred to as MV1 and MV2 (Figure 11). Prior to development, any water not infiltrated in MV1 and MV2 or the small basin located on the site would have run through the Nardine Catchment to the south of Sultana Road West in larger events (anticipated greater than the 63% AEP event) (Figure 11). The development of the Forrestfield-High Wycombe Industrial Area south of Sultana Road West has removed this historic flow path. This matter was discussed with the City who advised that their preferred option to manage this was installation of an infiltration basin within the RP to infiltrate stormwater from MV1 and MV2 until the infrastructure can be rectified (Bartlett D [CoK] 2017, pers. comm. 3 November).

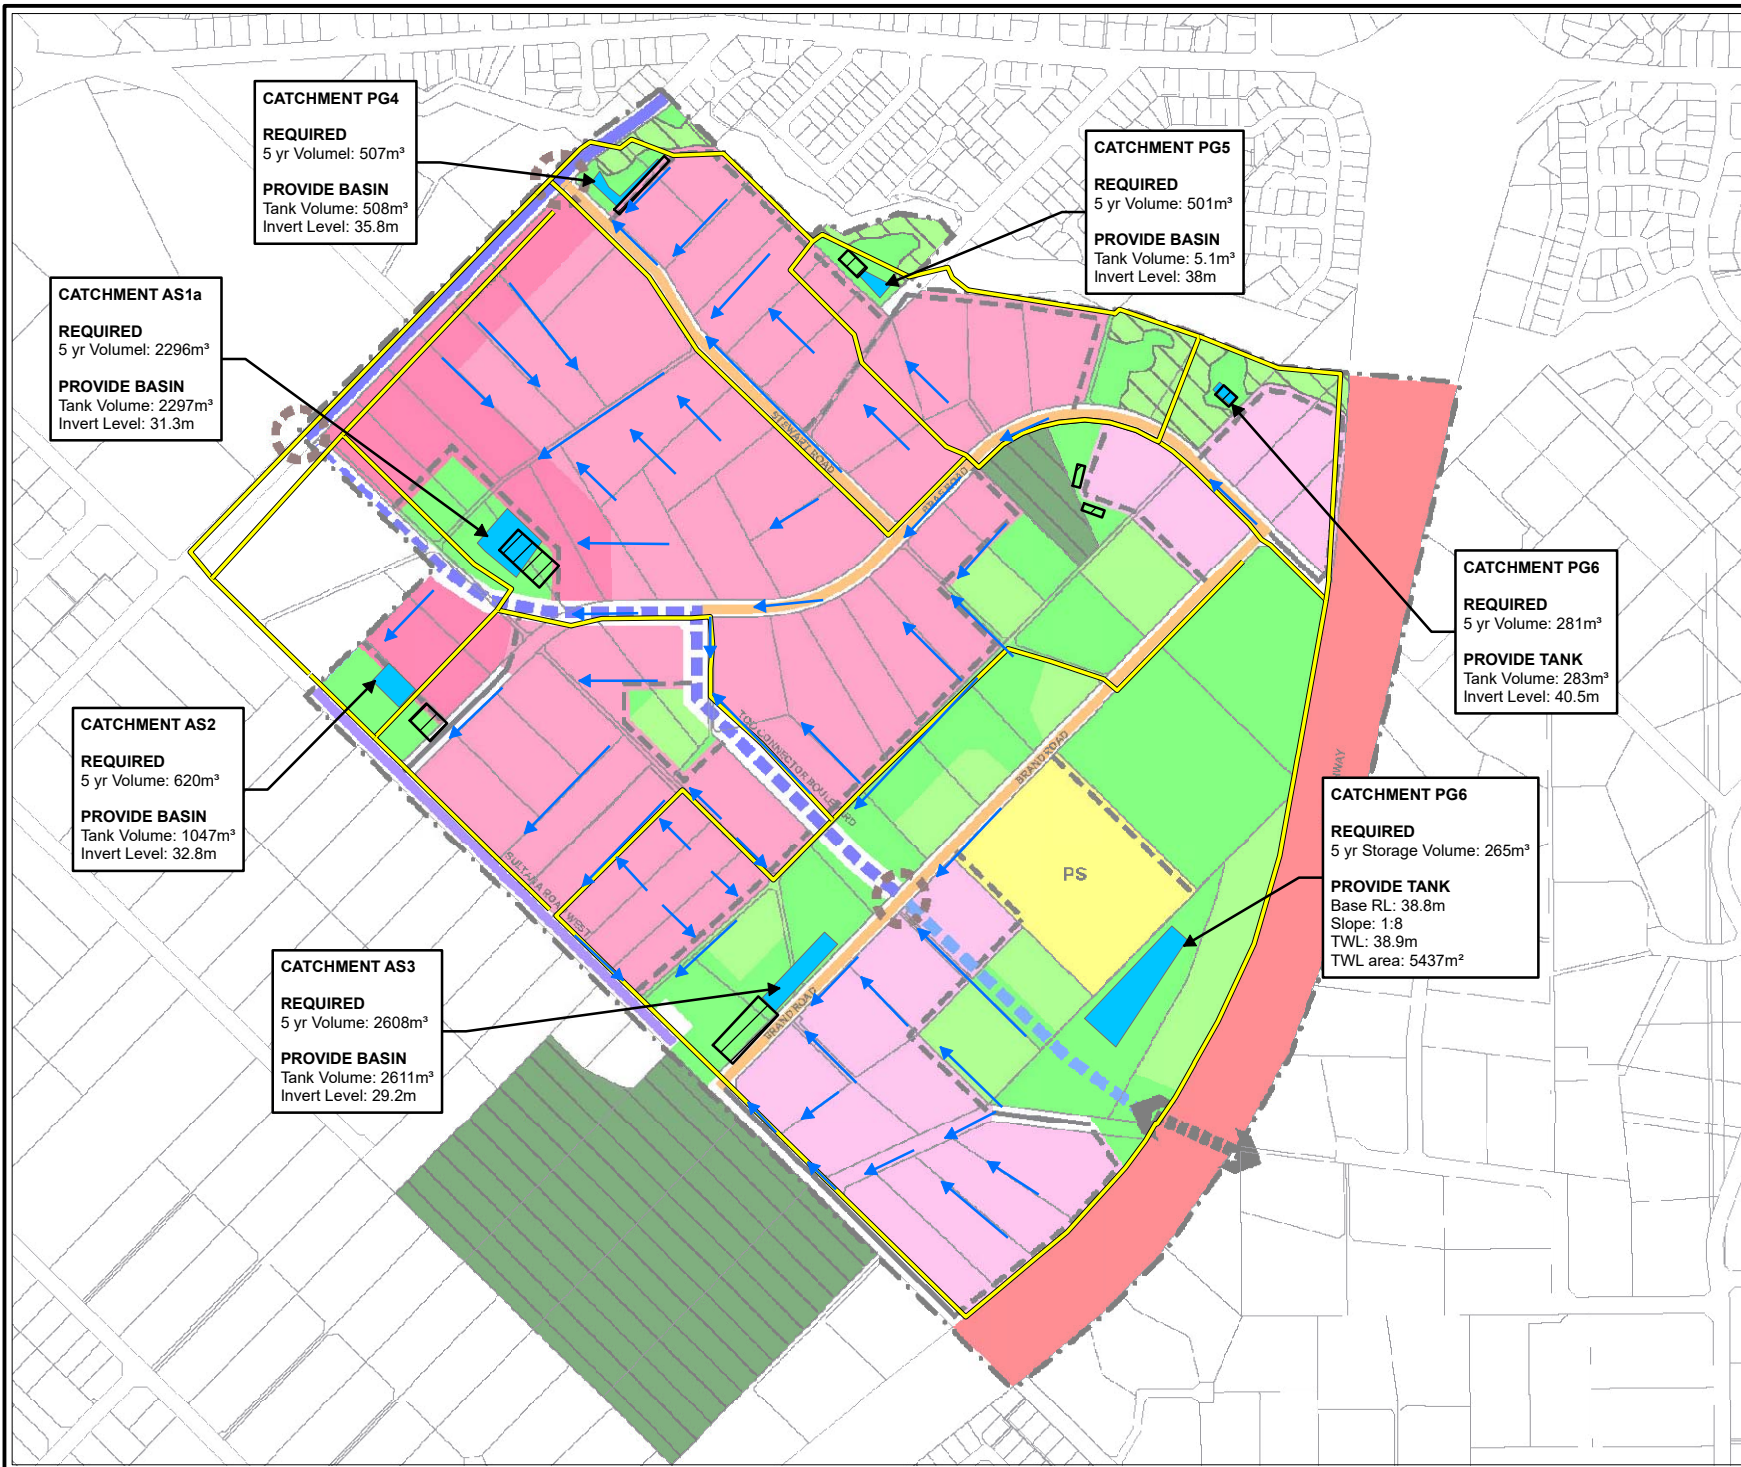
FIGURE 12

- 18% AEP (5yr ARI) (below ground)
- Storage tank conceptual shape stormtech MC3500 or similar
- 63% AEP (1yr ARI) TWL conceptual shape; 63% AEP (1yr ARI) TWL conceptual shape
- Catchment boundary
- Flow direction

Details of storages are presented in Figure 12, Figure 13, Table 11 and Table 12. Figure 14 provides a conceptual cross section of the proposed major event storage.

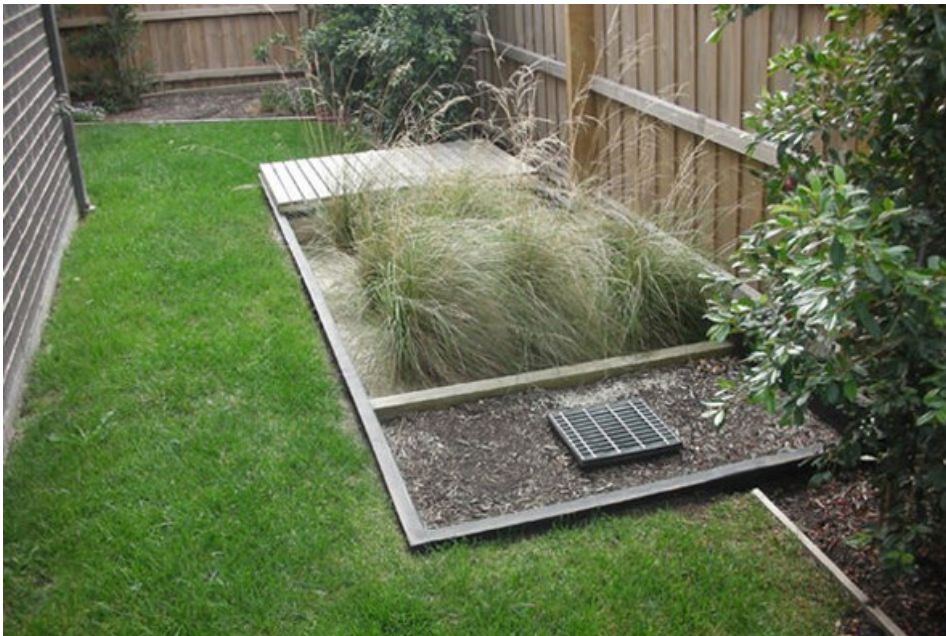
Plate 1: Lot scale bioretention systems

Lot scale water management systems should aim to include a treatment element in the form of a lot scale bioretention system (Plate 1), biofiltration tree pits or a planted roof garden to clean stormwater prior to infiltration. The use of pervious pavements for outdoor spaces and driveways is encouraged to reduce stormwater volumes, consistent with *Decision Process for Stormwater Management in Western Australia*, November 2017. Water may be infiltrated through soak wells and subsurface soakage tanks and cells if required. Pervious pavements may also be used for driveways and outdoor paving to reduce the amount of runoff produced on the lot (Section 5.1.4).

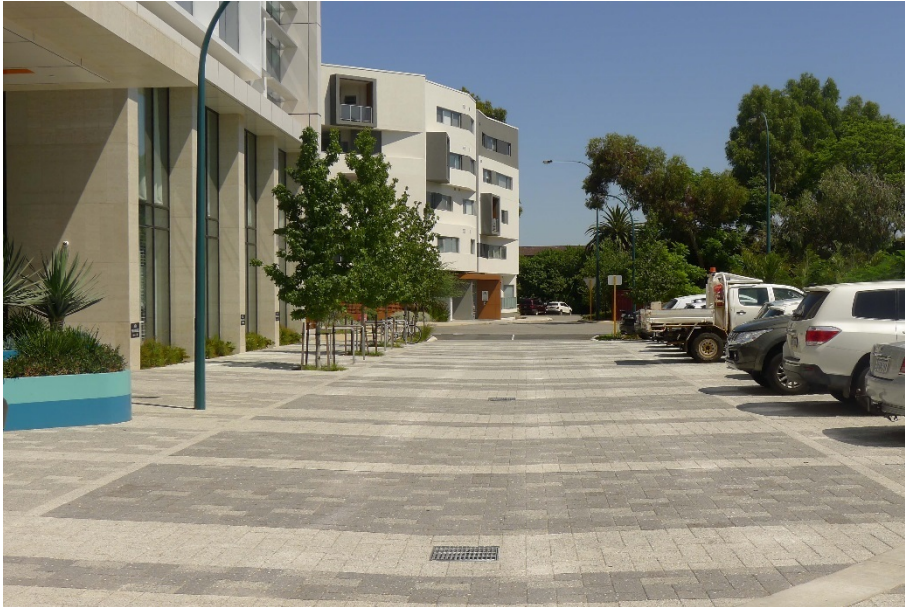
Plate 2: Permeable pavement with tree pits

1. Permeable pavements, which comprise a layer of paving blocks typically impervious, specially shaped to allow the ingress of water by way of vertical 'slots' or gravel-filled 'tubes'. There are generally large gaps between impervious paved areas for infiltration (Plate 2).
2. Porous pavements, which comprise a layer of highly porous material (DPLG 2010).

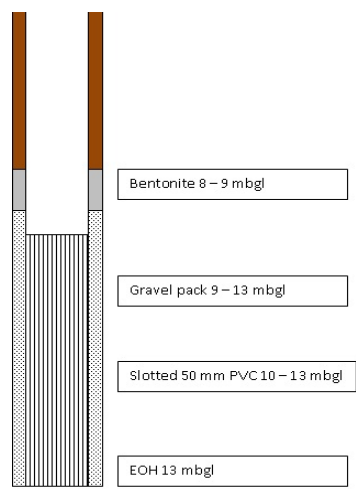
Soil Log

Page No:	1 of 1	Drill method:	Auger - Strataprobe
Job Number:	SKA11193.02	Hole diameter:	50 mm
Project:	Forrestdale	Groundwater at:	
Date of works:	9/09/2011	End of hole:	9 m
Borehole ID:	MB08	GPS:	E 405086.11
Logged by:	CJ		N 6463948.16

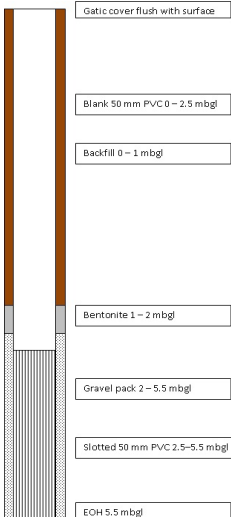
Page No:	1 of 1	Drill method:	Auger - Strataprobe
Job Number:	SKA11193.02	Hole diameter:	50 mm
Project:	Forrestdale	Groundwater at:	
Date of works:	9/09/2011	End of hole:	7 m
Borehole ID:	MB09		E 405255.15
Logged by:	CJ	GPS:	N 6464414.64

Depth (m)	Graphic log	Description of soil type	Additional observations
0 0.5 1		Sand, medium grained, subrounded black to 0.1 m and then grey	
1.5 2		1.5 -2.25 m, SAND, medium grained, subrounded, grey, moist	
2.5 3 3.5 4 4.5 5 5.5 6 6.5		2.25 m on, clayey SAND, medium grained, subrounded, orange, poorly sorted	
7 7.5 8 8.5 9 9.5 10 10.5 11 11.5 12 12.5 13 13.5 14 14.5 15

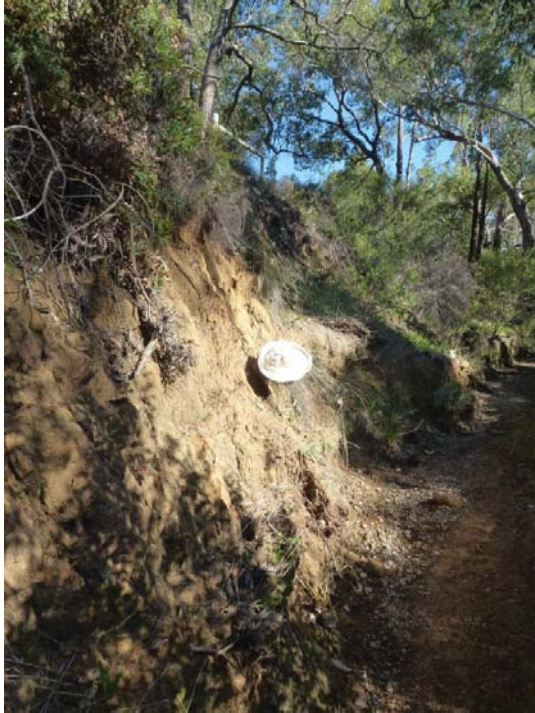
Plate 1 Photograph taken from low flow channel of Gully, showing steep banks of approximately 4 m in height (photo taken between Roe Highway and Littlefield Road)

height(Plate 1). Further west (downstream), the creek becomes less incised and shallower, with an approximately 0.5 m deep low flow channel with a width of approximately 1-2 m, with the outer incised channel reducing to a depth of 2 to 3 m and becoming less steep at the far western end, near Maida Vale Road.

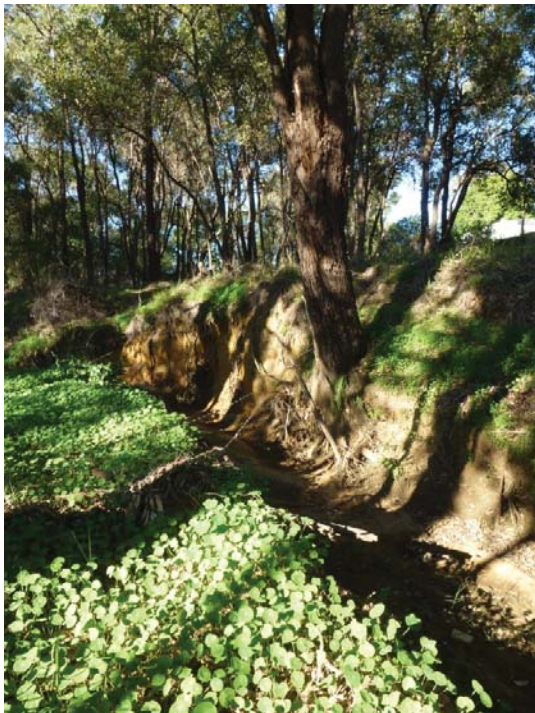
Plate 2 Exposed tree roots on bank of low flow channel, east of Milner Road

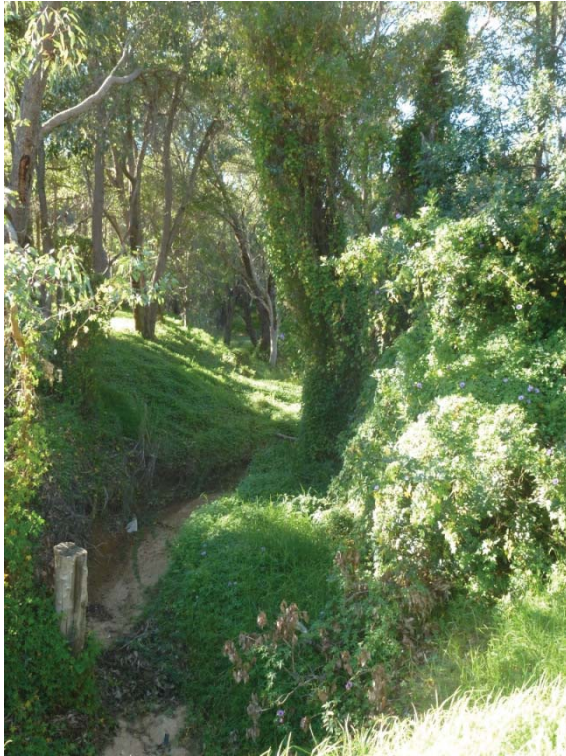
Plate 3 Morning glory infestation of Poison Gully on private land at Milner Road.

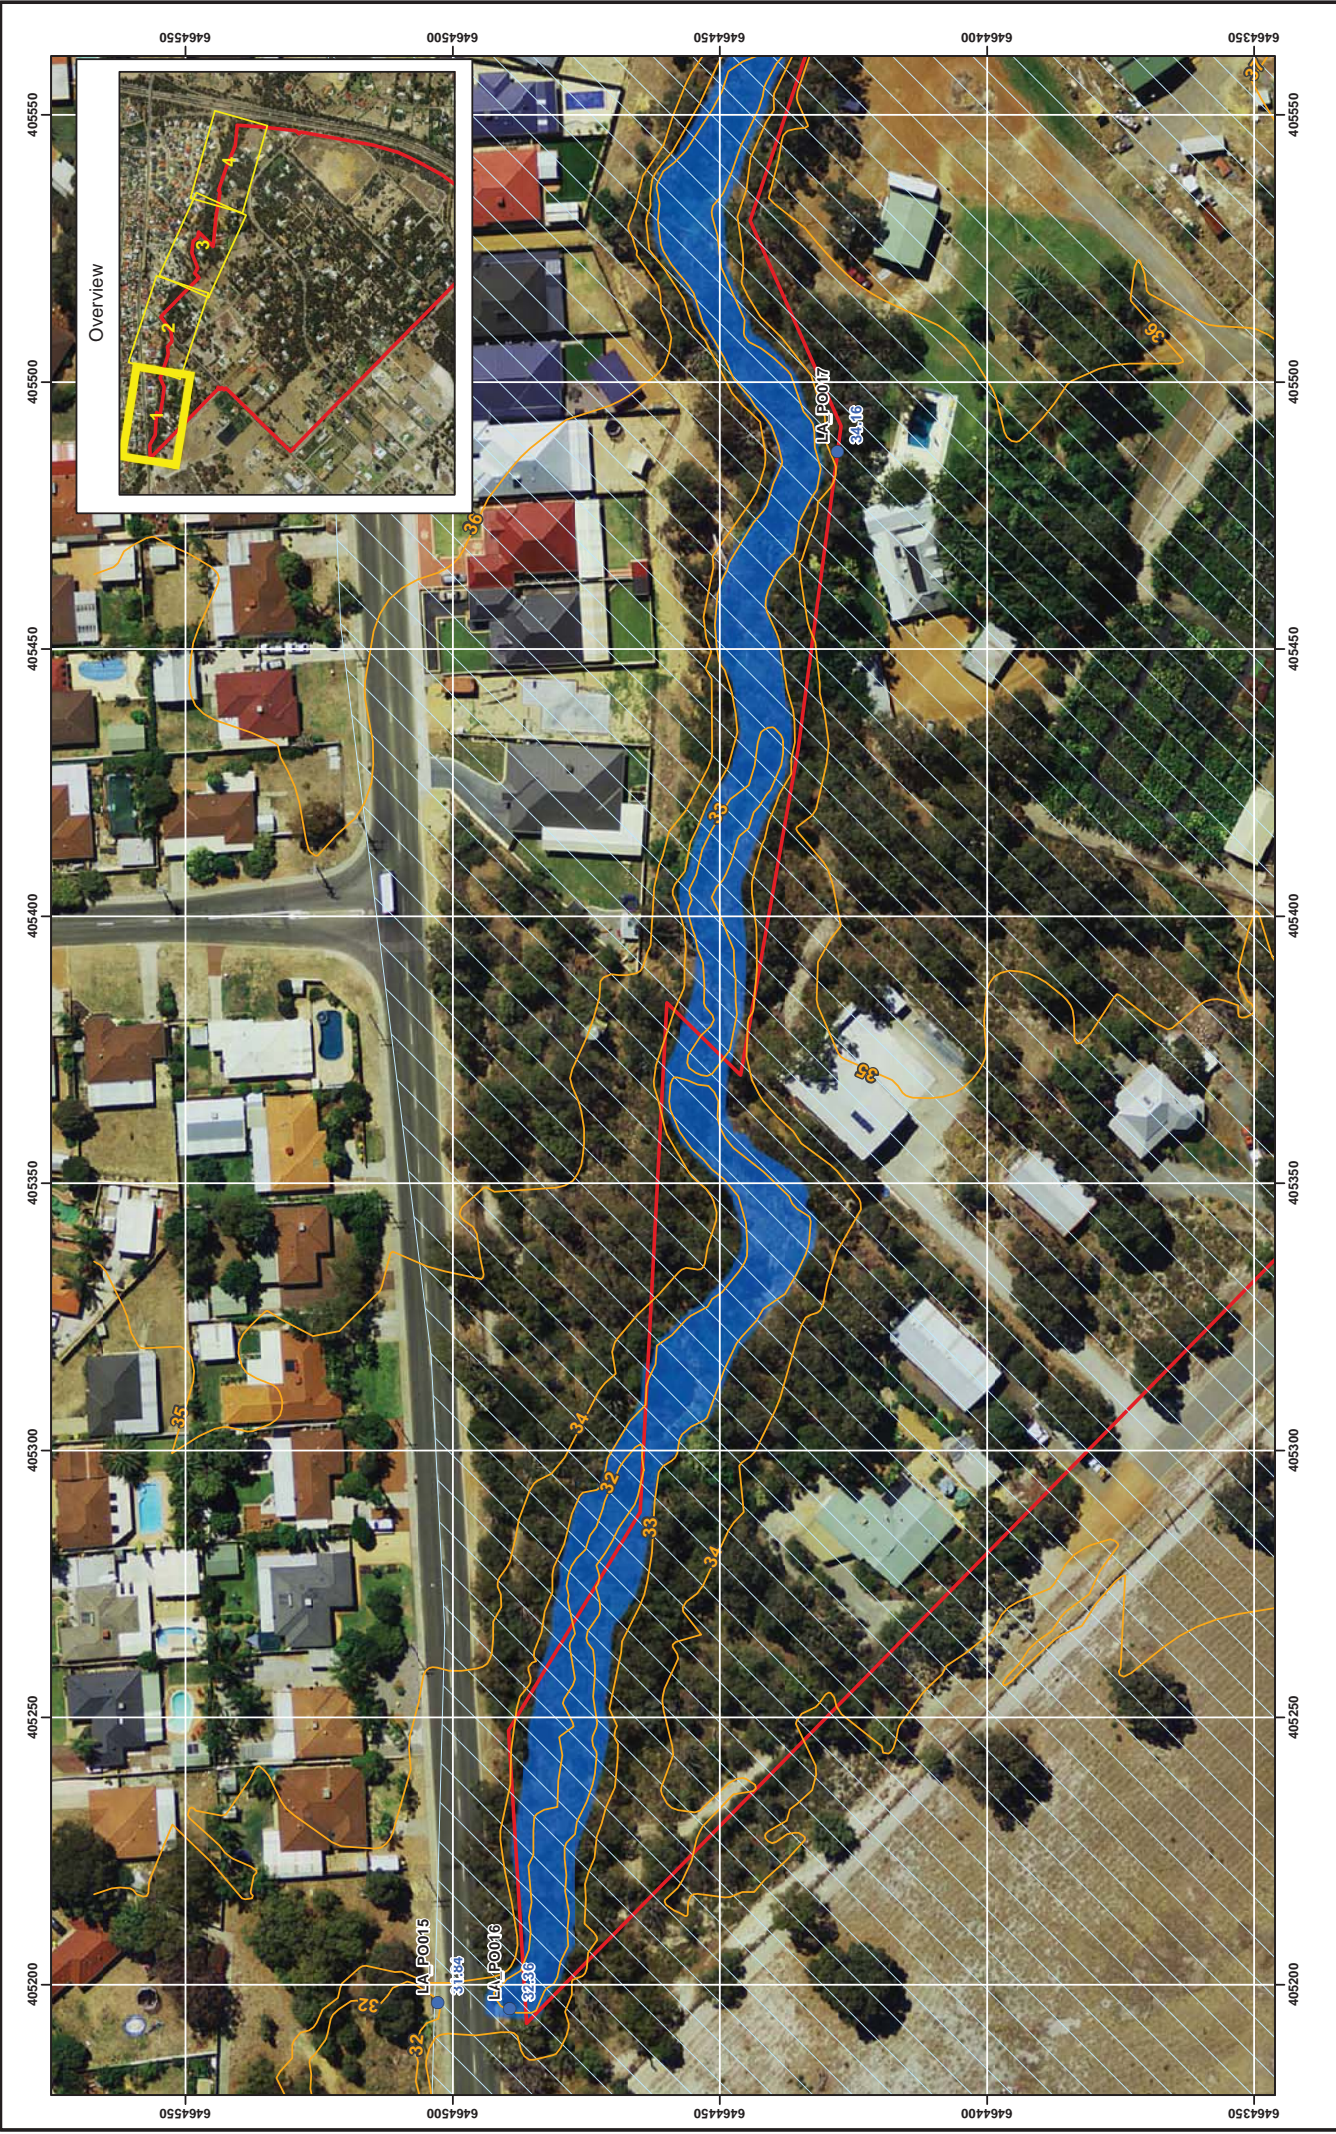
Figure 3 Map 1

- 100 year Flood Modelling Points (Water Corporation)
- Elevation (mAHD)
- Resource Enhancement Wetland
- Project Boundary
- Estimated 100 year flood area*

*1 in 100 year ARI flood levels have been projected based on Water Corporation modelling.
