Forrestfield North Residential Precinct LWMS

Local Water Management Strategy

Prepared for
Element
by Strategen-JBS&G

December 2020

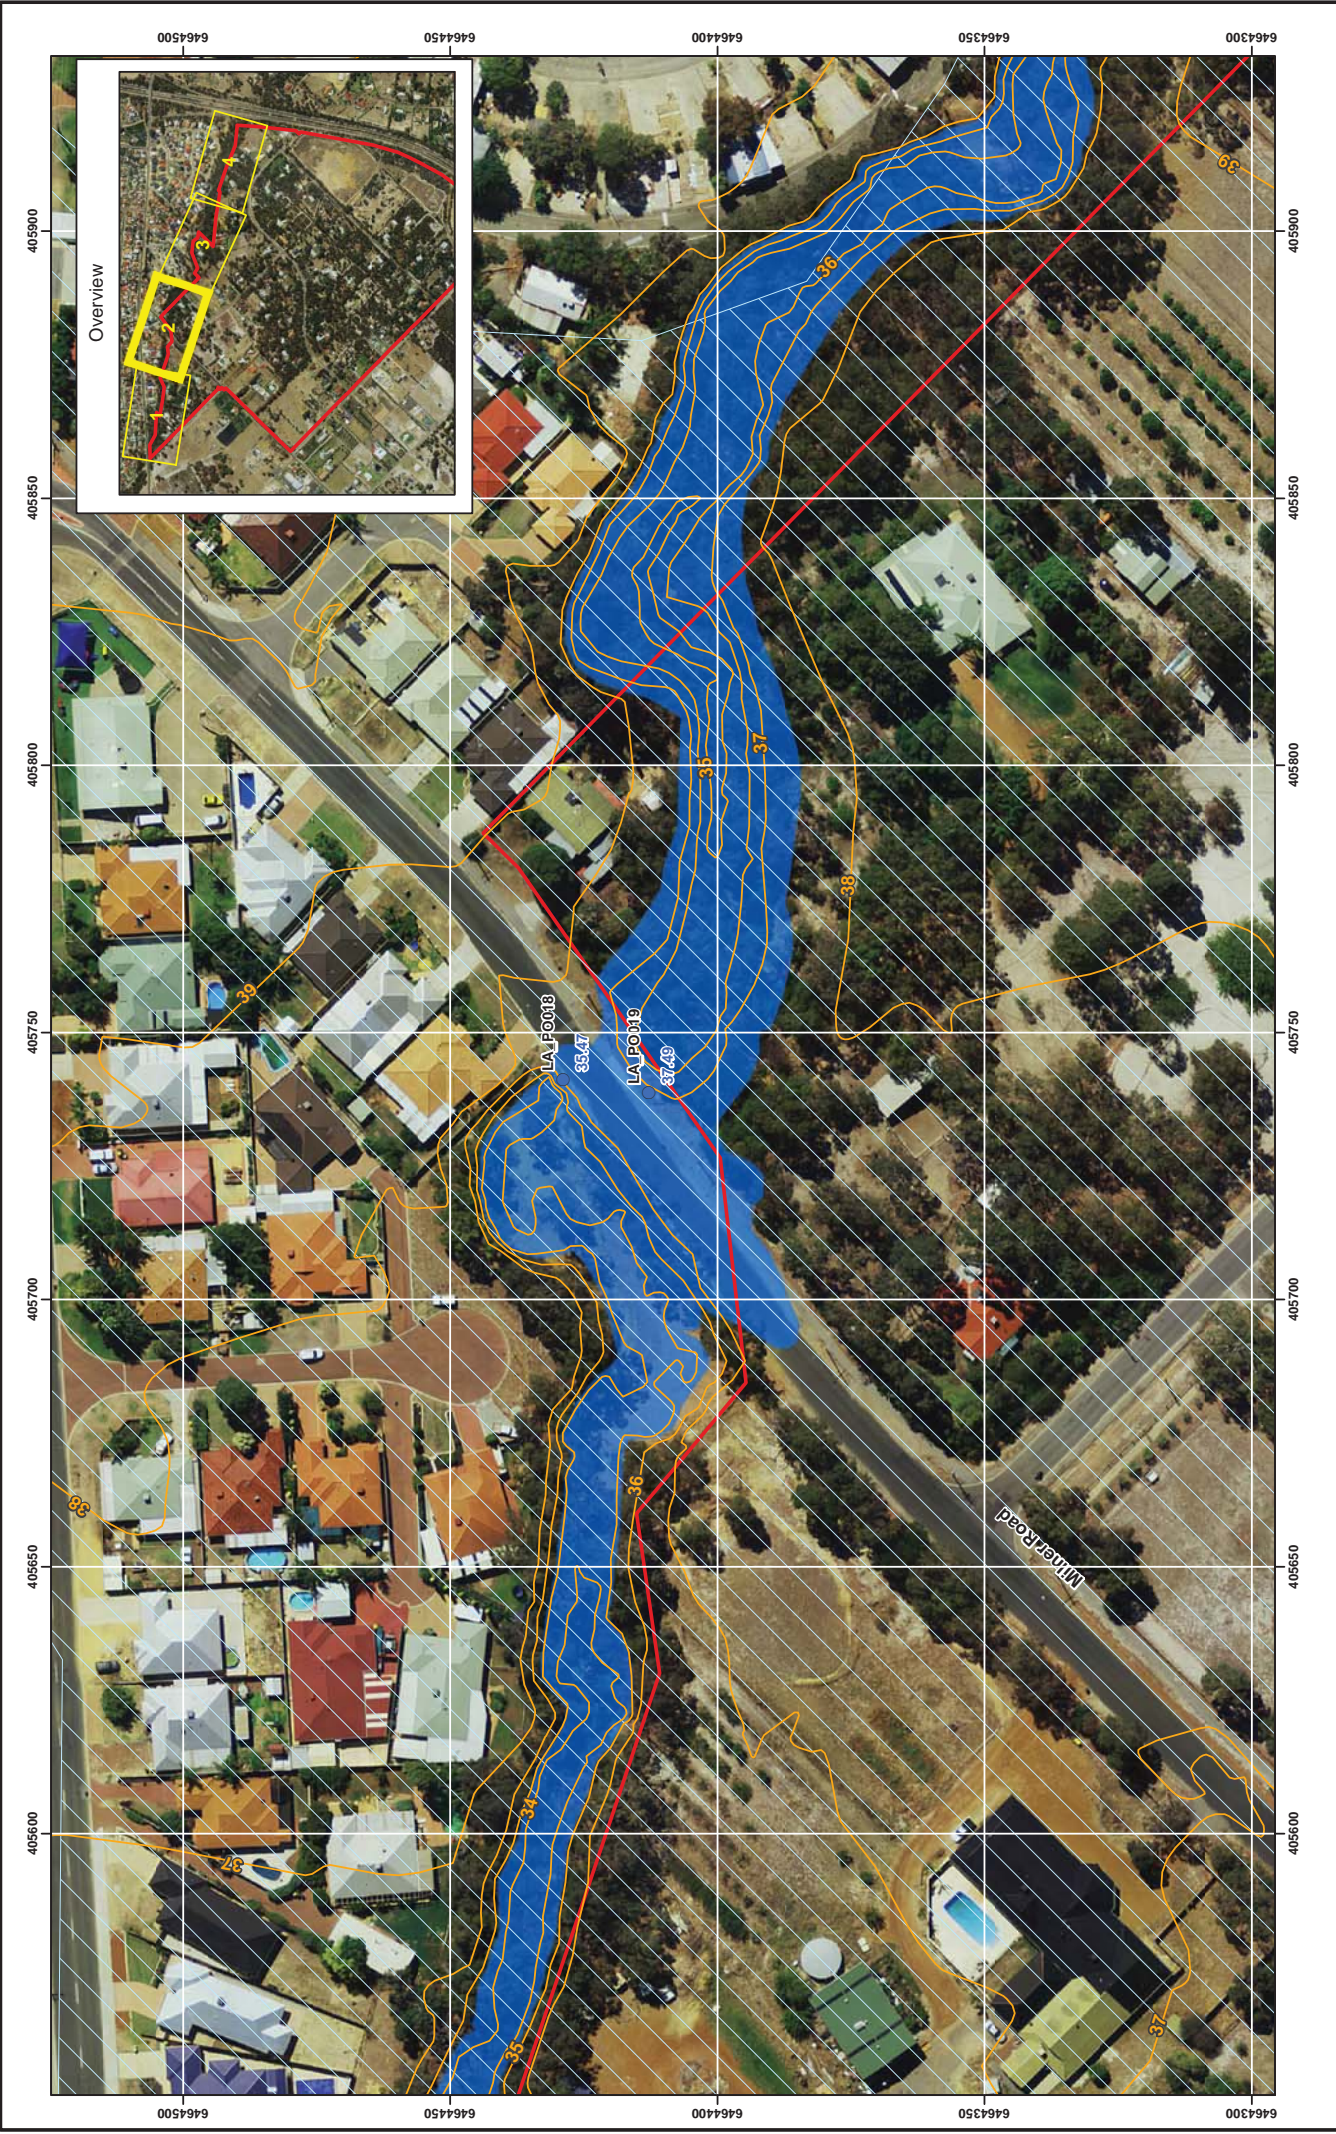
Figure 3 Map 2

- 100 year Flood Modelling Points (Water Corporation)
- Elevation (mAHD)
- Resource Enhancement Wetland
- Project Boundary
- Estimated 100 year flood area*

*1 in 100 year ARI flood levels have been projected based on Water Corporation modelling.

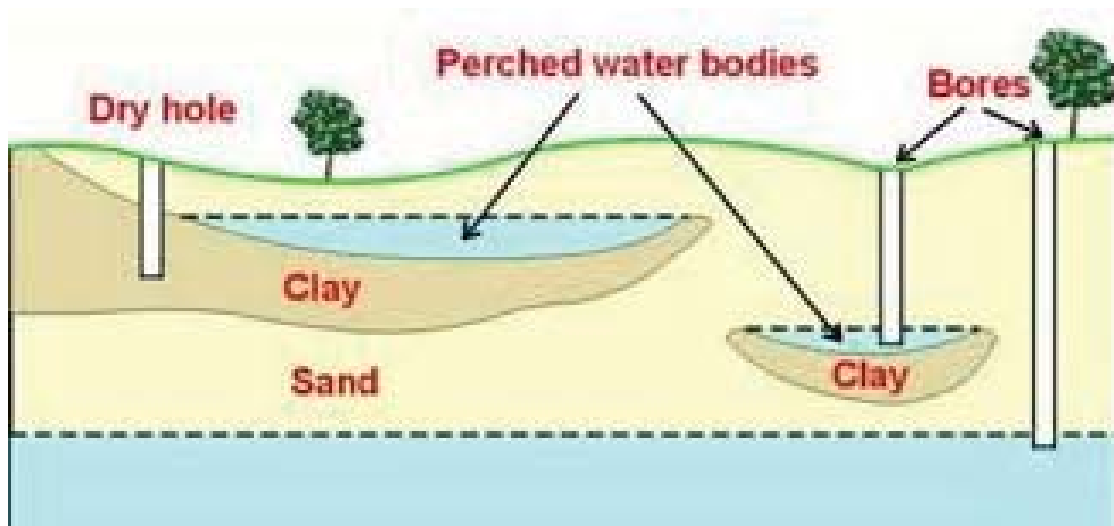
Figure 2-1: Conceptual cross section of perched water body

Perched groundwater can occur at any point in the soil profile where an impeding layer occurs above the permanent superficial aquifer. When present the perched groundwater reflects a localised zone of saturation within the vadose (unsaturated) zone above the permanent watertable. In some circumstances where there is sufficient recharge and sufficient thickness of permeable soils over less permeable soils the presence of perched groundwater can be semi-permanent to permanent. Soils beneath the impeding layer remain unsaturated and are not directly hydraulically connected to the underlying permanent superficial aquifer.

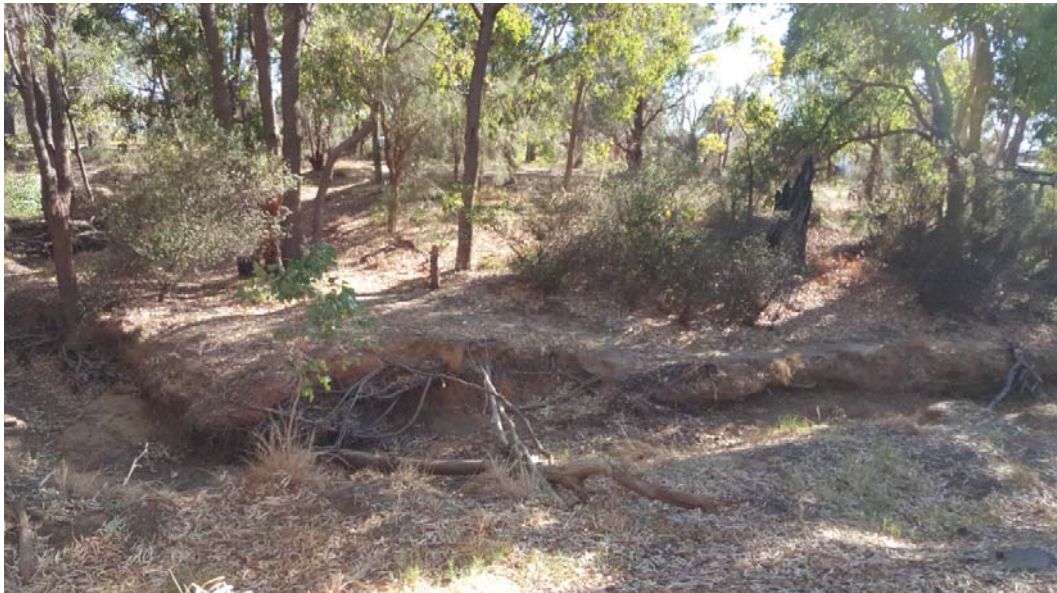
Plate 3: Poison Gully, February 2016 showing erosion

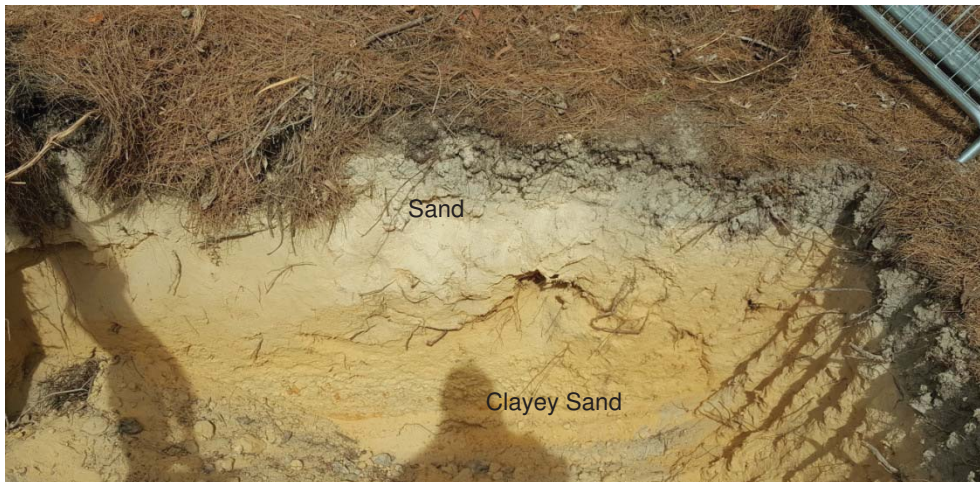
Plate 4: Soil profile at OP2

At all inspected locations, the soil profile was dry and showed no evidence of perching. It is highly unlikely there is any connectivity between potential perched groundwater layers and the regional superficial groundwater table.

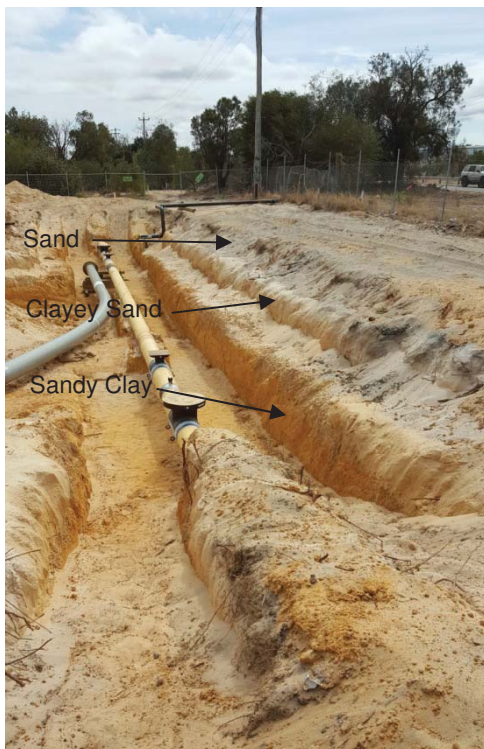
Plate 5: Soil observations at OP1

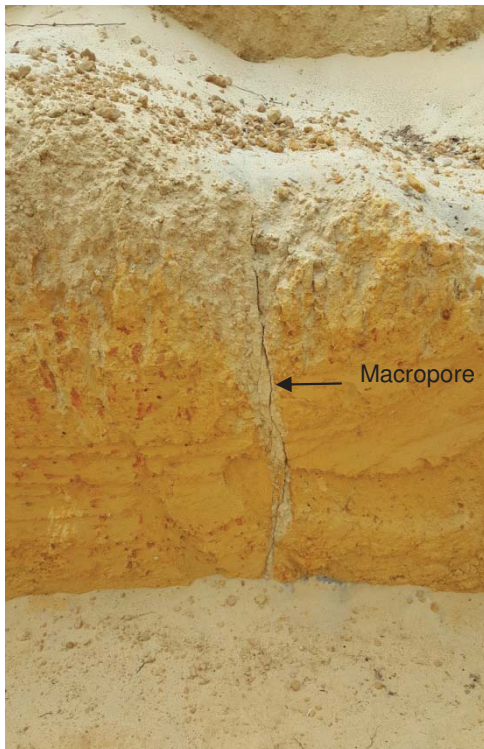
Plate 6: Macropore through sandy clay layer at OP1 and natural gravel within the profile

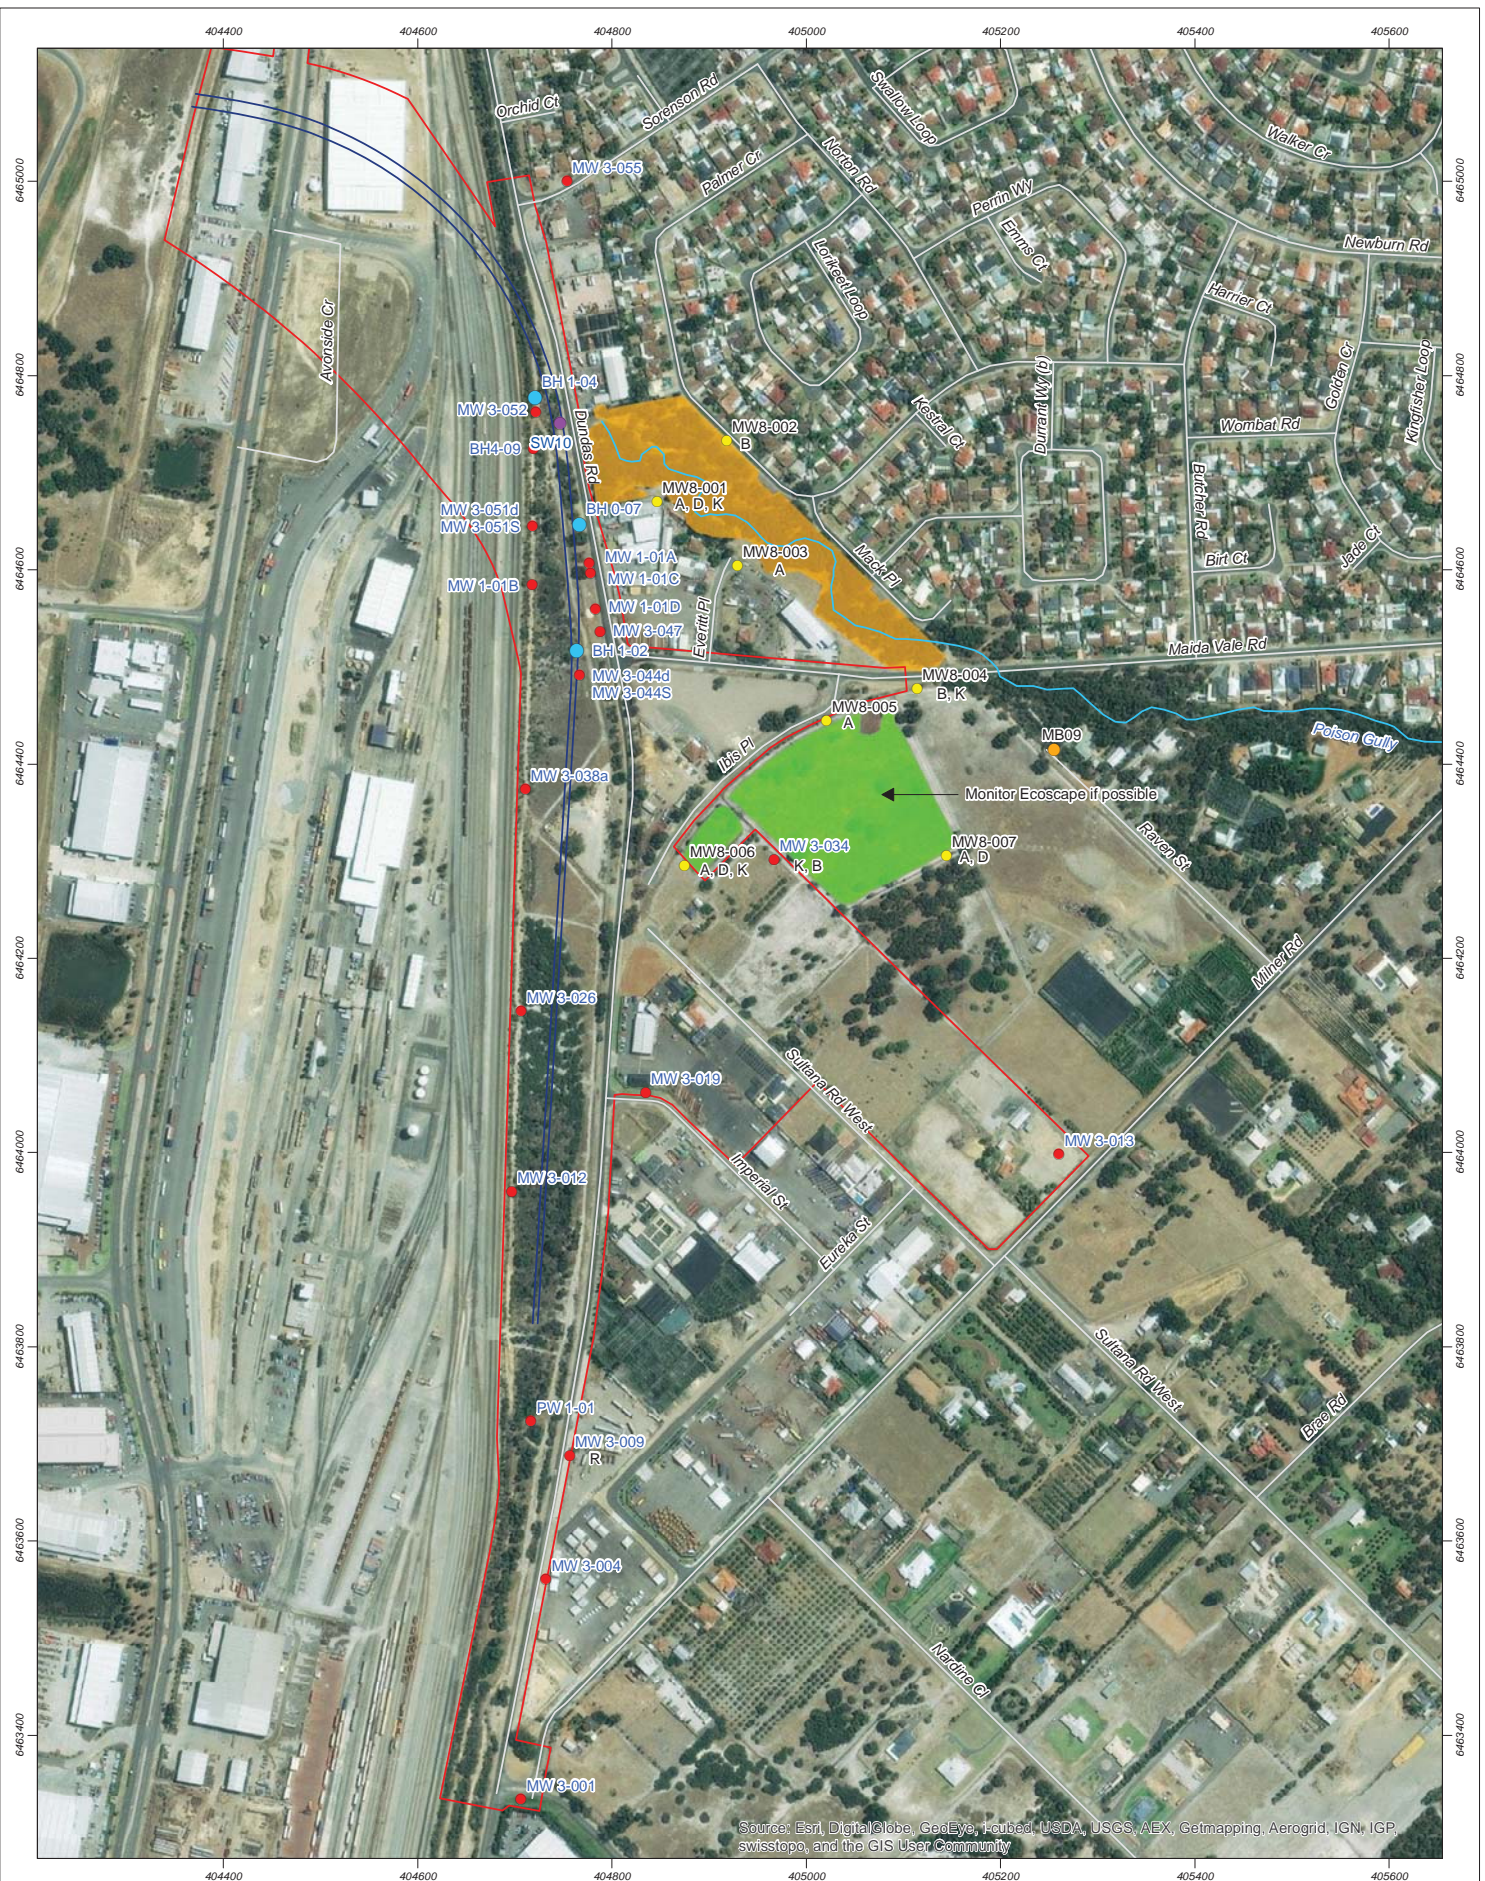
Figure 3-1: Proposed monitoring locations

Should this be the case, locations shall be moved to a nearby location without such sensitivities. The movement of locations may impact on the relevance of the data obtained to the Poison Gully TEC. Where such movement of locations is required, this shall be identified within subsequent reporting and the reason for such movements identified.
