# ASBESTOS REGISTER

KADS Theatre, 6 Central Road, Kalamunda, WA

Report ID: **34748Br0**

Prepared for: **City of Kalamunda**

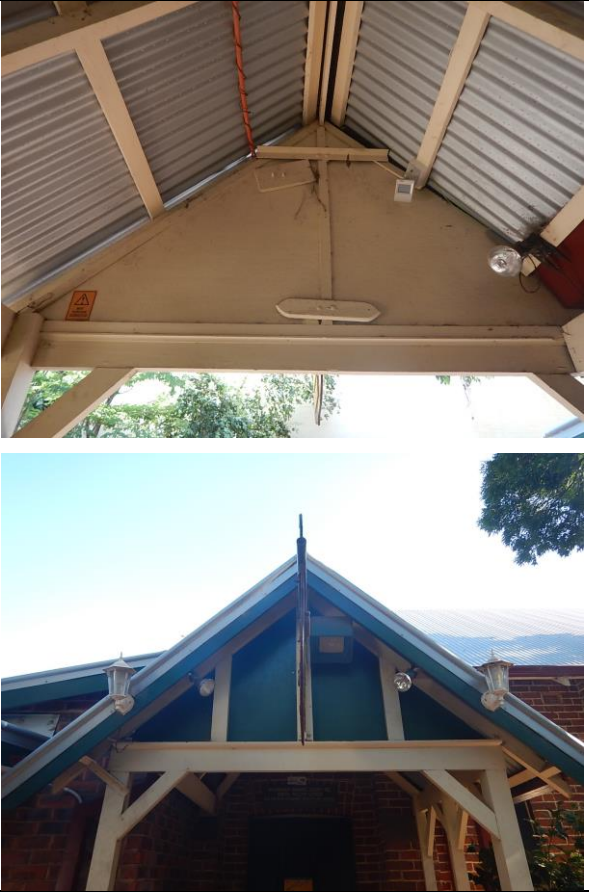
<b>ID 1:- Entry Walkway Fibre Cement Gable Panelling (Asbestos Detected)</b>

Material	Chrysotile asbestos detected.	
Lab No.	Eurofins ARL Lab No. 21-10098-115.	
QED Sample No.	ID: 32447.	
Locations	External – Main entry walkway, gable panels.	
Condition	Good, sealed, non-friable.	
Signage	Labelled.	
Potential for Disturbance	Low.	
<b>Risk</b>	<p>The ACM are not friable and are in stable condition. Ensure that they remain clearly labelled and regularly inspect to ensure they are not deteriorating or otherwise contributing to an unacceptable health risk.</p>	
Management Actions	<p>May remain in-situ until replacement is required.                  Manage as per <b>Asbestos Management Plan</b>.                  Administrative – Follow safe work procedures during removal and maintenance.                  Personal protective equipment – P2 facemask and coveralls required when working on material.</p>

References (See Appendices)	<p><b>Safe Work Australia, Code of Practice: How to Manage and Control Asbestos in the Workplace. WHS Appendix G—Recommended safe working practices</b>                  Safe work practice 1—Drilling of ACM                  Safe work practice 2—Sealing, painting, coating and cleaning of asbestos cement products  <b>Safe Work Australia, Code of Practice: How to Safely Remove Asbestos Appendix E—Examples of asbestos removal work</b>                  Asbestos cement products</p>	
Service Record	<p>Review– January 2028                  Company:                  Date:                  Works:                  Clearance certificate:</p>

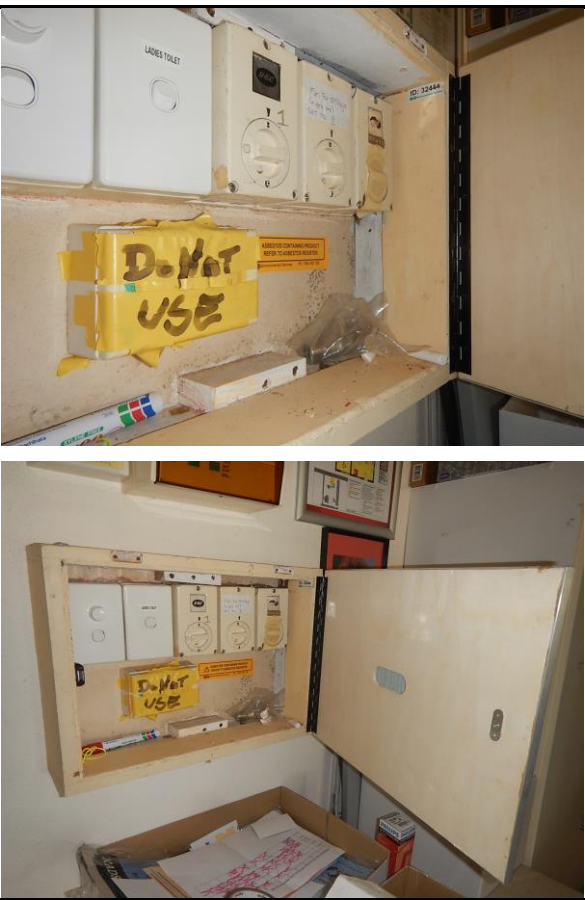
<b>ID 2:- Fibre Cement Electrical Cabinet Lining (Asbestos Detected)</b>

Material	Chrysotile and crocidolite asbestos detected.	
Lab No.	Eurofins ARL Lab No. 21-10098-118.	
QED Sample No.	ID: 32444.	
Locations	Internal – Kitchen, electrical switch cabinet, lining.	
Condition	Good, sealed, non-friable.	
Signage	Labelled.	
Potential for Disturbance	Low.	
<b>Risk</b>	<p><b>The ACM are not friable and are in stable condition. Ensure that they remain clearly labelled and regularly inspect to ensure they are not deteriorating or otherwise contributing to an unacceptable health risk.</b></p>	
Management Actions	<p>May remain in-situ until replacement is required.                  Manage as per <b>Asbestos Management Plan</b>.                  Administrative – Follow safe work procedures during removal and maintenance.                  Personal protective equipment – P2 facemask and coveralls required when working on material.</p>

References (See Appendices)	<p><b>Safe Work Australia, Code of Practice: How to Manage and Control Asbestos in the Workplace. WHS Appendix G—Recommended safe working practices</b>                  Safe work practice 1—Drilling of ACM                  Safe work practice 2—Sealing, painting, coating and cleaning of asbestos cement products</p> <p><b>Safe Work Australia, Code of Practice: How to Safely Remove Asbestos Appendix E—Examples of asbestos removal work</b>                  Asbestos cement products</p>	
Service Record	<p>Review– January 2028                  Company:                  Date:                  Works:                  Clearance certificate:</p>

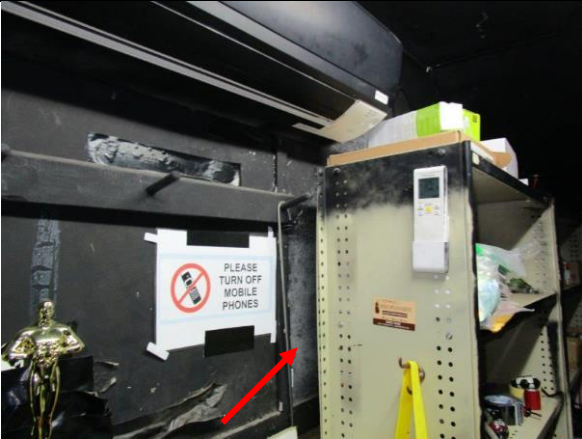
<b>ID 3:- "Bio Box" Wall Panelling (Asbestos Detected)</b>

Material	Chrysotile and crocidolite asbestos detected.	
Lab No.	Eurofins ARL Lab No. 21-10098-119.	
QED Sample No.	ID: 32443.	
Locations	Internal – "Bio Box", wall panels (behind metal cabinet).	
Condition	Good, sealed, non-friable.	
Signage	None.	
Potential for Disturbance	Low.	
<b>Risk</b>	<b>The ACM are not friable and are in stable condition. Ensure that they remain clearly labelled and regularly inspect to ensure they are not deteriorating or otherwise contributing to an unacceptable health risk.</b>	
Management Actions	Label when practicable. May remain in-situ until replacement is required. Manage as per <b>Asbestos Management Plan</b> . Administrative – Follow safe work procedures during removal and maintenance. Personal protective equipment – P2 facemask and coveralls required when working on material.	
References (See Appendices)	<b>Safe Work Australia, Code of Practice: How to Manage and Control Asbestos in the Workplace.</b> <b>WHS Appendix G—Recommended safe working practices</b> Safe work practice 1—Drilling of ACM Safe work practice 2—Sealing, painting, coating and cleaning of asbestos cement products <b>Safe Work Australia, Code of Practice: How to Safely Remove Asbestos</b> <b>Appendix E—Examples of asbestos removal work</b> Asbestos cement products

Service Record	Review– January 2028 Company: Date: Works: Clearance certificate:

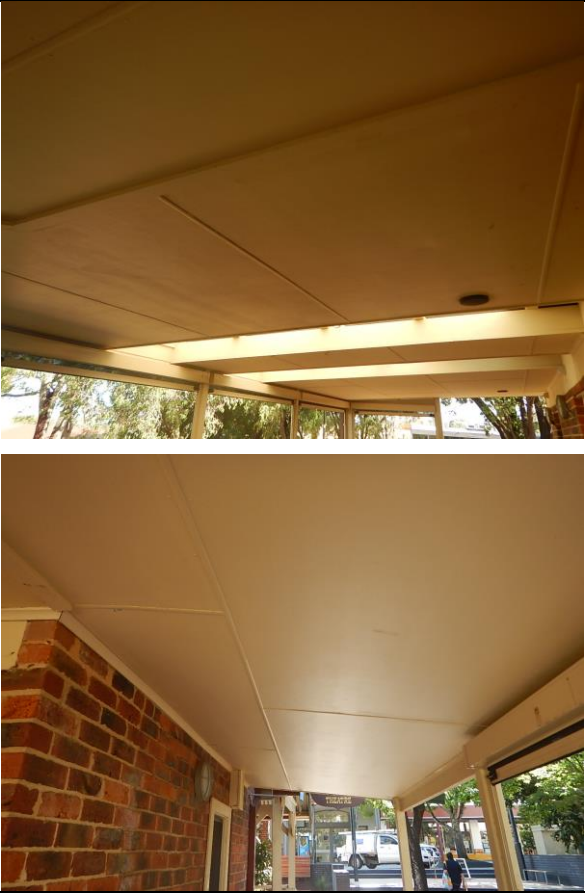
<b>ID 4:- Fibre Cement Canopy Panelling (Suspected Asbestos Containing Material)</b>

Material	Suspected asbestos containing material.	
Lab No.	Unable to obtain suitable sample.	
QED Sample No.	ID: Observed.	
Locations	External – Western elevation, canopy, ceiling panels.	
Condition	Good, sealed, non-friable.	
Signage	None.	
Potential for Disturbance	Low.	
<b>Risk</b>	<p><b>The ACM are not friable and are in stable condition. Ensure that they remain clearly labelled and regularly inspect to ensure they are not deteriorating or otherwise contributing to an unacceptable health risk.</b></p>	
Management Actions	<p>Label when practicable.                  May remain in-situ until replacement is required.                  Manage as per <b>Asbestos Management Plan</b>.                  Administrative – Follow safe work procedures during removal and maintenance.                  Personal protective equipment – P2 facemask and coveralls required when working on material.</p>

References (See Appendices)	<p><b>Safe Work Australia, Code of Practice: How to Manage and Control Asbestos in the Workplace.</b>  <b>WHS Appendix G—Recommended safe working practices</b>                  Safe work practice 1—Drilling of ACM                  Safe work practice 2—Sealing, painting, coating and cleaning of asbestos cement products  <b>Safe Work Australia, Code of Practice: How to Safely Remove Asbestos</b>  <b>Appendix E—Examples of asbestos removal work</b>                  Asbestos cement products</p>	
Service Record	<p>Review– January 2028                  Company:                  Date:                  Works:                  Clearance certificate:</p>
